UNITED STATES AIR FORCE
AIRCRAFT ACCIDENT INVESTIGATION
BOARD REPORT

C-17A, T/N 10-000215

16TH AIRLIFT SQUADRON
437TH AIRLIFT WING
JOINT BASE CHARLESTON, SOUTH CAROLINA

DATE OF ACCIDENT: 21 AUGUST 2023

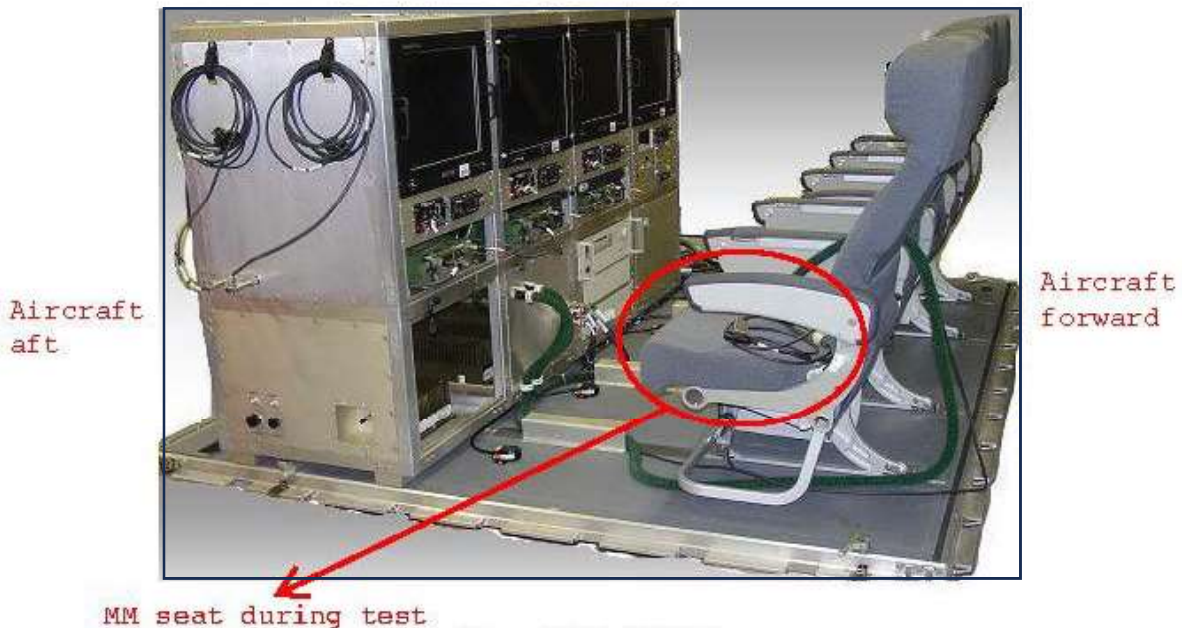
Figure 1 Tab BB-132

Figure 5.3.3-1. C3 Pallet

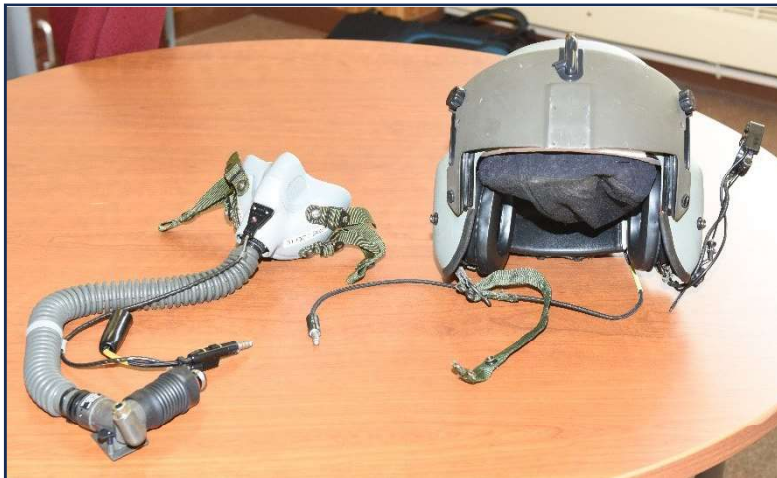
Figure 2 Tab Z-3

The MM's issued helmet and oxygen mask combination differed from other team members' helmets due to a previous fitting issue with the standard HGU-55/P helmet primarily used on the C-17 (Tab V-23.3 to V-23.5, Tab Z-3). The HGU-56/P helmet does not currently have a Safe-to-Fly certification for the C-17, which means it is not a qualified/certified helmet option for use on C-17 missions (Tab BB-4).

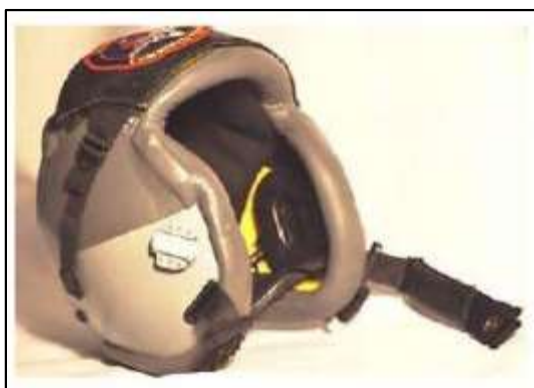
Figure 6 Tab Z-16

The HGU-55/P helmet is the primary qualified helmet issued to aircrew and MEP performing duties on the C-17 (Tab BB-145). Medium and large helmet sizes of the HGU-55/P are designed to satisfy the head size range from the 3rd to 98th percentile of all personnel (Tab BB-147 to BB-148). These sizes are supplemented with an X-large size for head sizes that range slightly beyond the 99th percentile (Tab BB-148). All members of the MS wore the HGU-55/P helmet with the exception of the MM (Tab V-13.9).

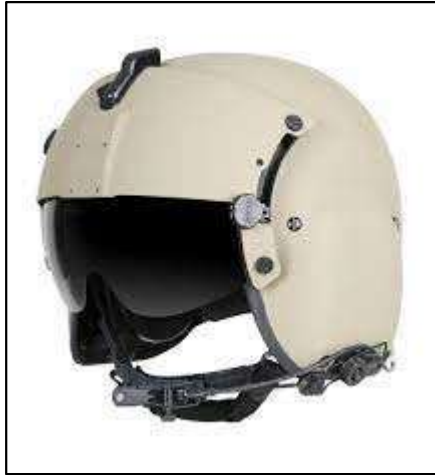
Figure 7 Tab Z-6

The HGU 56/P helmet displayed cosmetic damage but nothing affecting the operation of the helmet (Tab Z-12).
