UNITED STATES AIR FORCE
GROUND ACCIDENT INVESTIGATION
BOARD REPORT

**SEARCH AND RESCUE TACTICAL VEHICLE –
SIDE BY VEHICLE
S/N SRTVSXVD21AFM060**

**TYPE OF ACCIDENT:
Tactical Vehicle Serious Injury**

LOCATION: North Field, Tinian, Northern Mariana Islands

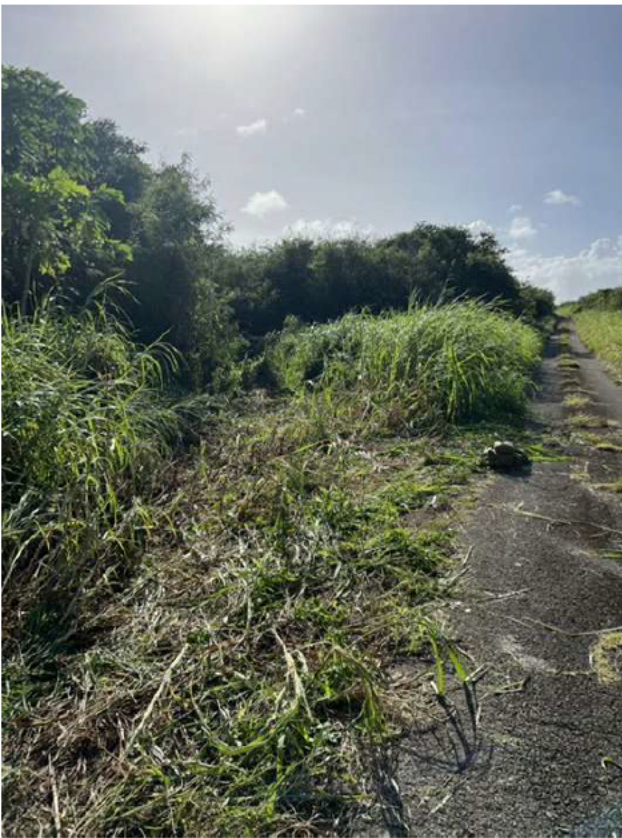
The MV departed the road to the left and entered the thick vegetation (Tabs R-77, R-97, and V-4.9). The MV completed a counterclockwise right leading rollover, coming to rest back on its tires against trees more than 30 feet from the road (Tabs R-77, R-97, O-4, and V-5.4.). Neither MA1 nor MA2 were wearing seatbelts or other personal protective equipment (Tabs V-3.6 and V-8.4 to V-8.5). MA1 was ejected from the MV and sustained serious injuries, resulting in permanent paralysis below the waist (Tabs V-4.9 and Tab X-4). MA2 was ejected from the MV (Tabs V-3.6 and V-8.6). During the rollover and after ejection, the MV struck MA2 causing life-threatening injuries to include a pelvic fracture and internal abdominal injuries, which has resulted in numerous corrective surgeries and an above-the-knee amputation (Tabs V-8.7 and Tab X-5 to X-6).

Figure 4: Vegetation flattened by MV after departing road (view - direction of travel) (Tab S-150)

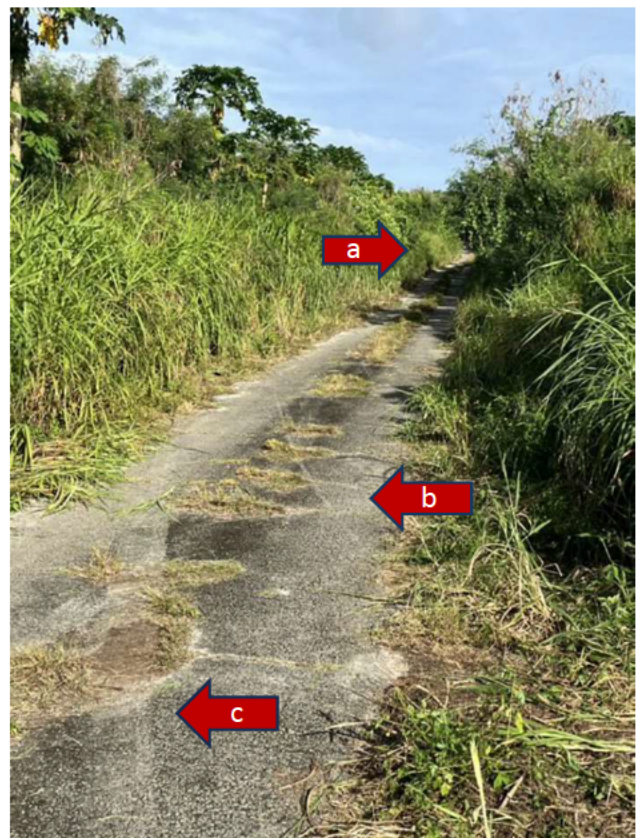
Figure 5: (a) Road narrowed by vegetation overgrowth, (b) and (c) MV tire marks departing road (view - opposite direction of travel) (Tab S-158)

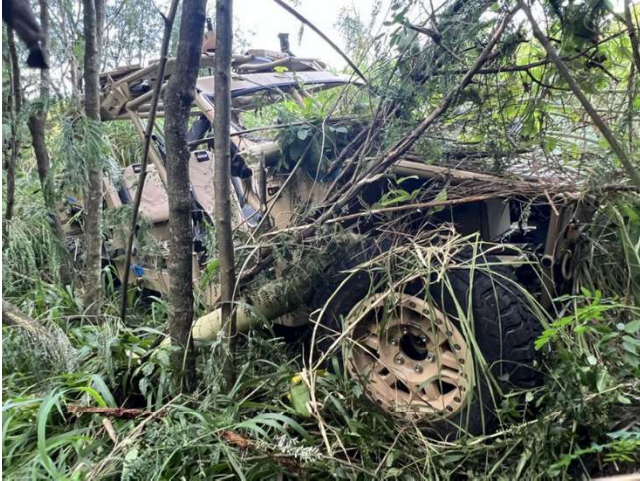
Figure 6: Passenger side of MV at mishap site (Tab S-172)

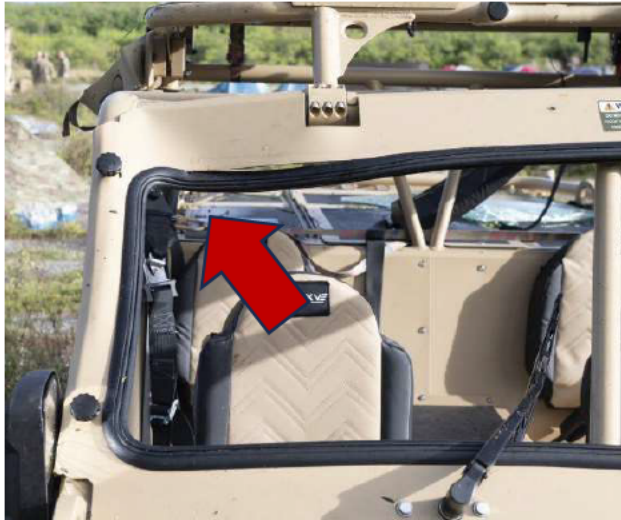
The MV was inspected by the GAIB, which noted that damage was almost entirely on the passenger (right) side (Tabs J-3 to J-6).

Figure 12: Missing passenger side windshield and bent frame (Tab S-73)

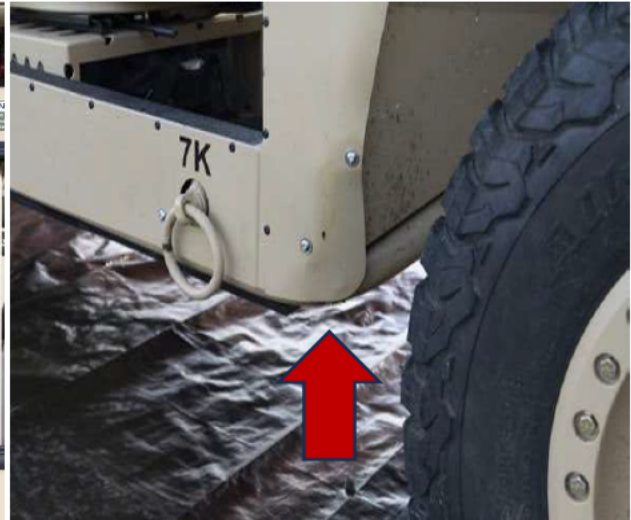
Figure 13: Passenger side wheel well damage (Tab S-69)

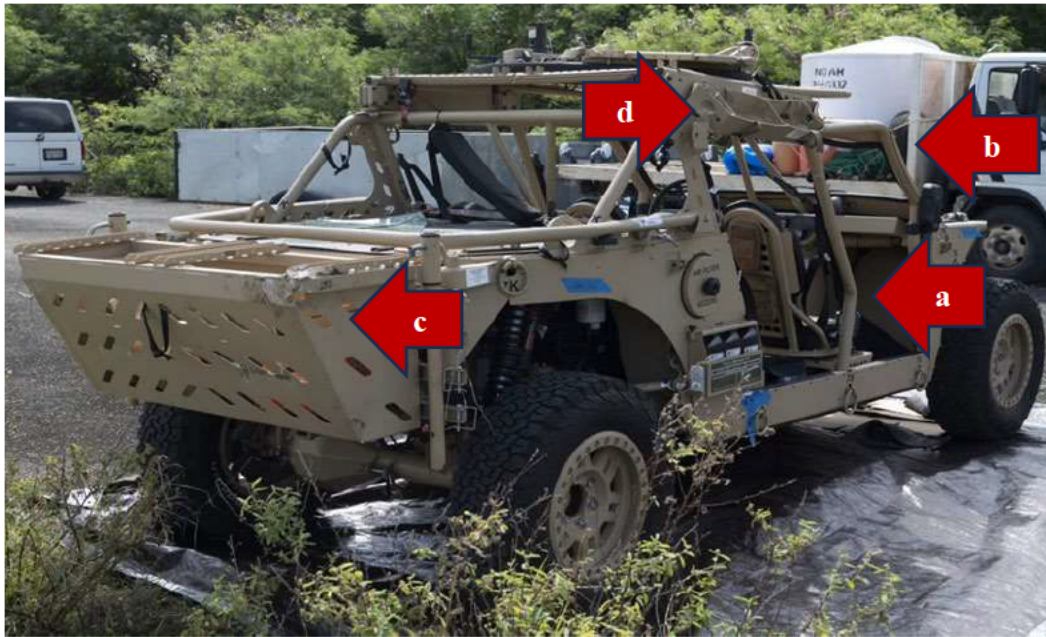
Figure 14: (a) Bent roll cage by passenger seat, (b) Bent windshield frame, (c) Damage to cargo bin on rear passenger side, (d) Crushed bins on passenger side roof (Tab S-142)

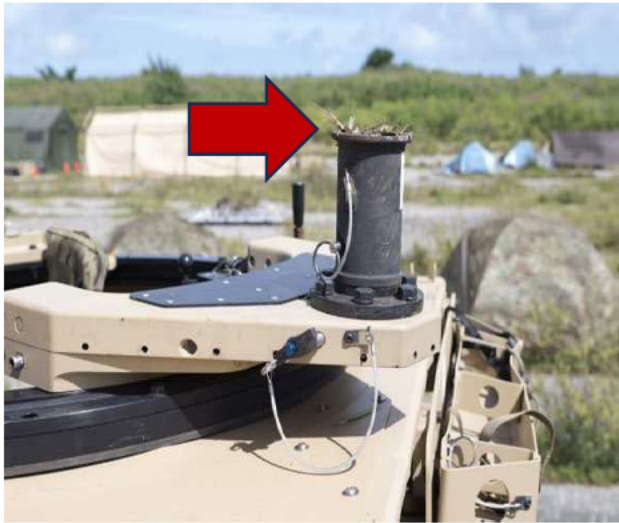
Figure 15: Turret mount packed with dirt and vegetation on roof of the driver side (Tab S-136)

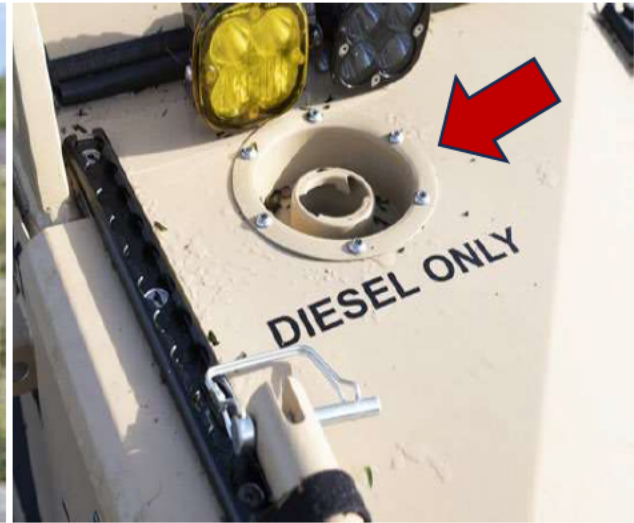
Figure 16: Missing diesel fuel cap on the passenger side hood (Tab S-88)

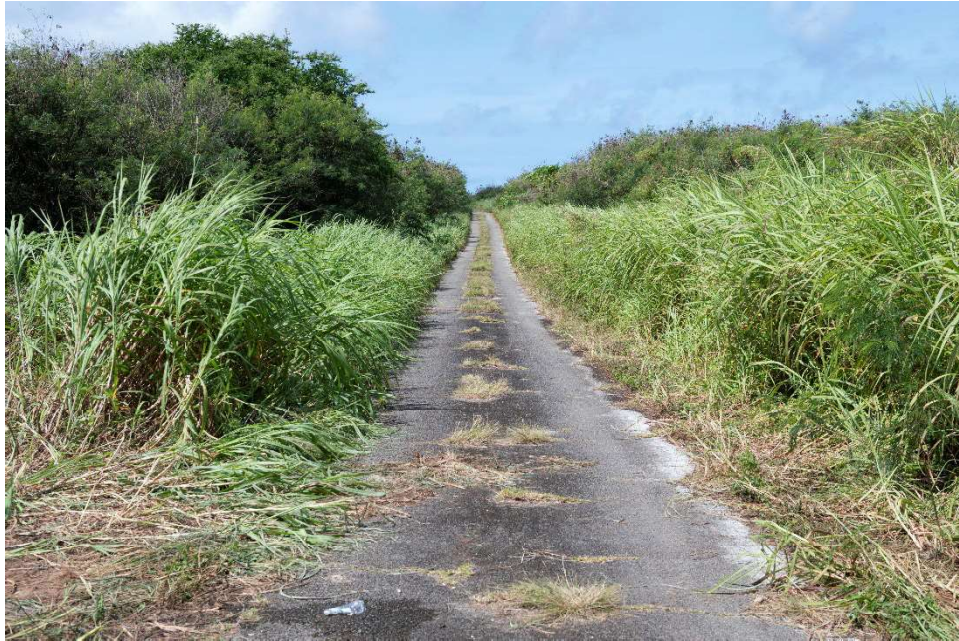
Most roads on Tinian were designed, developed, and constructed in 1944, with many of the existing roads now in poor condition (Tab BB-84). The unnamed roads in the North Field area are typically unpaved, moderately to severely overgrown with vegetation, and experience low traffic volumes (Tab BB-86). These roads have not been improved or resurfaced since their original construction during World War II (Tab V-5.6).

Figure 17 - Unnamed Road Where Mishap Occurred (Tab S-13)
