UNITED STATES AIR FORCE
AIRCRAFT ACCIDENT INVESTIGATION
BOARD REPORT

CV-22B, T/N 10-0054

**21st SPECIAL OPERATIONS SQUADRON
353rd SPECIAL OPERATIONS WING
YOKOTA AIR BASE, JAPAN**

DATE OF ACCIDENT: 29 NOVEMBER 2023

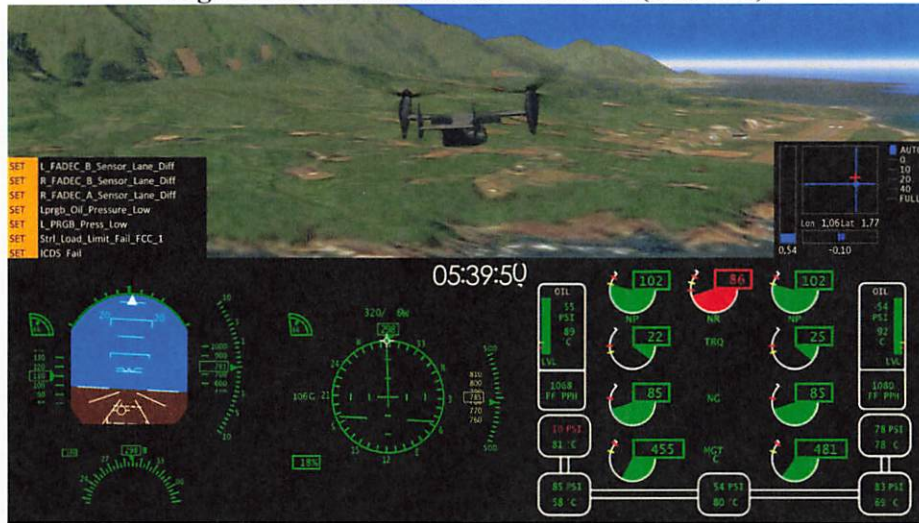
Within the last six seconds of data, cascading failures in short succession were recorded by the KVADR (Tab DD-49). Audible engine surges could be heard in the ambient recording from the cockpit microphone, followed by an auditory master caution tone (Tab DD-49). Left-hand PRGB oil pressure rapidly dropped with an associated, “L PRGB OIL PRESS LOW” caution, followed by a voice warning, “DRIVESHAFT FAILURE, DRIVESHAFT” (Tabs DD-49, and II-64).

Figure 13. Animation at 14:39:50L (Tab Z-9)

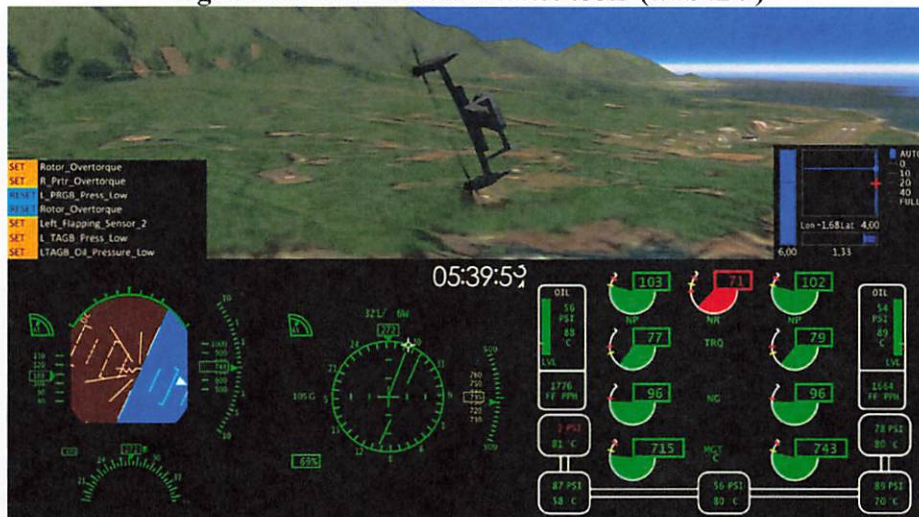
Approximately one-half mile from the approach end of runway 32, the MA was at 785 feet, 106 knots ground speed, with nacelles at 66 degrees, flaps set to auto, and the landing gear retracted, as shown in Figure 15 (Tab DD-49 to DD-50). Every step of the Before Landing Checklist was completed except the extension of the landing gear (Tab II-58). At 14:39:53L (5:39:53Z), 49 minutes after the first left-hand PRGB CHIP BURN advisory posted, the MA abruptly rolled left and rapidly exceeded 90 degrees angle of bank (Tab DD-50). The KVADR's last record was at 5:39:53Z (14:39:53L) depicted in Figure 16 below (Tab Z-9). The thrust control lever was all the way forward at full power (Tab DD-50). The cyclic was 1.6 inches forward of center and full right, the rudder was 1.3 inches right (Tab DD-50). The MA rolled inverted and continued to roll to the left, the left nacelle caught on fire, and an object separated from the MA and fell to the water to the right of the aircraft flight path (Tab DD-50). The MA disappeared from radar at 14:40L (5:40Z) (Tab EE-9). The MA impacted the water upright, nose down, and rolling left (Tab DD-50).

Figure 14. Animation at 14:39:53L (Tab Z-9)

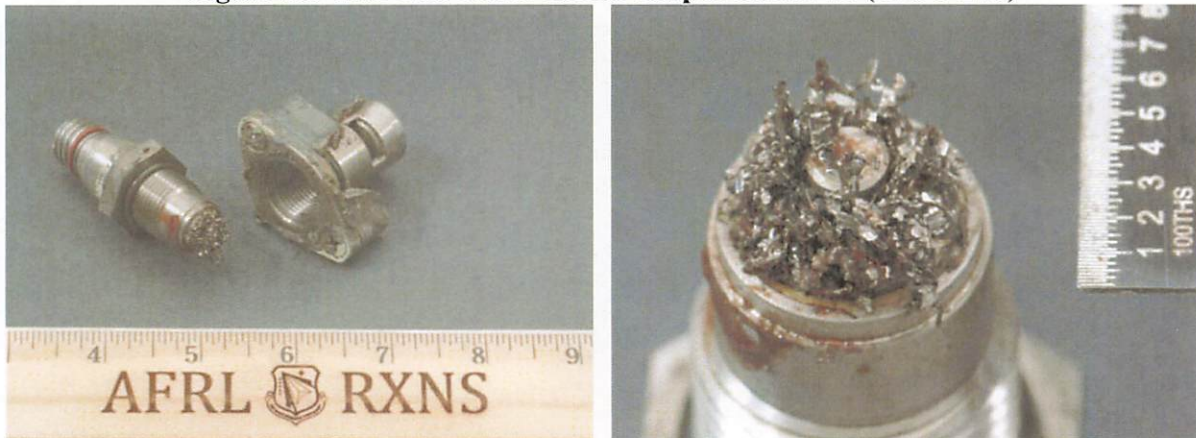
When tested with debris present, as seen in figures 17, 18, and 19 low resistance was measured across the left-hand #1, left-hand #2, and left-hand #3 detector electrodes (Tab J-231). After the debris was removed, nominal resistances were measured (Tab J-231). The change in resistance after the debris was removed confirms that the debris sensors were correctly reporting to the monitoring systems (Tab J-231). Fracture of the right-hand #3 detector housing is consistent with impact damage (Tab J-231). Excess signal leakage current and galvanic voltage noted on the left-hand #2 detector are consistent with intrusion of ionic fluid, such as saltwater (Tab J-231).

Figure 15. MA Left-Hand PRGB Chip Detector #1 (Tab J-240)

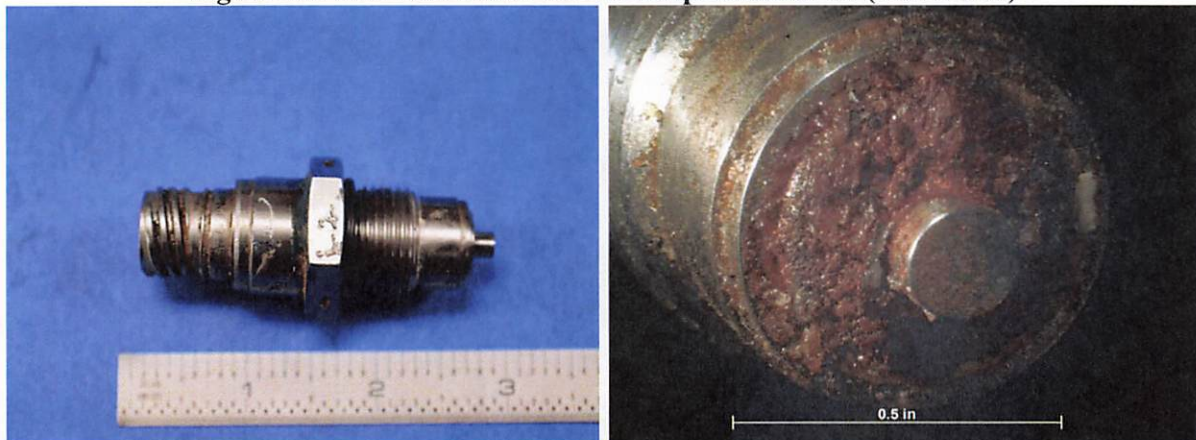
Figure 16. MA Left-Hand PRGB Chip Detector #2 (Tab J-241)

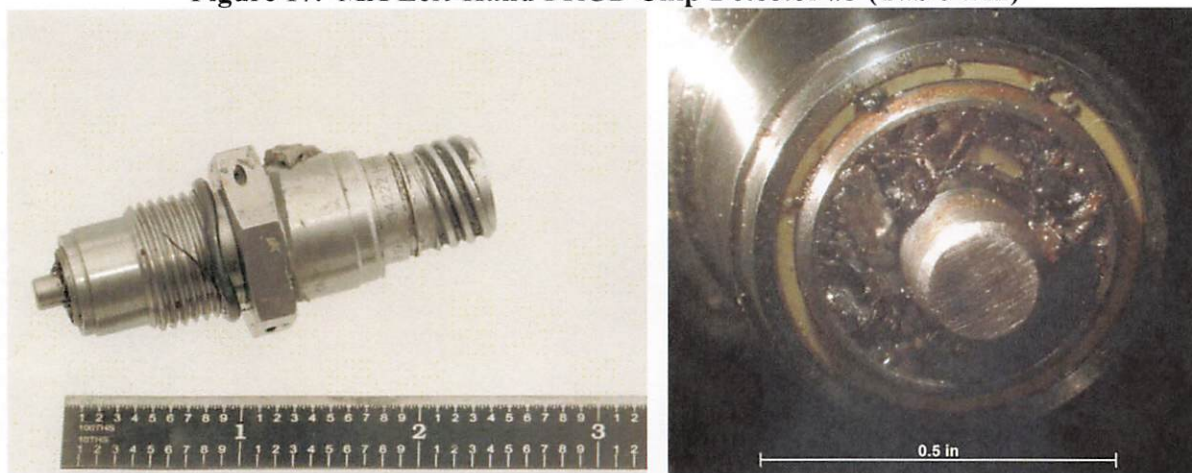
Figure 17. MA Left-Hand PRGB Chip Detector #3 (Tab J-242)

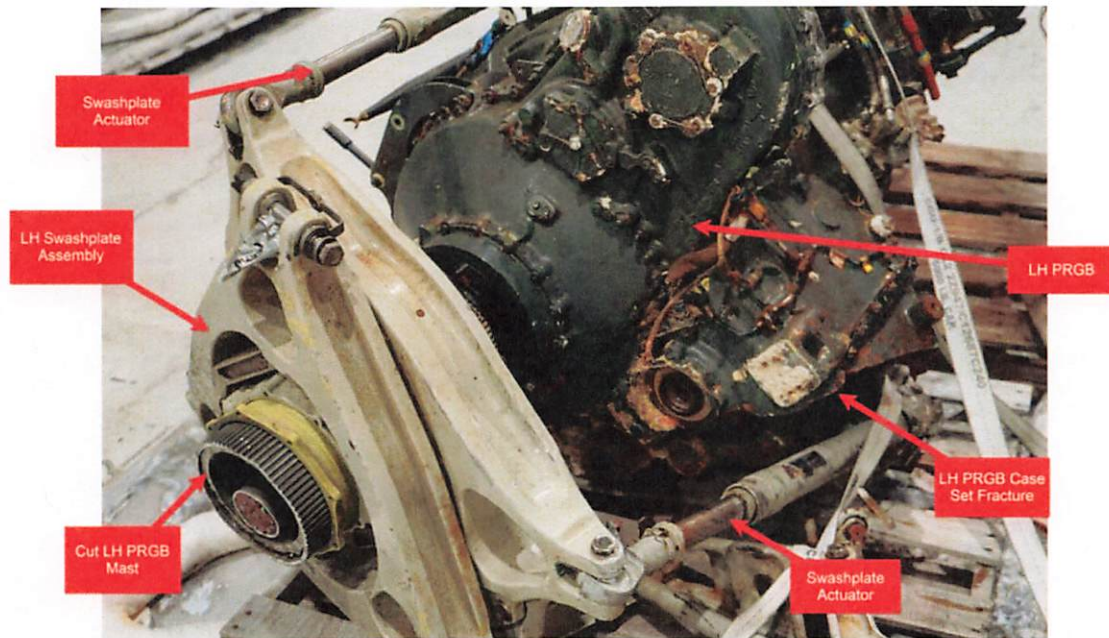
Figure 18. MA Left-Hand PRGB Barrel Section As-Received (Tab J-379)

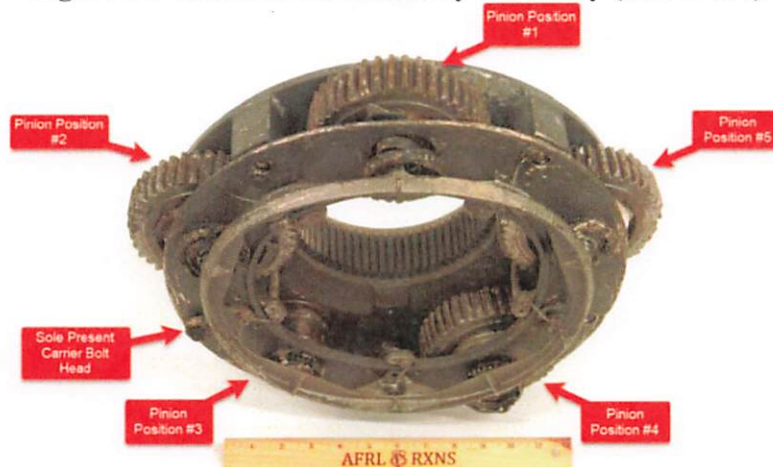
Figure 21. Cleaned HS Planetary Assembly (Tab J-427)

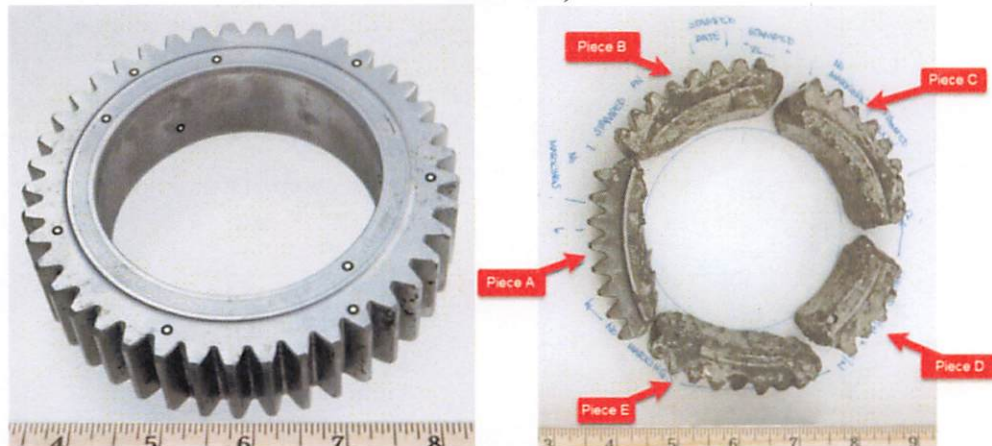
Figure 22. New vs. Five Pieces of Broken High-Speed Planetary Gear Pinion (Tab J-172, and J-421)
