UNITED STATES AIR FORCE
GROUND ACCIDENT INVESTIGATION
BOARD REPORT

UA-HMMWV, L/P 12L00750

**341st Missile Security Forces Squadron
341st Missile Wing
Malmstrom Air Force Base, Montana**

**UA-HMMWV, L/P 12L00750
US HIGHWAY 89, MILE MARKER 59
21 OCTOBER 2023**

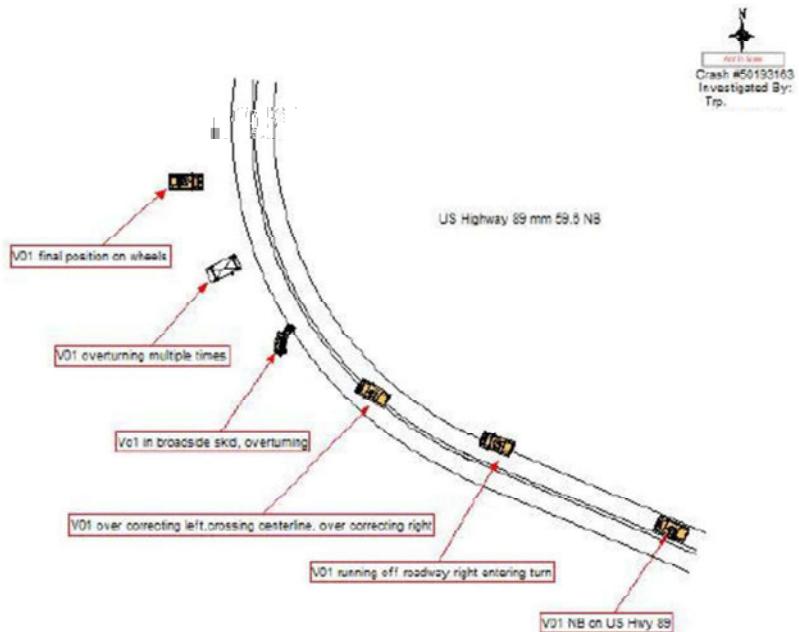
Figure 4-3 (Tab FF-8)
Diagram of Crash

his head was down and told him that they were no longer on the road (Tab EE-157). MPAX was initially unsure whether MVO was asleep or looking at the fuel gauge; however, he clarified that he believes MVO was asleep because of the way he jerked his body when MPAX called out to him (Tabs V-1.2, V-1.6, and EE-157). After MPAX called out, MVO jerked the steering wheel and the MV swerved into the left lane (Tab EE-157). MVO then swerved the vehicle back to the right (Tab EE-157). Due to being oversteered to the right, the MV started sliding forward in a clockwise direction, which left three separate yaw marks as it left the roadway (Tab EE-157 and FF-6). It departed the left-hand side of the roadway before tripping and overturning multiple times along the roadway's edge (Tab FF-6). The MV came to rest on the left side of the roadway on its wheels with the front end of the MV facing the roadway (Tab FF-8).

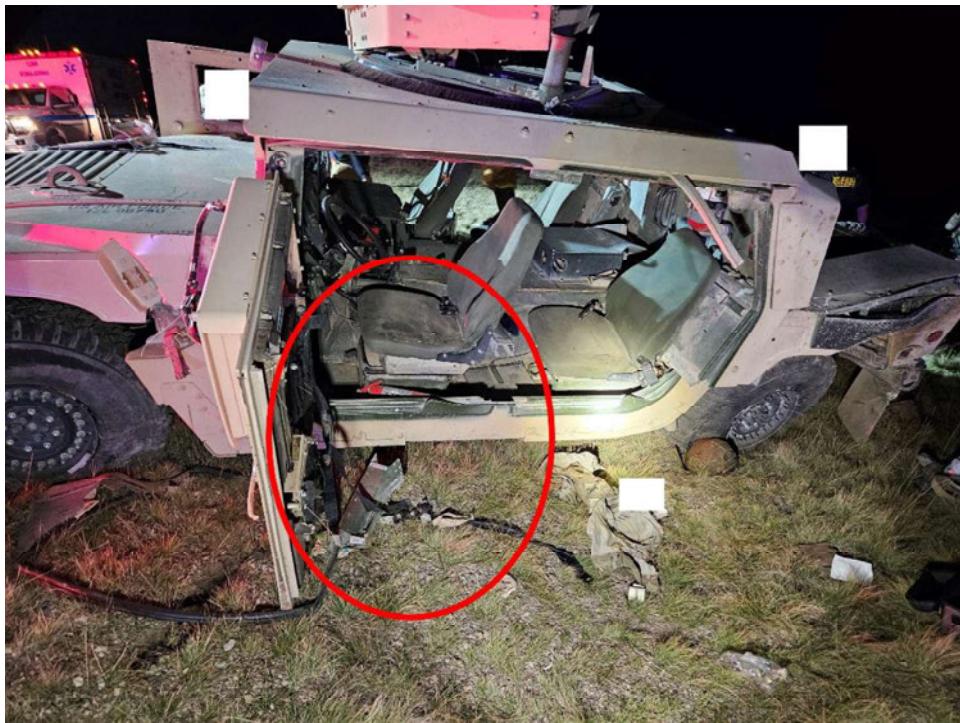
Figure 4-4 (Tab Z-4)
Driver Side Lapbelt – unattached, center unclasped to remove MVO

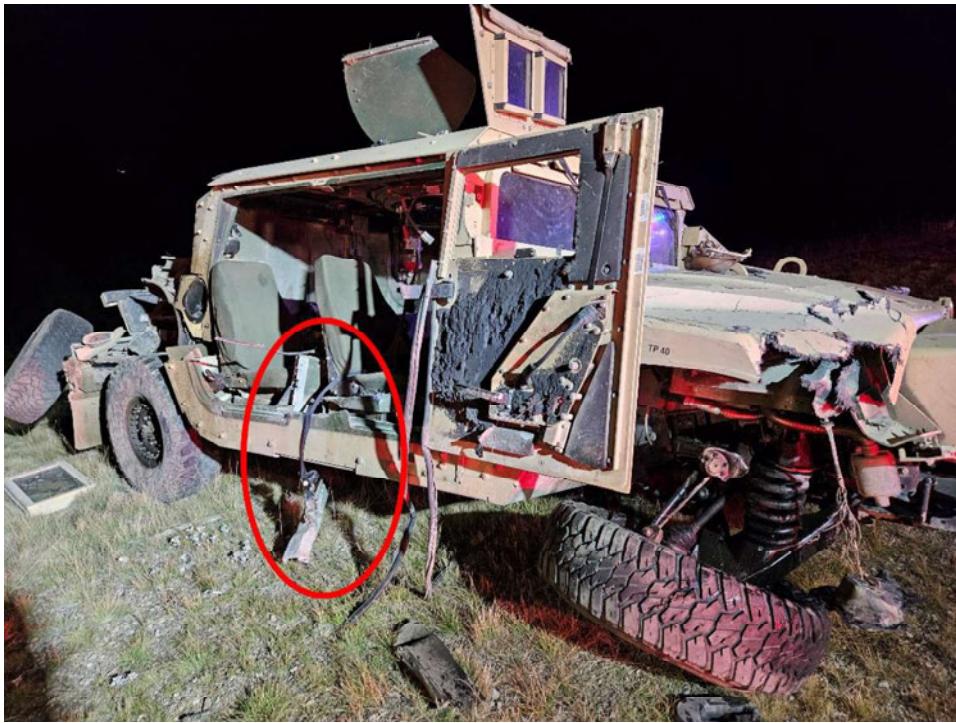
Figure 4-5 (Tab Z-3)
Passenger Side Lapbelt - unattached

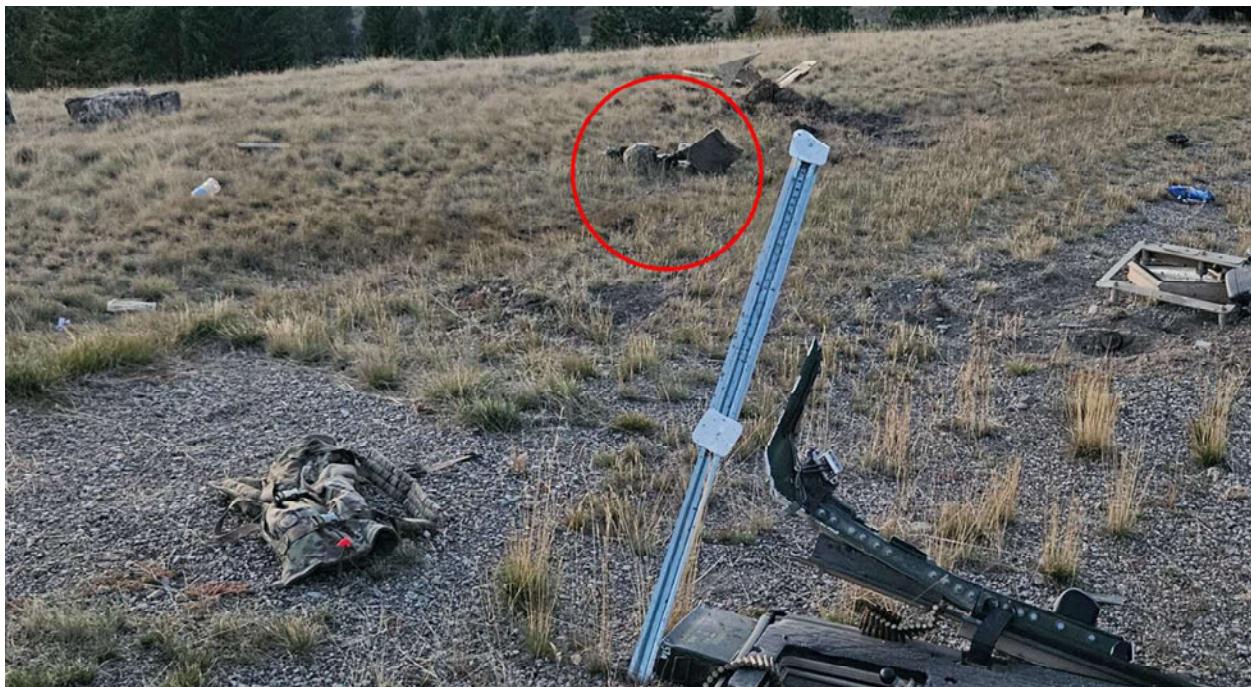
At the time of the rollover, MPAX was not wearing his helmet but tucked his chin and closed his eyes (Tabs Z-4, EE-157, and EE-220). When the MV came to rest, MPAX exited the vehicle and

**Figure 4-5 (Tab Z-6)
MPAX Helmet**

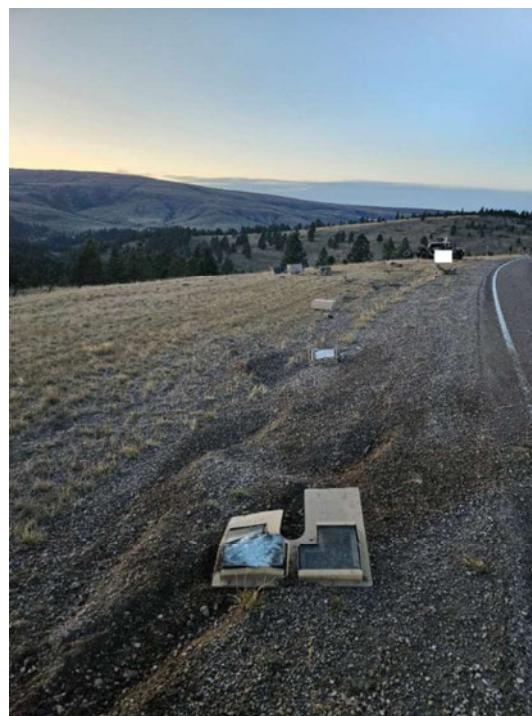
**Figure 4-6 (Tab Z-5)
FR10 Photo - Debris Field**

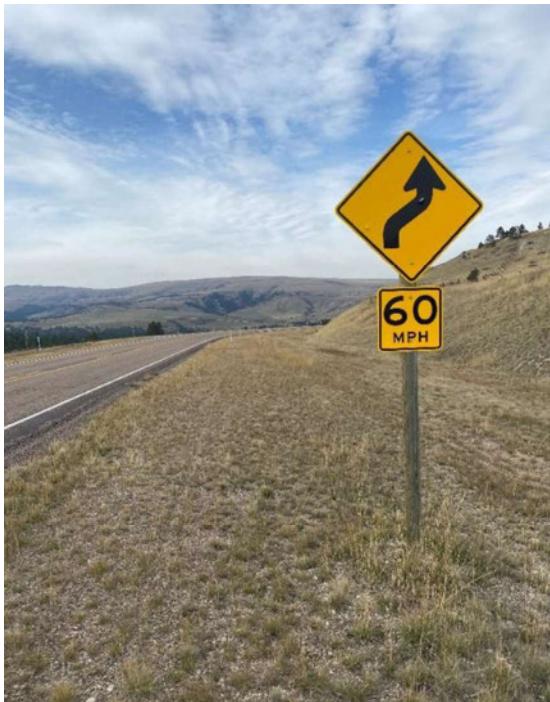
Figure 7-2 (Tab S-3)
Approach to MS

Approaching the turn where the mishap occurred, a yellow caution sign recommends limiting speed to 60 MPH (Tab S-3).

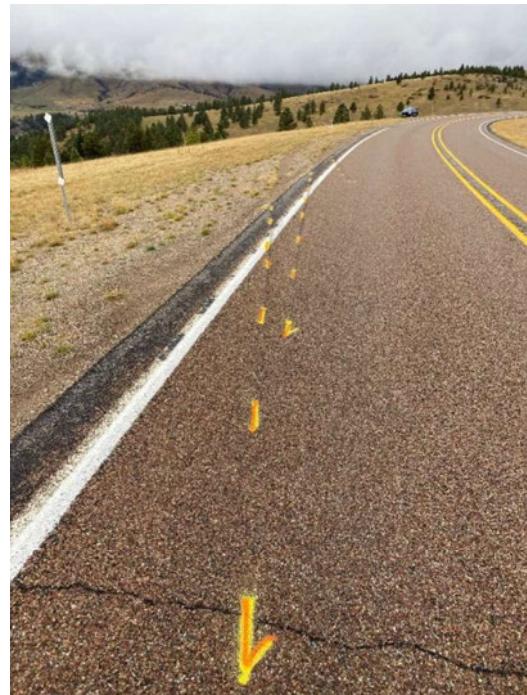
Figure 7-3 (Tab S-5)
Leaving Roadway

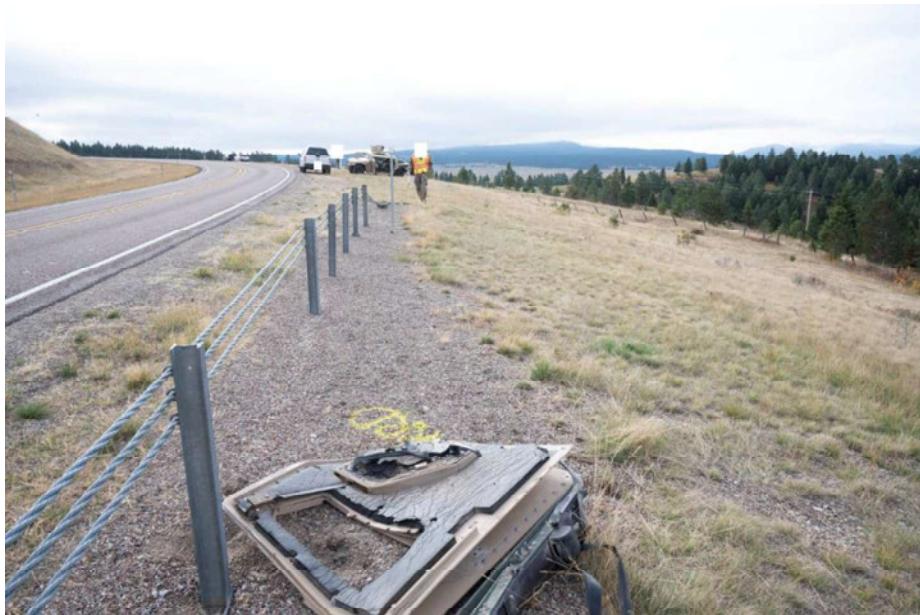
**Figure 7-4 (Tab S-9)
MS from Reverse Approach**
