**UNITED STATES AIR FORCE**  
**AIRCRAFT ACCIDENT INVESTIGATION**  
**BOARD REPORT**

**OA-1K, T/N 23-000009**

**17TH SPECIAL OPERATIONS SQUADRON  
492D SPECIAL OPERATIONS WING  
WILL ROGERS AIR NATIONAL GUARD BASE, OKLAHOMA**

**DATE OF ACCIDENT: 23 OCTOBER 2025**

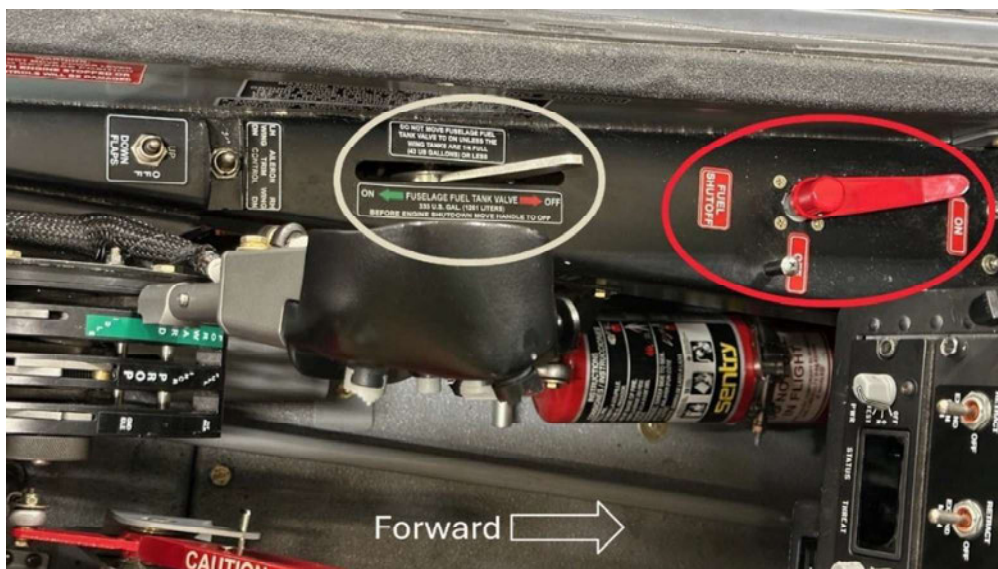
Figure 1. Block-1, FCP, Overhead View (Tab Z-3)

In the Block-0 and Block-1 variants, the fuselage fuel tank valve lever is painted silver and actuated on nearly every flight for a function check and then to feed fuel from the fuselage tank to the engine, as needed (Figures 1 and 4, below, and Tab R-22 and R-102). In both variants, the fuel shutoff valve handle is painted red and designed for emergency use to interrupt fuel to the engine (Tab R-18 and R-109). The fuselage fuel tank valve lever is engaged by pulling/pushing the level back/forward (Tab R-54 and R-145). The fuel shutoff valve handle is engaged by rotating it clockwise (Tab R-54 and R-151). Given space constraints within the cockpits, the fuselage fuel tank valve lever in the front cockpit (FCP) is located five inches below the fuel shutoff valve handle (Figure 2, below, and Tab Z-3). In the Block-1 variant, the fuselage fuel tank valve lever is visually obscured by an inboard power lever (Figure 3, below, and Tab Z-2). The Block-0 variant has a significantly smaller power lever than the Block-1 variant and does not visually obscure the fuel shutoff valve handle (Figure 4, below, and Tab Z-2).

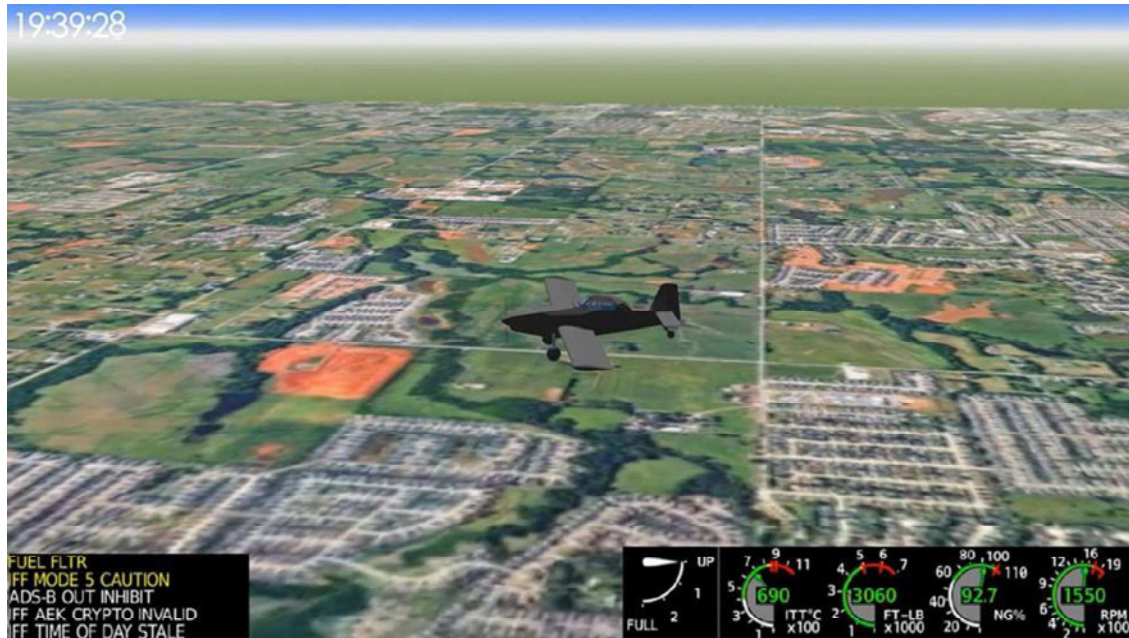
Figure 5. Animation at 14:39:28L (Tab Z-4)

At 14:39:16L, the MIP instructed the MP to open the fuselage fuel tank valve to ensure functionality, which the MP replied, "Copy that" (Tabs J-17 and N-17). However, there was a notable absence of the white Crew Alerting System (CAS) "FUSE FUEL VLV OPEN" message which would have confirmed the fuselage fuel tank valve as being in the open position (Tab J-17 and DD-3). The MP incorrectly identified the fuel shutoff valve handle as the fuselage fuel tank valve lever and moved the fuel shutoff valve to the "OFF" position (Tabs V-3.9 and DD-10). Once the fuel shutoff valve was moved to the OFF position, fuel supply was isolated from the MA's firewall, starving the engine of fuel in flight (Tab DD-10). After incorrectly moving the fuel shutoff valve handle, the MP immediately redirected his attention to the other side of the aircraft to troubleshoot his communications issues (Tab V-3.6). At 14:39:28L, the first indication of an issue shows up in the form of a "FUEL FLTR" CAS message notifying the MC that pressure across the fuel filter was greater than 2.9 pounds per square inch (Figure 5, below, and Tabs J-17 and DD-6 and DD-9).

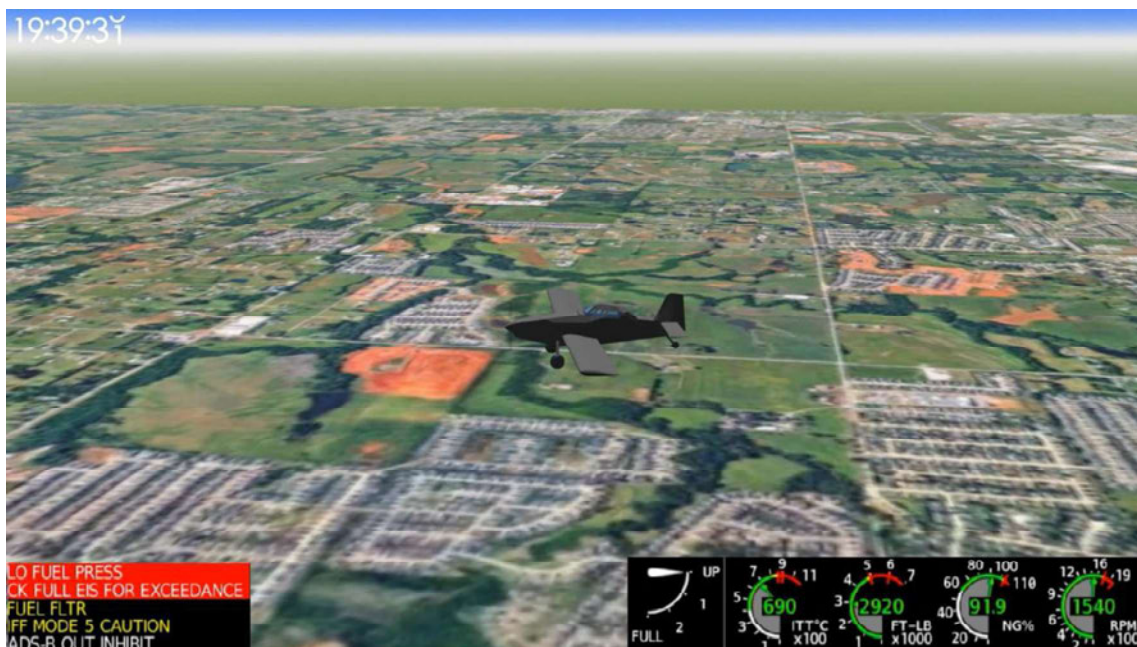
Figure 6. Animation at 14:39:31L (Tab Z-4)

Between 14:39:28L and 14:39:31L several other CAS messages appeared including “LO FUEL PRESS” due to fuel pressure dropping below five pounds per square inch and “CK FULL EIS FOR EXCEEDANCE,” indicating an engine parameter exceedance and alerting the MC to check the Engine Information System (EIS) for other indications such as oil temperature, oil pressure, fuel pressure, etc., at which point the MIP said, “Give me a second” (Figure 6, below, and Tabs J-17 and DD-6 and DD-9).

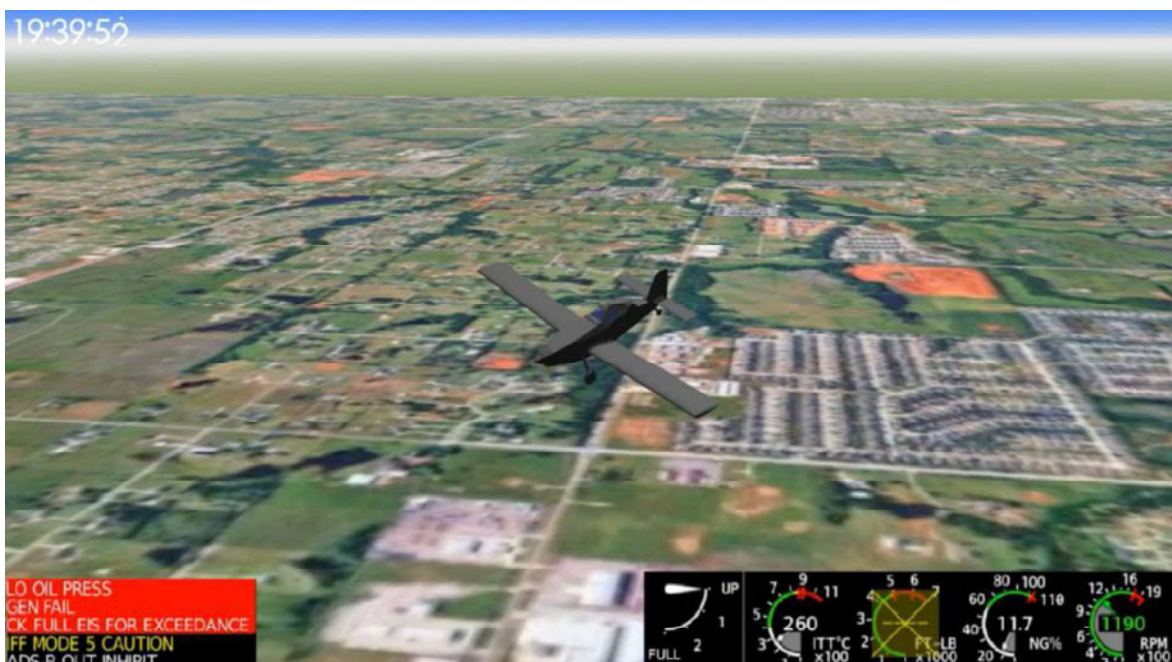
**Figure 7. Animation at 14:39:52L (Tab Z-4)**

At 14:39:34L, the MIP felt a surge of power and thought the MP pulled the power lever back, so the MIP instructed the MP not to touch the power, stating, “Do not do that. Do not do that” (Tabs J-17 and V-1.3). At 14:39:38L, the MIP stated, “Put that power back in” (Tabs J-17 and N-17). At 14:39:39L, the MP replied, “I didn’t touch power” (Tab J-17). Around that time, the MP noticed the fuel shutoff valve was in the “OFF” position and turned it back to the “ON” position (Tab V-3.9 and V-3.10). The MP did not communicate to the MIP that the fuel shutoff valve was in the “OFF” position or that he turned it back to the “ON” position (Tab V-3.10). At 14:39:40L, the “LO FUEL PRESS” followed by the “FUEL FLTR” CAS messages cleared (Figure 8, below, and Tab Z-4). At 14:39:41L, the MIP stated, “I have flight controls” and the autopilot was disconnected at 14:39:42L (Tab J-18). At 14:39:50L, the MIP instructed the MP to get ready to call for mayday (Tab J-18). At 14:39:52L, the MP responded, “Copy that” (Tab J-19).

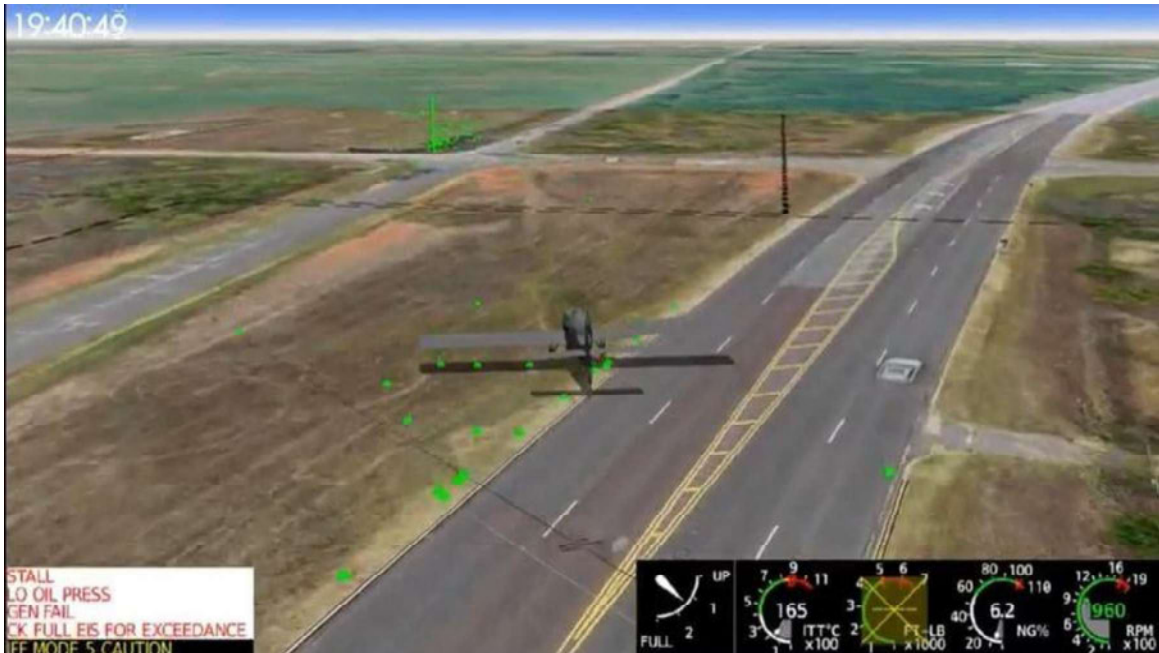
**Figure 8. Animation at 14:40:49L (Tab Z-4)**

At 14:39:54L, the MIP asked the MP if he saw an open area (Tab J-19). At 14:39:57L, the MIP asked again, “Open area?” (Tab J-19). At 14:39:58L, the MP responded, “Off to the right” (Tab J-19). At 14:40:00L, the MIP called for the MP to engage the FCU handle, and MP responded “FCU override” (Tab J-19). At 14:40:05L, the MIP contacted ATC and called “Mayday, mayday, mayday” (Tab J-19). At 14:40:49L, audible distress noises were heard from the MC as the MA initially impacted the ground (Figure 8, below, and Tabs J-14, J-21, and Z-4).

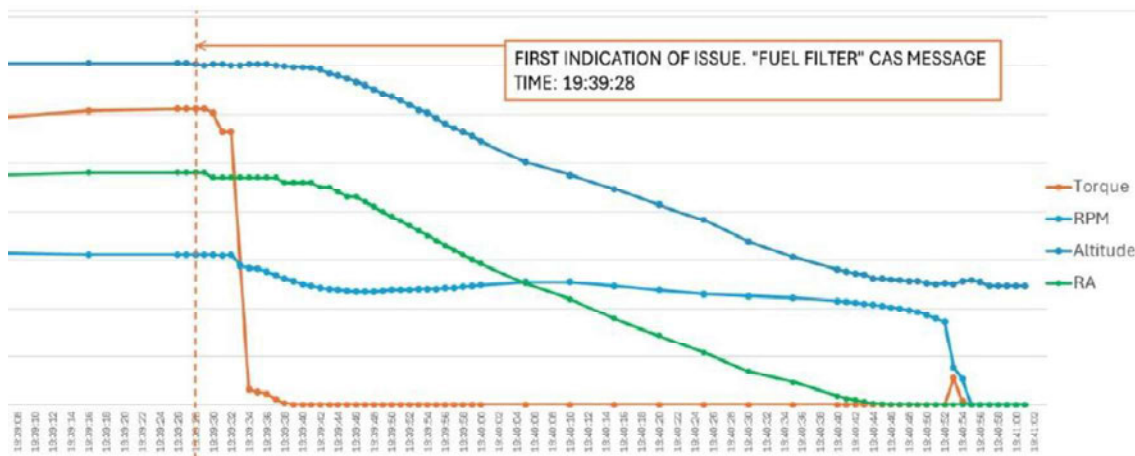
**Figure 9. Torque, Propeller RPM, and Altitudes (Pressure and Radar) (Tab J-24)**

Figure 9, below, illustrates the MA’s altitude in MSL (based on pressure altitude) and above ground level (AGL) (based on the radar altimeter (RA)), with time expressed in Z (Tab J-14). The vertical dashed orange line indicates the time of the first CAS message indicating an issue with the MA (Tab J-24). This graphic also shows engine torque and propeller revolutions per minute (RPM) (Tab J-14). From this graphic, engine torque drops off one second after the first CAS message appears and drops off rapidly within four seconds, consistent with total loss of fuel (Tab J-14). The propeller RPM decreases, but does not go to zero, carrying RPM consistent with a windmilling propeller that is not feathered (Tab J-14). This propeller RPM indication continues until the aircraft impacts the ground (Tab J-14). There is a torque spike at 14:40:53L accompanied by a rapid reduction in propeller RPM to zero, consistent with the propeller striking a utility pole guy-wire and barbed-wire fencing (Tab J-14). The propeller blade was bent by the wire strike and the wire wrapped around the propeller hub and engine (Tab J-14).

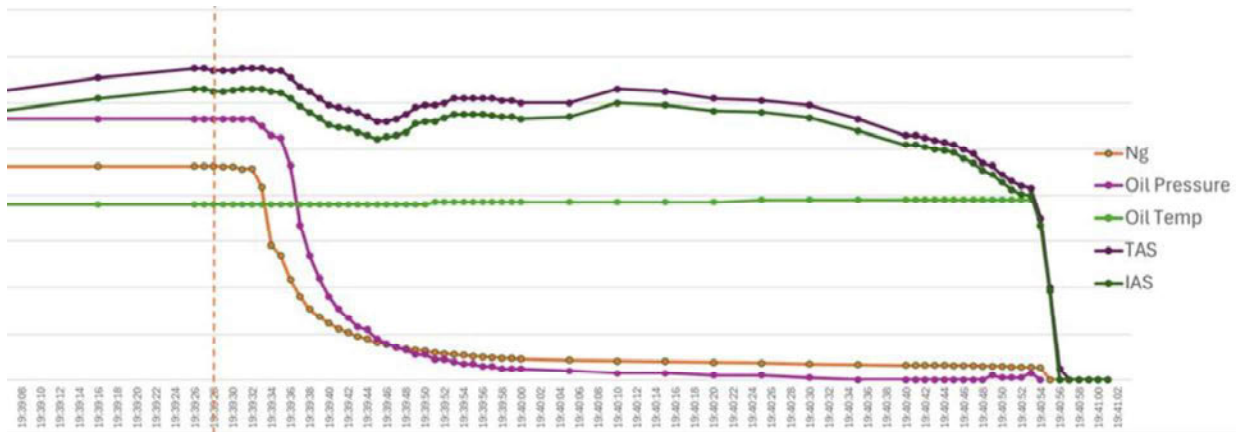
**Figure 10. Ng, Oil pressure and Temp, TAS, and IAS (Tab J-24)**

Figure 10, below, includes a plot of compressor speed (Ng), oil pressure, oil temperature, true air speed (TAS), and indicated air speed (IAS) with time expressed in Z (Tab J-14). The rapid decrease in Ng and oil pressure correlated with the decrease in torque from Figure 4, above, consistent with a loss of fuel and winding down of the engine (Tab J-14 to J-15). Ng began to decrease at 14:39:32L and within eight seconds it was below 50 percent at 14:39:36L (Tab J-15 and J-17). Ng decreased to below 10 percent by 14:39:57L as the engine continued winding down (Tab J-15). Oil temperature climbed slightly after the first indication of the issue, consistent with an engine no longer turning and circulating oil. (Tab J-15). TAS and IAS indications tracked one another until the aircraft impacted the ground (Tab J-15).

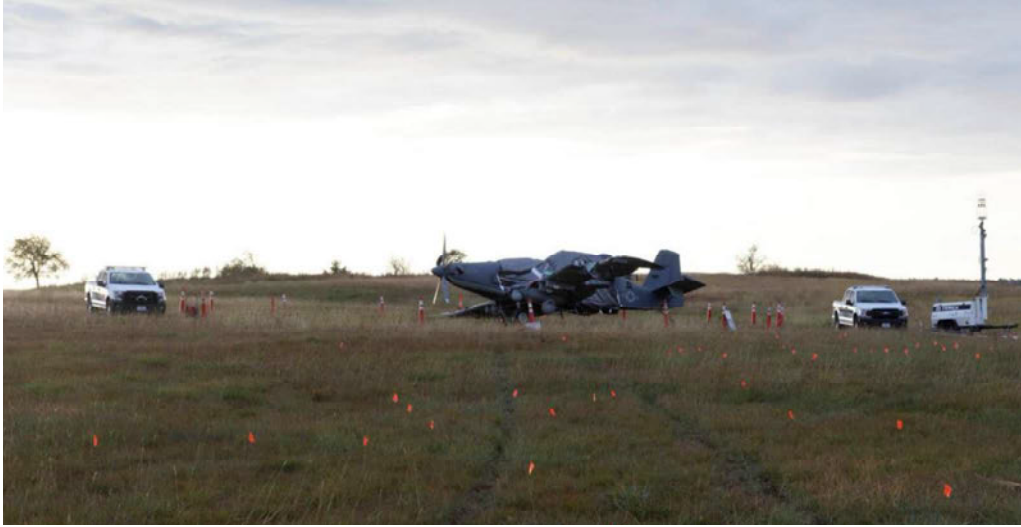
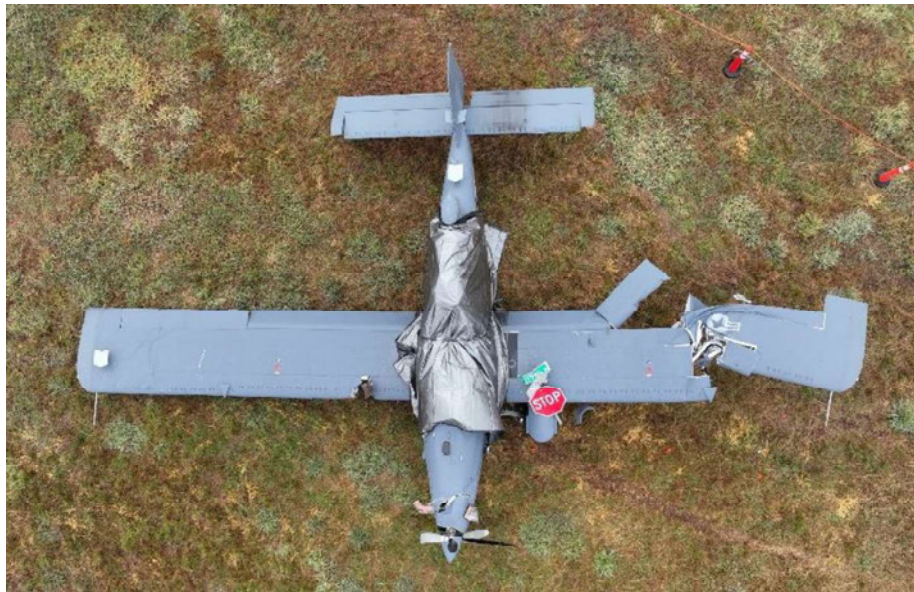
At approximately 14:41:00L the MC landed the MA in an open field after impacting a tree, road signs, utility poles, barbed-wire fences, and various uneven, unimproved surfaces (Figures 11 and 12, below, and Tab J-9 and J-22).

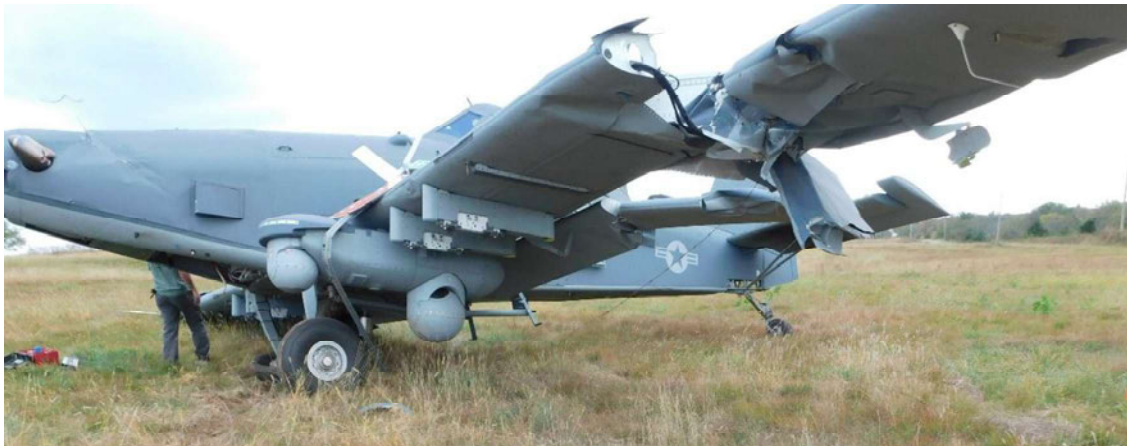
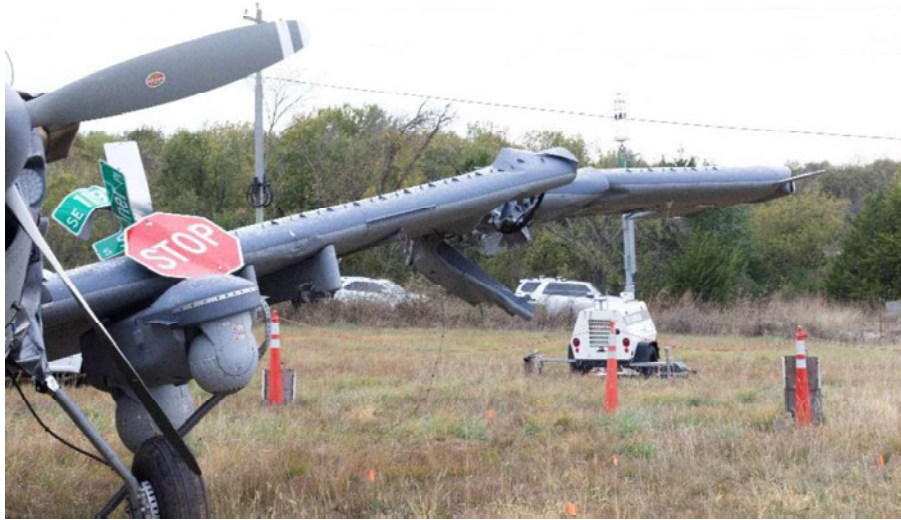
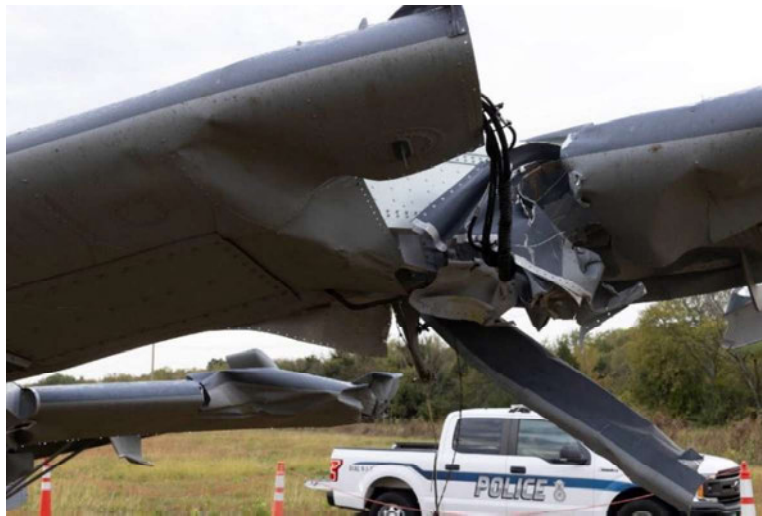
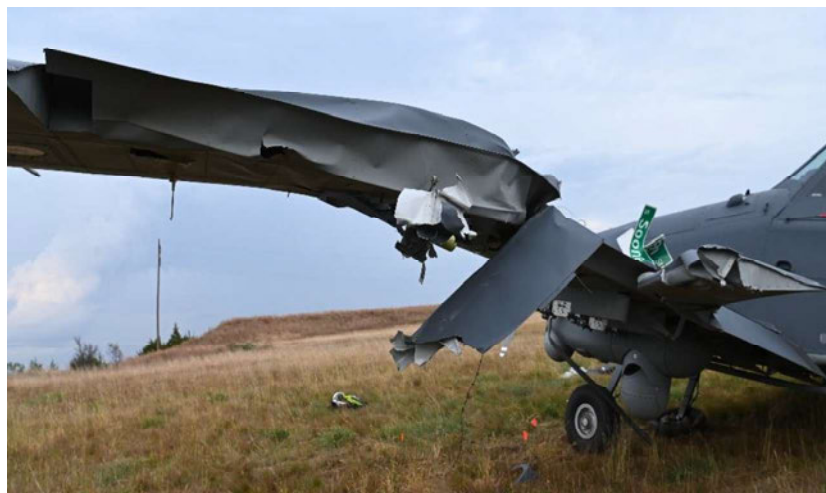
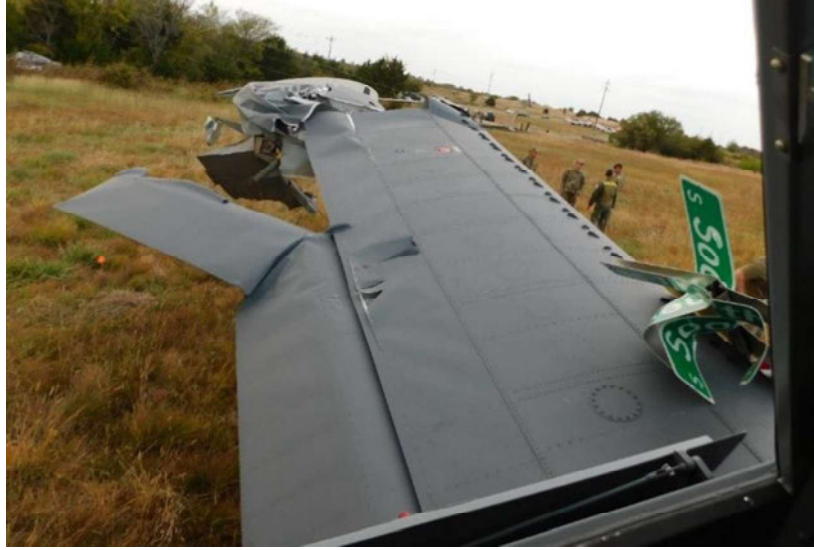
The left-wing flap was bent, and a section of the aileron, the hinged flap on the trailing edge of the MA's wing, was separated from the wing structure (Figures 13 to 17, below, and Tab J-3). The right wing shows severe impact damage to the leading edge (Figures 18 and 19, below, and Tab J-12).

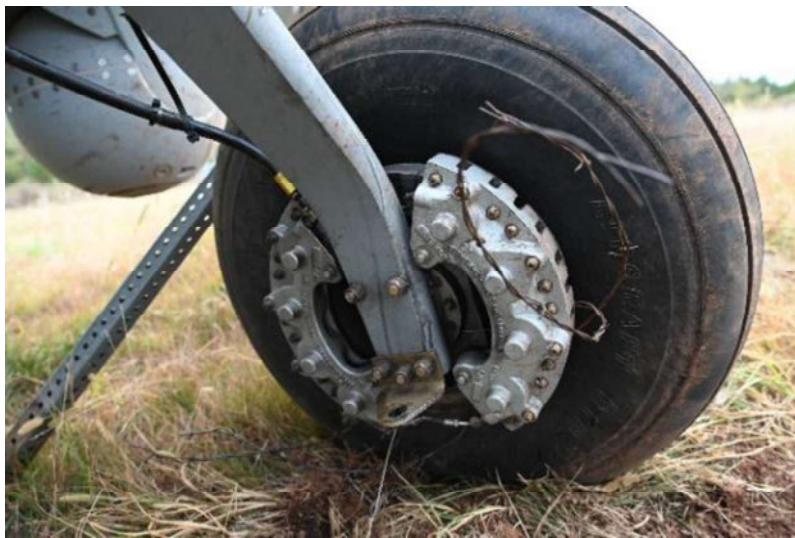
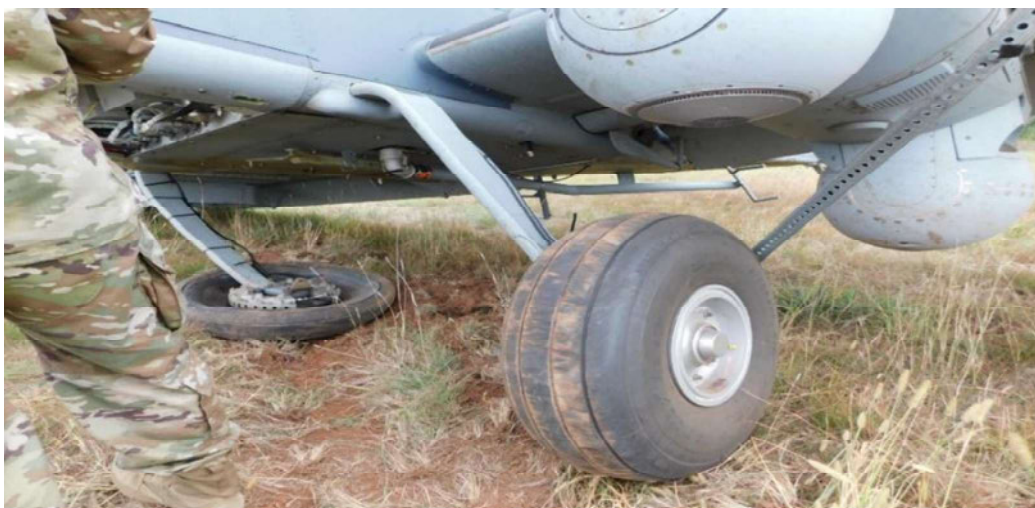
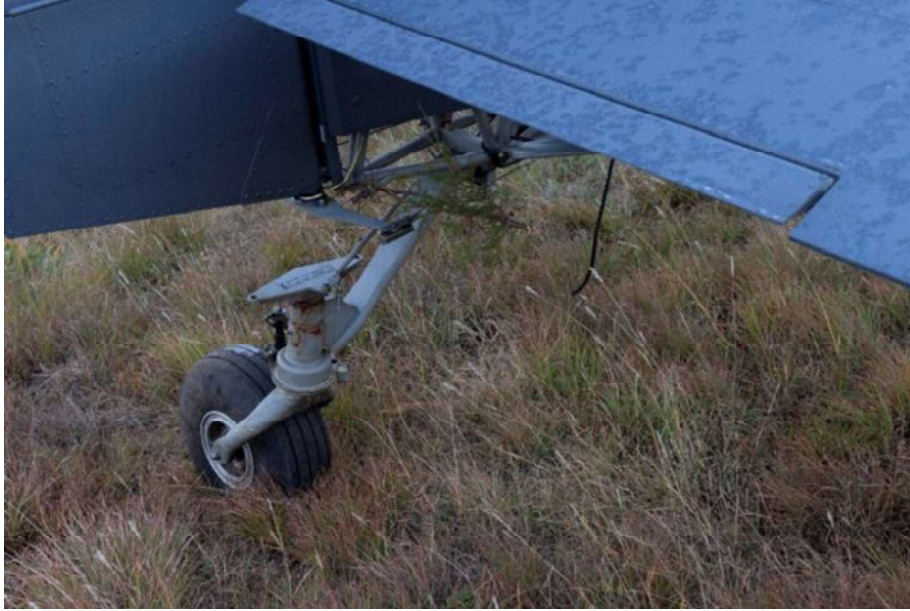
The right main landing gear spring was bent inboard, and the entire assembly folded underneath the fuselage (Figure 21, below, and Tab J-3). Barbed-wire from a fence was found tangled in the left main landing gear (Figure 19, below, and Tab Z-8). The tailwheel sustained little damage (Tab J-3).

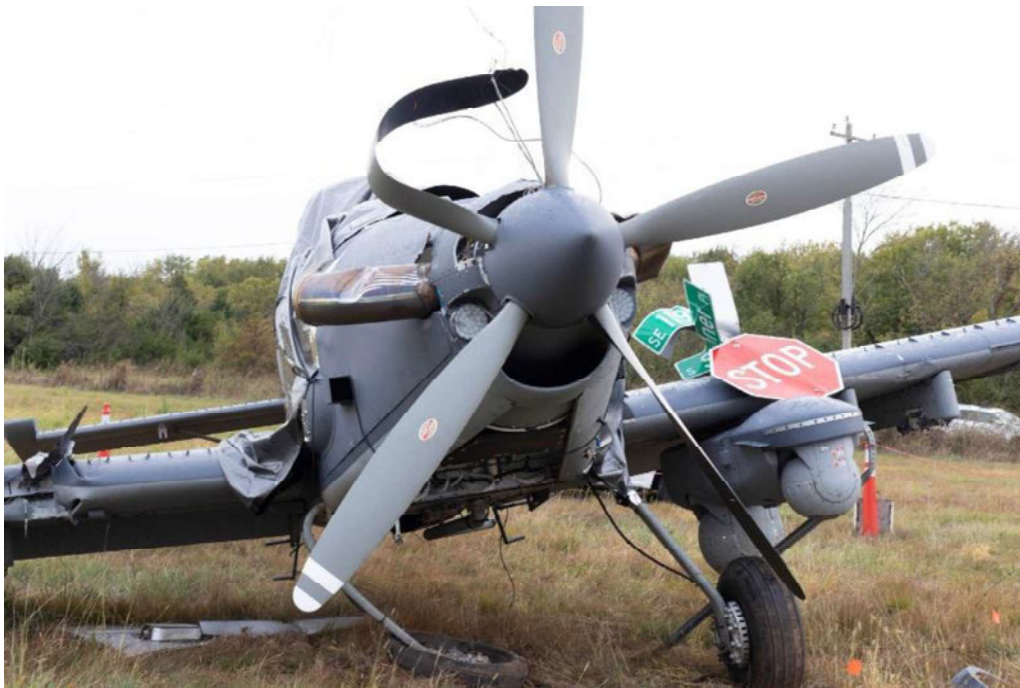
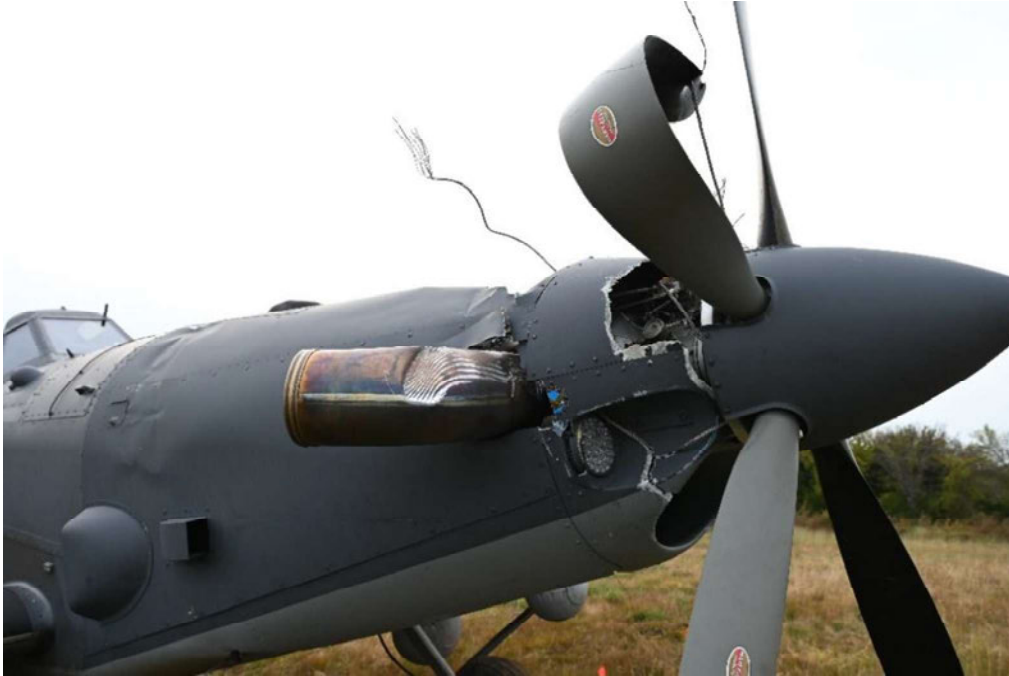
A utility pole guy-wire was wrapped around the propeller reduction gearbox (Figures 23 and 24, below, and Tab J-5). The propeller blades were still attached to the hub, and one propeller blade was bent past 90 degrees (Figures 23 and 24, below, and Tab J-5). A piece of the utility pole guy-wire was embedded in the bent propeller blade (Figures 23 and 24, below, and Tab Z-9).
