UNITED STATES AIR FORCE
AIRCRAFT ACCIDENT INVESTIGATION
BOARD REPORT

T-6A, T/N 08-3915

**89TH FLYING TRAINING SQUADRON
80TH FLYING TRAINING WING
SHEPPARD AIR FORCE BASE, TEXAS**

DATE OF ACCIDENT: 13 MAY 2024

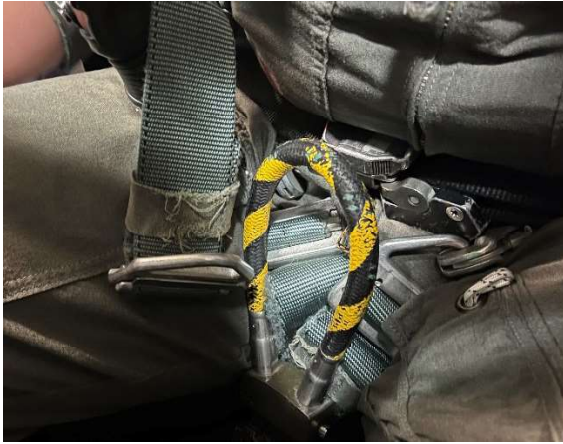
The AIB recreation showed that disconnecting the harness chest strap allowed both the ejector snap and the V-ring to hang from the pilot's harness in the cockpit (Figure 8) (Tab LL-2). If the pilot reaches down to disconnect the left leg restraint garter, the V-ring from the pilot's harness chest strap can unknowingly become caught in the ejection seat control handle (Figure 9) (Tab LL-2). When the pilot sits back upright after bending over to disconnect the left leg restraint garter, the pilot can inadvertently actuate the ejection seat control handle if the V-ring from the pilot's harness chest strap is caught in the ejection seat control handle and the seat safety pin is not fully installed into the seat (Tab LL-2).

Figure 8: Harness Chest Strap V-Ring Disconnected and Hanging with Pilot Leaning Forward (AIB re-creation) NOTE: the yellow and black handle is the ejection seat control handle. (Tabs LL-2 & MM-2)

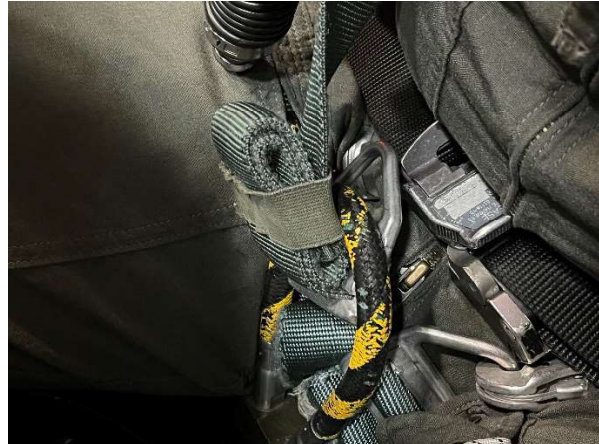
Figure 9: Harness Chest Strap V-Ring in Ejection Seat Control Handle with Pilot Leaning Forward (AIB re-creation) NOTE: the yellow and black handle is the ejection seat control handle. (Tabs LL-2 & MM-2)

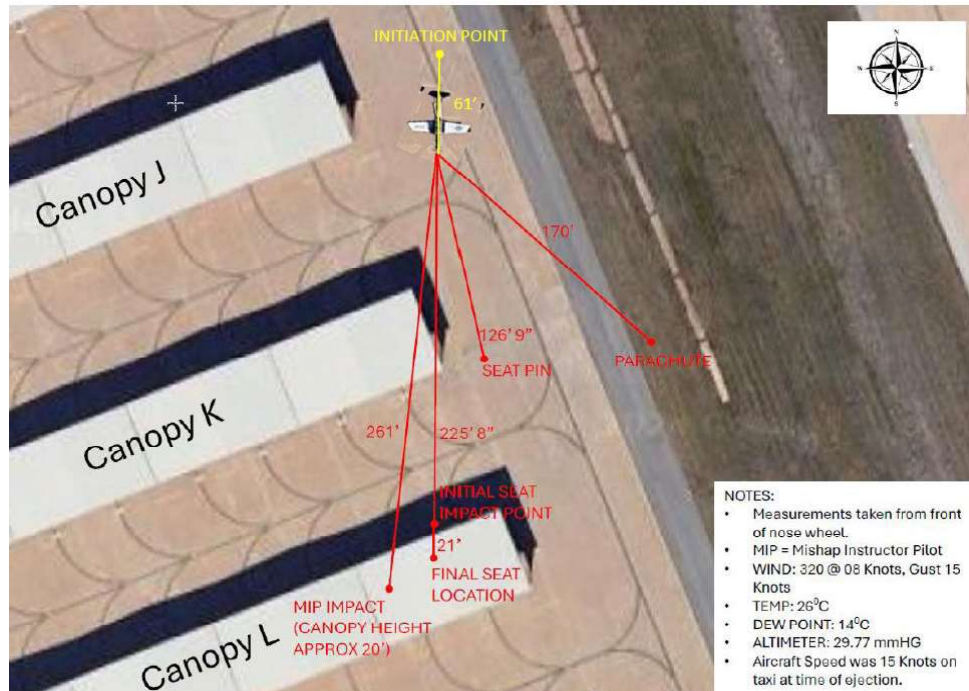
The RCP ejection seat safety pin was found on the ground between the MA and the RCP ejection seat along the general direction of travel of the RCP ejection seat (Figure 10) (Tab J-47).

The MIP's parachute landed in the grass next to the parking ramp approximately 170 ft from the MA in a direction approximately 45 degrees offset from the direction of travel of the ejection seat and the MIP (Figure 10) (Tab J-47). With the MIP not attached to the parachute risers, the parachute did not fully open or remain with the MIP (Tabs J-47 & V-27.4 to V-27.5). The parachute observed by at least one witness as attached to the MIP or the ejection seat was the drogue chute that stabilizes and decelerates the ejection seat prior to the parachute inflating (Tabs V-27.5 & KK-20 to KK-21).

(Figure 10: Mishap Site Diagram) (Tab J-47)

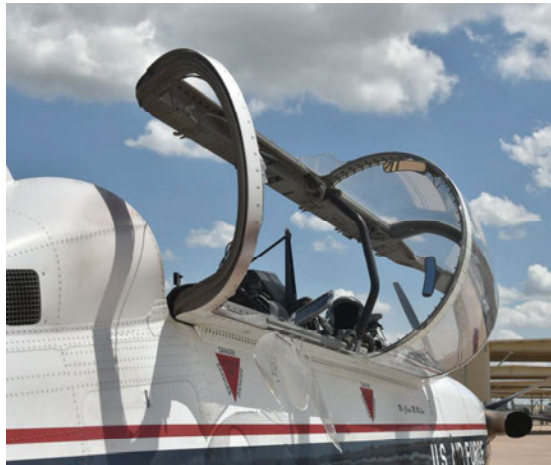
In an ejection, the CFS automatically initiates to shatter the canopy above the seat that is ejecting (Tabs KK-2 to KK-3). The system is designed to jettison the canopy parts away from the canopy frame to ensure a clear ejection path for the pilot (Tabs KK-2 to KK-3). The rear canopy was fractured as designed as part of the ejection sequence (Figure 11) (Tabs V-5.16 & Z-6). Large shards of the canopy glass littered the taxiway near the MA (Tabs V-5.16 & S-1). The windscreen and front canopy remained fully intact, and the canopy hinges were still functional, enabling the MSP to egress normally (Tabs R-10.3, V-5.16 & Z-6). The CFS functioned properly in the RCP of the MA (Tabs KK-2 to KK-3).

(Figure 11: Mishap Aircraft Fractured Canopy) (Tab Z-6)

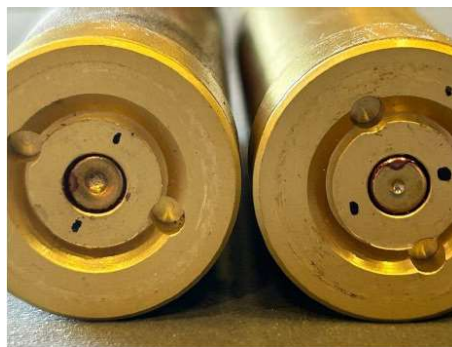
Post-mishap engineering analysis by the AFLCMC determined that the right firing mechanism did not strike the primer with sufficient force to initiate the right MPI cartridge (Figure 12) (Tab J-3). The left initiator cartridge fired normally, initiating the RCP ejection sequence (Figure 12) (Tab J-3). Previous manufacturer testing of the ejection control handle being pulled at various angles shows that pulling the ejection handle off center results in a lower force on the initiator cartridge on the opposite side (Tabs KK-26 to KK-27 & KK-41). Analysis indicates that the RCP ejection control handle was pulled by the MIP to the left instead of straight up as part of the ejection sequence (Tabs KK-26 to KK-27 & KK-41).

(Figure 12: Mishap Aircraft RCP Seat Initiator Cartridges, Left and Right) (Tab J-3)

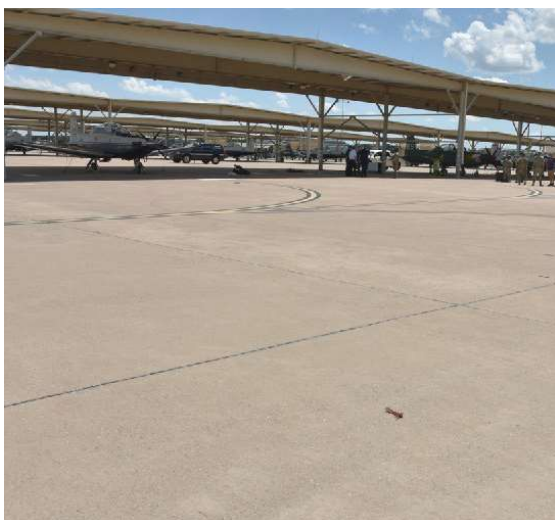
The RCP ejection seat safety pin was found on the parking ramp along the direction of travel of the RCP ejection seat from the MA to the impact location (Figures 10, 13 & 14) (Tabs Z-8 to Z-9).

(Figure 13: Mishap Aircraft RCP Seat Safety Pin Location) (Tab Z-8)

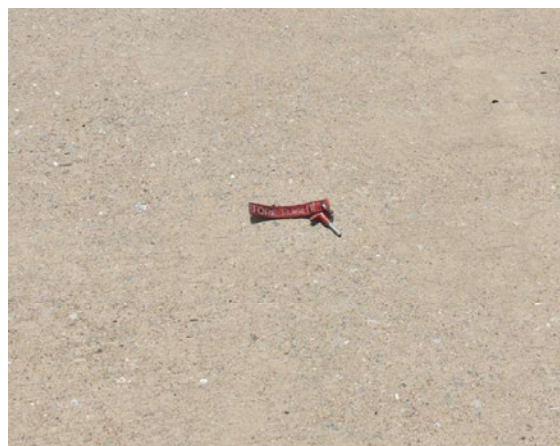
(Figure 14: Mishap Aircraft RCP Seat Safety Pin) (Tab Z-9)

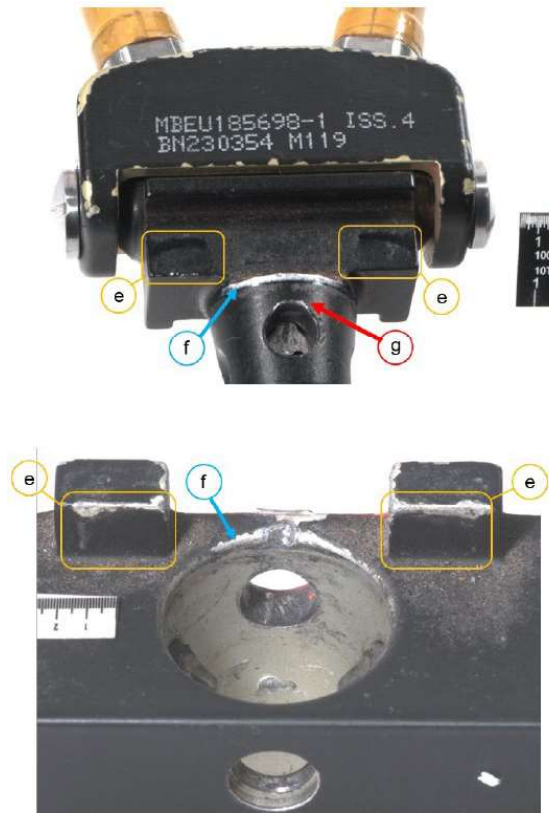
The Air Force Research Laboratory (AFRL) provided the AIB images of the ejection handle and ejection handle housing after disassembly of the system in their laboratory (Tab J-69). The images show elongation of the seat safety pin hole on both the leading surface of the housing and front edge of the ejection handle (Figure 15 location (g)) (Tab J-69). Post-mishap engineering analysis by AFRL of the pin holes from both the ejection handle and ejection handle housing determined that the elongation is only possible if the pin was installed (Tabs J-60 & J-69). The elongation of the seat safety pin hole at the front of the housing is consistent with a partially installed seat safety pin (Tab J-58).

(Figure 15: Mishap Aircraft RCP Ejection Handle Housing) (Tab J-69)

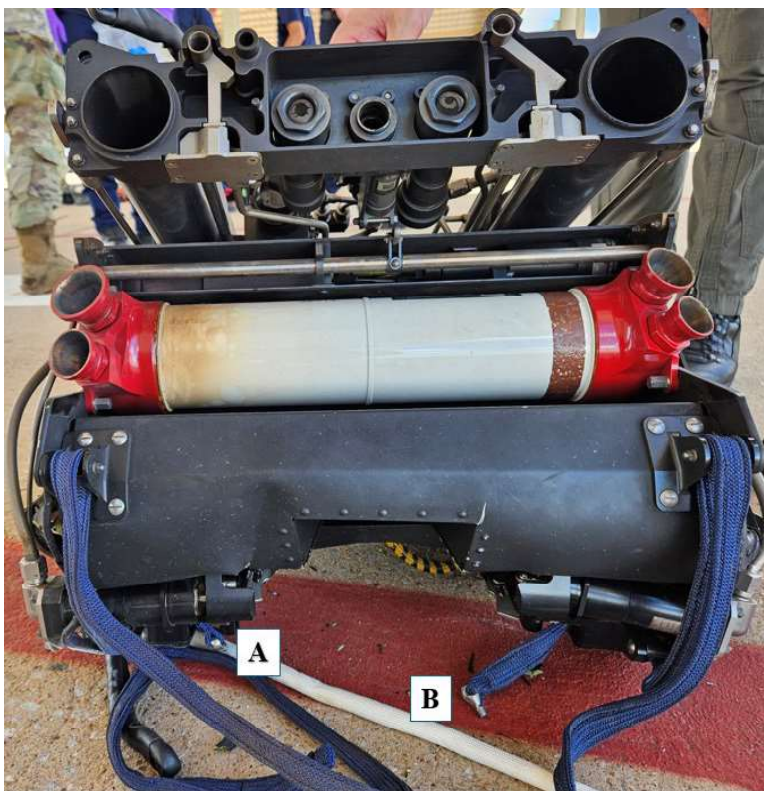
As the ejection seat travels upward, each leg restraint line is pulled through the D-ring on the leg restraint garter, restraining the occupant's legs (Tab J-2). Post-mishap pictures of the MIP's ejection seat show a difference in the amount the left and right leg restraint lines retracted during the ejection sequence (Figure 16) (Tab Z-10). In Figure 16, the left leg restraint line is annotated by (A), and the right leg restraint line is annotated by (B) (Tab Z-10). The left restraint line was able to retract more than expected during the ejection sequence due to the left leg restraint garter not being connected to the MIP's leg (Tab V-16.4). When the leg restraint lines were released during pilot/seat separation, the left leg restraint garter was able to fall to the ground independent of the MIP (Tabs J-2 & V16.7 to V-16.8). The MIP's left leg restraint garter was found on the parking ramp between the MA and the MIP (Figure 17) (Tabs S-3 & Z-11).

(Figure 16: Mishap Aircraft RCP Bottom of Ejection Seat) (Tab Z-10)

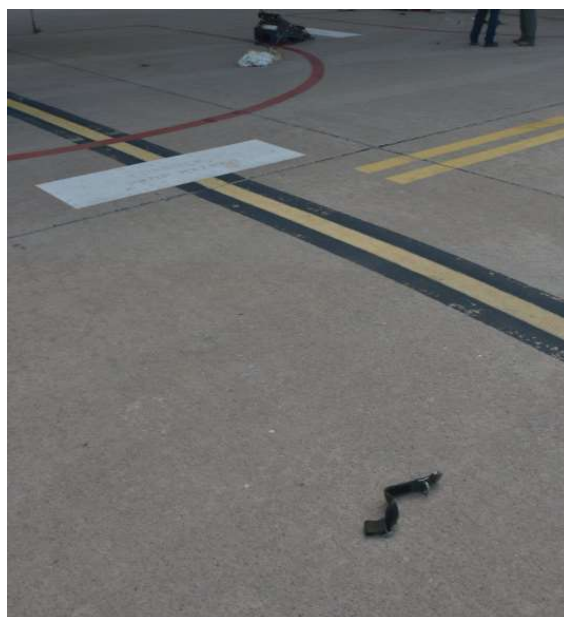
The MIP's left leg restraint garter was found on the parking ramp (Tabs S-3 & Z-11). The MIP disconnected the left leg restraint garter during the taxi back to the parking ramp (Tabs V-16.4 & Z-10 to Z-11). The left leg restraint garter remained attached to the ejection seat system until the automatic seat/pilot separation at which time the leg restraint garter connection to the ejection seat released normally (Tabs V-16.6 & Z-10).

(Figure 17: MIP's Left Leg Restraint Garter) (Tab Z-11)

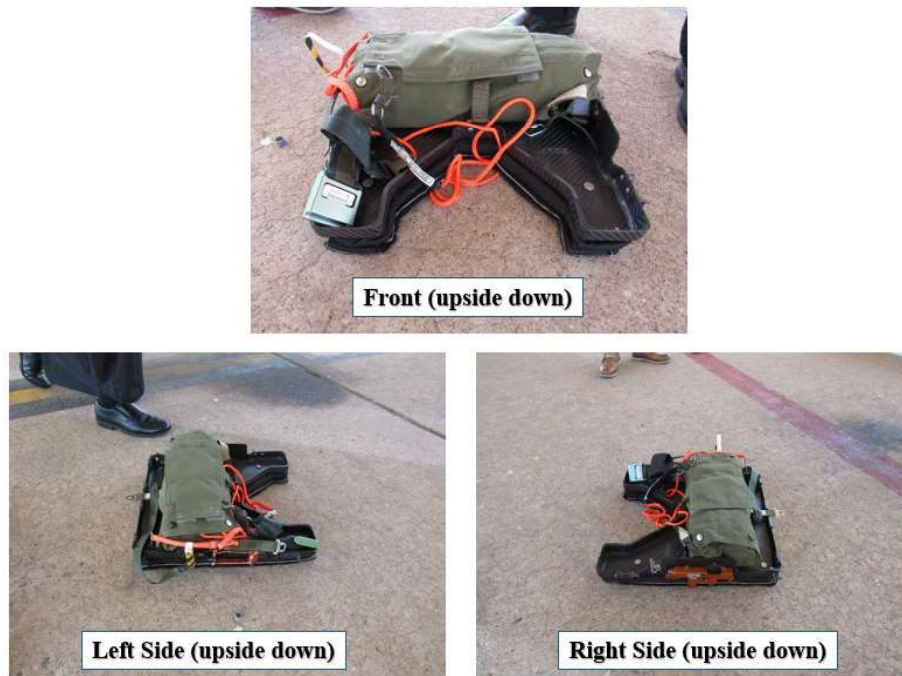
The RCP SSK was located on the ground near the MIP and the ejection seat (Tabs V-27.3 & Z-12). The SSK did not deploy as intended during the ejection sequence, instead staying attached to the seat casing (Tabs J-39, V-28.8 to V-28.9 & Z-12). The left SSK buckle was found with the SSK, while the right SSK buckle was found attached to the MIP's harness (Tabs V-28.12, Z-1, Z-12 & Z-13).

Post-mishap, the SSK was found near the MIP (Tabs V-27.3 to V-23.4 & Z-12). The MIP's SSK did not fully deploy during the ejection sequence (Tabs J-39, V-28.8 to V-28.9, KK-21 & KK-23). Figure 18 shows the condition of the SSK at the scene (Tab Z-12). The black plastic housing shown is the seat for the RCP (Tab KK-12). The green buckle is the left SSK buckle (Tab V-28.8). Figure 19 shows the MIP's PCU-15/P Harness post-mishap where both the right and left SSK buckles should have been connected (Tabs V-28.8 to V-28.10 & Z-13). The green buckle in the middle left of the picture is the right SSK buckle (Tabs V-28.8 to V-28.10 & KK-12).

(Figure 18: Mishap Aircraft RCP SSK, various positions) (Tab Z-12)

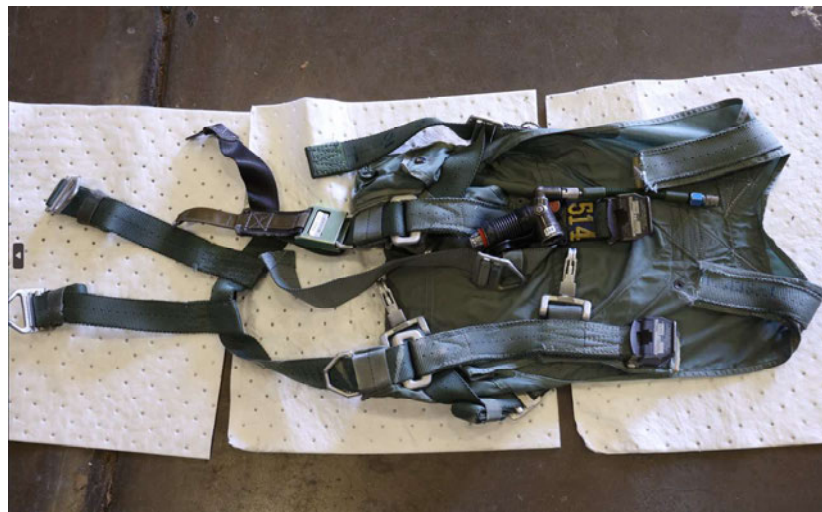
(Figure 19: MIP's PCU-15/P Harness) (Tab Z-13)

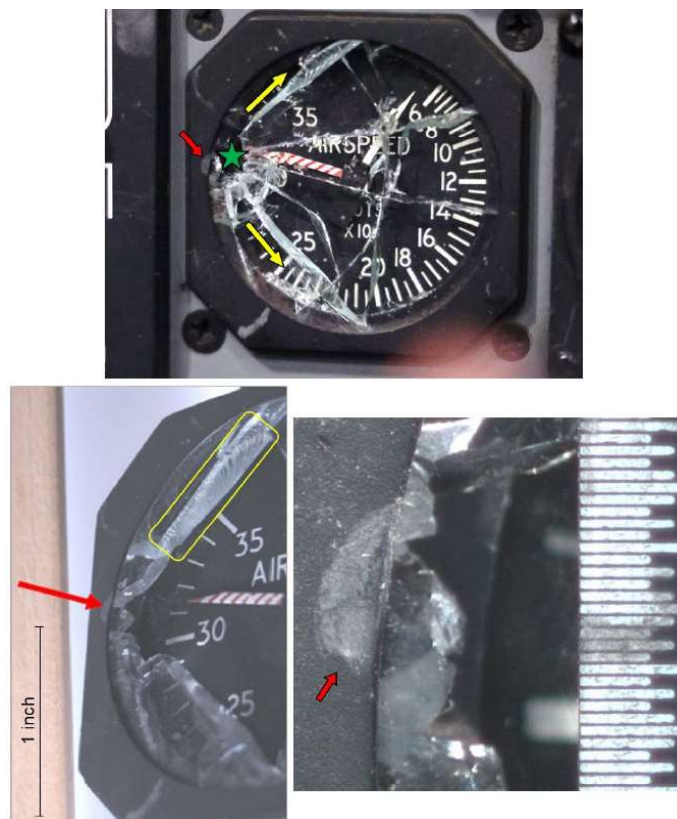
The outer layer of glass on the RCP ASI was cracked during the ejection sequence (Tab J-59). There was an elliptical witness (strike) mark in the black bezel near the initiation site (Tab J-59). Small pieces of glass from the cracked screen were found inside the cockpit (Tab J-65). In Figure 20, the top image shows the standby airspeed indicator prior to removal from the aircraft (Tab J-73). The red arrows indicate the witness (strike) mark on the bezel (Tab J-73). The yellow arrows and rectangle identify Wallner lines indicating direction of crack propagation (Tab J-73). The green star indicates crack origin location (Tab J-73). Post-mishap engineering analysis by AFRL of the RCP ASI identified potential matches to the elliptical witness (strike) mark on the black bezel as the RCP seat safety pin shank, a carabiner attached to the MIP's helmet bag, or the open buckle of the leg restraint garter (Tabs J-59 & KK-39).

(Figure 20: Mishap Aircraft RCP Cracked Air Speed Indicator) (Tab J-73)
