UNITED STATES AIR FORCE
GROUND ACCIDENT INVESTIGATION
BOARD REPORT

UA-HMMWV, R/N 10L00805

TYPE OF ACCIDENT: Motor Vehicle

LOCATION: Weld County, Colorado

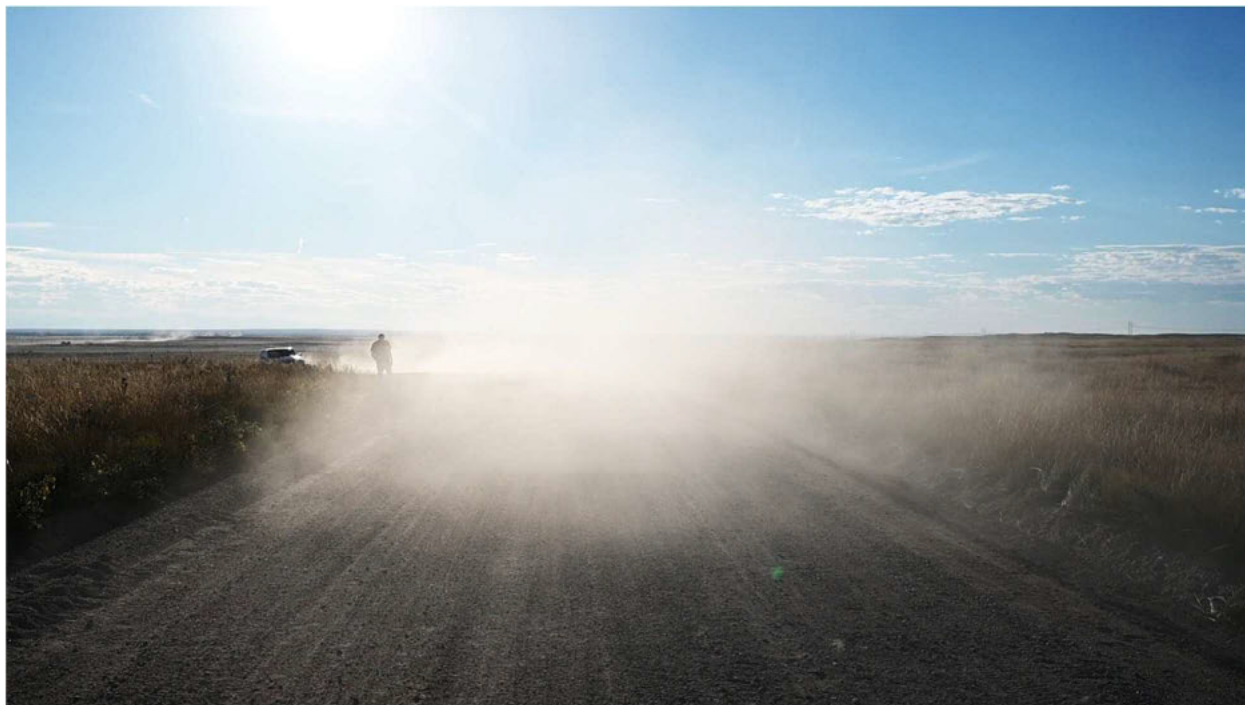
**Figure 4-3 (Tab S-119)
Recreation of Mishap Conditions**

As MVO followed OP1 along the route, his vision was impaired by the sun in his eyes and by the dust created by Vehicle 1's passage, compounded by the "terrible" windshields in the MV (Tab R-19).

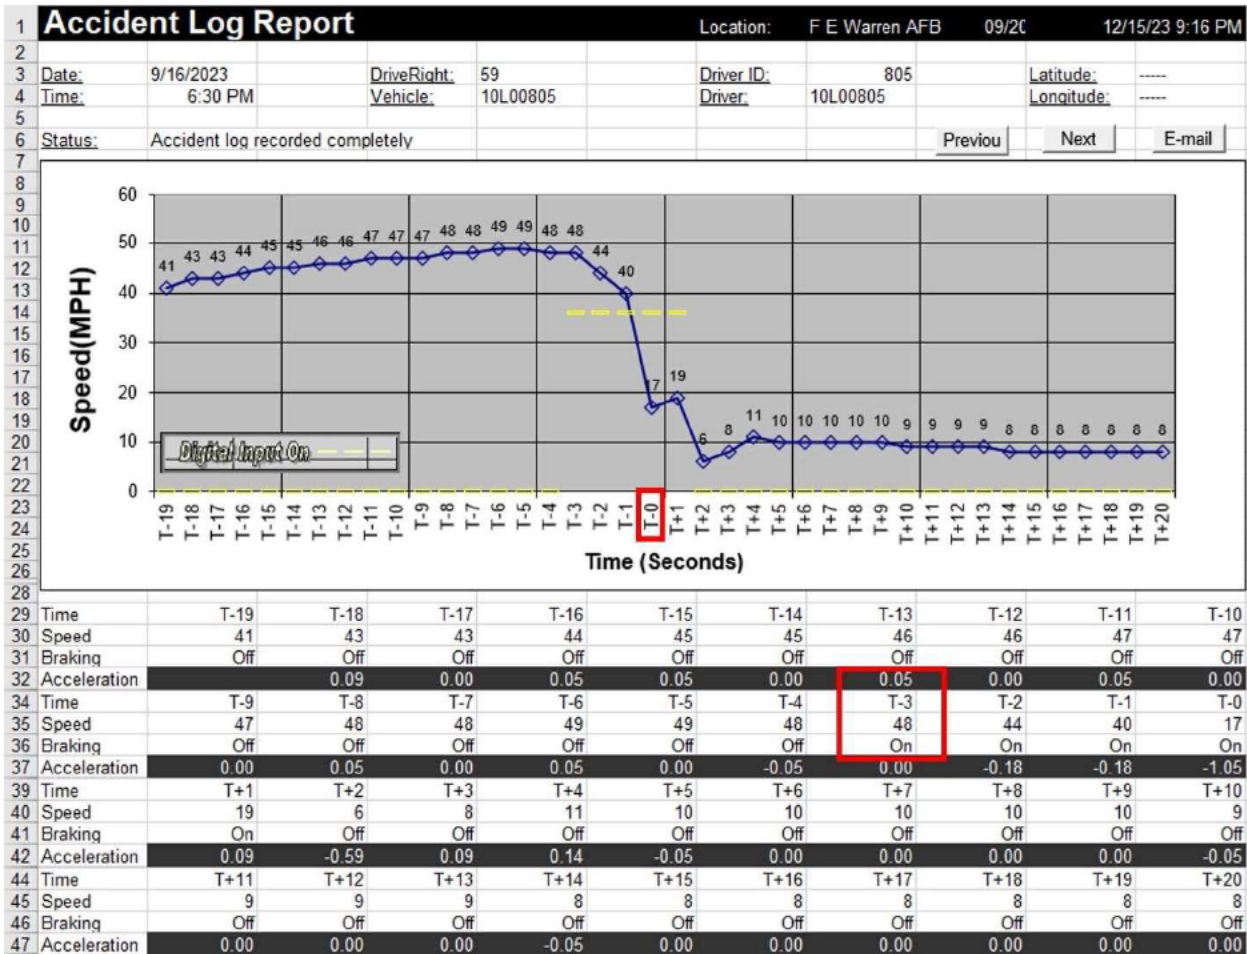
**Figure 4-4 (Tab EE-2)
DriveRight Accident Log Report**

At the time of the mishap, MVO was approximately 20 feet (ft) behind OP1's vehicle and focusing on OP1's taillights to not lose Vehicle 1 (Tab R-28). The MV was traveling between 40 MPH and 49 MPH at the time of the mishap (EE-2).

At the time of the mishap, the MV was equipped with a DriveRight tracking system (Tab V-11.5). DriveRight can track eight data parameters when installed in a vehicle, which are set by AFGSC (Tab V-11.5). The DriveRight on the MV was set to track brake application, acceleration, deceleration, speed, and accident data (Tab V-11.5). When certain parameters are met, such as exceeding an authorized speed or being involved in an accident, the system starts recording data and events (Tab V-11.5). The DriveRight on the MV was set to start recording speed and send a report if the driver exceeded 58 MPH (Tab V-11.6). For an accident, the system records the data from 19 seconds before the event until 19 seconds after the event and send a report (Tab V-11.6). At 1813L, 17 minutes before the mishap, DriveRight recorded the MV traveling at 56 MPH on a gravel road (Tab EE-44). In the 19 seconds preceding the mishap, which DriveRight records at 1830L, the MV was traveling between 40 MPH and 49 MPH, see Figure 4-4 (Tab EE-2). MVO began applying brakes to the MV approximately 3 seconds prior to the mishap, see Figure 4-4 (Tab EE-2).

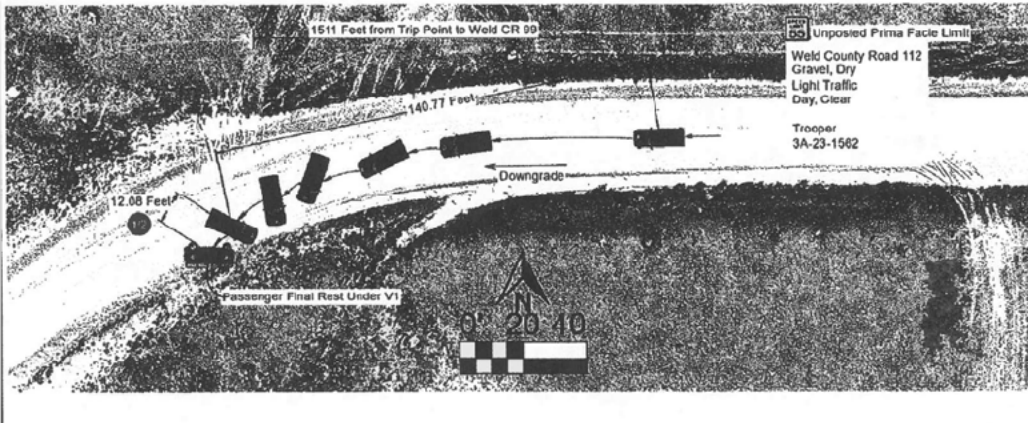
**Figure 4-6 (Tab O-3)
Colorado State Police Accident Recreation**

MVO was driving in the middle of the road (Tab R-19). He started going downhill a little and then braked more (Tab R-19). The steering wheel locked up and he had difficulty turning the steering wheel back to the middle of the road (Tab R-19). He started to brake more, and the steering wheel locked up more (Tab R-19). As MVO tried to come to a complete stop, he hit a patch of “wash-boarding” on the road and lost traction, which is when the MV began to slide and turn (Tab R-20). The MV’s vehicle type is not equipped with antilock braking system (ABS) (Tabs EE-23 and EE-34). The Operator’s Manual for MV’s UA-HMMWV model states that in hazardous conditions like ice and snow, sudden braking will cause wheels to lock and vehicle to slide out of control, causing damage to vehicle and injury or death to personnel (Tab BB-54).

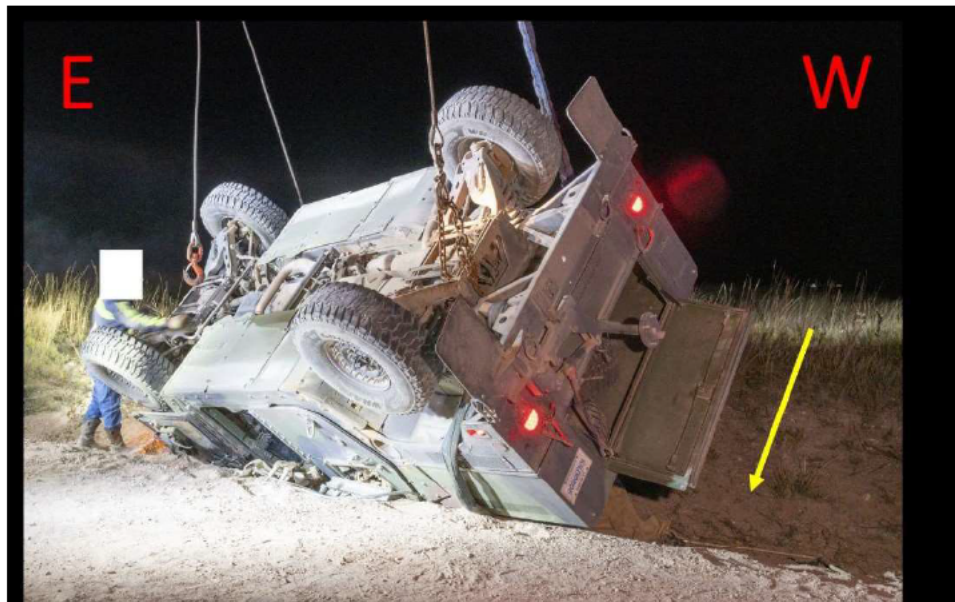
**Figure 4-7 (Tab S-5)
Post Mishap Photo of Rear and Under MV**

During the mishap, both of the MV's front doors opened (Tab EE-16). MVO attempted to grab MPAX at some point during the rollover but was unable to grab her (Tab V-21.8). MPAX was ejected from the MV and became trapped under it (Tab X-3). The MV was traveling east to west on CR 112 prior to the mishap but came to rest with the nose of the MV facing east and laying on its right side, see Figure 4-7 (Tabs S-5 and EE-146).

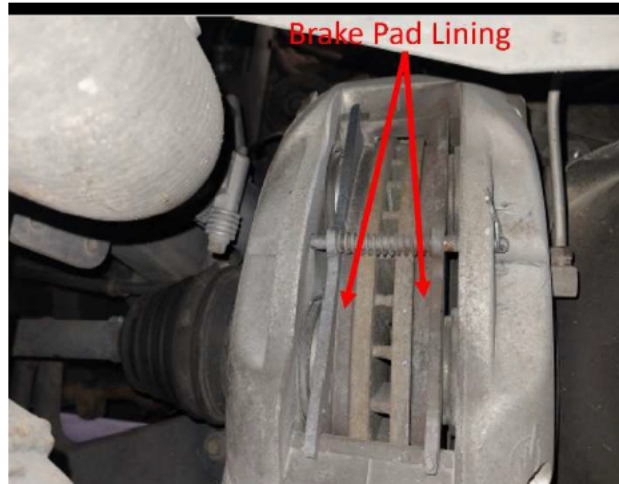
Figure 6-1 (Tab DD-41)
1 Brake Pad and Brake Pad Lining Kit in MV

(b) Analysis. A visual inspection of the MV's brake rotors and service pads revealed that each component exceeded the minimum tolerances (Tabs DD-37 to DD-46 and DD-85). There is no indication that any brake system component was leaking or malfunctioning (Tab DD-37 to DD-38 and DD-85).

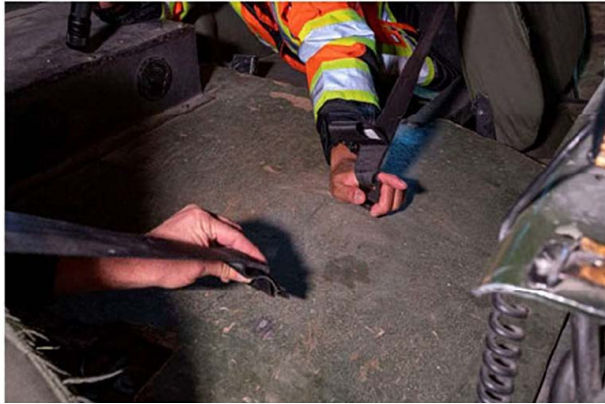
**Figure 6-3 (Tab S-71)
MV Seatbelt Extension**

(b) Analysis. The MV's front right passenger improved personal restraint system was fully functional; the shoulder and lap straps were undamaged, the retractors worked properly, and they latched into their respective buckles securely (Tabs S-69 to S-72, DD-56, and DD-85).

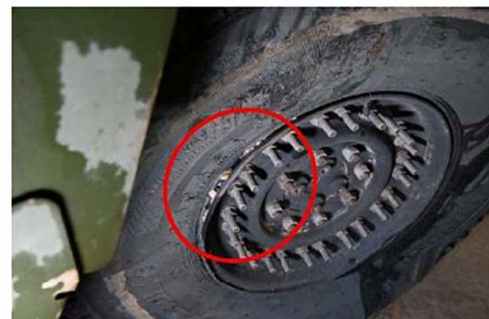
**Figure 6-5 (Tab S-186)
Broken Bead, Front Right Tire**

(b) Analysis. The MV is equipped with four load range E Goodyear Wrangler MT tires (Tabs DD-66 to DD-78 and DD-85). The front right and rear left tire tread was exceptionally worn in comparison to the rest of the tires, but each met the minimum tread requirement of 1/16 in. (Tabs DD-79 to DD-82 and DD-85). During the mishap, the bead on the front right tire broke and a section between the wheel and bead filled with rocks (Tab S-186 and DD-85). No damage was noted prior to the mishap during the VMS courtesy check on 14 September 2024 (Tabs U-781 to U-782 and V-11.2).

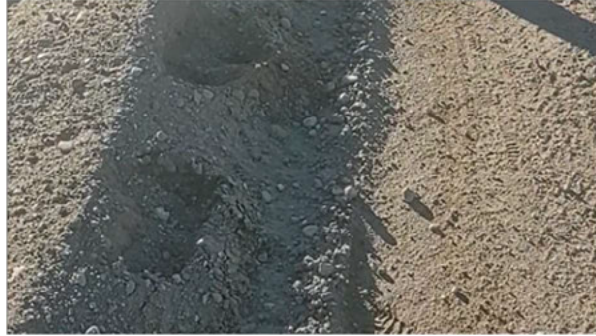
**Figure 7-2 (Tab DD-4)
200 lbs Indents in Shoulder of CR 112
6 December 2023**

CR 112 consists of dirt, gravel roads, located at approximately 5200 ft above sea level (Tabs V-22.6 and DD-8 to DD-10). The edges of the road were described as soft, and the surface described as a loose gravel dirt road at the time of the accident and consistent with typical road conditions in the area (Tabs V-18.7 to V-18.8 and V-22.6 to V-22.8). There was some washboarding in the area, see Figures 7-5 and 7-6 (Tab V-22.6). The paramedic who responded to the scene on 16 September 2023 described how her ambulance, weighing approximately 10,000 lbs, became caught on the shoulder of CR 112 as she navigated west on CR 112 past the mishap site while going less than 10 MPH (Tabs V-18.2 and V-18.8).

Figure 7-2 shows indents created by an approximately 200 lbs individual on the shoulder of CR 112 at the mishap site on 6 December 2023 (Tab DD-3 to DD-4).

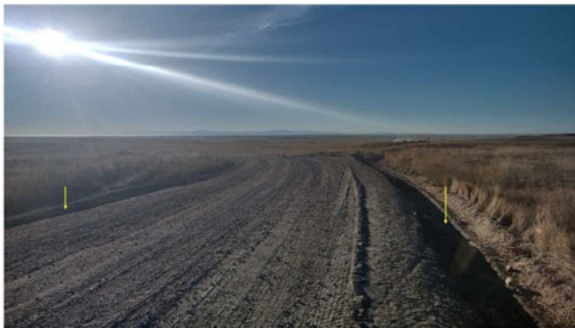
**Figure 7-3 (Tab DD-7)
Leftward Bend with Ditches
CR 112 East to West Prior Approaching
Mishap Site
6 December 2023**

The road on which the mishap occurred was level with flanking ditches approximate nine inches in depth and three ft wide (Tab DD-3 and DD-6 to DD-7). There was a leftward bend in the road with a downslope that decreases 10 ft in elevation extending west (Tabs DD-3 and DD-6 to DD-10). The United States Department of Transportation’s Federal Highway Administration (US DOT FHA) states that high shoulders and secondary ditches can create serious safety hazard (Tab BB-21).
