UNITED STATES AIR FORCE
AIRCRAFT ACCIDENT INVESTIGATION
BOARD REPORT

KC-46, T/N 17-6028

DATE OF ACCIDENT: 21 AUGUST 2024

SUMMARY OF FACTS AND STATEMENT OF OPINION
KC-46, T/N 17-006028
TRAVIS AIR FORCE BASE, CALIFORNIA
21 AUGUST 2024

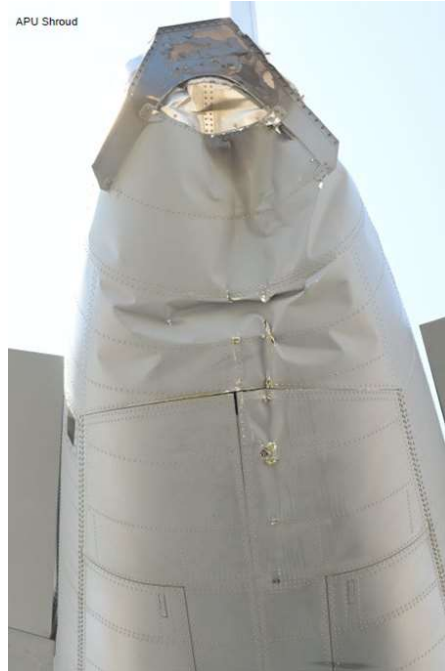
Figure 4.5 APU Shroud (Tab S-3)

At approximately 09:27:39.6L/16:27:39.6Z, the boom impacted the fuselage 0.5 seconds after release from MA2's receptacle (Tab J-12 and J-15). MP3 observed the boom began to "sway and oscillate back and forth in an obviously uncontrolled manner" after impact (Tab V-6.18).

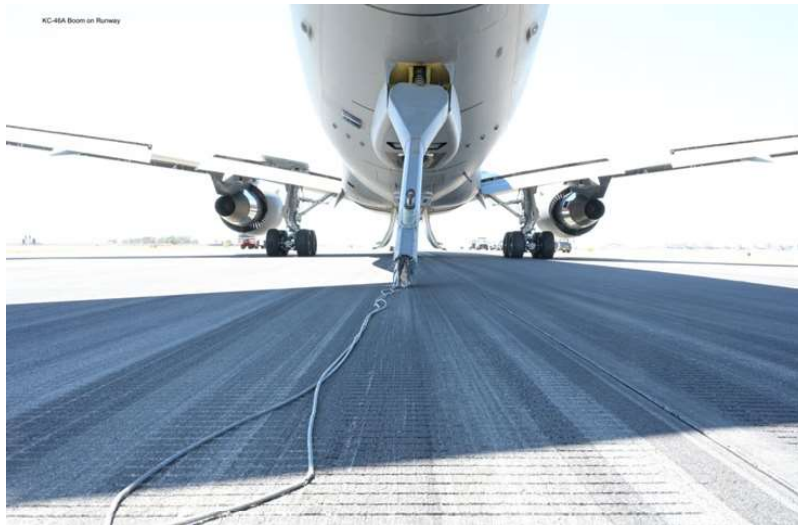
Figure 4.6 T/N 17-6028 after landing (Tab S-4)

Upon exiting the SWISS ATCAA, the MC officially declared an In-Flight Emergency (IFE) to get preferential treatment and vectoring back to the planned recovery airfield (Travis AFB) (Tab V-3.25, V-3.6). The MC continued to coordinate to land at Travis AFB, California (Tab V-3.7 to Tab V-3.8). MP1 accomplished the landing from the left seat utilizing an area navigation (RNAV) 21L approach (Tab V-3.7). Emergency Response personnel were dispatched to meet the aircraft on the runway after arrival (Tab V-3.29, V-3.26).

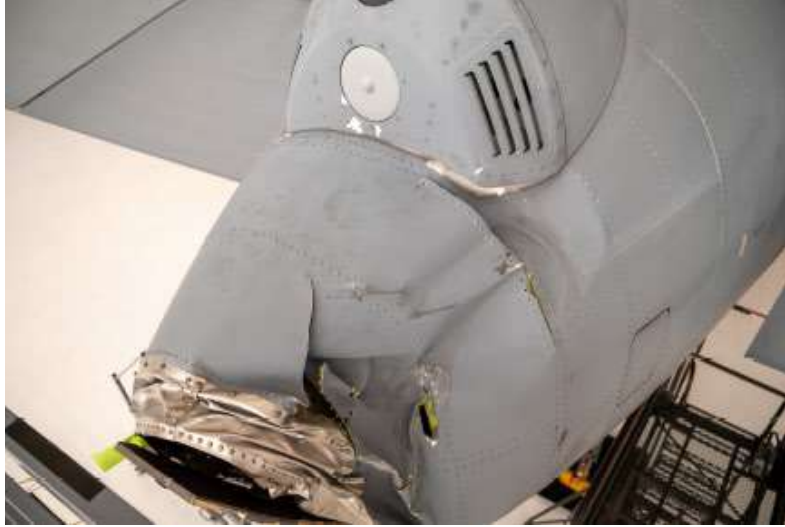
Figure 4.7 APU Shroud (Tab S-5)

Upon landing, MP2 turned on the Auxiliary Power Unit (APU) IAW with the After Landing Procedures (Tab V-3.8, Tab V-3.27). Shortly after shutting down the right-side engine, the MC began to smell unpleasant fumes on the flight deck (Tab V-3.8, Tab V-3.27, Tab V-3.7). MP2 reached up and shut off the APU bleed switch, which immediately shut down the APU (Tab V-3.8, Tab V-3.9). Shortly thereafter, ground crew plugged their headset in to MA1 and asked the MC not to shut down in order to preserve flight data (Tab V-3.8, Tab V-3.9). The MC turned the APU back on and immediately noticed fumes on the flight deck again (Tab V-3.9). One of the emergency responders on the ground started yelling “shut it [APU] off” (Tab V-3.9, Tab V-3.27). MP1 switched the APU switch to the “off” position and pulled the APU fire switch to immediately shut it off (Tab V-3.8, V-3.27). It was noted from the ground that the damage was considerably more severe than the single 6-inch deep dent initially reported by the MWSO, with some of the damage blocking the APU exhaust, thus causing the fumes on the flight deck (Tab V-3.27). The MC obtained positive control of their controlled items and egressed the aircraft through the emergency bay (Tab V-3.9).

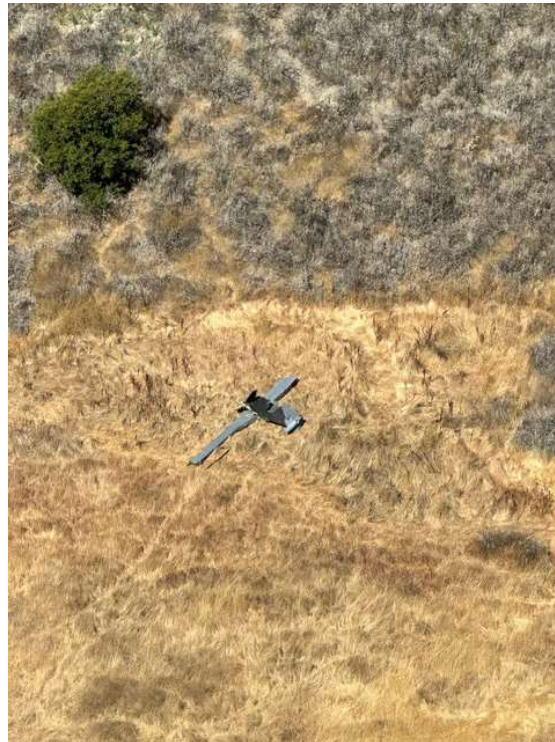
Figure 4.8 Boom Wreckage (Tab S-6)

The location of the broken boom was provided via a mark point from MA2, at 35°06'08.0"N 120°16'37.3"W (Tab L-14). The boom fell in an open field with no injuries or fatalities reported (Tab S-6).

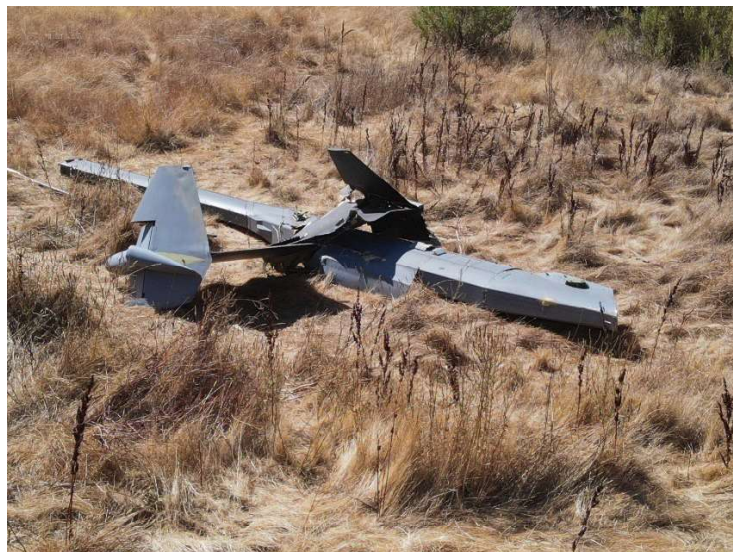
Figure 6.1 Boom Wreckage (Tab Z-3)

During the mishap the two faired tubes broke just aft of the boom shock absorber, along with all associated wire harness and hydraulic lines that run through the boom. Somewhere between contact with the aircraft fuselage and ground impact the U-Tail was damaged, breaking the rudder structure and the mount that holds it. The telescope was separated from the boom structure and to this date has not been recovered. The actuator for the elevator was damaged and ripped from its mounting point (Tab Z-3).

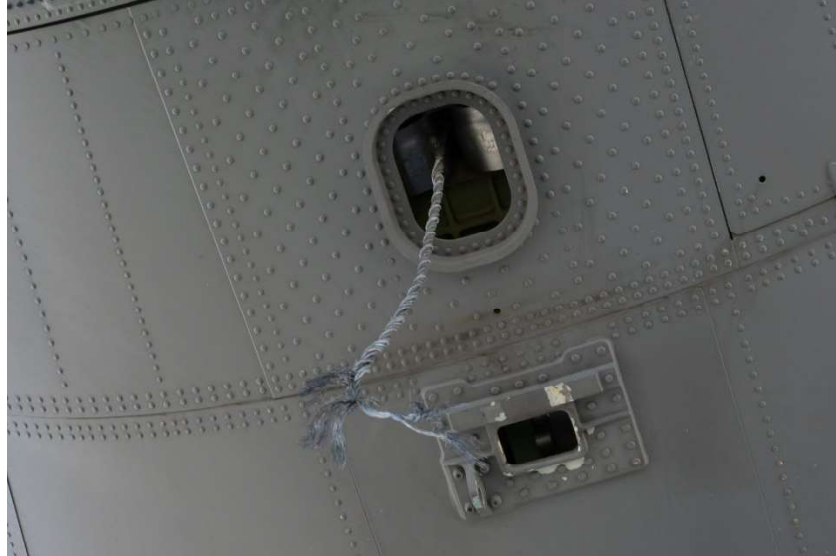
Figure 6.2 Boom Hoist Cable (Tab Z-4)

The Boom Hoist cable ripped out of the cable end attached to the boom and was left trailing during the remainder of the mission (Tab S-7).

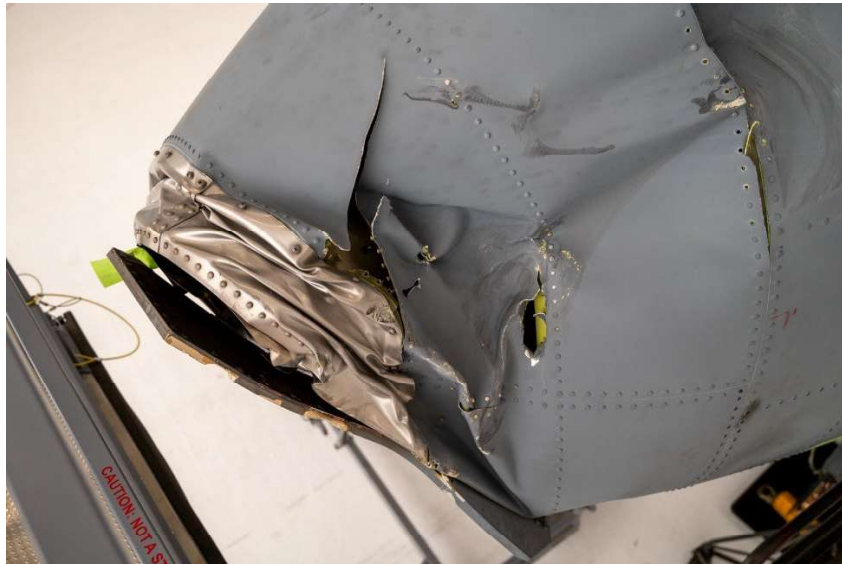
Figure 6.3 APU Shroud Damage Closeup (Tab Z-5)

The tail cone of the aircraft was damaged during the mishap, which resulted in the Auxiliary Power Unit (APU) exhaust duct not allowing the gases to release as normal (Tab S-9). When the MC turned on the APU upon landing to provide power for emergency ground crews, the damage resulted in insufficient release of the gases (Tab V-3.27).

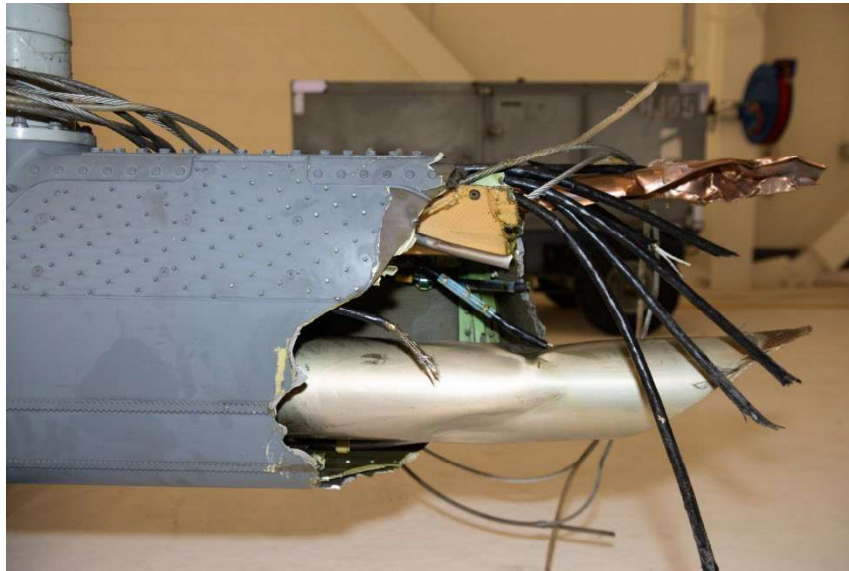
Figure 6.4 Boom Damage Closeup (Tab Z-6)

The breaking of the boom caused a loss of the center hydraulic system due to the hydraulics lines being severed (Tab Z-6).
