UNITED STATES AIR FORCE
AIRCRAFT ACCIDENT INVESTIGATION
BOARD REPORT

HH60W, TAIL NUMBER 21-4513

**33rd RESCUE SQUADRON
18th WING
KADENA AIR BASE**

DATE OF ACCIDENT: 22 APRIL 2025

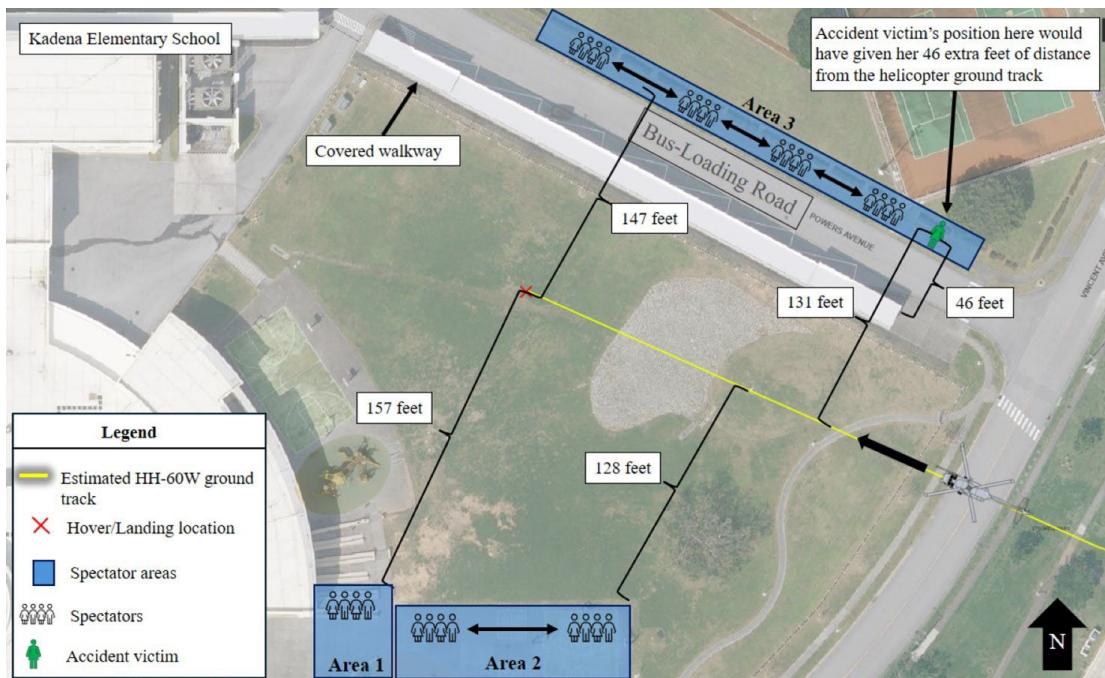
The PO and LZL intended for spectators along the bus-loading road to be positioned on the *north* side of the road, roughly 45 feet back from the fence and covered walkway along the road's *south* side (Tabs V-15.11 and Z-5). The KAO stated that, during the site visit on 17 March 2025, he walked with the PO and LZL along a fence adjacent to the covered walkway (Tabs V-9.2 and V-9.3). Of note, the only fence along this road is at the edge of the grass on the road's south side, but the PO incorrectly recalled a fence on the north side (Tabs V-15.10, V-15.11, and Z-6). The KAO did not recall any conversation about the specific side of the road on which students and faculty members should stand (Tab V-9.3). Other than the PO and LZL, no other military members or school administrators recalled any guidance about the side of the road on which the spectators should be located (Tabs V-1.4, V-1.5, V-2.9, V-3.6, V-9.10, V-14.16, V-16.4, V-16.5, CC-3, and CC-5).

Figure 1. (Tab Z-5) Spectator Placement Intended by PO and LZL (*north* side of bus-loading road)

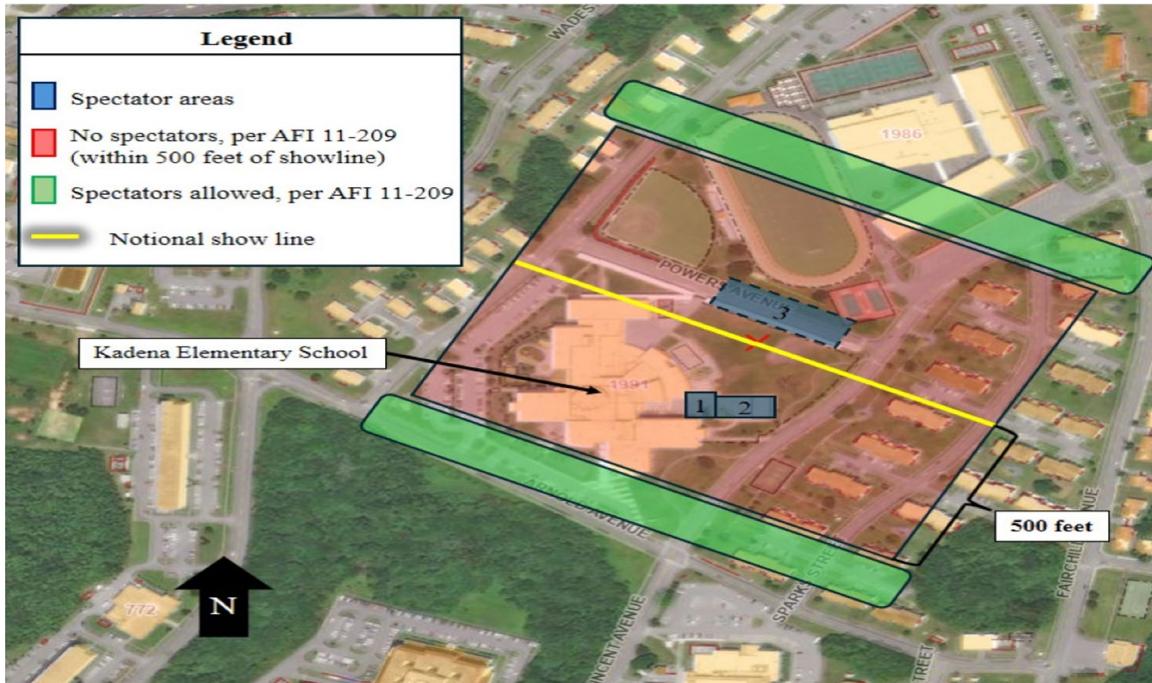
until after the accident on 22 April 2025 (Tab V-14.9, V-14.10, V-15.15, and V-15.16). No school administrators or staff were informed of the 500-feet or 600-feet requirements (Tab V-9.5).

Figure 2. (Tab Z-4) Spectator Areas Relative to Required Safe Distance, per AFI 11-209 (500 feet)

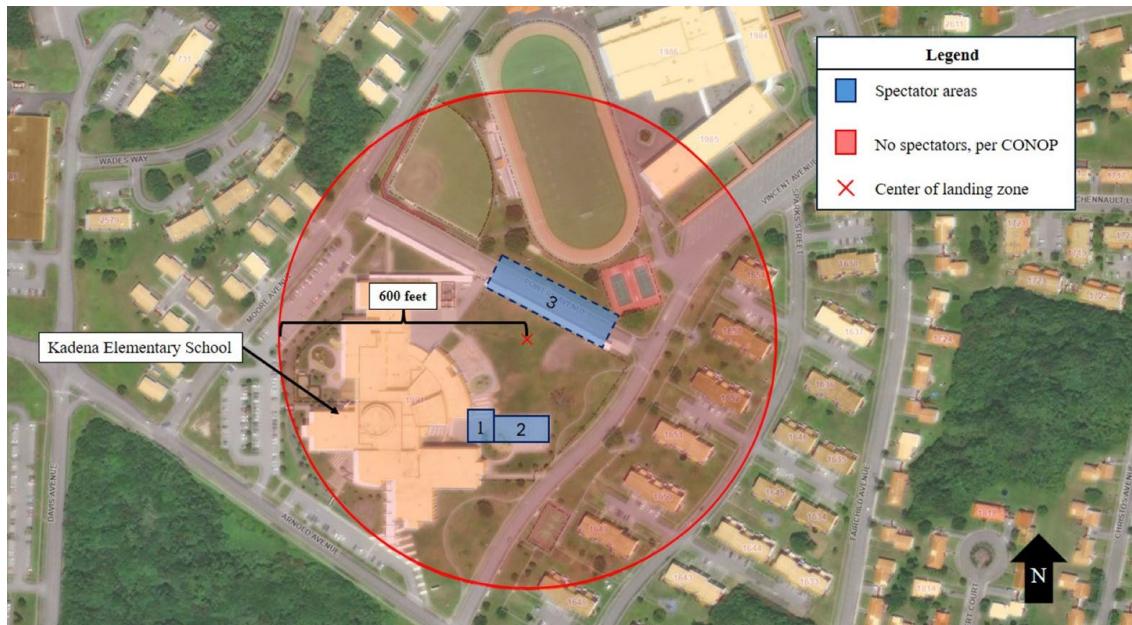
Figure 3. (Tab Z-5) Spectator Areas Relative to Required Safe Distance, per CONOP (600 feet)

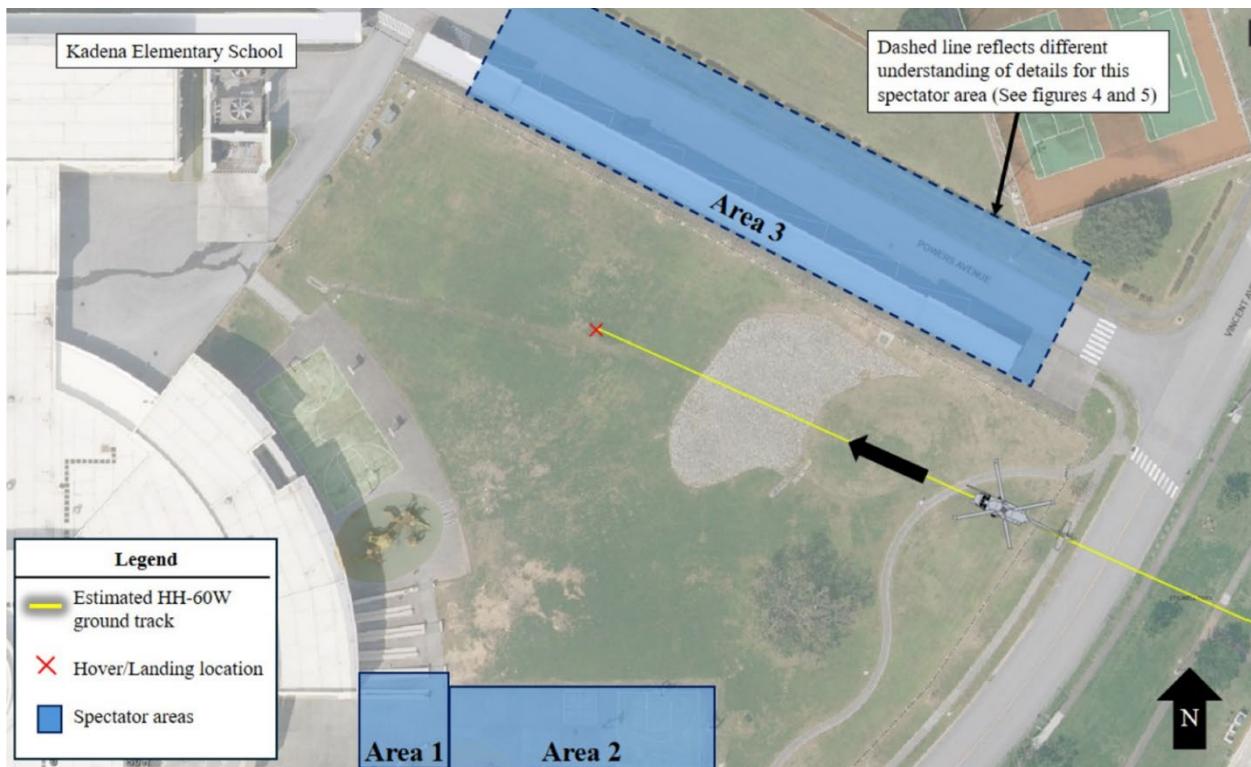
On the day of the event, the GC had a radio and a satellite map from the PO that showed the KES LZ and hand-drawn markings the PO added to describe spectator locations (Tabs R-15, V-15.19, V-16.4, V-16.6, and V-16.14). The GC did not recall any specific details about the hand-drawn spectator locations other than their general placement near the basketball court, amphitheater, and a road used for bus loading and unloading (Tab V-16.14). The GC did not participate in the pre-flight mission brief because she was not part of the aircrew (Tabs V-11.6 and V-16.5 to V-16.6). The GC arrived at KES about 30 minutes in advance of the scheduled demonstration time (Tabs V-15.18 to V-15.19). She walked through the LZ looking for debris and contacted school administrators (Tabs V-16.4 and V-16.6 to V-16.7). A member of the KES staff showed the GC a seating chart that school administrators created to illustrate safe spectator areas (reflecting the areas that military mission planners verbally communicated to the KAO during an LZ survey on 17 March) (Tabs R-7, V-16.4, and CC-5). The GC described this school-provided chart—which had generalized depictions of the spectator areas—as her main reference for understanding seating locations (Tabs R7, V-16.4, and CC-5).

Figure 4. (Tab Z-4) Location of Designated Spectator Area at KES

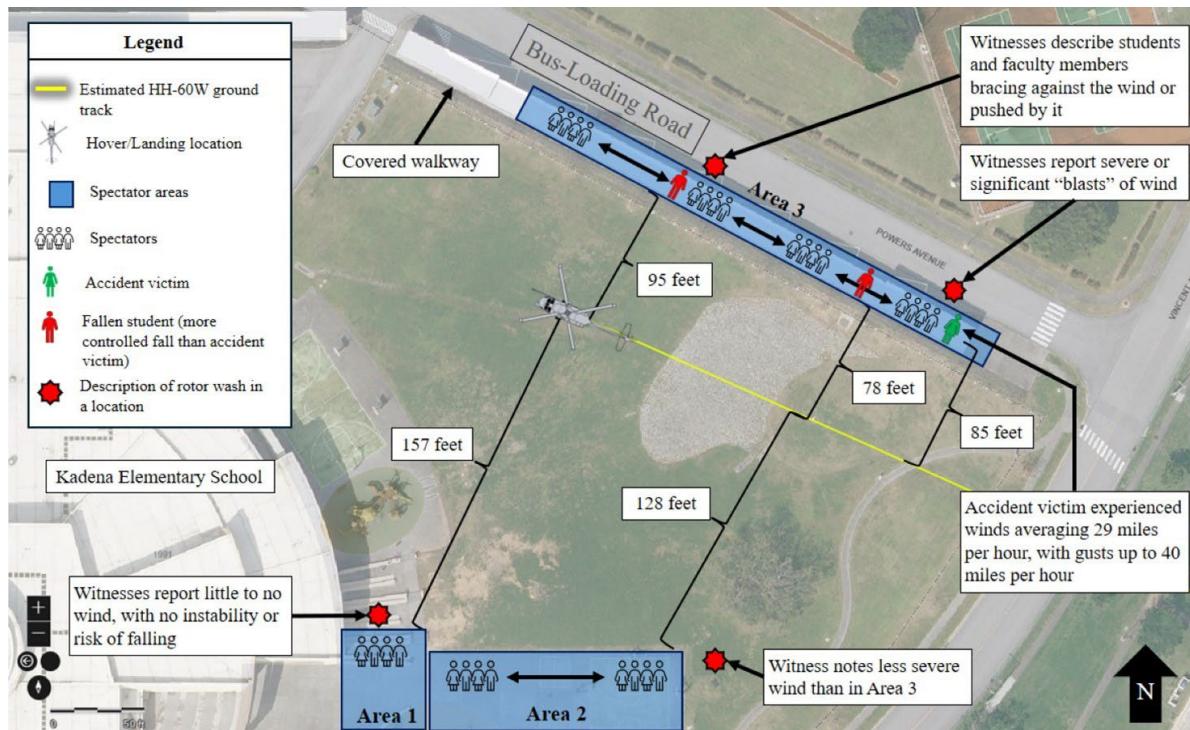
As the HH60W approached the LZ, the AV—a DoDEA teacher at BES—was approximately 85 feet from the helicopter’s flight path (Tabs Z-5, Z-6, Z-19, and GG-5). The AV’s location placed her as close or closer to the helicopter than almost any other spectator at the event (Tabs Z-5, Z-6, Z-11, and GG-5). During the aircraft’s final approach to KES, at approximately 0930, the helicopter produced a strong gust of downward and outward flowing wind (rotor wash) that rapidly approached the AV (Tabs Z-7 and Z-11). The rotor wash, made visible as it dislodged rainwater from two trees near the AV, immediately struck the AV (Tabs V-9.6, Z-7, Z-11, and Z-17).

Figure 5 (Tab Z-6) Actual Spectator Placement on 22 April 2025 (south side of bus-loading road)

The rotor wash caught an umbrella that was hanging on the AV’s left arm and briefly forced it open, roughly perpendicular to the AV’s body and pointed in the same direction as the wind flow (Tabs Z-7 and Z-11). The wind’s impact on the open umbrella knocked the AV off-balance and rapidly pulled her down onto the concrete walkway (falling in the same direction as the rotor wash) (Tabs Z-7, Z-11, and Z-17). Her head struck the concrete at an accelerated speed that caused head injuries much more severe than typically expected from a routine fall (Tabs Z-7, Z-11, Z-17, and GG-3 to GG-4).

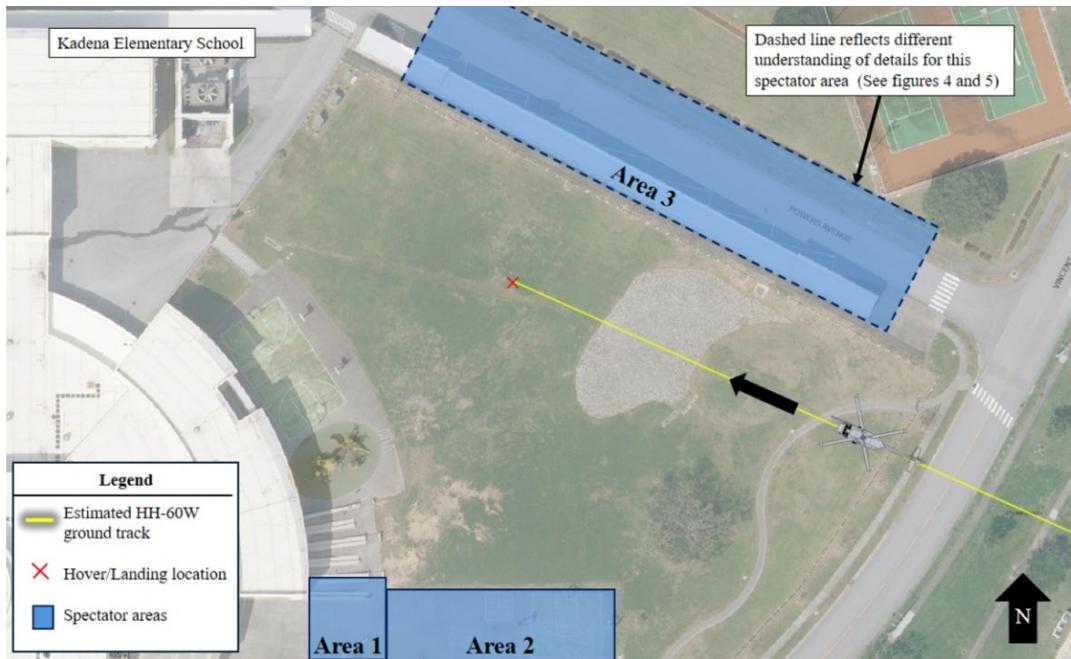
Figure 1. Location of Designated Spectator Areas at KES

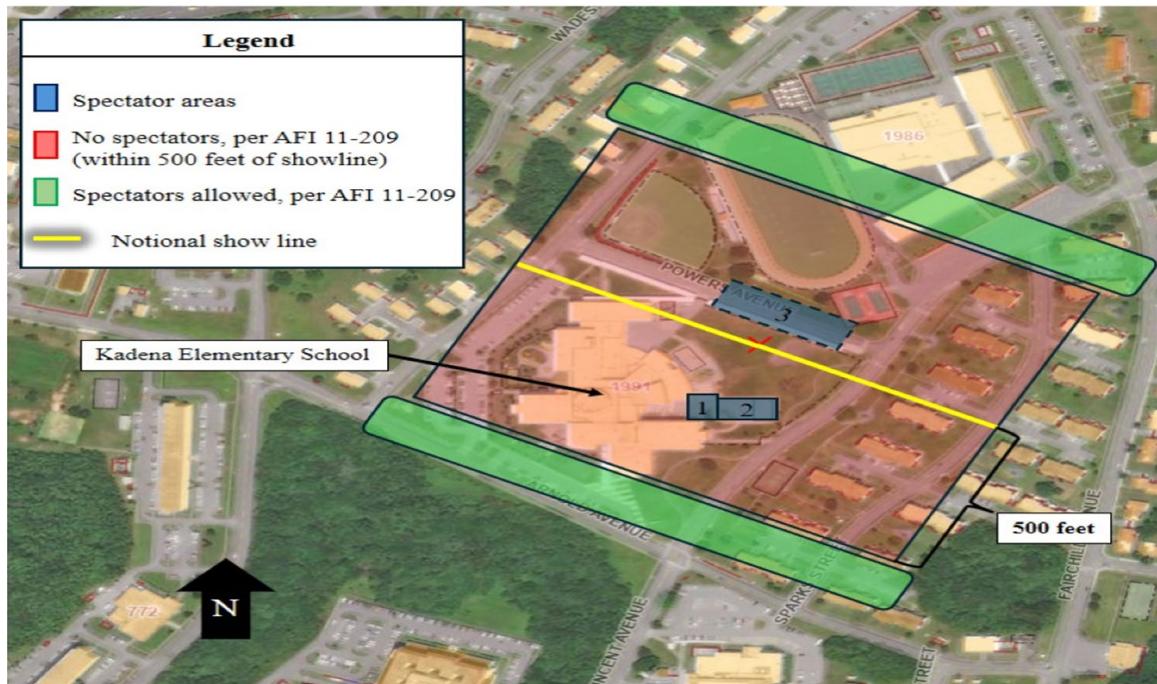
The unsafe distance between the aircraft and victim resulted from a failure in military mission planning to comply with spectator distance requirements from AFI 11-209 and the event's concept of operations (CONOP). For the demonstration at KES, AFI 11-209 mandated 500 feet between spectator areas and a designated show line—defined by the AFI as a prominent reference line—for the demonstration. Military mission planners selected three spectator areas at KES for students and faculty to observe the HH60W demonstration (*Figure 1*). The distance between each of the spectator areas and the helicopter's ground track or LZ was significantly less than 500 feet, meaning no spectators at the demonstration were at the distance required by AFI 11-209 (*Figure 2*). The approved CONOP for the aerial demonstration specified that all students (and implicitly faculty) would be at least 600 feet away from the helicopter's LZ. Each of the three spectator areas that military mission planners designated for KES, however, placed students and faculty members at distances much less than 600 feet from the LZ (*Figure 3*). Our investigation was unable to determine why the CONOP specified a distance 100 feet greater than the AFI. Plans for the demonstration failed to meet either requirement.

Figure 2. Spectator Areas Relative to Required Safe Distance, per AFI 11-209 (500 feet)

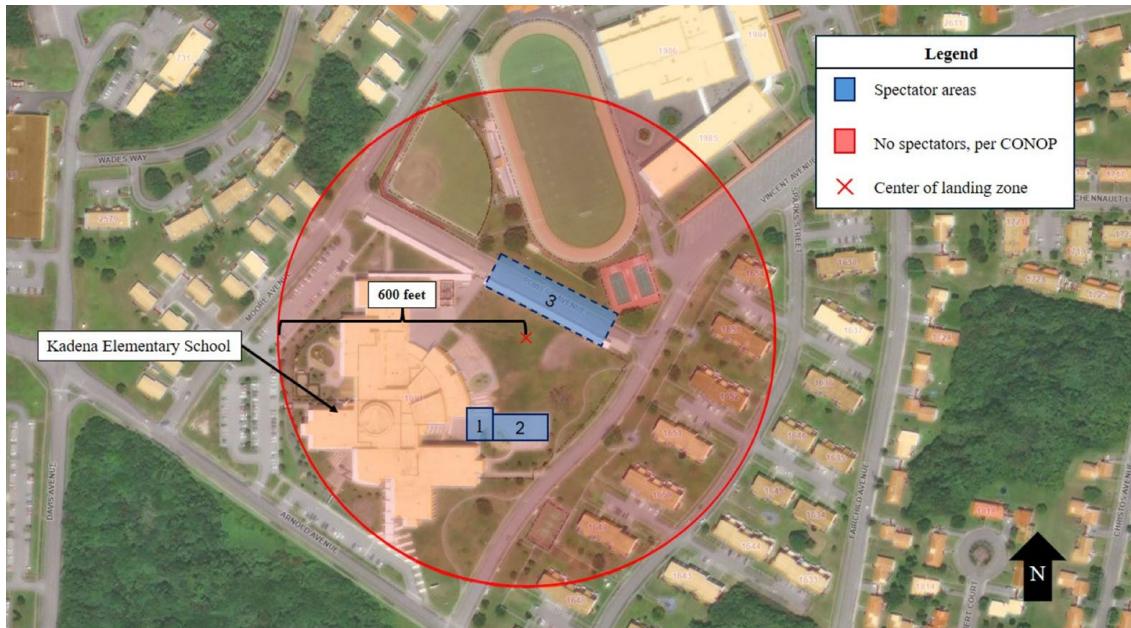
Figure 3. Spectator Areas Relative to Required Safe Distance, per CONOP (600 feet)

The AV's position during the demonstration was approximately 85 feet from the arriving HH60W, based on physical measurements and a summary of video evidence, far short of the 500 feet required by AFI 11-209 and the 600 feet specified in the demonstration's CONOP. This placed the AV among the closest to the helicopter relative to all other spectators at the event.

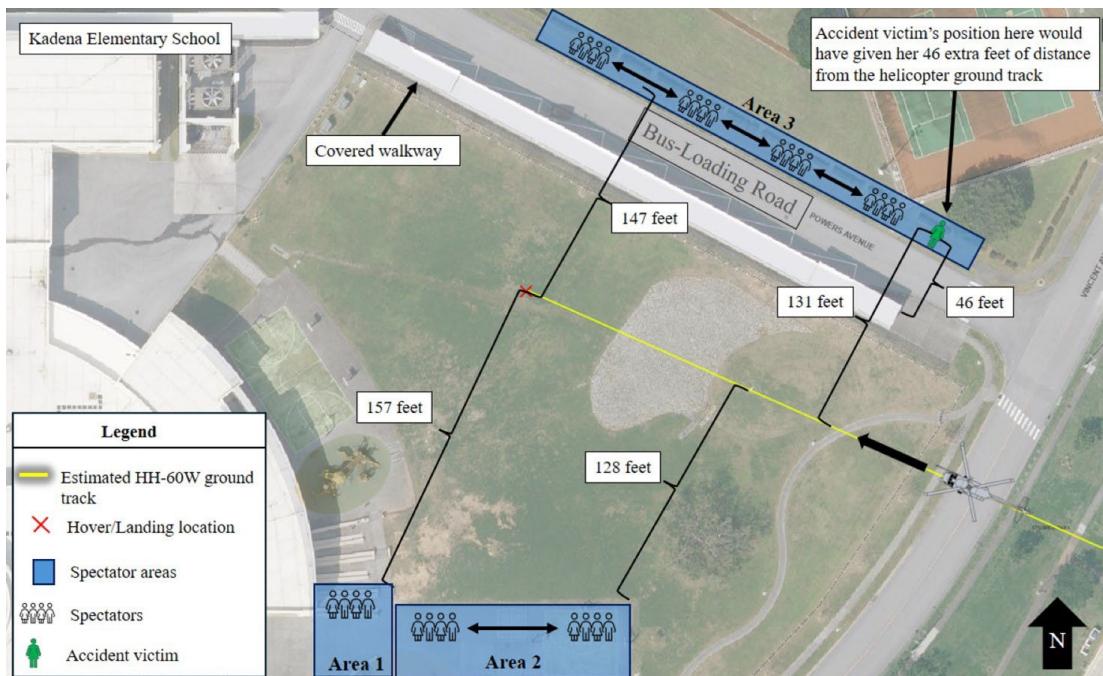
The PO and LZL did not document in writing details of their approved spectator areas, relying instead on verbal communication of the details. A lack of documented details prevented shared understanding—by school officials, the 33rd RQS's GC assigned to KES, and the flight crew—of a need to keep spectators north of the bus-loading road. Our investigation found that only the PO and LZL knew of the need to keep spectators on the road's north side.

Figure 4. Spectator Placement Intended by PO and LZL (north side of bus-loading road)

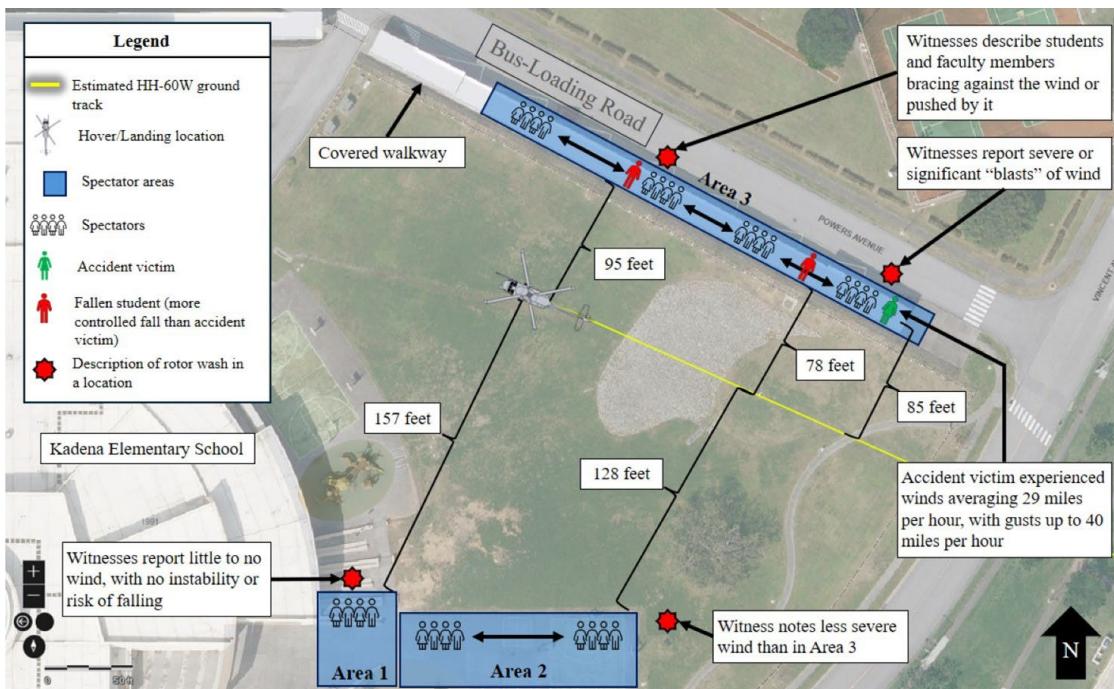
On the day of the demonstration, spectators in this area actually stood on the *south* side of the road, under or near a covered walkway roughly 45 feet closer to the arriving helicopter than the PO and LZL deemed safe (Figure 5). Had the AV been on the road's north side, the additional distance between the HH60W and the AV still would have placed her far short of distance requirements in AFI 11-209 or the CONOP, but the extra distance would have subjected her to less severe rotor wash due to dissipating strength of rotor wash as it moves laterally.

As a result, on the day of the demonstration, school spectator plans allowed students and faculty (including the AV) to stand on the south side of the bus-loading road (under the covered walkway). In addition, the lone GC at KES did not know about the planners' intent to restrict spectators to the road's north side, and aircrew members were unaware spectators were on the road's south side until on final approach to KES, just before the accident. The mission copilot (MCP) testified that the covered walkway blocked the aircrew's view of spectators during the initial high-level overflight of the area. When the mishap pilot first saw spectators on the covered walkway during the approach to KES, he directed the MCP—who was flying the helicopter—to “slide left” away from them. The MCP testified that he would have directed the GC to move spectators back from the road's south side had they been visible during the high-level overflight.

Figure 5. Actual Spectator Placement on 22 April 2025 (south side of bus-loading road)
