**UNITED STATES AIR FORCE**  
**AIRCRAFT ACCIDENT INVESTIGATION**  
**BOARD REPORT**

**F-22A, T/N AK 07-0137**  
**90TH FIGHTER GENERATION SQUADRON**  
**3RD WING**  
**JOINT BASE ELMENDORF-RICHARDSON, ALASKA**

**DATE OF ACCIDENT: 15 MARCH 2024**

**F-22A, T/N AK 07-0137  
JOINT BASE ELMENDORF-RICHARDSON, ALASKA  
15 MARCH 2024**

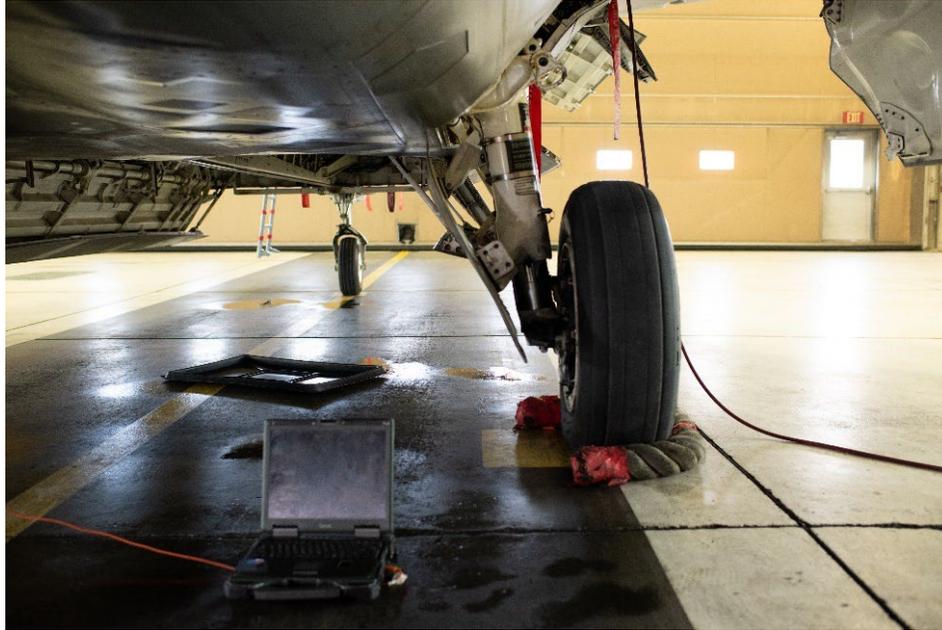
**Figure 3 - Location of PMA during normal maintenance of right-side weapons bay. Image not associated with MA. Tab Z-13**

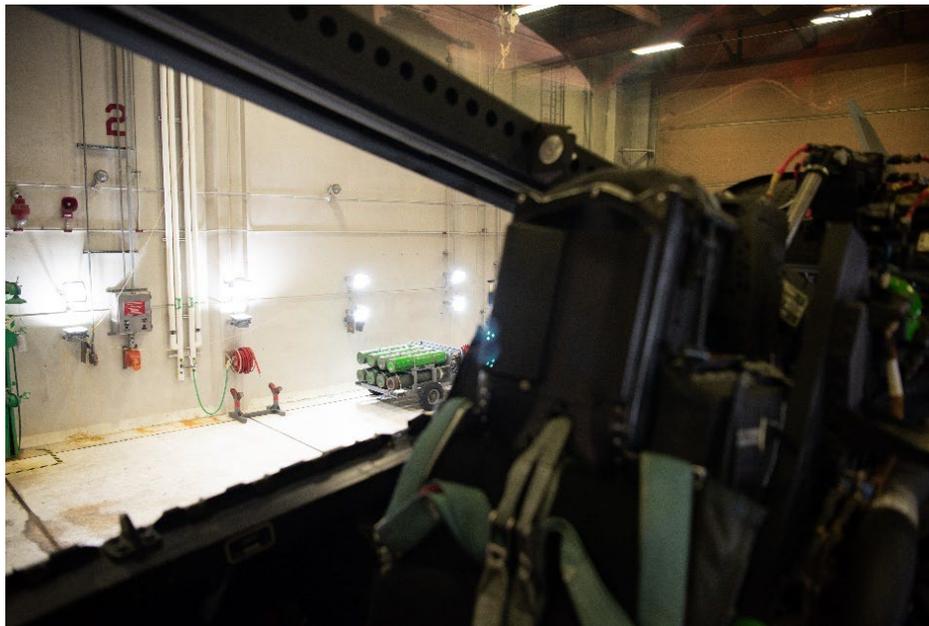
Figure 6 - View from cockpit ladder to right side of aircraft. Image not associated with MA. (Tab Z-16)

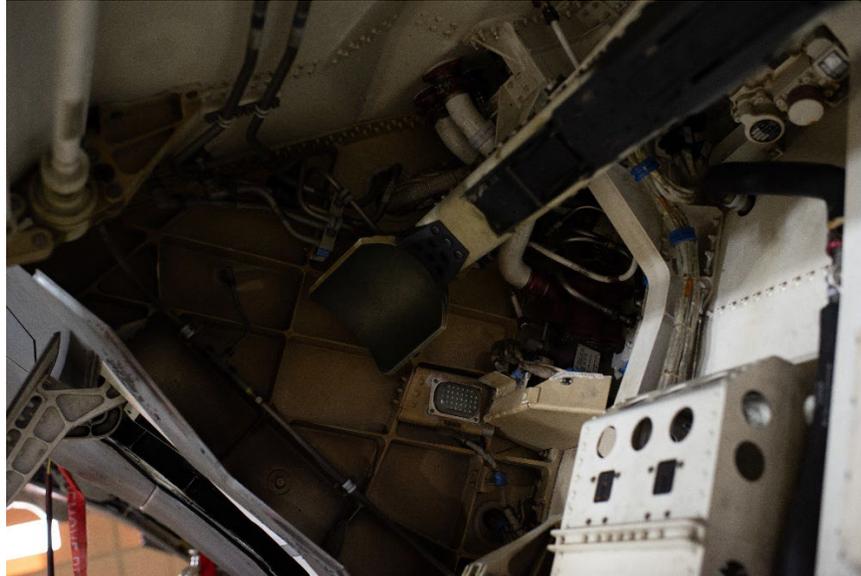
**Figure 7 - View of CRL plume deflector looking towards aft of weapons bay. CRL is fully retracted. Image not associated with MA. (Tab Z-17)**

Seconds into Retraction	CRL Plume Deflector Distance to Bulkhead
0	16.7 inches
1	10.6 inches
2	5.9 inches
3	4.3 inches
4	1.8 inches
5	1 inch
