UNITED STATES AIR FORCE
AIRCRAFT ACCIDENT INVESTIGATION
BOARD REPORT

KC-46A, T/N 15-46070

DATE OF ACCIDENT: 7 November 2022

SUMMARY OF FACTS AND STATEMENT OF OPINION
KC-46A, T/N 15-046070
Off the Coast of Florida
7 November 2022

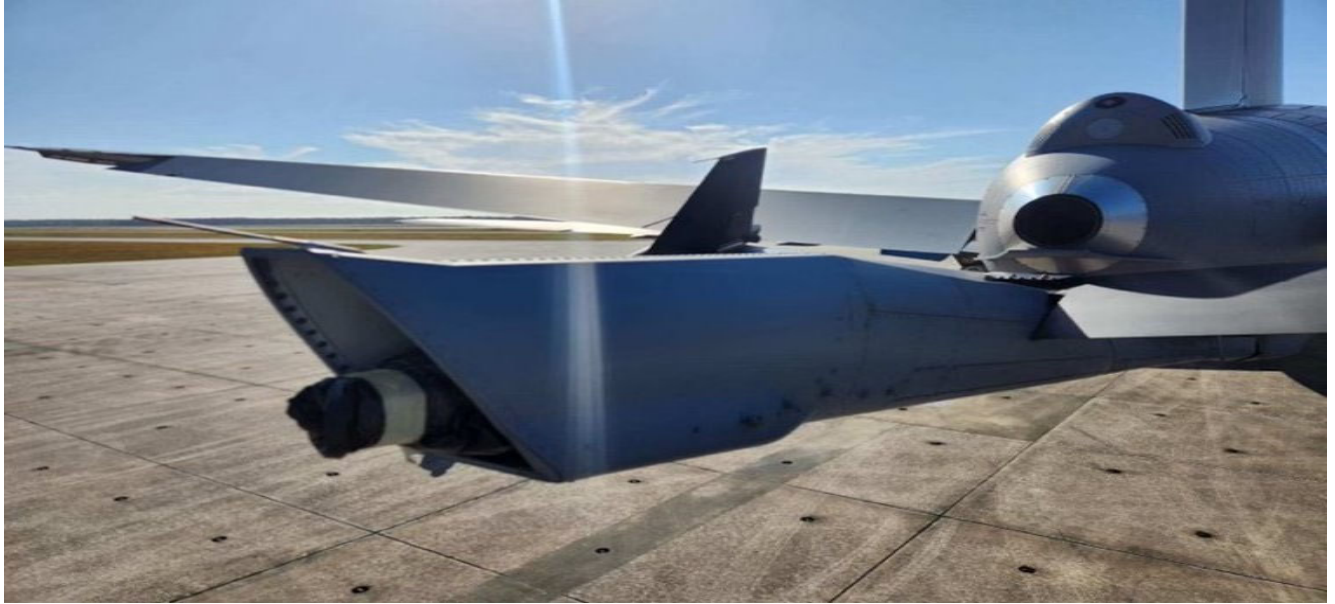
Figure 1: ARB With Nozzle Covered (Tab S-4)

MA1 sustained damage to the Aerial Refueling Boom Nozzle.

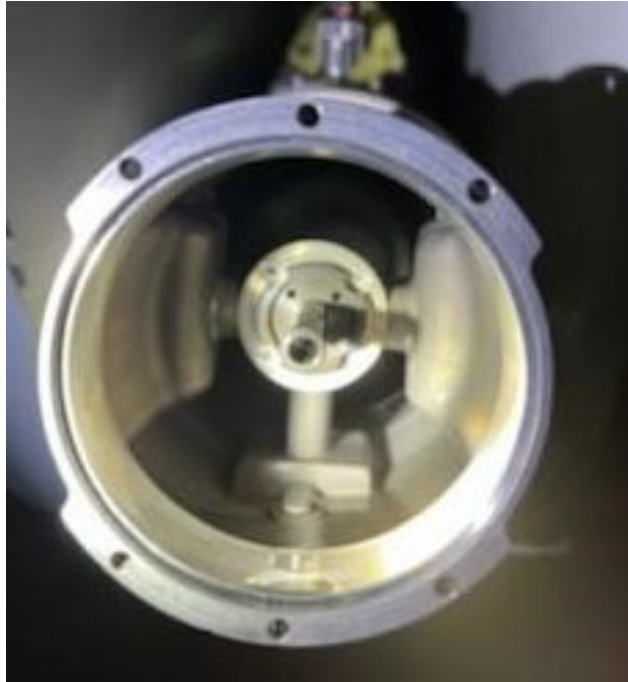
Figure 3: ARB Nozzle After Landing (Tab Z-3)

At the conclusion of the event, MA1 was in level flight at approximately 325 knots indicated airspeed, at approximately N 29° 19.80’ W 087° 33.60’ (Tab DD-10). The Boom Nozzle Poppet Valve separated from the aircraft, with the valve retaining ring remaining lodged in the receptacle of MA2 and the remainder of the assembly falling into the open ocean; no injuries were reported (Tabs R-6, K-3). MA2 joined formation with RAPTOR 3, and after performing a battle damage assessment, departed the air refueling formation to participate in the joint force exercise (Tab V-3.4).

The Boom Nozzle was stressed beyond its limit, breaking the Nut Nozzle Assembly allowing the poppet valve to fall free of the aircraft.

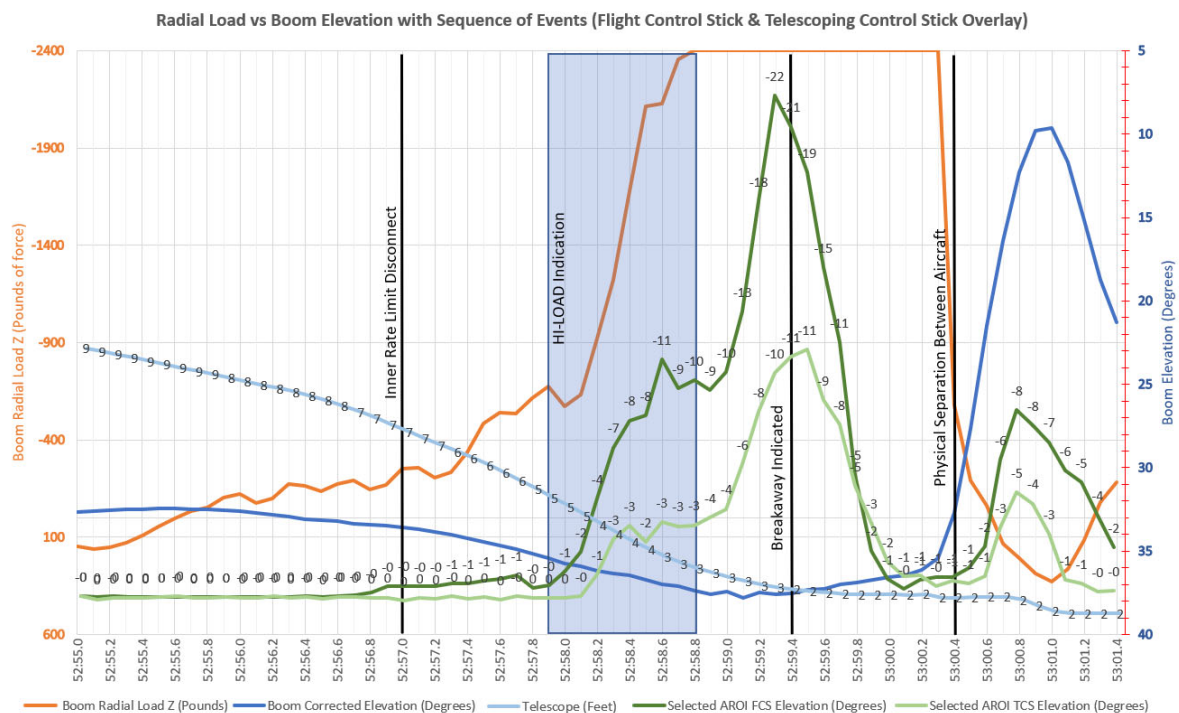
Figure 5: Radial Load vs Boom Elevation with Sequence of Events (FCS & TCS Overlay)
(Tab DD-15)

Analysis of the MA1's ARCC data was conducted by the AIB's Pilot and Boom Members with technical information from a Boeing employee (Tabs DD-9-11, DD-3). This analysis yielded a detailed sequence of events focused on the period where the ARB was powered on, including the air refueling contact and breakaway emergency procedure with MA2 (Tab DD-9). Additionally, the AIB was able to plot the position of the ARB (elevation and telescope), the radial force placed on the ARB nozzle, and the position of the AROI FCS and TCS controls to illustrate the multiple forces which interacted over the very brief period (3.4 seconds) in question (See figure 3) (Tab DD-11).

In the 1.0 sec following the triggered disconnect, ARCC data indicates MBO1 applied up to 0.94 degrees of FCS input which is consistent with MBO1's testimony of commanding a disconnect and making radio calls. In combination with the receiver's rapid forward movement, ARCC data showed that the radial nozzle load exceeded 500 lbs. 0.6 seconds later, MBO1 starts to retract the ARB which was unsuccessful, indicating the bound condition had already occurred.
