**UNITED STATES AIR FORCE**  
**AIRCRAFT ACCIDENT INVESTIGATION**  
**BOARD REPORT**

**F-16C, T/N 89-2013**

**DATE OF ACCIDENT: 31 JANUARY 2024**

**EXECUTIVE SUMMARY  
UNITED STATES AIR FORCE  
AIRCRAFT ACCIDENT INVESTIGATION**

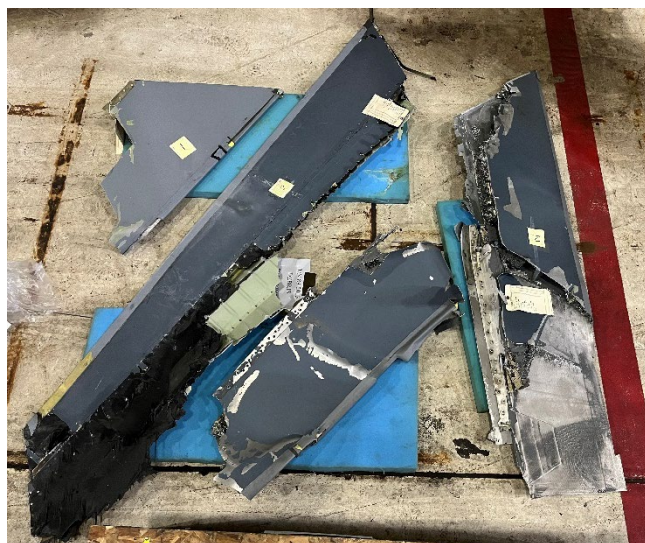
**Figure 3: MA debris collected from Yellow Sea (Tab Z-19)**

A limited number of debris was retrieved from the Yellow Sea. Most of the MA was never recovered. Pieces retrieved from the MA ranged in size from a few inches to four feet and only represented parts of the MA without retrievable historical flight data (i.e. leading edge). Debris recovered did not assist in the AIB findings and were irrelevant to the mishap.
