United States Air Force Accident Investigation Board Report

CV-22B, T/N 17-0077
MELROSE AIR FORCE RANGE, NEW MEXICO
22 AUGUST 2023

**SUMMARY OF FACTS AND STATEMENT OF OPINION
CV-22B, T/N 17-0077
MELROSE AIR FORCE RANGE, NEW MEXICO
22 AUGUST 2023**

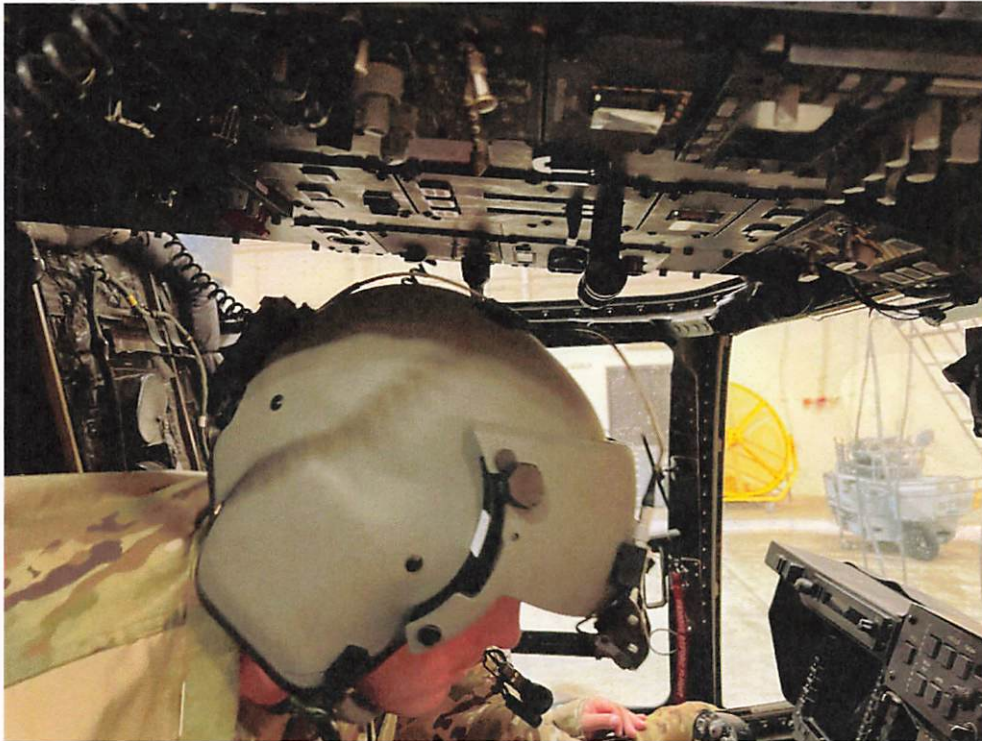
Figure 4-1. FE clearance from ECL while entering cockpit (Tab Z-91)

At 2129:26 MST, as the MA was at 190 ft AGL and 20 knots ground speed, the right ECL was moved backwards out of the FLY position to the OFF position within 0.5 seconds, bypassing 2 detents, and commanded a controlled shutdown of the right engine (Tab FF-3 to FF-4, and FF-7). MAC and MFE1 stated the ECL did not move out of the FLY position; MCP, MFE2, and MFE3 had no knowledge of the ECL movement (Tabs V-6.7, V-7.13, V-8.12, V-9.10, and V-10.10). The MA was unable to generate the power required to maintain the hover with one engine inoperative (53% Qm available vs the 76% Qm required) and began to descend towards the ground (Tab FF-3). MCP observed an increasing descent rate on his vertical velocity indicator and attempted to command more power from the MA by moving the Thrust Control Lever (TCL) to the full forward position (Tabs R-6.5, R-11.3, and FF-3). As the descent rate increased past 600 FPM, the MC received the audible “Sink Rate” warning at 2129:28 MST indicating the aircraft was descending vertically at a potentially unsafe rate; as designed no other warnings, cautions, or advisories were displayed by the system (Tabs R-6.5, R-11.3, BB-71, and FF-3 to FF-4). Upon hearing the “Sink Rate” warning, MFE1 looked at MAC’s flight displays and observed an increasing descent rate on the Vertical Velocity Indicator (VVI) and continued watching the VVI until the eventual impact with the terrain; MFE1 made no verbal calls or announcements to the rest of the MC through the remainder of the mishap (Tab V-6.8 and V-6.21 to V-6.23). MCP announced “Power’s all in. Power’s all in, bird’s coming down” to inform the MC that he was unable to arrest the descent despite commanding full power from the MA (Tabs N-76 and R-11.3). The MA’s sink rate increased and approached a 1,500 FPM descent rate before stabilizing in a 1,200 FPM descent towards the ground (Tab FF-3). As the MA approached 30 ft AGL, MAC called “power...power...power” and moved his hand to the TCL to ensure that it was full forward (Tabs N-76, R-6.5, and FF-3). MCP responded with “power’s full in” (Tabs N-76, R-6.5, and R-11.3).

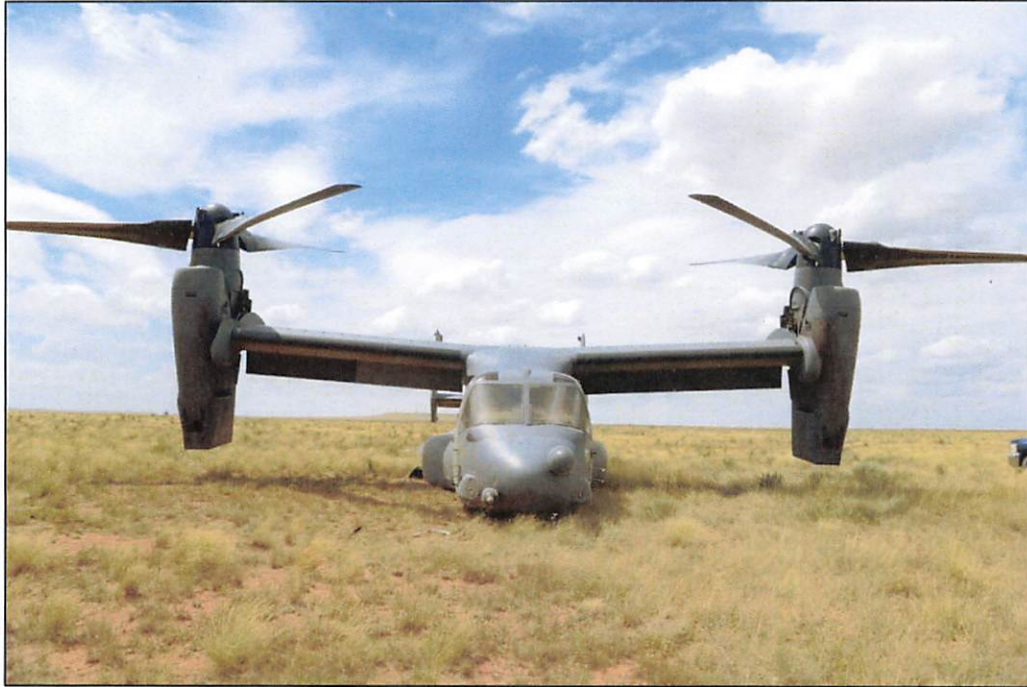
Figure 4-5. MA Final Position (Tab Z-19)

MAC and MCP reduced the TCL to the full aft position just before the MA “skipped” once across the ground at 4 ft AGL before making a second, stronger impact, measured by the MA to be approximately 4 g, where the MA stayed on the ground as it continued its slide (Tabs R-6.5 and FF-3). The antennae, lights, nose landing gear doors, and the Forward-Looking Infrared (FLIR) turret positioned on the bottom of the MA were crushed, destroyed, and spread along the skid path (Tab Z-11, Z-25 to Z-27, Z-39 to Z-43, and Z-61 to Z-71). The jolt caused by the impact with the ground caused MAC or MCP to inadvertently apply full right pedal for approximately three seconds, causing the MA yaw right approximately 50-feet after the first impact point (Tab FF-3). Partway through the rotation, the FLIR turret separated from the MA and came to rest 20 feet from the nose while the right main landing gear door was damaged and pulled away from the drag strut (Tab Z-27, Z-45, and Z-47). The MA came to a full stop approximately 360-ft away from the initial impact point and on a 051-degree heading, 139-degrees right of its heading at initial impact (Tab FF-3). The MA stayed intact apart from the destroyed/separated antennae, lights, nose landing gear doors, forward external cargo hook bay doors, and FLIR turret (Tab Z-5 to Tab Z-9 and Z-19). The Crash Position Indicator did not activate for this mishap as the maximum impact recorded of 4 g was below the 5 to 7 g activation threshold for the device (Tabs AA-879 to AA-880 and FF-3).

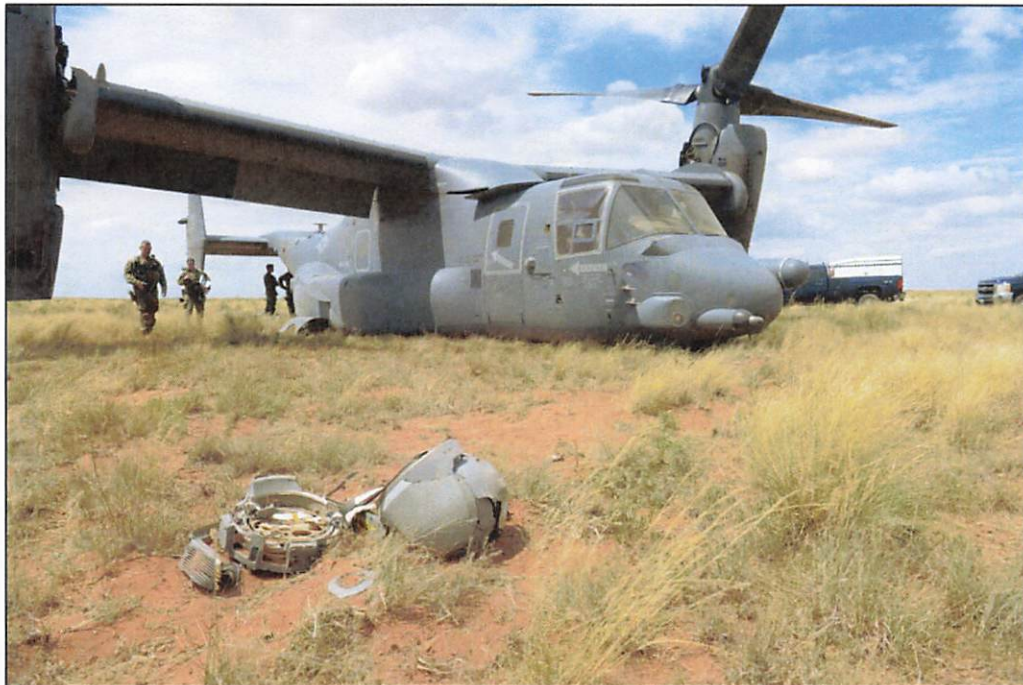
Figure 4-8. MA and FLIR Turret (Tab Z-27)

The FLIR turret, which provides a thermal image that enables a pilot to take-off, navigate at low altitudes and land in total darkness, was found crushed and separated approximately 20 feet from the nose of the aircraft (Tabs Z-27, Z-63 to Z-71, Z-77, and AA-866).

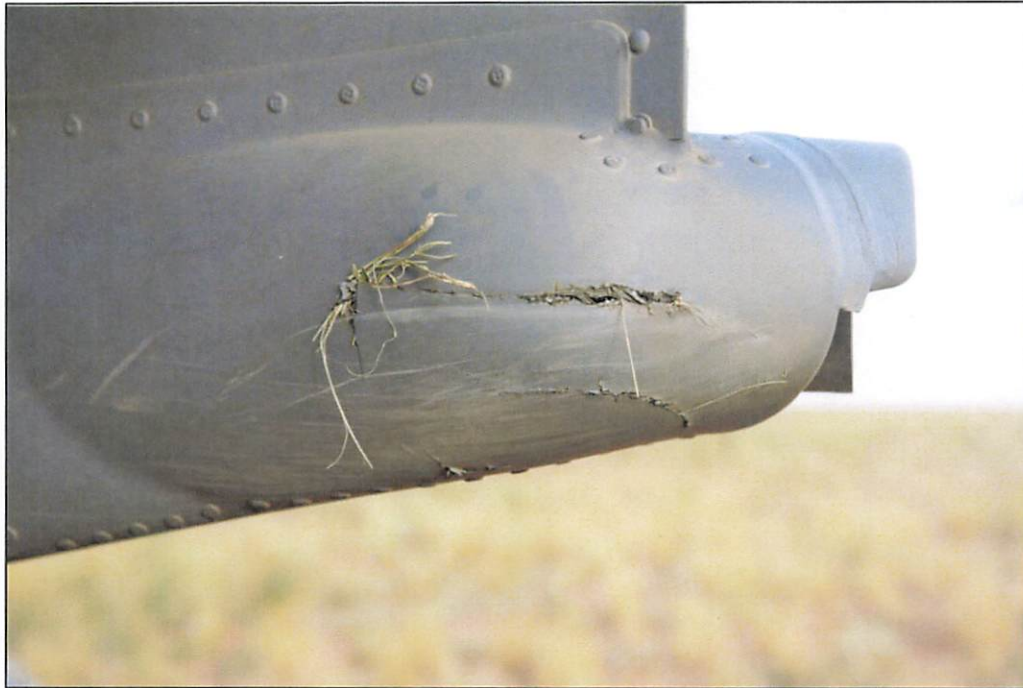
Figure 4-9. MA Damage, Right Vertical Stabilizer (Tab Z-37)

Three horizontal cracks were sustained to the right inboard SIRFC receive antenna fairing located on the right inboard bottom trailing edge of the right vertical stabilizer (Tabs Z-53 to Z-55, Z-73, and AA-865 to AA-867).

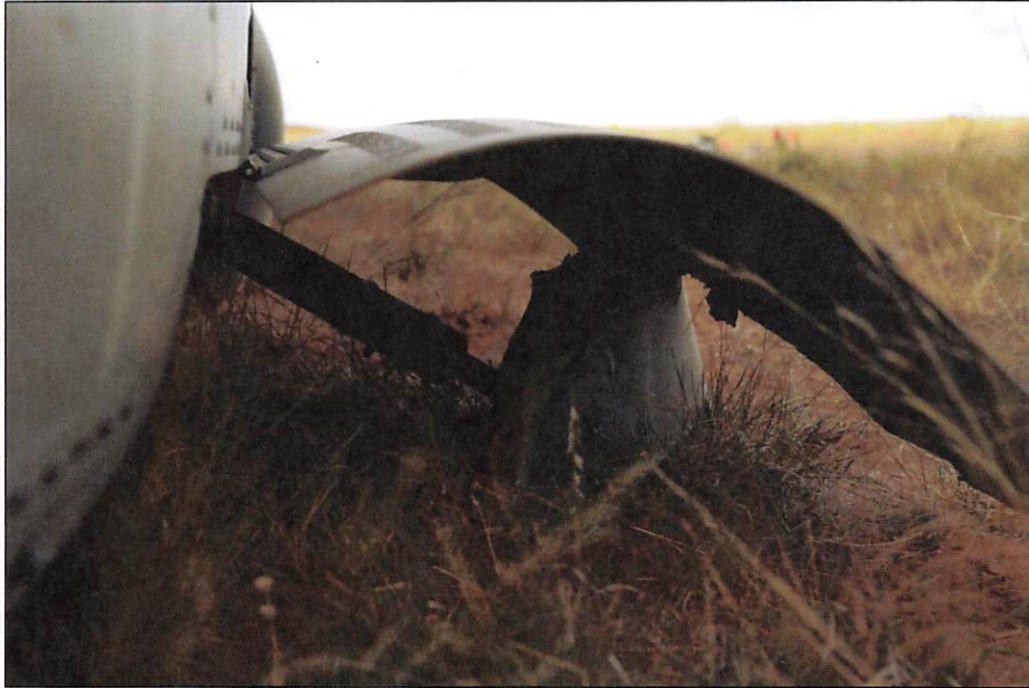
Figure 4-11. MA Damage, Right Gear Door (Tab Z-47)

The FLIR turret, cargo ramp, upper and lower cabin door area, vertical stabilizer fairing, right main landing gear door, and forward external cargo hook bay doors sustained damage (Tab Z-29, Z-33, Z-37, Z-45 to Z-49, Z-63 to Z-71, and Z-77 to Z-83).

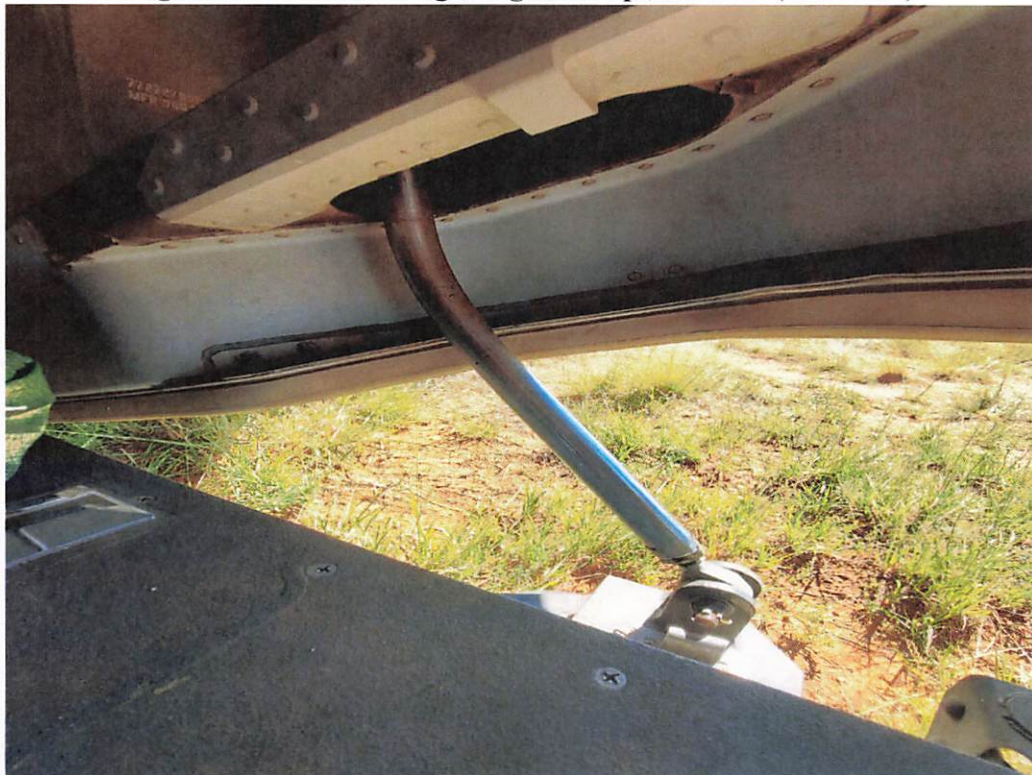
Figure 4-12. MA Damage, Right Ramp Actuator (Tab Z-73)

The cargo ramp assembly sustained damage during the mishap (Tab Z-13 to Z-16). Actuator fittings are mechanically connected to each side beam of the ramp assembly which allows for movement and mechanically connects the cargo ramp assembly and actuators (Tab Z-29 to Z-75). On the MA, the left ramp actuator fitting was sheared, and both the left and right ramp actuators suffered bent rods and rod ends (Tab Z-29 to Z-75). Further assessment of the ramp assembly and associated components is required to determine the full extent of damage to the ramp as a result of the mishap. There is no evidence that the ramp assembly or associated components had any impact on the mishap or the functionality of the MA.

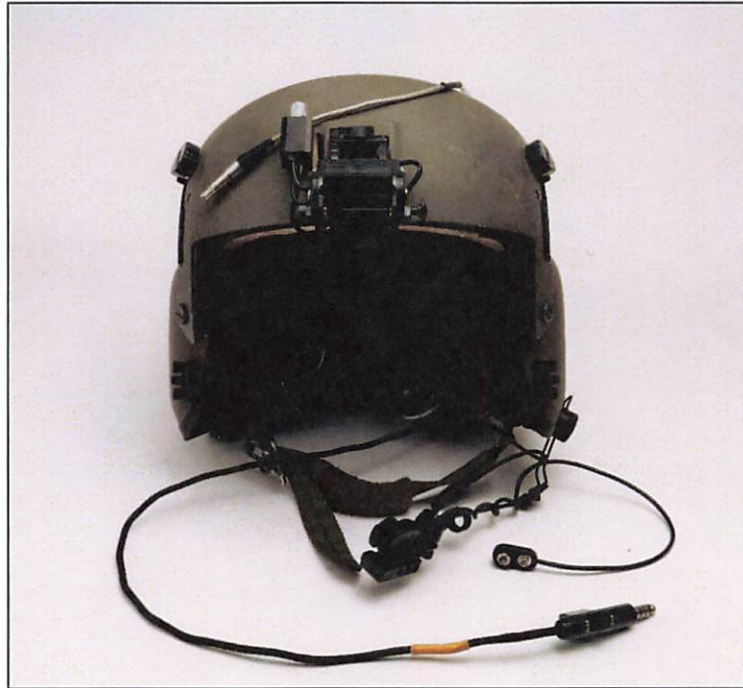
Figure 4-13. MFE1 Helmet with severed NVG cable (Tab EE-3)

MAC commanded the MC to perform an emergency shutdown which was executed by MFE1 (Tabs N-77, R-11.3, R-16.4, R-19.2, and V-7.6). Of note, as MAC gave the command to perform the emergency shutdown the right engine speed and temperature both began to increase, signifying the engine was continuing its restart (Tab FF-3 to FF-4). At the completion of the emergency shutdown, the MC conducted an emergency egress from the aircraft (Tabs R-11.3, R-16.4, R-19.2, and V-7.6). Aircrew flight equipment maintainability, serviceability, and inspections were not a factor in this mishap (Tab G-81 to G-86, G-405 to G-410, G-557 to G-562, G-573 to G-578, and G-579 to G-583). MFE1's NVG low-profile battery pack cable was found to be ripped from the NVG mount connector port with pieces of the cable connector found within the port (Tab EE-3, EE-9, and EE-18). The cable connector pieces within the cable port and the testimony from MFE1 that they were performing NVG aerial gunnery prior to the mishap both indicates the cable was attached to the NVG mount at the time of the mishap (Tabs V-6.7, EE-9, and EE-14).

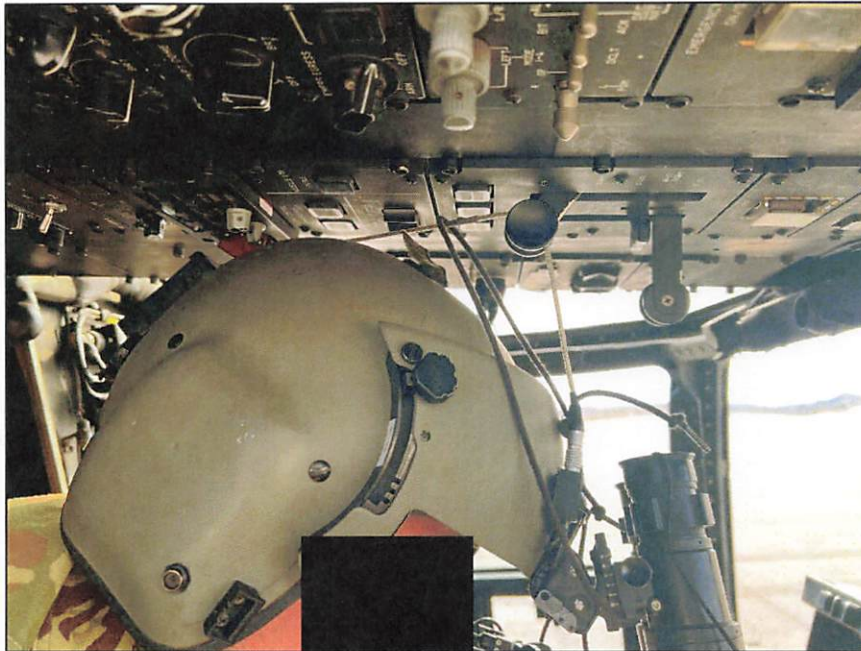
Figure 2-1. NVG Battery Cable on Right ECL

While bending forward, the low-profile battery pack cable on MFE1's helmet caught the right ECL. At 2129:26 MST, as MFE1 attempted to sit down and the MA was at 190 ft AGL and 20 knots ground speed (airspeed was too low to register), the right ECL was moved backwards out of the FLY position to the OFF position within 0.5 seconds. His movement caused the ECL to bypass two detents, and commanded the right engine to perform a controlled shutdown. With the loss of engine power, the MA was unable to generate enough thrust to maintain altitude and began to descend. MCP noticed their Vertical Velocity Indicator (VVI) was starting to show the descent and moved the thrust control lever (TCL) to the full forward position to command full power from the MA. With a single engine, the MA was only able to develop 53% mast torque (Qm), significantly less than the 76% Qm previously required to maintain the hover and the descent rate continued to increase. As the descent rate increased and passed 600 FPM, the MC heard the aural "Sink Rate" warning at 2129:28 MST. The MCP announced to the MC that "Power's all in. Power's all in, bird's coming down", which verified to the crew that they were commanding full power from the MA and was unable to arrest the descent. The MA stabilized in a 1,200 FPM descent towards the ground. As the MA approached 30 ft AGL, the MAC called "power...power...power" as he moved his hand to the TCL to ensure that it was full forward and the MCP confirmed "power's full in." MAC pulled the cyclic aft in an attempt to reduce forward airspeed at approximately 10 ft AGL; this and the aircraft entering ground effect caused the descent rate to decrease to approximately 800 FPM just prior to impact with the ground.

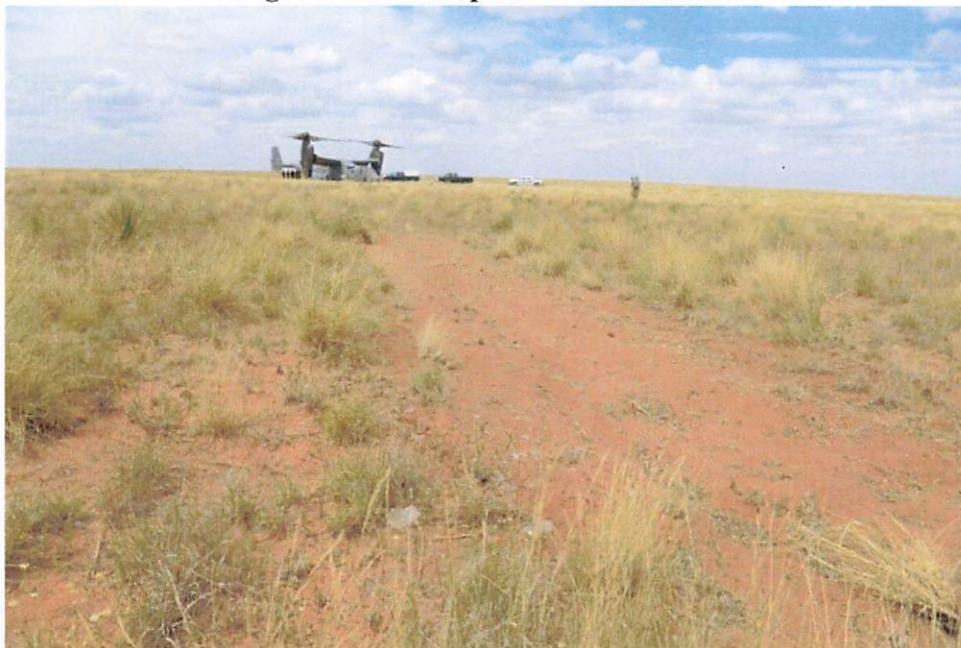
Figure 2-2. Mishap Aircraft Skid Path

The MA made first impact with the ground at approximately 2129:37 MST just west of Jockey. The MA impacted with 40 knots ground speed on a 272-degree heading with the nacelles at 78-degrees and 10-degrees nose up with the wings near level. The impact of the MA ramp on the ground caused both ramp hydraulic actuators to bend and the mount to the left actuator on the ramp

side to break. The right vertical stabilizer and right nacelle also contacted the ground and received light damage. As the MA made initial impact with the ground, the ECL was moved forward into the FLY position within 0.2 seconds as MFE1, still snagged on the ECL, was thrown forward. MFE1's forward momentum ripped the NVG battery cable out of the NVG mount connector port on the front of his helmet as the ECL reached the forward stop. The movement of the ECL to the FLY position commanded the right engine to restart, as recorded by VSLED. The MC reduced the TCL to the full aft position just before the MA "skipped" once across the ground before making a second larger and final impact. The antennae, lights, nose landing gear doors, and the Forward-Looking Infrared (FLIR) turret positioned on the bottom of the MA were crushed, destroyed, and spread along the skid path. The jolt caused by the impact with the ground caused MAC or MCP to inadvertently apply full right pedal for approximately 3 seconds, causing the MA to begin right yaw 50 ft after the first impact point. Part way through the rotation, the FLIR turret separated from the MA and came to rest 20 ft from the nose of the MA and the right main landing gear door was damaged and pulled away from the drag strut. The MA came to a full stop approximately 360 ft away from the initial impact point and on a 051-degree heading, 139-degrees right of its initial heading (Figure 2-2).

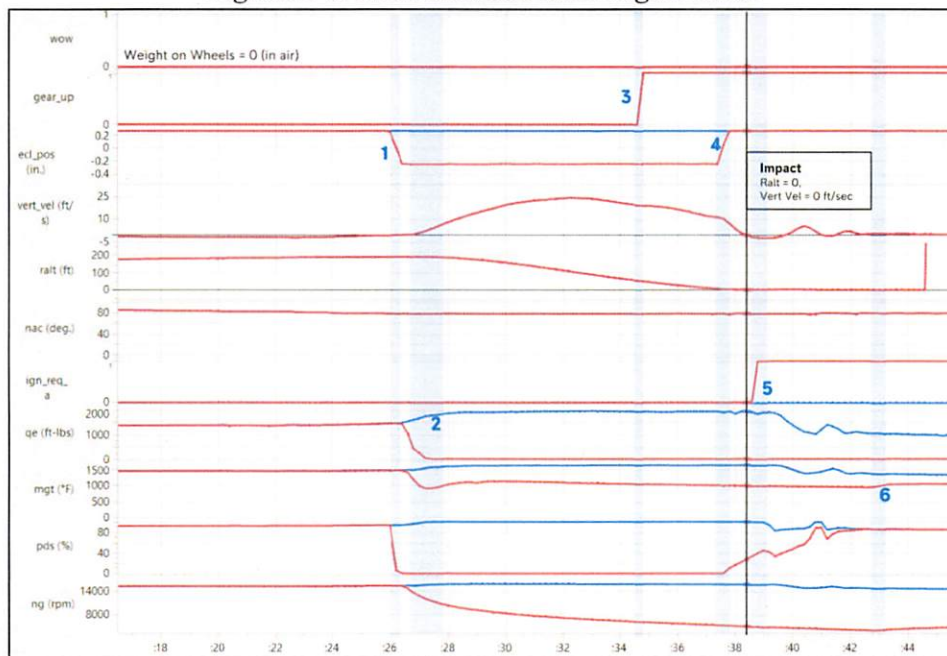
Figure 2-3. ECL Position and Engine Data

to check that the ECLs were fully forward in the fly position following the sink rate warning. MFE1 stated he did the same immediately following MAC. VSLED data and audio recordings indicate that the right ECL was pulled to the OFF position as MFE1 moved into the FE seat and remained in the OFF position until the first impact with the ground. VSLED data shows the exact position of the ECL and displayed the expected indications on the engine during a commanded shutdown through manipulation of the ECL (Figure 2-3). The flight deck microphone captured the audible click of the ECL as it traveled to the OFF position and corresponds with the VSLED data. There are no indications or warnings in the CV-22 when an ECL is moved to OFF while in flight. All evidence and technical analysis shows that the MA and all subsystems, including the Engine Control Panel, engine, and Flight Control systems, were fully functional and operating normally at the time of the mishap and that this was not a mechanical error but rather a human error.

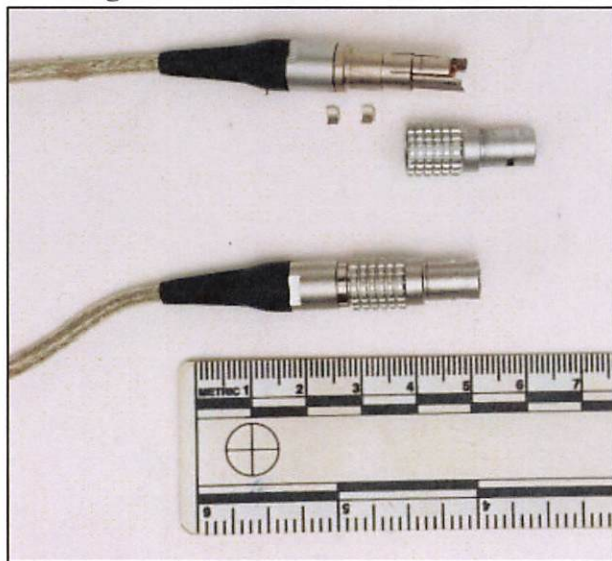
Figure 2-4. Broken NVG Connector

MFE1 was not secured in the FE seat and was thrown forward on impact while his NVG battery pack cable was snagged on the ECL, moving the ECL back into the FLY position 0.25 seconds after initial impact with the ground. This resulted in his head and neck being yanked backwards to the extreme of flexion and extension, as documented by his immediate and follow-up medical treatment after the mishap. After the NVG battery pack cable broke, MFE1's forward momentum forced him to slam his face into the CDU. Medical testimony and aviation psychologist testimony
