**UNITED STATES AIR FORCE**  
**AIRCRAFT ACCIDENT INVESTIGATION**  
**BOARD REPORT**

**KC-46A, T/N 18-6054**

**LOCATION: FAIRBANKS INTERNATIONAL AIRPORT, ALASKA**

**DATE OF ACCIDENT: 16 JULY 2025**

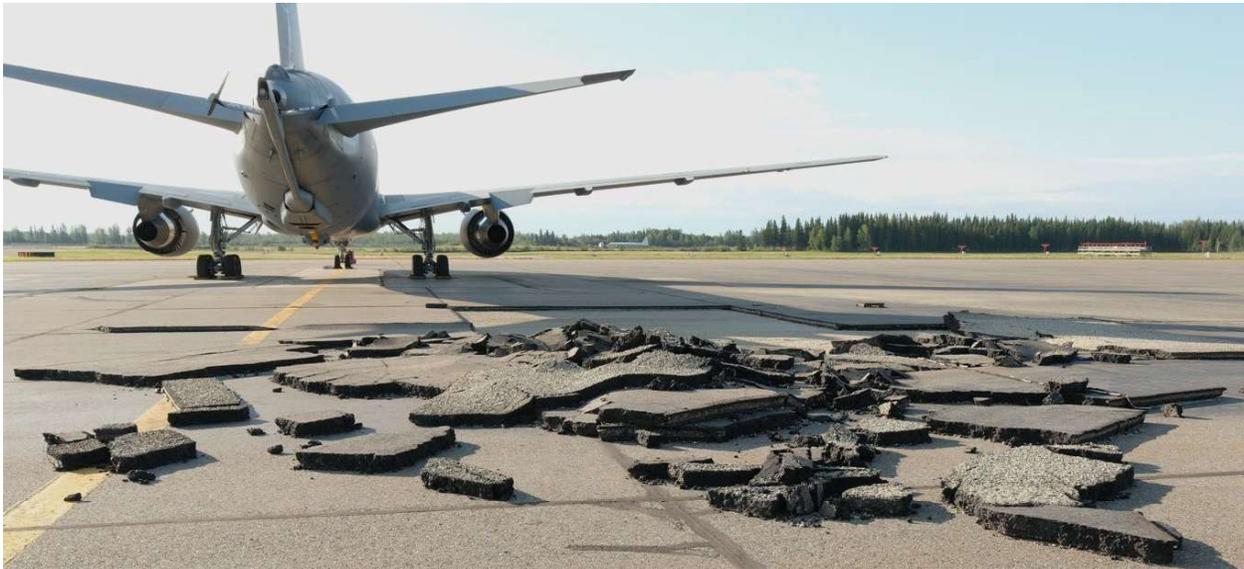
**Figure 2: Damage to the asphalt behind the right engine**

Ultimately, due to consistent heat and exhaust velocity from the engines, the seals securing the asphalt blocks failed and the pavement lifted into the air (Tabs Z-8, BB-159, BB-161-162). The repair area covered approximately 3,200 square feet (Tabs CC-15-16).

I find, by a preponderance of evidence, that the mishap was caused by persistent high temperatures in combination with repeated high-speed exhaust from the MA's right engine. These conditions severely degraded the bituminous sealant behind the MA and ultimately dislodged two 25-foot-long by 25-foot-wide asphalt blocks.

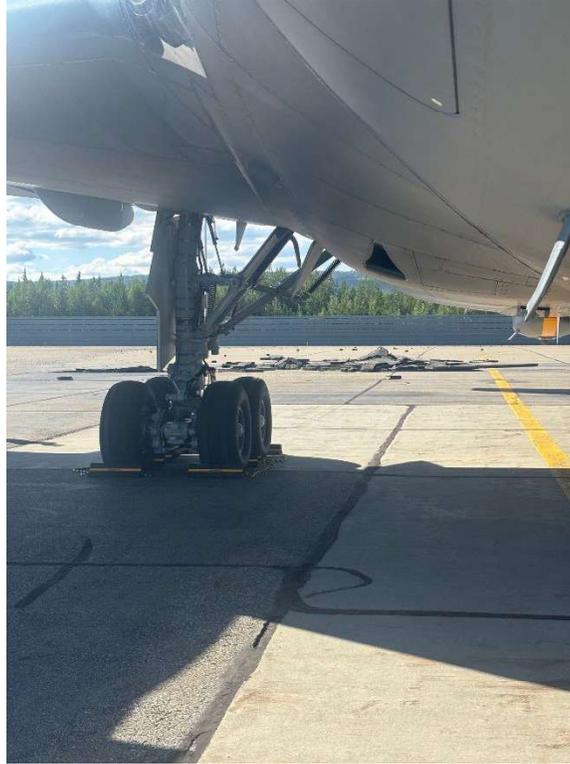
**Figure 3: Right Main Landing Gear Located on Concrete “T” Structure**

A few days later, on 15 July 2025, the FCC team along with the assistance of the Airport Ground Manager (AGM) towed the aircraft to the HCR (Tabs V-2.3 and V-2.4). The spots designated for aircraft parking at FIA, with the exclusion of the main gate terminal parking locations, were structured with concrete in a "T" shape for the placement of the aircraft's nose and main landing gear, whereas the surrounding pavement consisted of asphalt (Tab Z-3).

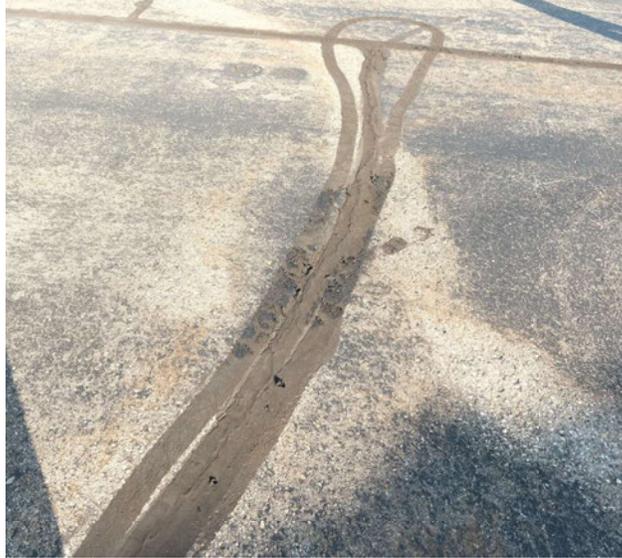
**Figure 5: Noticeable Heat Damage to Asphalt Sealant Behind the Left Engine**

In accordance with established procedures, the MRT completed approximately ten HPERs between 1000L and 1800L on 16 July 2025 (Tab R-3). For reference and context, Figure 5 shows an asphalt seal behind the left engine following the asphalt dislodging behind the right engine (Tab Z-7).

Furthermore, it is important to note the significance that both engines operated simultaneously during the engine-run process. The sealant behind the left engine showed signs of heat damage, while the area behind the right engine ultimately failed. It could not be determined why the sealant

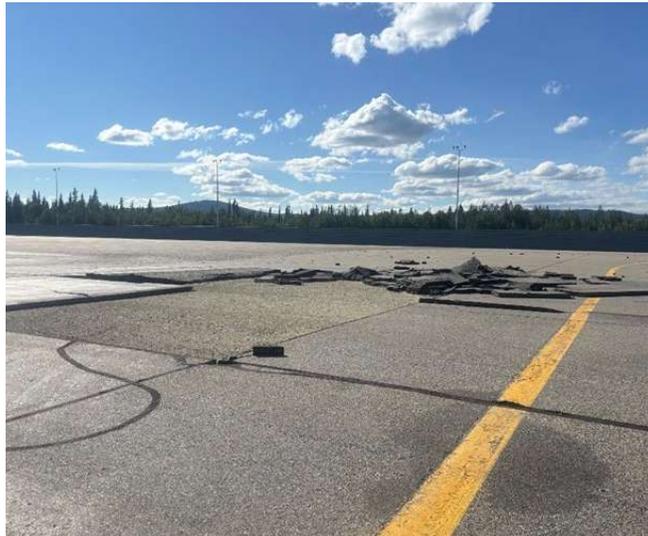
**Figure 6: Damage to Heavy Cargo Ramp Following Multiple KC-46A Engine-runs**

failed (ie. structural imperfections, environmental impact, etc.), but it most likely failed due to the consistent harsh conditions imposed during multiple engine-runs.
