UNITED STATES AIR FORCE
AIRCRAFT ACCIDENT INVESTIGATION
BOARD REPORT

F-16C, T/N 86-0322

18TH FIGHTER INTERCEPTOR SQUADRON
354TH FIGHTER WING
EIELSON AIR FORCE BASE, ALASKA

DATE OF ACCIDENT: 28 MAY 2024

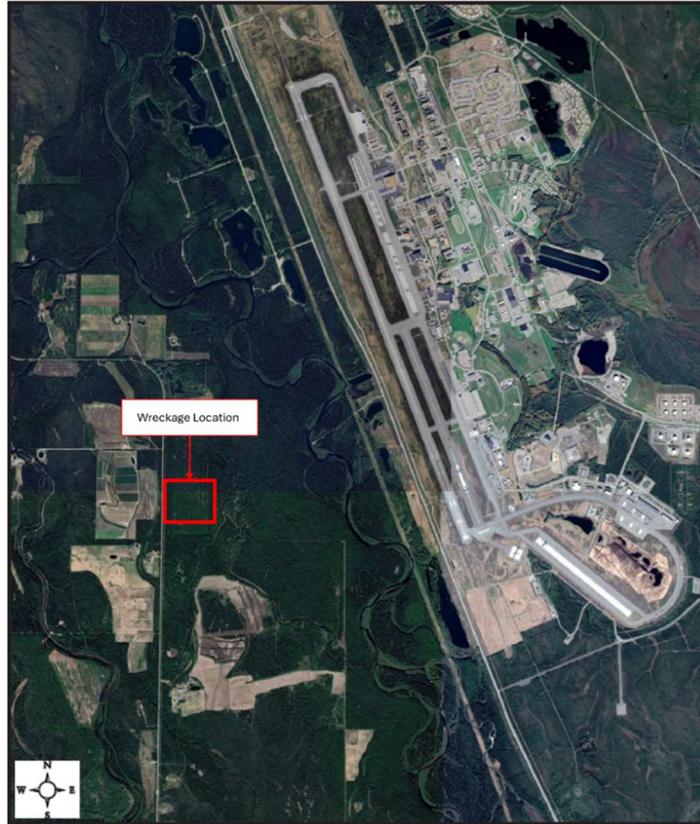
This mishap did not include an aircraft crash site (Tab L-3). However, Eielson AFB personnel were dispatched shortly after safe landing of the MA to locate the jettisoned external fuel tanks (Tab V-5.3). Based on accounts from the MP, the fuel tanks were assessed to have landed off military installation property (Tab V-5.3). Base emergency response personnel coordinated with local area responders and the Civil Air Patrol to conduct a search of the likely wreckage area (Tab V-5.4). Both fuel tanks were located on the date of the mishap, and both were found to have been destroyed upon impact (Tab V-5.4). The fuel tanks impacted in an undeveloped forested area with no resulting injuries or damage to built infrastructure (Tabs DD-3, V-5.3 and Z-5 to Z-6).

Figure 1: Impacted Fuel Tanks Site Location (Tab Z-5)

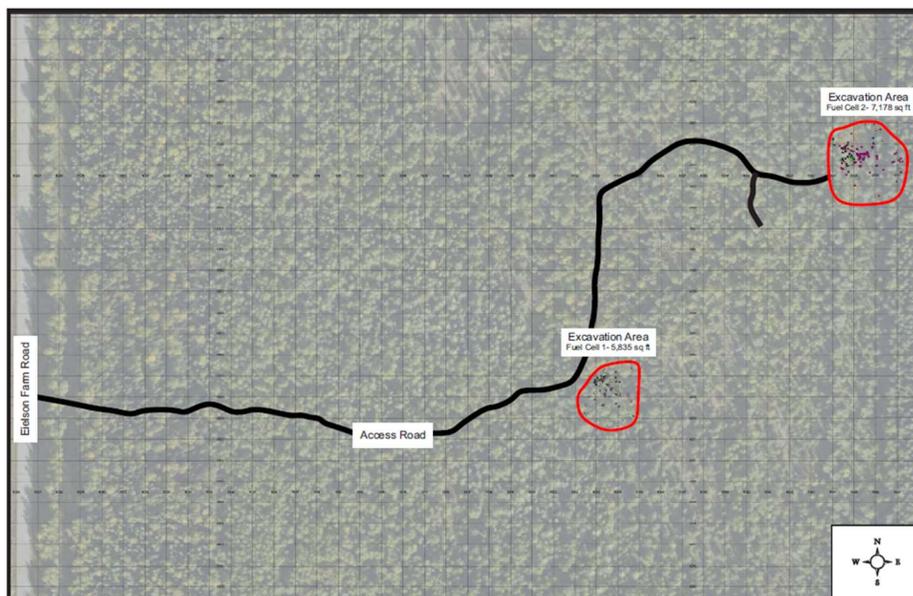
The 354 FW assigned a Recovery Operations Chief (ROC) to lead recovery efforts at the wreckage sites (Tab V-3.2). Wreckage materials were surveyed and removed (Tab V-3.3 to V-3.4). The location and survey results of the wreckage are depicted below in Figures 1 and 2, respectively (Tab Z-5 to Z-6). While the exact volume of JP-8 stored in the tanks at the time of impact is unknown, the capacity of each tank was 370 gal (Tab DD-3). The ROC coordinated with State agencies to develop a plan to remediate any soil contaminated by fuel released by the tanks on impact (Tabs DD-3 and V-3.3 to V-3.4). Remediation efforts, which were still underway at the

time of this report, used a combination of federal government and contracted services to sample, test, remove, and dispose of contaminated soil at the site (Tabs DD-3 and V-3.3 to V-3.4). At the time of this report, 354 FW personnel were in coordination with the property owner regarding the final disposition of the affected land (Tabs V-3.4 and P-3).

Figure 2: Impacted Fuel Tank Excavation Areas (Tab Z-6)

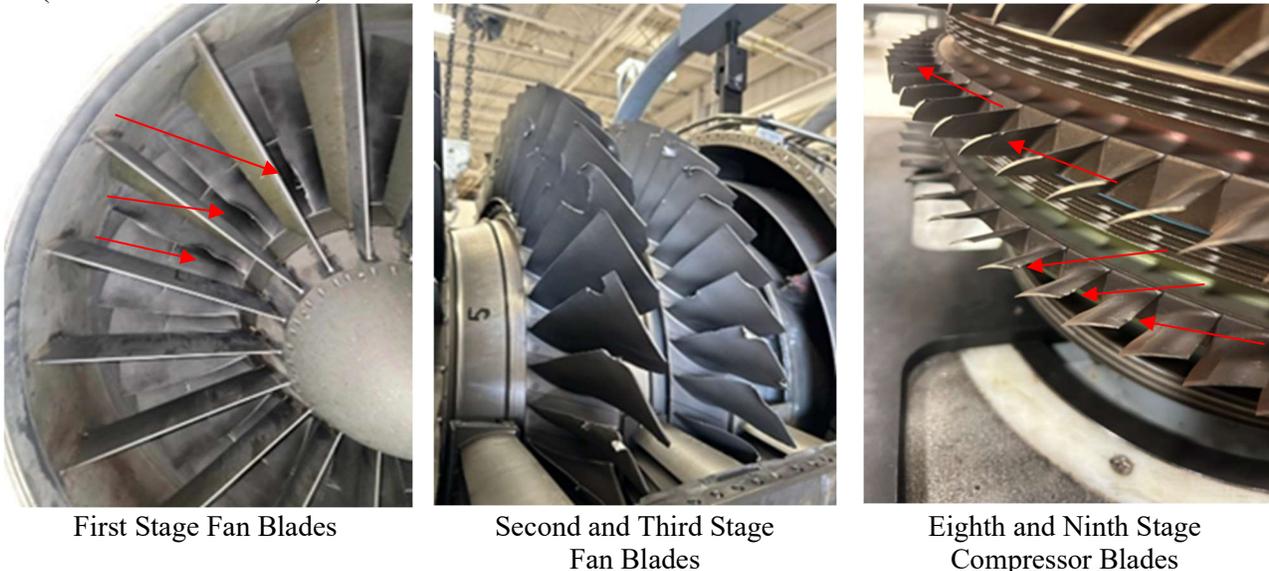
The MA engine sustained damage to the inlet guide vanes, all three Fan Stages and all nine stages of the rear compressor in the core engine module due to foreign object damage (FOD) after ingesting at least one white-winged scoter, a type of migratory waterfowl (Tabs S-3 to S-6, W-4). The AIB additionally discovered evidence of bird remains scattered throughout the engine (Tab S-3 to S-6). The engine continued to operate in low to mid-range throttle position, however, the MP reported engine stalls to his wingmen in flight, distinct visible shaking can be observed in the HUD video, and the number two wingman as well as an eyewitness reported flames shooting from the engine nozzle consistent with engine stalls (Tabs L-3, R-74, R-81 and V-8.1). First Responder (FR1), the commander of the emergency response team, reported the smell of burnt feathers and debris on the engine nozzle when he responded to the MA after it landed and taxied (Tab V-6.3). There were no indications of an engine fire reported by the aircraft detection systems, engine instruments during flight, nor observations by emergency responders during the ground response (Tab V-1.6 and V-6.2).

Figure 3: F-16C Engine Damage (Tabs S-5 to S-6, and Z-3)

The engine data downloaded from the digital engine control (DEC) by the 354th Maintenance Squadron (354 MXS) revealed eight separate engine stall events over the course of 30 seconds (Tab L-3). The first through third fan stages were sent to the Air Force Life Cycle Management Center (AFLCMC) for analysis (Tab I-4).

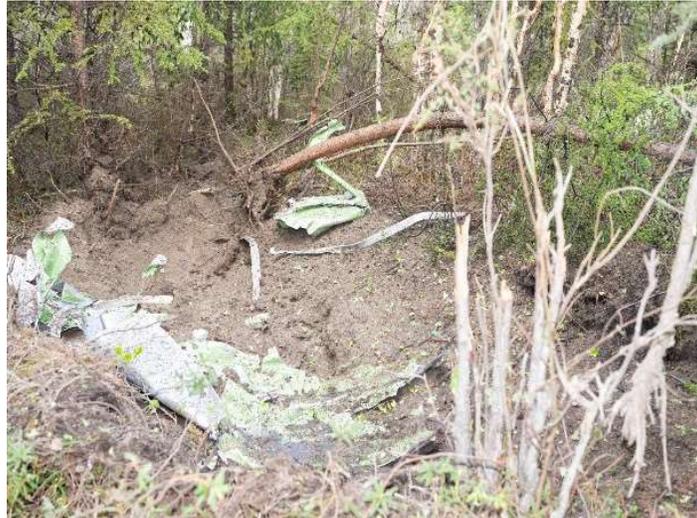
The MA was equipped with two external fuel tanks (Tab S-7). The 370-gal capacity external wing fuel tanks and wing fuel pylons were jettisoned during the mishap and impacted the ground approximately 1.2 nautical miles to the southwest of Runway 32 approximately 375 ft apart (Tab S-7). They were destroyed on impact (Tab S-7).

Figure 4: Destroyed Fuel Tank (Tab S-7)
