UNITED STATES AIR FORCE
AIRCRAFT ACCIDENT INVESTIGATION
BOARD REPORT

TH-1H, T/N 74-22313

LOCATION: SKELLY STAGEFIELD ARMY HELIPORT

DATE OF ACCIDENT: 3 APRIL 2024

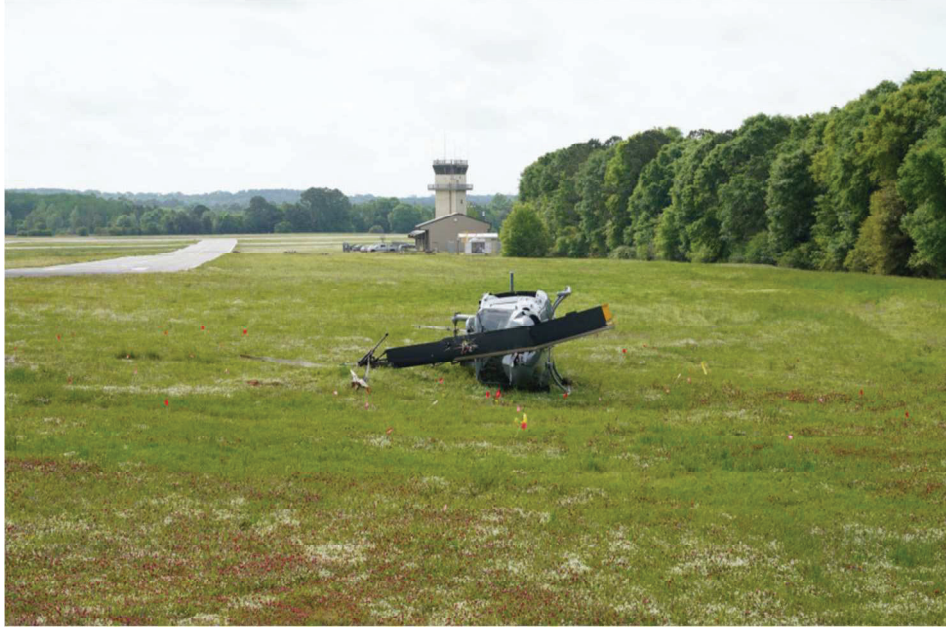
At approximately 0939L, the MA MRBs contacted the ground followed by the fuselage of the aircraft coming to rest on the right side (Tabs R-86, R-90, and R-92). The MIP and MSP1 shut off the throttle, fuel switches, and battery switch after the aircraft came to a stop. (Tab R-9).

MA at impact site (Tab S-2)

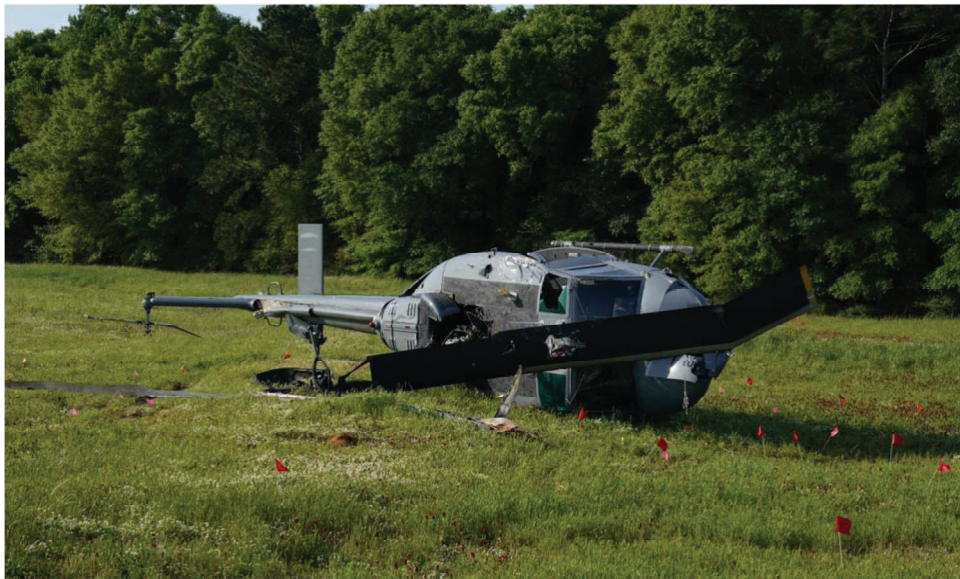
MA at mishap site (Tab S-3)

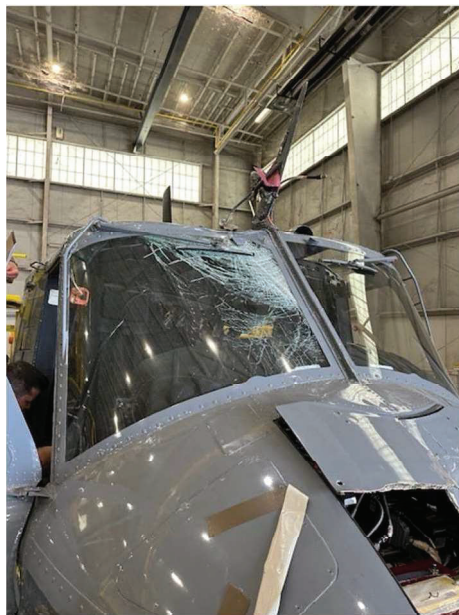
i. Cabin Nose Section

The MA sustained significant damage at Skelly Stagefield Army Heliport due to impact with the ground in the following areas: cabin nose section, cabin tunnel area, the mast & main rotor head (MRH) assembly, and the tail rotor assembly. (Tabs S-3, S-6, S-10, and S-11 to Tab S-13). Damage to the nose section of the airframe exposed the battery compartment. (Tab S-10).

Damage to Cabin Nose Section (Tab S-10)

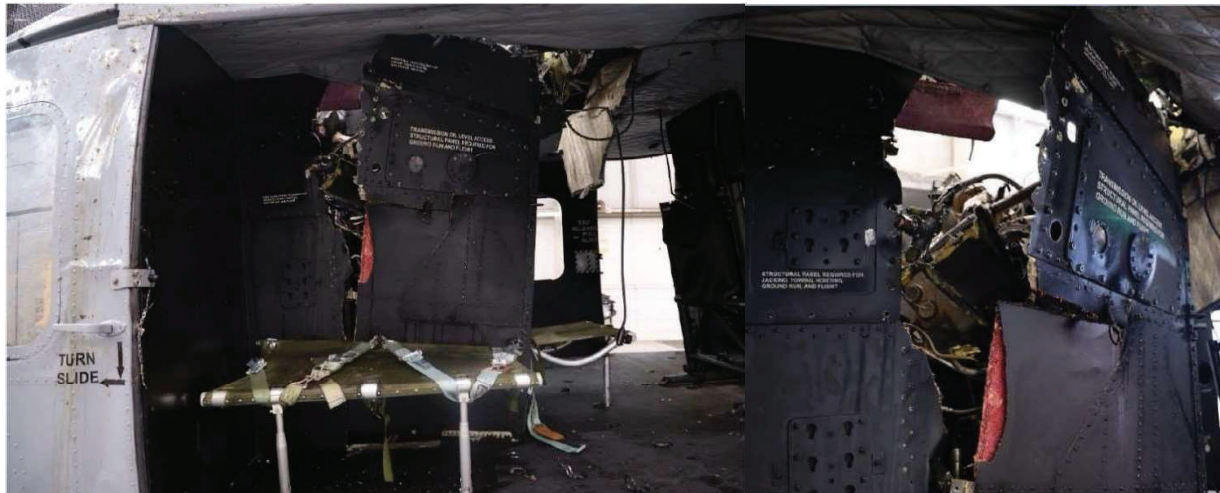
ii. Cabin Tunnel Area

Damage to cabin tunnel area (Tab S-11)

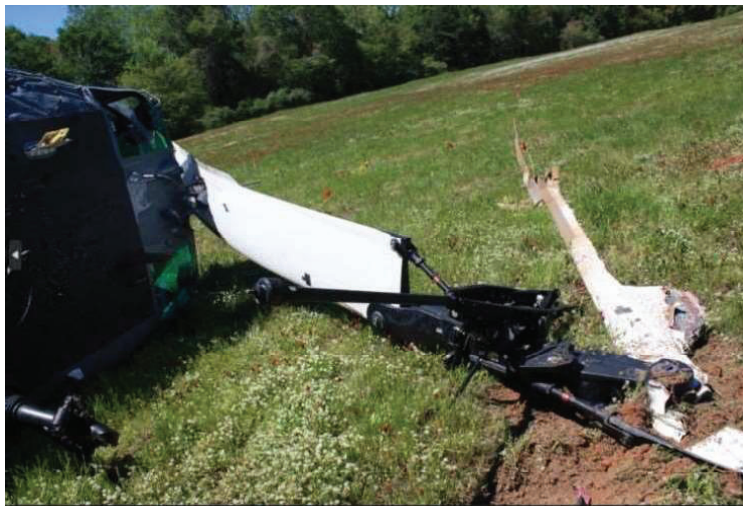
iii. Mast and MRH Assembly

MRH separated from transmission upon impact with ground (Tab S-12)

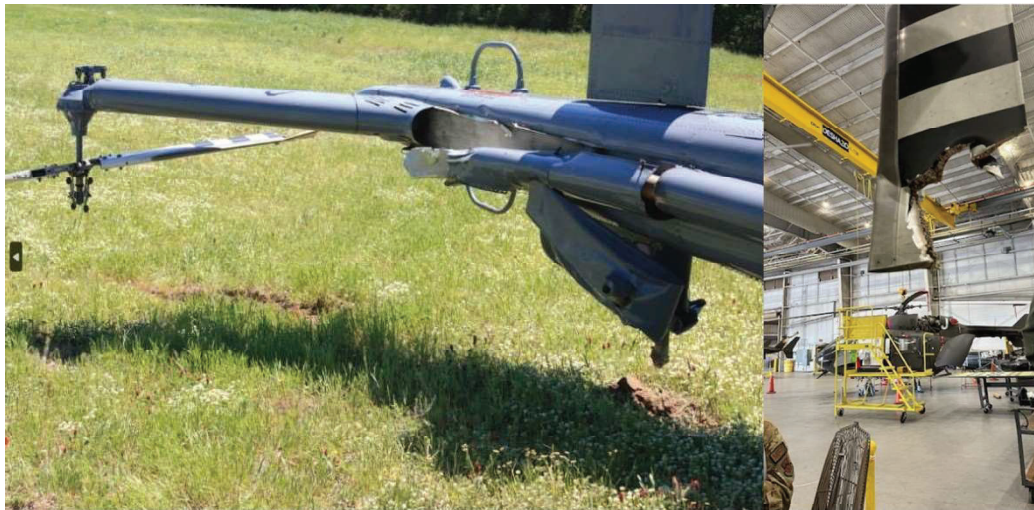
iv. Tail Rotor Assembly

Damage to tail rotor assembly (Tab S-13)
