**UNITED STATES AIR FORCE**  
**AIRCRAFT ACCIDENT INVESTIGATION**  
**BOARD REPORT**

**CV-22B, T/N 11-0060**

**20TH SPECIAL OPERATIONS SQUADRON  
27TH SPECIAL OPERATIONS WING  
CANNON AIR FORCE BASE, NEW MEXICO**

**DATE OF ACCIDENT: 20 NOVEMBER 2024**

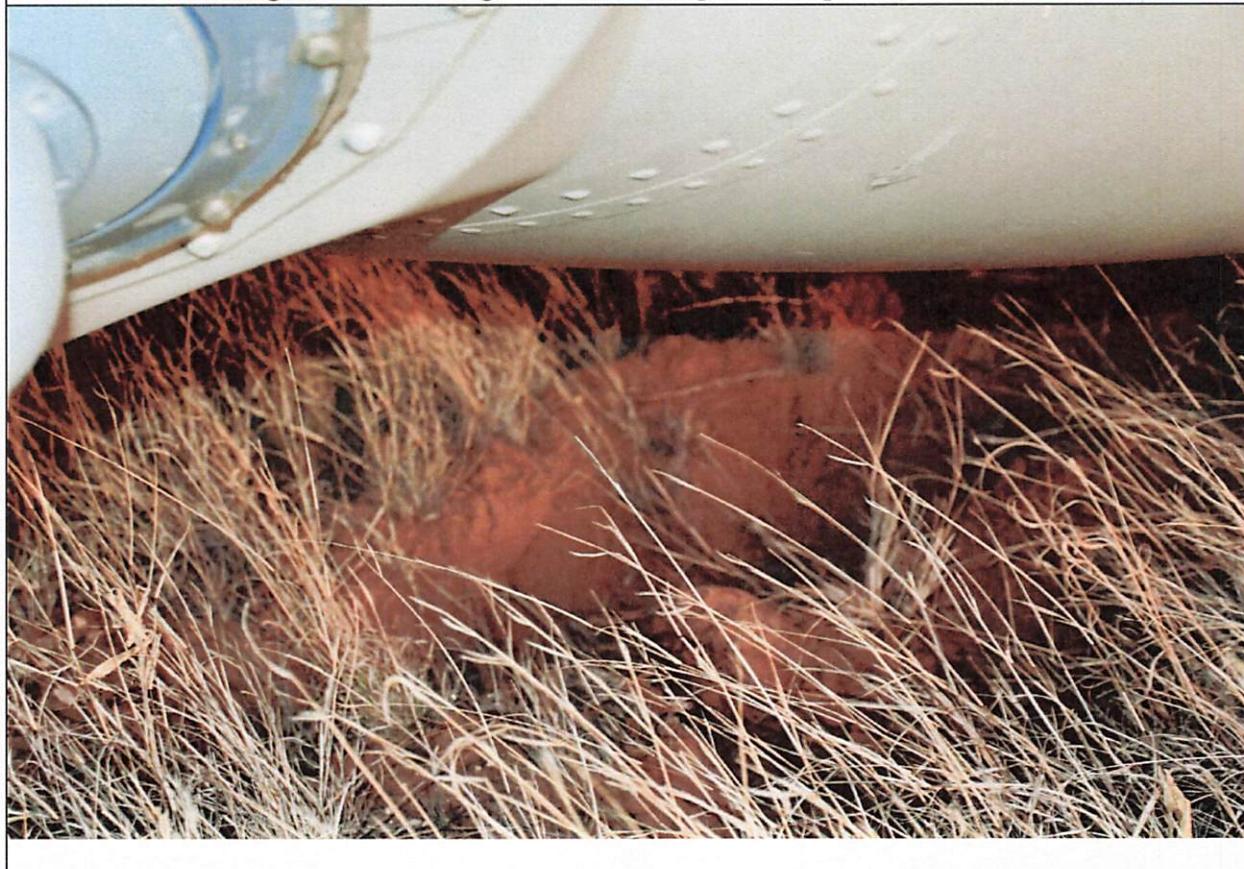
Figure 4-1. MA Right Main Landing Gear Imprint (Tab S-2)

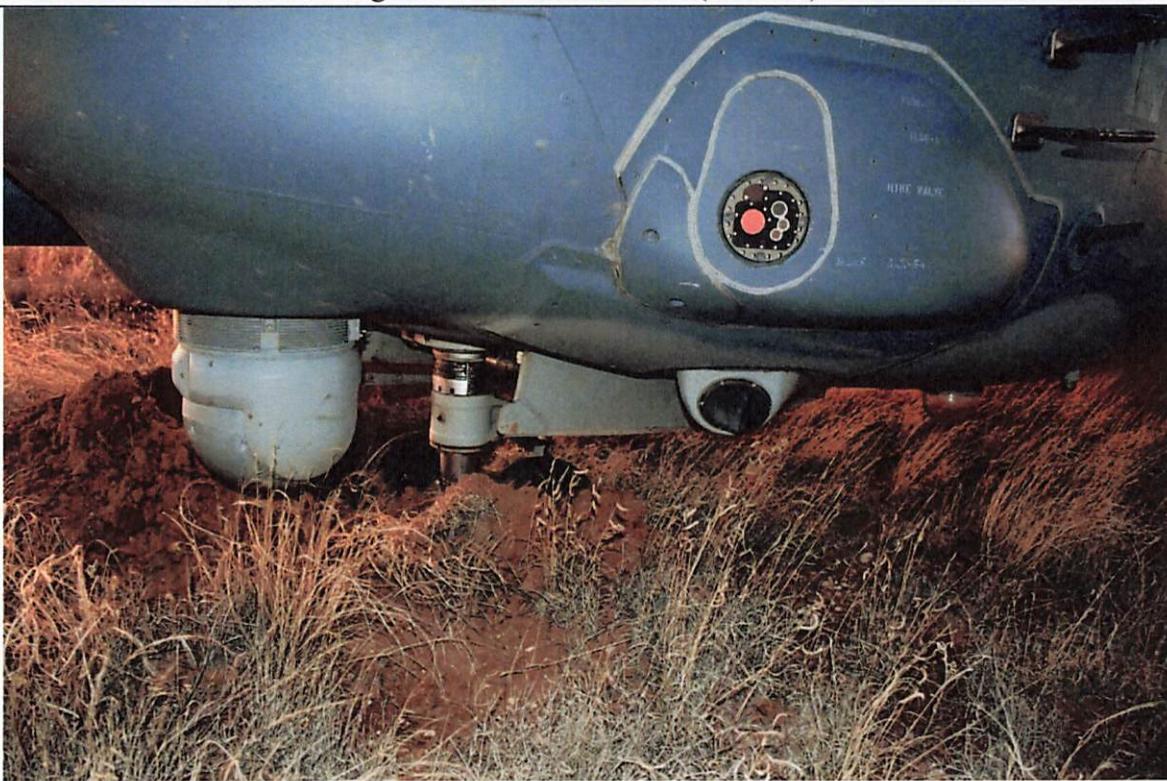
Figure 4-2. MA Nose Gear (Tab S-3)

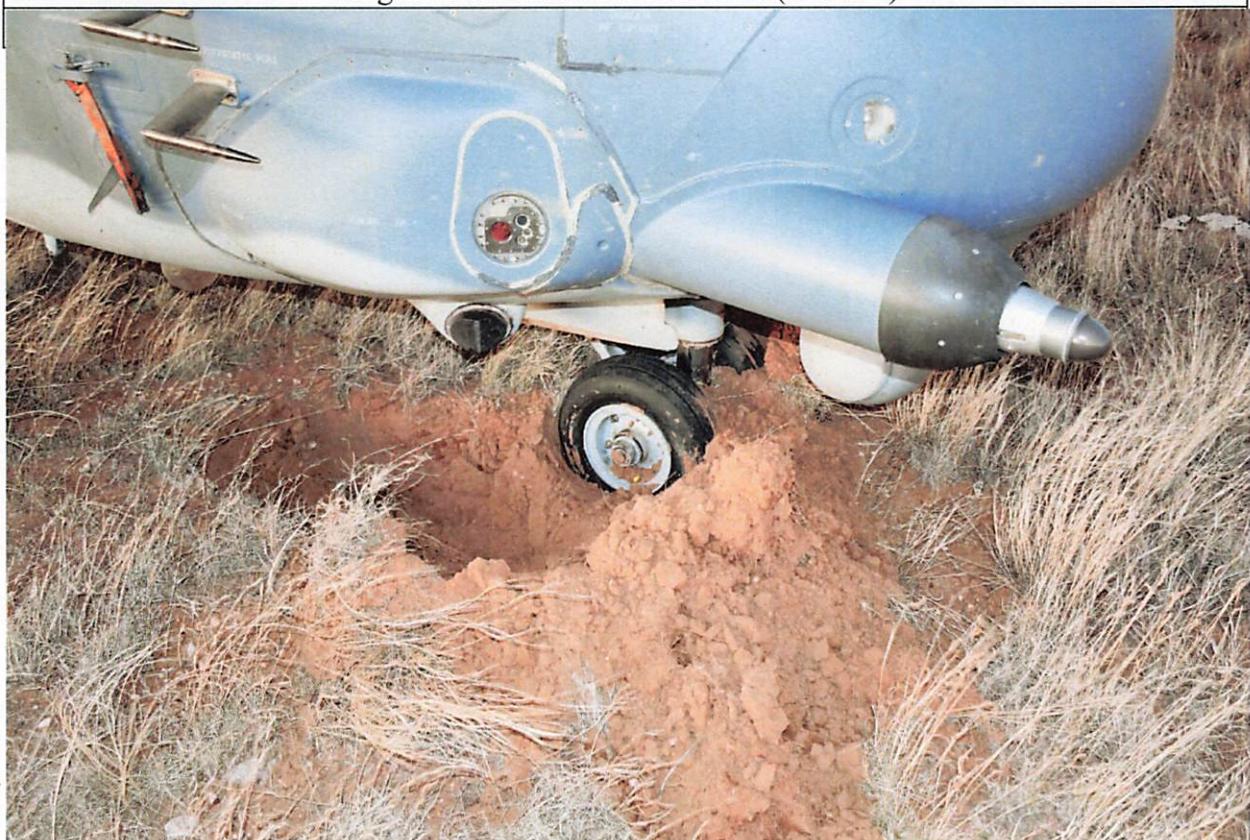
Figure 4-3. MA Nose Gear ditch (Tab S-4)

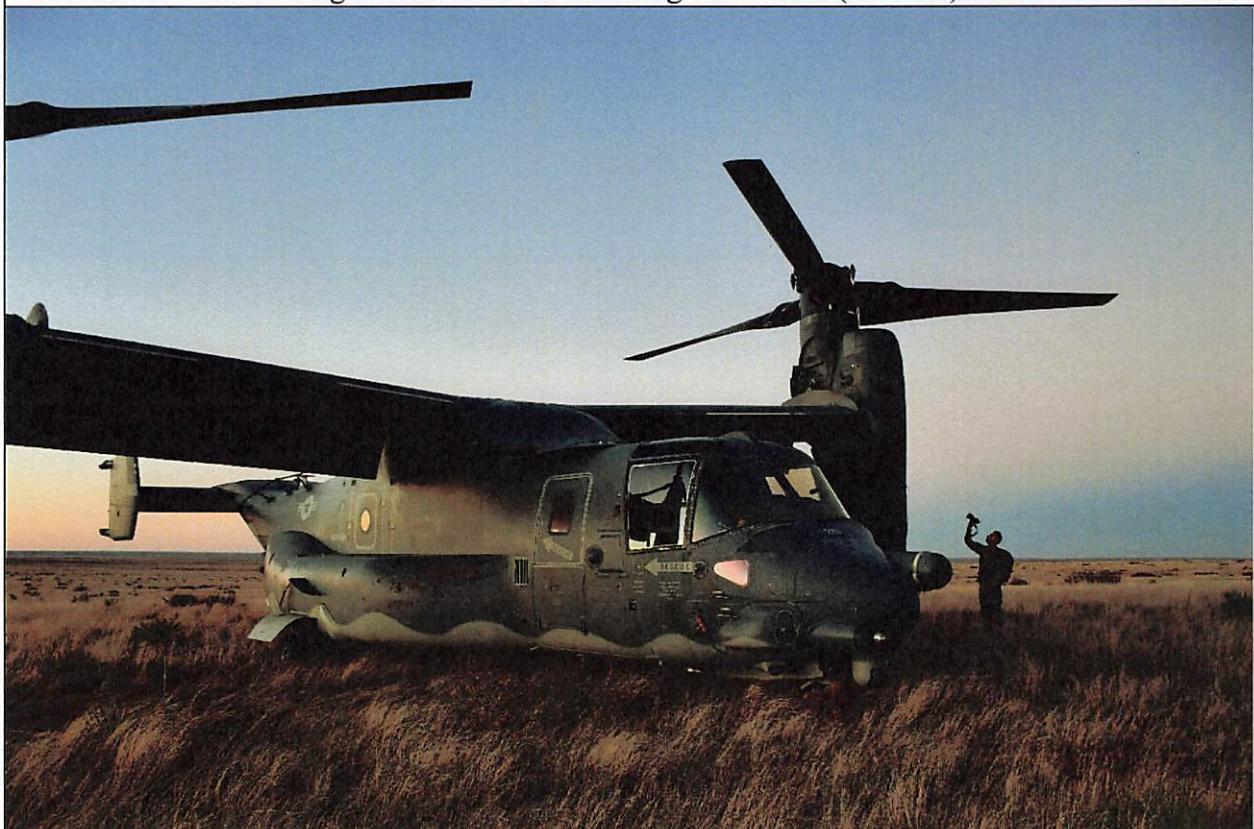
Figure 4-3. MA Final landing orientation (Tab S-5).

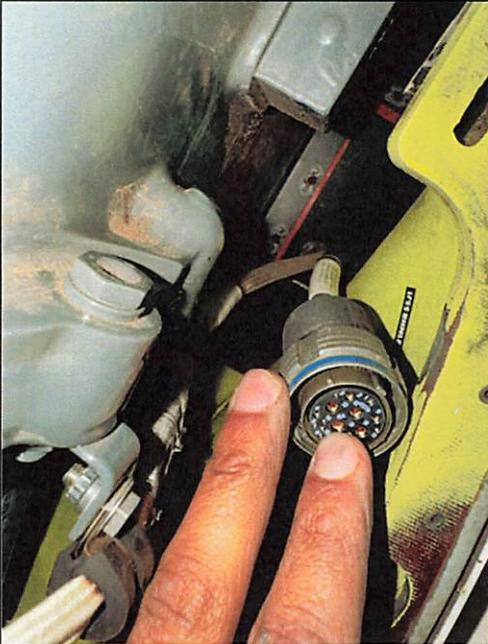
**Figure 5-1. View of Outboard LH PRGB Looking UP (Tab U-26)**

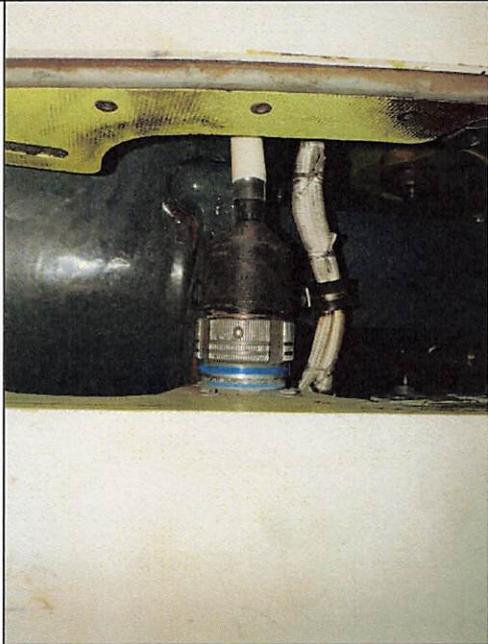
**Figure 5-2. View of Outboard LH PRGB Looking Inboard (Tab U-27)**

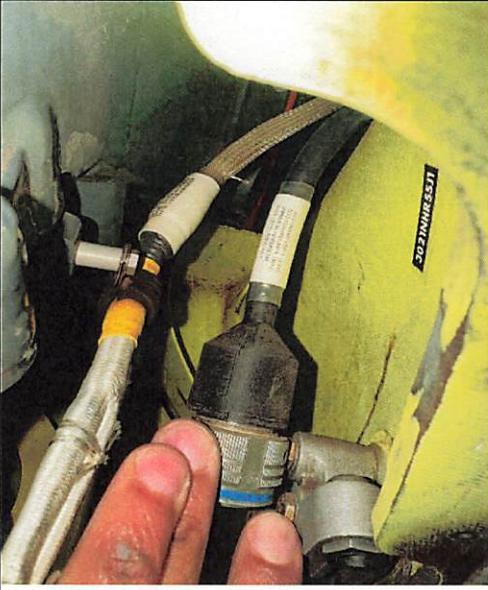
**Figure 5-3. View of Outboard LH PRGB Looking Up and Aft (Tab U-28)**

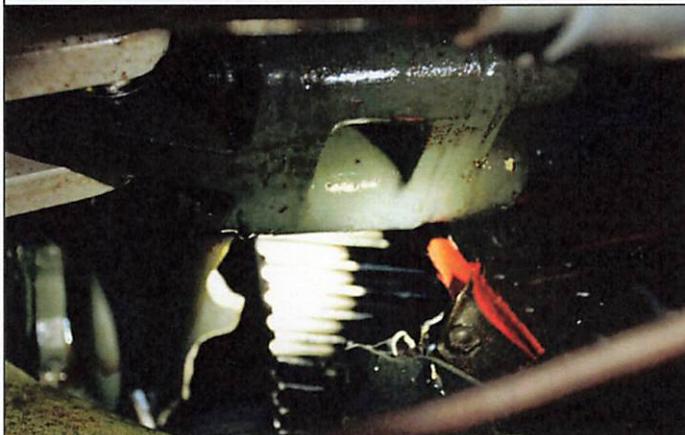
Upon investigation of the LH PRGB, the following damage was identified (Tab J-39 to J-49). A hole in the LH PRGB case measuring approximately 12 inches by 6 inches on the outboard side of the helical section (Tab J-39). The PRGB cover internal surfaces exhibited significant damage and material loss in the vicinity of the failed -105 Lower Input Idler Helical Gear (Tab J-43). The shroud that covers the input helical gears was bent and mangled (Tab J-43). An 8-tooth piece of the -105 Lower Input Idler Helical Gear was found in the LH center body inlet assembly. (Tab J-40). The remaining 43-tooth section of the -105 Lower Input Idler Helical Gear was deformed into a "J" shape and wedged in the hole in the helical section of the PRGB (Tab J-39). The -105 Upper Input Idler Helical Gear exhibited minor tooth damage and evidence of debris processing (Tab J-48). The -109 Input Idler Helical Gear exhibited significant tooth damage, chipping, cracking, and material loss (Tab J-45). All four primary oil lubrication jets adjacent to the failed -105 Upper Input Idler Helical Gear exhibit damage (Tab J-43). Evidence of milling damage and material loss on the internal LH PRGB case under the bore of the Oil Pump Drive Roller Bearing was found (Tab J-43). The -101 Input Helical Gear exhibited minor tooth damage and chipping (Tab J-47). The -113 Bull Gear exhibits minor evidence of debris processing (Tab J-48). The Oil Pump Drive Spur and Helical Gear exhibited evidence of grinding/milling and material loss (Tab J-49).

**Figure 6.2. Photo of LH PRGB Damage While Still on MA (Tab S-6)**

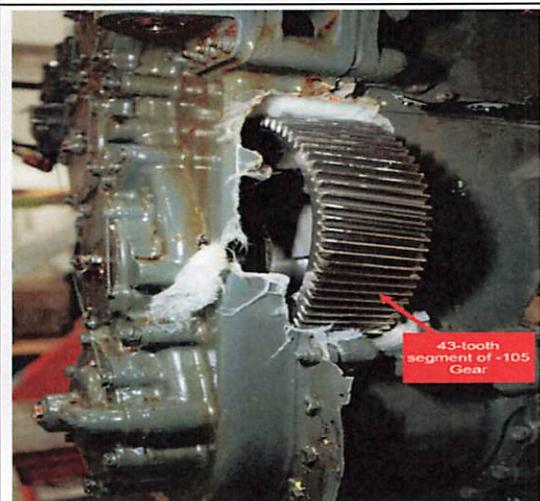
**Figure 6-3. LH PRGB Outboard Case Damage with Wedged -150 Gear Segment (Tab J-39)**

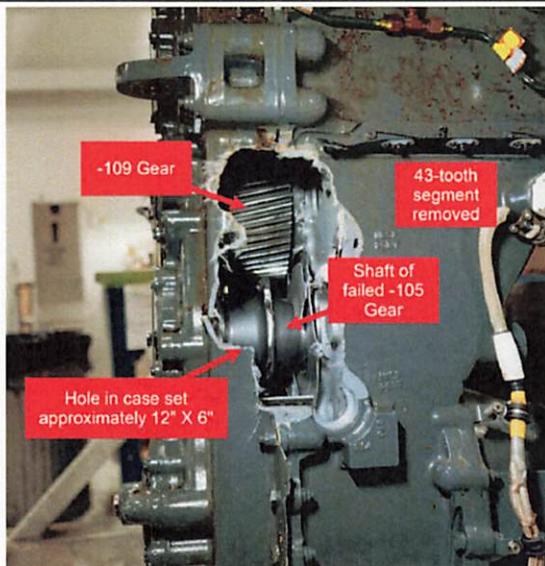
**Figure 6-4. Photo of LH PRGB Outboard Case Damage (Tab J-42)**

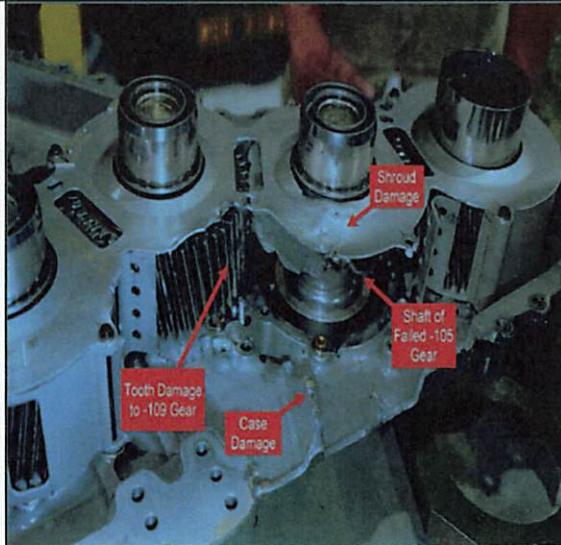
**Figure 6-5. Photo of LH PRGB Helical Drive Section Damage (Tab J-44)**

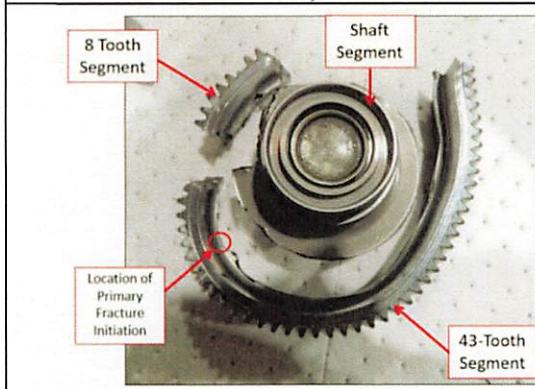
**Figure 6-6. Photo of LH PRGB -105 Lower Input Idler Helical Gear Damage (Tab J-53)**

I found, by a preponderance of the evidence, the mishap was caused by a catastrophic failure of the LH PRGB Lower Input Idler Helical Gear, P/N 901-044-105-101, S/N VL00205587 (-105) due to a non-metallic material inclusion in the gear’s rim-to-web radius interface. Immediately following materiel failure, an 8-tooth section of the -105 gear punctured the PRGB case causing a 12-inch by 6-inch hole, leading to the immediate loss of LH PRGB oil and oil pressure followed by a LH engine overspeed condition. It is assessed that the LH engine’s momentary overspeed condition was caused by the no-load condition induced by the failure of the -105 gear. As designed, this overspeed caused the controlling FADEC to command a shutdown of the LH engine. As designed, Right Hand (RH) engine power via the Interconnect Drive System (ICDS) was then automatically transferred to the LH PRGB for the left proprotor to provide enough lift for the MC to maintain controlled flight and conduct a safe EL.

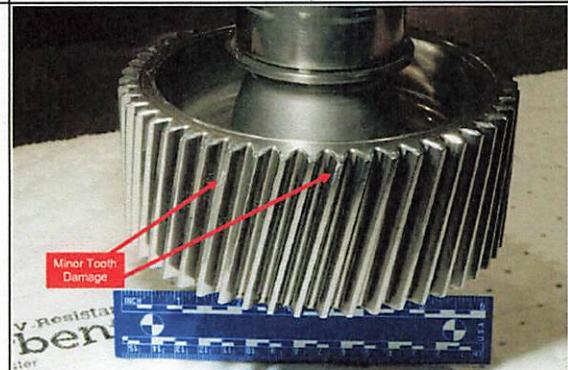
**Figure 6-7. Photo of LH PRGB -105 Upper Input Idler Helical Gear Damage (Tab J-48)**

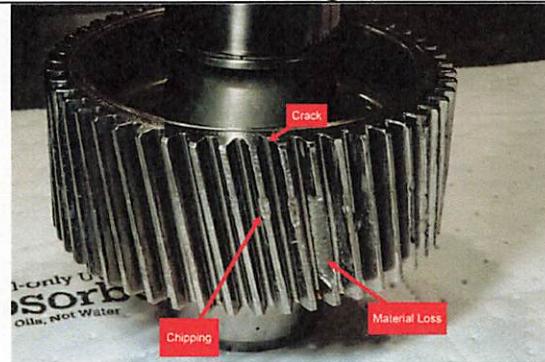
**Figure 6-8. Photo of -109 Input Idler Helical Gear Damage (Tab J-47)**

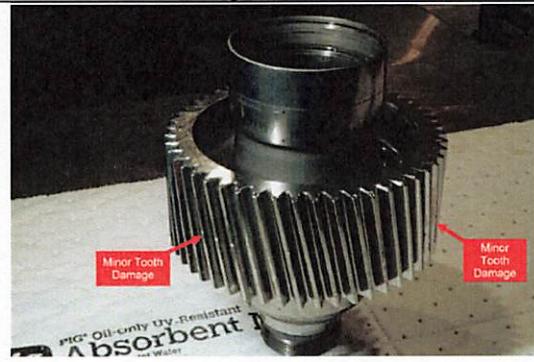
**Figure 6-9. Photo of -101 Input Helical Gear Damage (Tab J-47)**

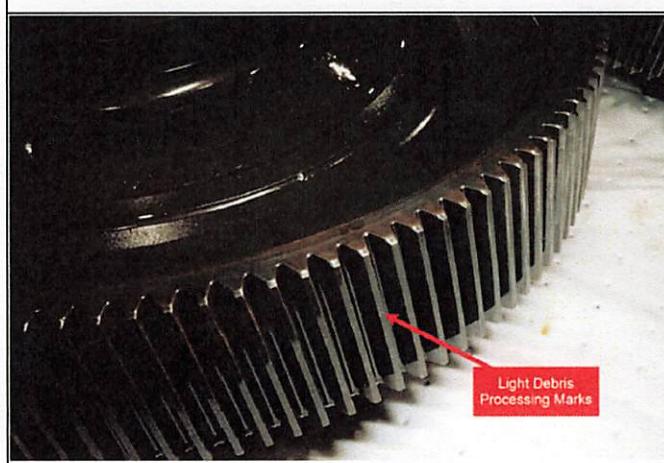
**Figure 6-10. Photo of -113 Bull Gear Damage (Tab J-48)**

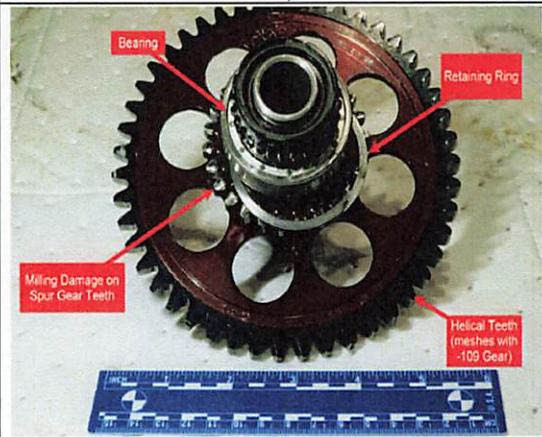
**Figure 6-11. Photo of Oil Pump Drive Spur and Helical Gear Damage (Tab J-49)**

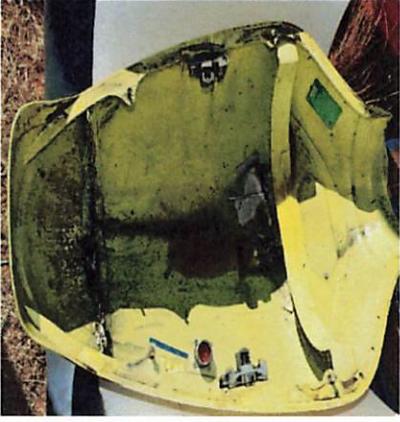
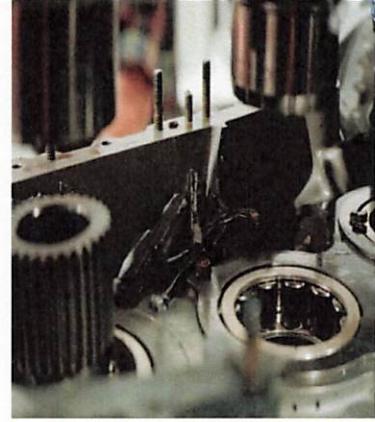
<b>Figure 6.12. Photo of Debris found in LH Centerbody Inlet (Tab S-7)</b>	<b>Figure 6.13. Photo of Debris in LH PRGB Helical Section (Tab S-8)</b>

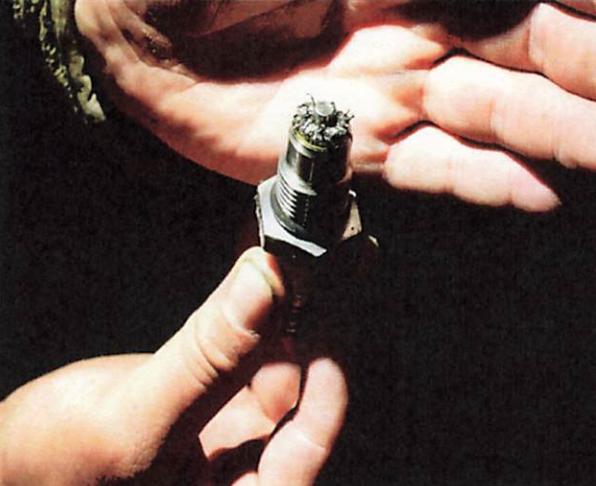
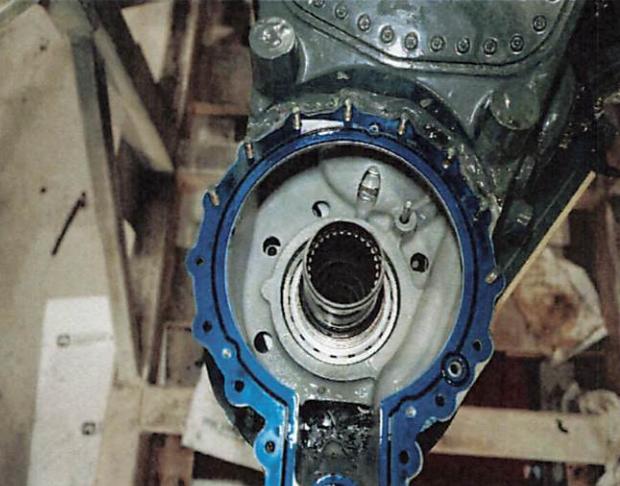
<b>Figure 6.14. Photo of LH PRGB Chip Detector #1 with Debris (Tab S-9)</b>	<b>Figure 6.15. Photo of Debris in LH PRGB with IQA Removed (Tab S-10)</b>

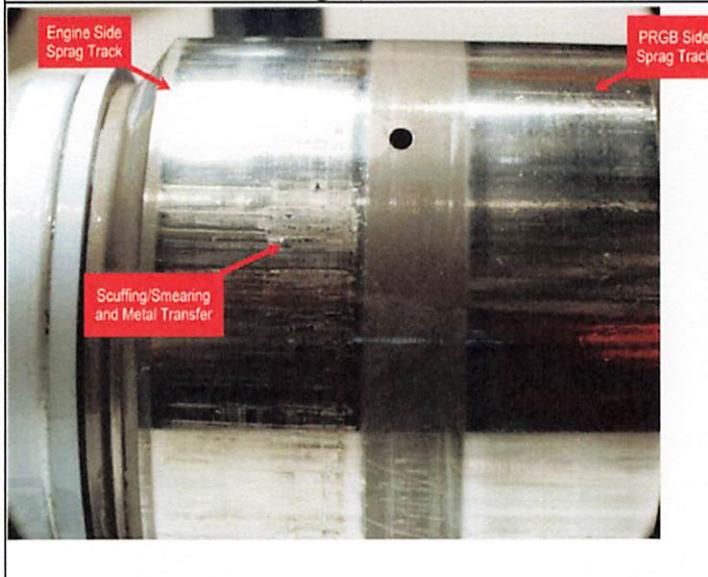
The LH IQA, P/N 901-044-055-103, S/N A-102, was disassembled from the LH PRGB and inspected (Tab J-50). The clutch inner race exhibited evidence of minor scuffing/smearing and material transfer forward of the engine side sprag track (Tab J-50). The PRGB side sprag track exhibit normal wear (Tab J-50). The engine side sprag retainer assembly on 3 sprags exhibited significant scuffing/scoring and material loss on the forward edges (Tab J-50). the PRGB side sprag retainer assembly exhibited normal wear (Tab J-50). The Clutch outer race exhibited normal wear (Tab J-50).

**Figure 6-16. Photo of LH IQA Clutch Sprag Track Damage (Tab J-50)**

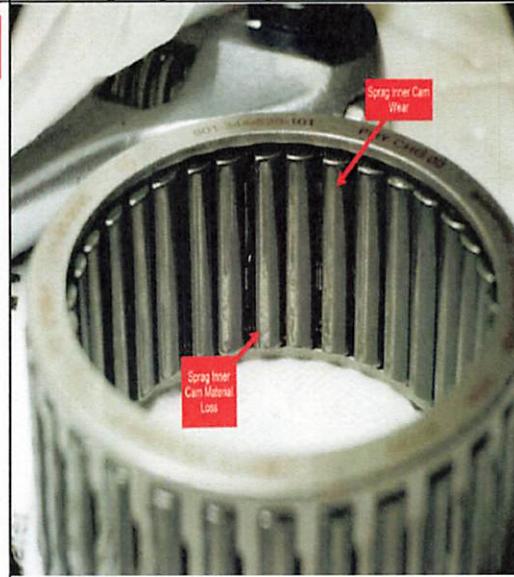
**Figure 6-17. Photo of LH IQA Clutch Sprag Damage (Tab J-51)**

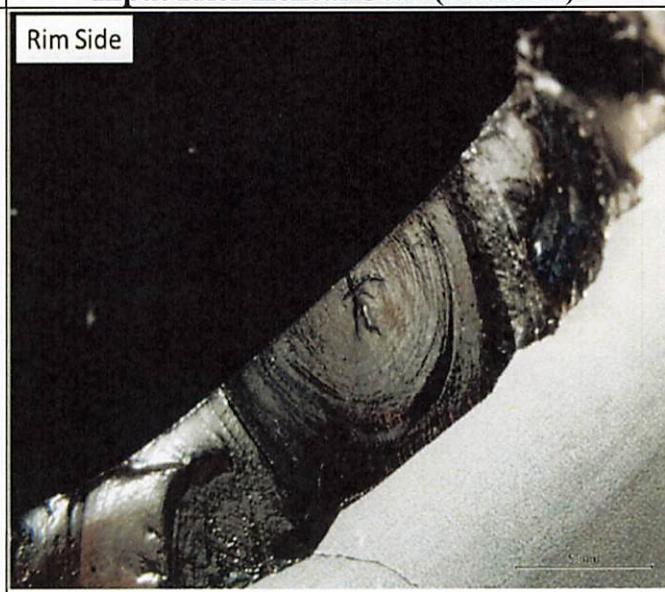
Fracture analysis of the failed -105 Input Idler Helical Gear pieces identified multiple locations with evidence of fatigue crack origination (Tab J-52). Analysis revealed one fatigue origination on the 43-tooth segment web to rim interface with corresponding evidence of fatigue on the gear shaft segment at the associated location (Tab J-52). This was determined to be the primary crack initiation site (Tab J-52). The crack propagated from the origin circumferentially both clockwise and counterclockwise around the gear (Tab J-52). A segment of the gear shaft was sectioned by FRC East to have the fatigue origin evaluated under Scanning Electron Microscope (SEM) (Tab J-54). The SEM chemical analysis identified the presence of a non-metallic inclusion consisting of aluminum, calcium, and oxygen measuring 0.055 inches long by 0.011 inches wide (Tab J-54). A material certification and process review of the raw material supplier for the failed -105 gear determined the X-53 bar stock conformed to all material specifications at the time of production and inspection (Tab J-59).

**Figure 6-19. Photo of Inclusion Found in -105 Input Idler Helical Gear (Tab J-56)**
