**UNITED STATES AIR FORCE**  
**AIRCRAFT ACCIDENT INVESTIGATION**  
**BOARD REPORT**

**CV-22B OSPREY, T/N 06-0031**

**8TH SPECIAL OPERATIONS SQUADRON  
1ST SPECIAL OPERATIONS WING  
HURLBURT FIELD, FLORIDA**

**DATE OF ACCIDENT: 9 APRIL 2010 (L)**

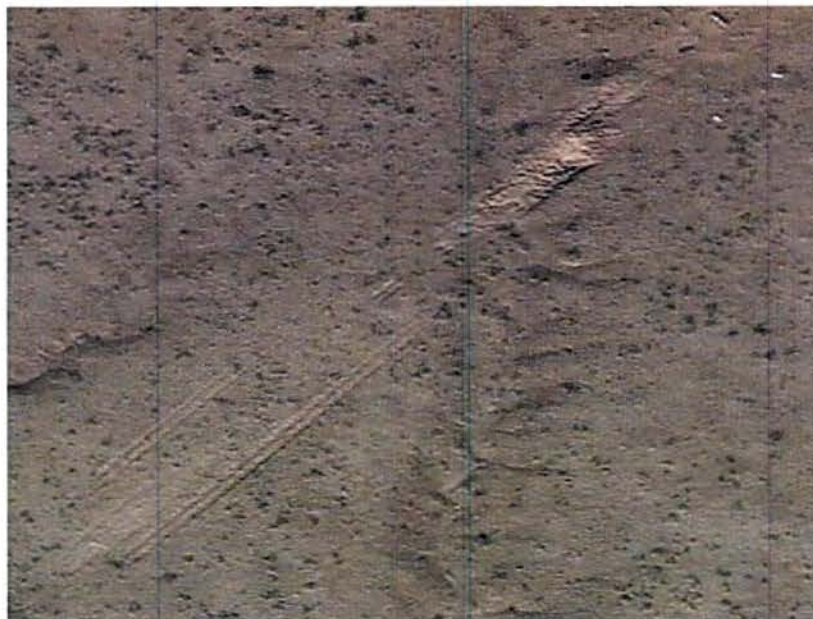
(Landing gear touchdown tracks)

The right main landing gear (MLG) touched down four feet prior to the left MLG. (Tab V-48.3, Tab Z-25) The MA's pitch attitude was less than 14 degrees pitch up at touchdown. (Tab Z-3) The MLG rolled for nine feet prior to the ramp contacting the ground. While the ramp scraped the ground, the MLG continued to roll for another ten feet. The nose gear then impacted the ground and rolled for three feet. The MLG stayed in contact with the ground throughout this time. The MLG made impressions in the sand that were approximately eight inches deep, with the right side MLG slightly deeper than the left MLG. (Tab Z-3, Tab GG-4) The impressions

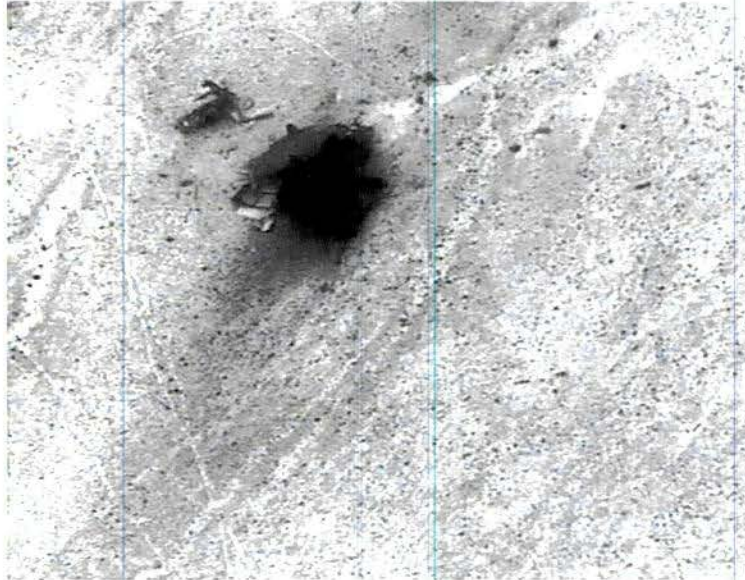
(Post-crash wreckage before kinetic destruction)

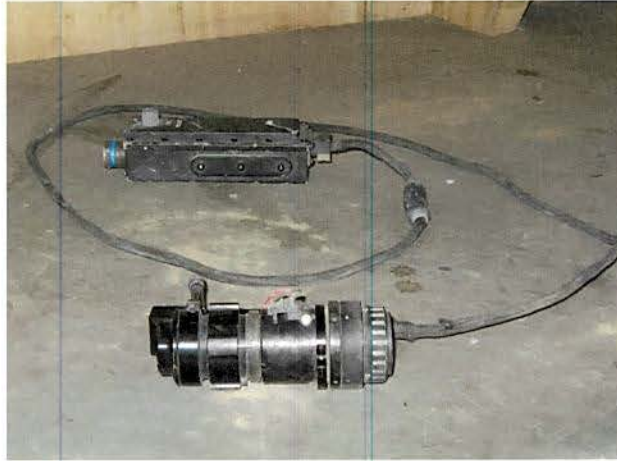
MCP's seat had fallen out of the cockpit during the crash sequence and was located 30 meters away from where the aircraft came to rest. (Tab V-49.5, V-63.11) When MCP awoke, he was still strapped into his seat. (Tab V-1.21) CHK1A unbuckled the MCP. (Tab V-19.6) The MCP's survival radio had a broken battery compartment, preventing him from using it to call for rescue forces. (Tab V-1.21 thru V-1.22, V-49.5) The MP's night vision goggles (NVGs) broke in the crash sequence, separating the two tubes. The HUD was still attached to the right tube. (Tab K-23, Tab V-39.10, Tab Z-21)

(MP's right NVG tube with HUD attached)

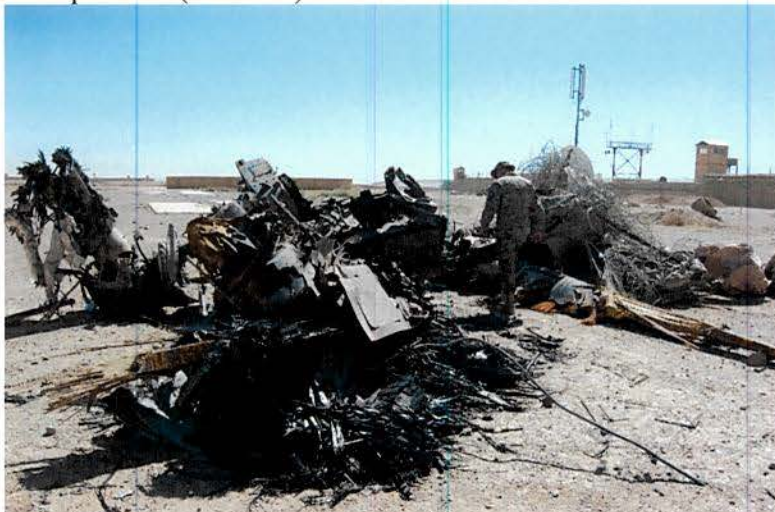
Prior to the mishap sequence, the aircraft, engines, and systems appeared to operate within normal mission parameters. (Tab V-1.11, V-60.7) Due to the MA being destroyed for security purposes, impact analysis was not conducted at the crash site. Several pieces of the wreckage have been removed to FOB Apache.<sup>7</sup> (Tab II-3)

(Wreckage at FOB Apache)
