UNITED STATES AIR FORCE
AIRCRAFT ACCIDENT INVESTIGATION
BOARD REPORT

F-16CJ, T/N 92-3890

UNITED STATES AIR FORCE AIR DEMONSTRATION SQUADRON
57th WING
NELLIS AIR FORCE BASE, NEVADA

DATE OF ACCIDENT: 2 JUNE 2016

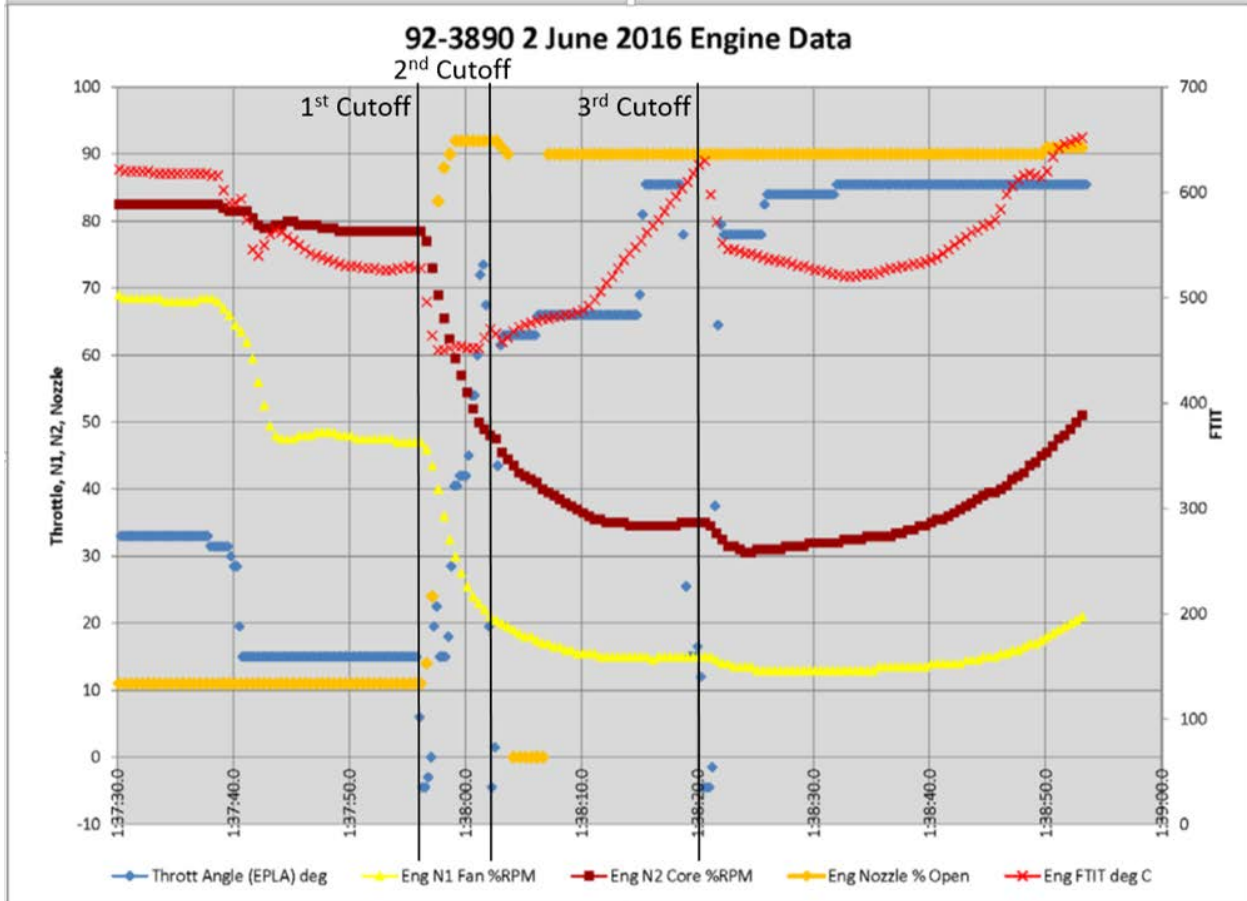
Figure 1: MA Engine Data (Tab EE-15)

See Figure 1 (below), for a visual depiction of the MA's engine systems for approximately the last minute and a half prior to impact (Tab EE-15). The blue data points ["Thrott Angle (EPLA) deg"] indicate throttle placement fore and aft in angular degrees, with lower numbers meaning a throttle position further aft, and vice versa (Tab EE-15). At lines "1st Cutoff", "2nd Cutoff" and "3rd Cutoff", the blue data points go below "0", showing that the throttle was pulled aft to the cutoff position (Tab EE-15).

The dark red data points, ("Eng N2 Core %RPM"), show the RPM of the engine as a percentage, with a higher percentage meaning greater thrust (~70 - ~80% RPM indicates idle thrust) (Tabs V-1.3, EE-15). After the line noted as "1st Cutoff", the RPM drops rapidly, representative of an engine shutdown (Tabs BB-8 and EE-15). The red data points begin to stabilize just prior to the line labeled "3rd Cutoff", indicating an engine beginning to restart (Tabs BB-6, BB-7, and EE-15). The increasing RPM after "3rd Cutoff" is indicative of an engine in the process of restarting; however, the engine would not have regained usable thrust, prior to ground impact (Tabs BB-5 to, BB-7, and EE-13).

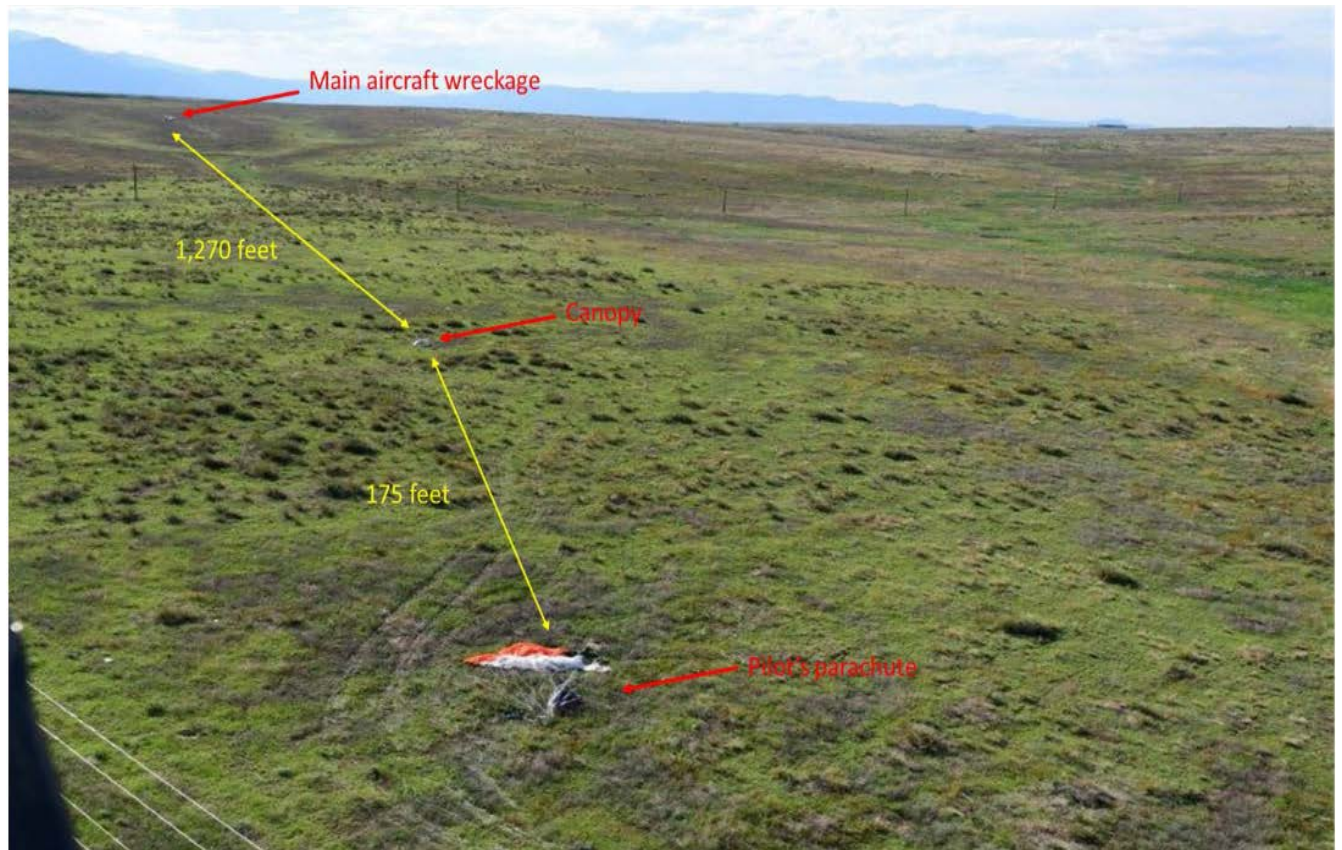
The MA impacted the ground at 13:00:36L in an open grassy field, off-base (Tabs Q-5, S-2, EE-6, and EE-14). The MA impacted at relatively wings level, slightly nose high, and came to rest 1,240 feet from initial impact on a slight uphill slope (Tabs S-2, EE-6 and EE-9). The MP's parachute was found 1,450 feet southeast from the initial impact point (Tabs EE-6 to EE-7). The impact area was two miles south of Runway 35R at Peterson AFB, and just to the north of a residential area (Tabs S-2 and EE-8). Figure 3 shows the impact area and Figure 4 shows the aircraft after impact (Tab S-2).

Figure 3: MA Crash Site Looking Northwest. (Tab S-4)

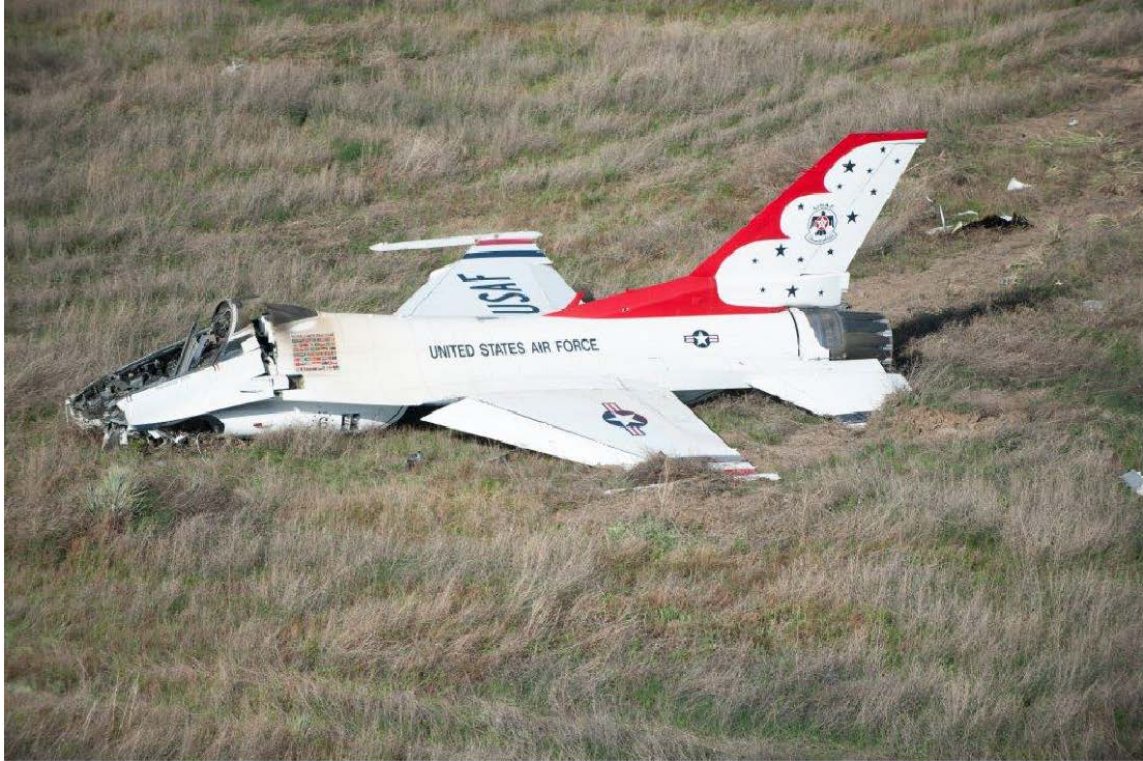
Figure 4: MA post impact (Tab S-2)

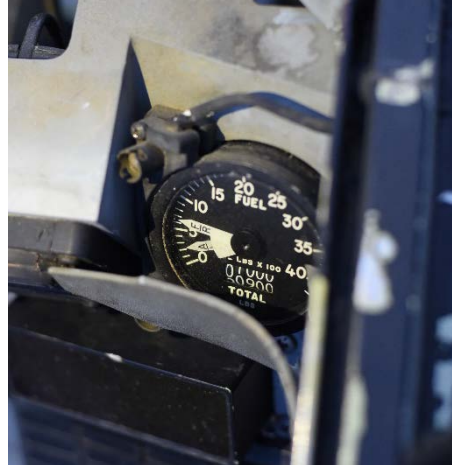
Figure 5. Fuel gauge for the MA indicating approximately 900 pounds of fuel in the fuel tanks after impact (Tab Z-13)

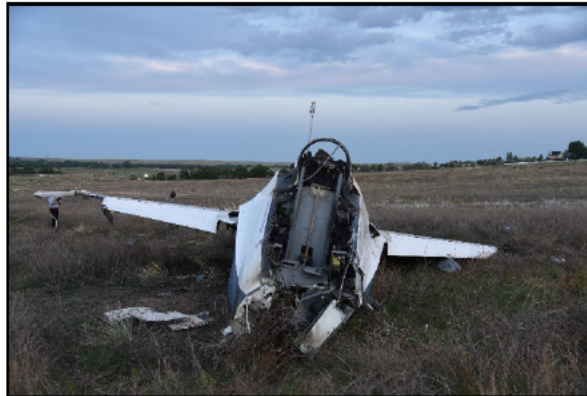
The forward fuselage module (nosecone) sustained damage upon impact and separated from the aircraft (Figure 7, Tab Z-2). The cockpit structure sustained damage upon impact and was partially separated just forward of center fuselage (Figure 8, Tab Z-4). The engine intake module sustained damage upon impact (Figure 9, Tab Z-5). The right main landing gear was twisted and bent rearward after the landing bay doors were torn from the undercarriage (Tab EE-37). The aft engine access cover sustained damage and was found in the debris trail (Figures 10 and 11, Tab Z-6).

Figure 7. Front view (looking aft) of MA showing damage to cockpit and right and left wings (Tab Z-2)

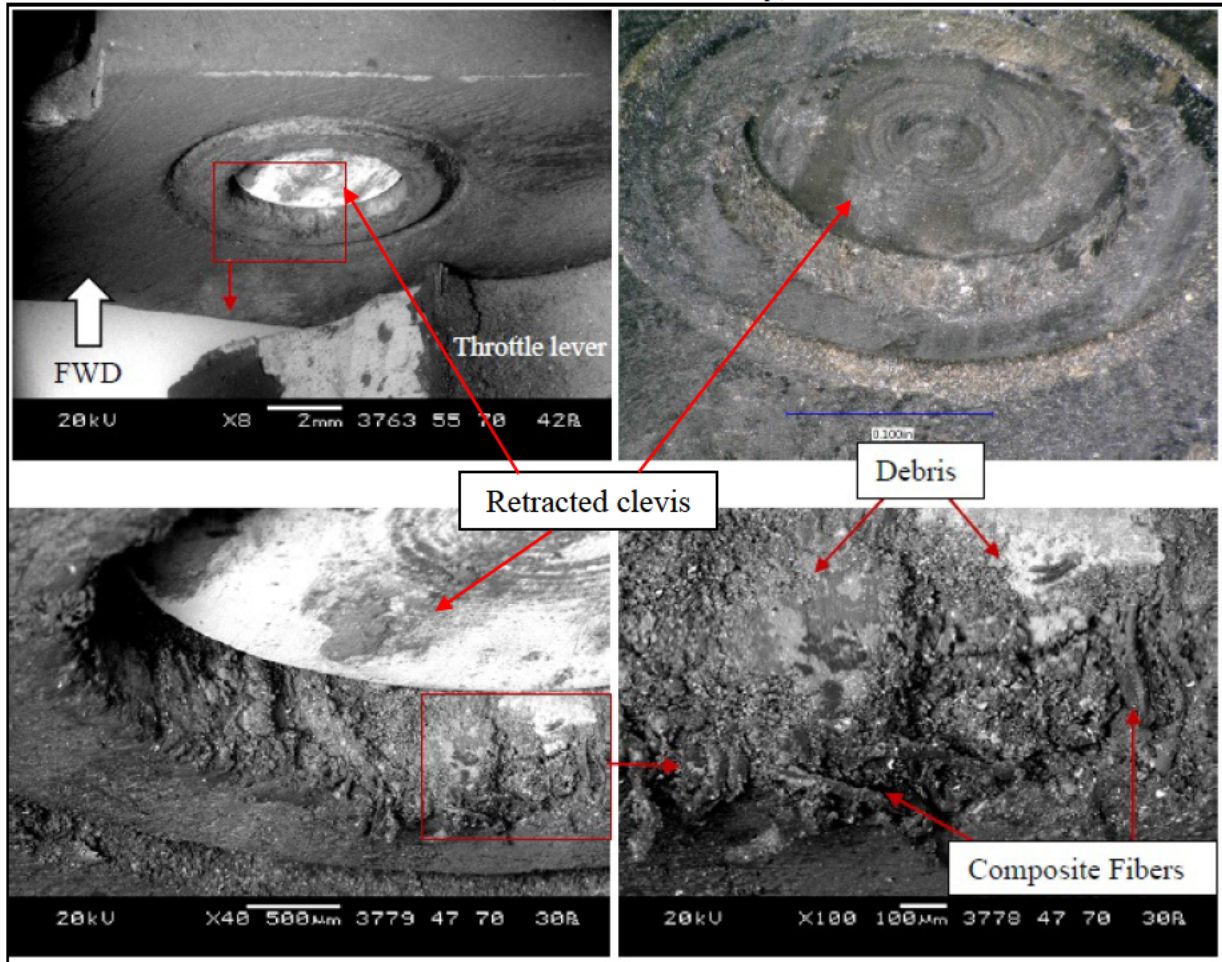
The bushing was inspected with the throttle trigger clevis pin in the retracted position (Tab FF-8). A significant amount of debris was present within and around the bushing and broken composite fibers protruded from the bushing (Figure 16, Tab FF-8). Debris contamination and damage to the throttle trigger bushing due to throttle trigger clevis pin misalignment (not visible to the naked eye), caused friction between the throttle trigger clevis pin and the throttle trigger bushing (Tab FF-9). The debris was analyzed by electroscopic dispersive spectroscopy and composition was consistent with a mixture of aluminum, steel (consistent with wear debris from throttle lever), dirt, and a lubrication compound (molybdenum disulfide) (Figure 16, Tabs FF-8 and FF-19).

Figure 17. Contamination of the MA's throttle trigger clevis bushing evident with the pin in the retracted position (Tab FF-19)
