UNITED STATES AIR FORCE AIRCRAFT
ACCIDENT INVESTIGATION BOARD
REPORT

RQ-4B, T/N 09-2041

LOCATION: NEAR THE COAST OF ROTA, SPAIN

DATE OF ACCIDENT: 26 JUNE 2018

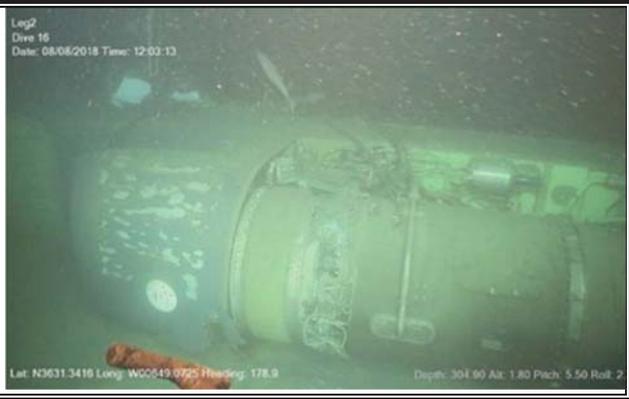
Fuselage on ocean floor (Tab S-2).

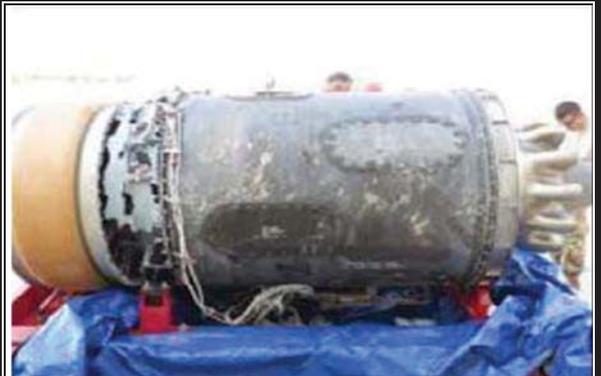
Recovered engine at GFAFB (Tab S-4).

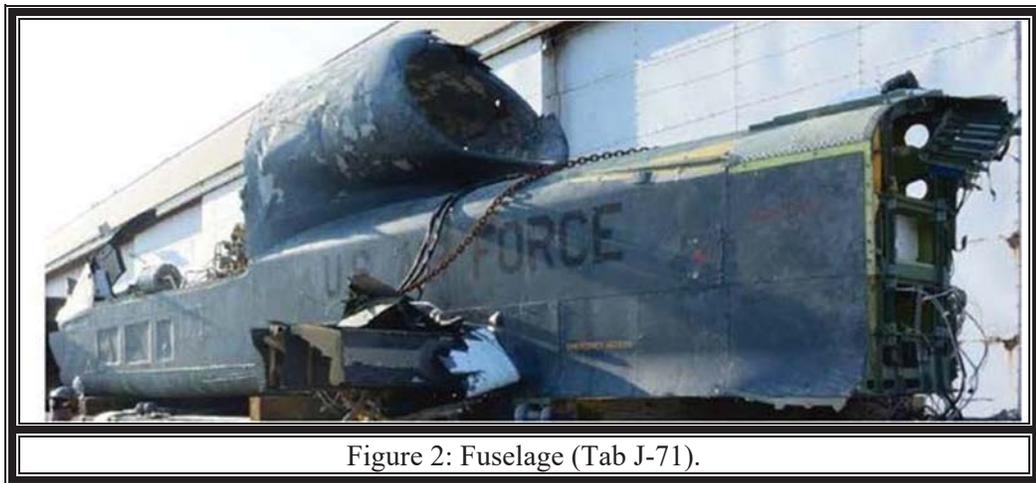
Figure 2: Fuselage (Tab J-71).

The technical report found no data suggesting structural failure prior to the MRPA’s impact (Tabs J-67 and L-2). NG’s visual assessment of the main fuselage showed no evidence of missing doors

or panels, as seen in Figure 2 below (Tab J-68 and J-71). There was no evidence of large scale damage within the engine inlet (Tab J-68). Engine fan blades were not damaged, as seen in Figure 5 and Figure 6 (Tab J-68 and J-70). There was no evidence of engine foreign object debris ingestion (Tab J-68 and J-70). The NG team noted the engine deck was intact and had no signs of damage or heat discoloration (J-68). There was no obvious puncture, cracking or signs of heat damage, as seen in Figure 3 and Figure 4 (Tab J-68 and J-72). NG also reported that the structure around the bulkheads showed no signs of discoloration, damage, failure or deformation, as seen in Figure 7 and Figure 8 (Tab J-74 to J-75). There was no evidence of an inflight engine fire (Tab J-68). According to NG, the structural damage seen in the Figures 2-8 can be attributed to the aircraft's impact with the ocean and not causal from either a primary or secondary control surface, panel or door departure ingested into the engine (Tab J-68). Based upon the MRPA's expected performance prior to and after engine failure, NG technical representatives asserted that the root cause was not related to aircraft structure or guidance and control systems (Tab J-65).

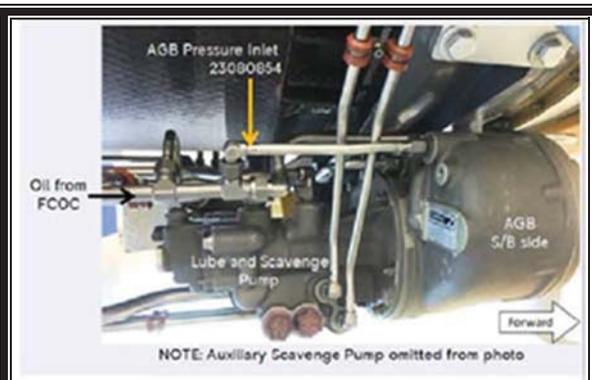
Figure 10: Installed oil line 230808 (Tab J-105).

On 18 August 2018, the engine, the Accessory Gearbox (AGB) and both FADECs were recovered from the ocean depths (Tab J-102 to J-103). These components were shipped to RRC, Indianapolis, for examination (Tab J-104). The engine was torn down to investigate the engine failure (Tab J-104). During disassembly, the engineers discovered all engine oil lines were intact, holding the proper torque values (Tab J-105). Oil lines were further inspected for material failure (Tab J-105). The AGB oil line showed evidence of fatigue and can be seen at Figures 10 through 13 (Tab J-105 to J-106). This oil line provides pressurized oil from the oil coolers to the AGB for lubrication and heat management (Tab J-105 to J-106). This AGB oil line can be seen at Figure 12 and Figure 13 (Tab J-105 to J-106). Examination of the AGB line showed the circumferential crack began on the outer surface and propagated inward to a length of 0.66 inch (Tab J-106). The fracture was near, but did not reach, the weld between the extruded tube and elbow fitting (Tab J-106). The fracture also did not reach the adjacent heat affected zone (Tab J-106).

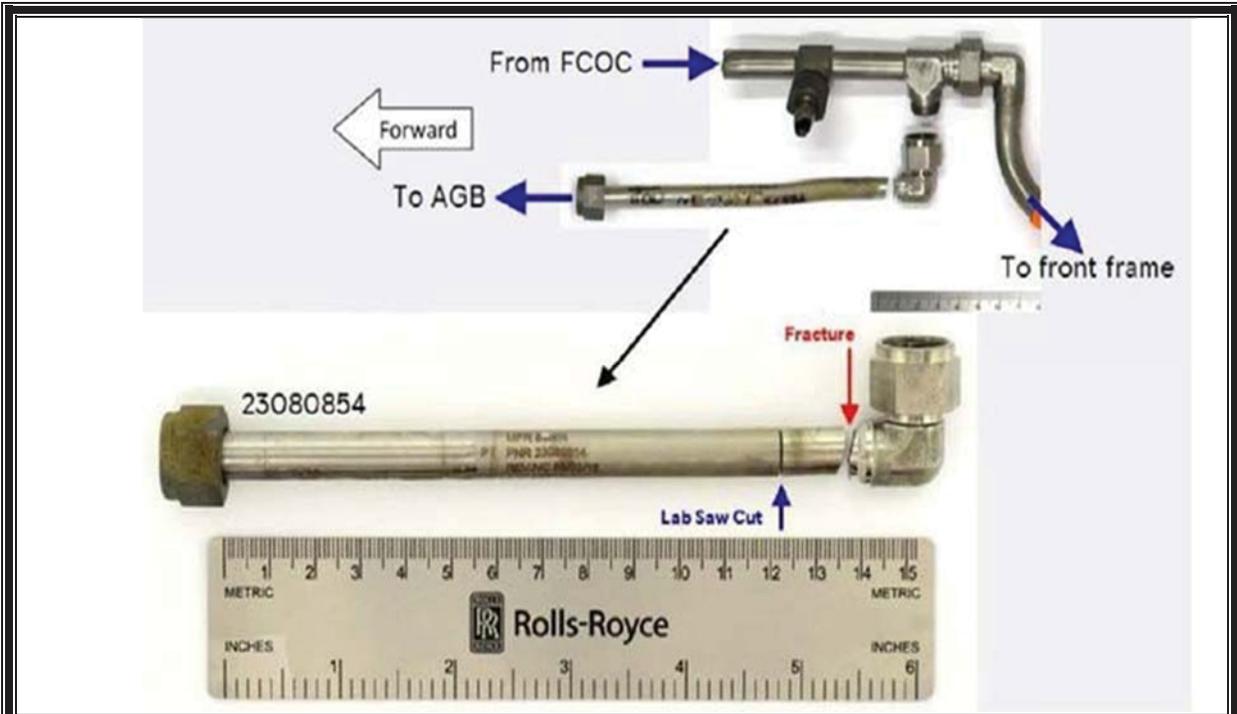
Figure 12: Failed oil line (Tab J-106).

On 5 September 2018, the engine, AGB and FADECs arrived at RRC for examination (Tab J-104). USAF personnel, RRC and NG engineers were on-site (Tab J-104). During engine teardown, engineers discovered a fatigued AGB pressured oil line (Tab J-83 and J-105 to J-106). This oil line delivers pressurized oil to the engine's AGB (Tab J-83). Further analysis on the oil line was conducted at the RRC Failure Analysis Laboratory (Tab J-83). Engineers discovered evidence of high cycle fatigue (HCF), observed in a crack on the surface of the oil line (Tab J-83 and J-106).

HCF is fatigue that results in failure after a large number of repeated cycles, usually caused by high-frequency vibration. Furthermore, according to the engineer SME, HCF is derivative where the number of cycles between possible inspection(s) is too large to be able to do anything about it in a practical sense (Tab FF-161 to FF-162). The engineer SME further describes HCF to occur at the right end of the S-N curve (conventional stress-life) where the number of cycles is usually too large to be able to obtain sufficient statistically significant data to be able to characterize the material behavior with a very high degree of confidence (Tab FF-162). Using a scanning electronic microscope, RRC Failure Analysis engineers ascertained that the line cracked on the outer surface and propagated inwards (Tab J-106). There was no sign of chaffing on the oil line nor did the line fracture at a weld point, as seen in Figure 12 and Figure 13 (Tab J-106 to J-107). Upon arrival at RRC, the oil line was completely broken (Tab J-106). Inspection of the fractured surfaces revealed that 60 percent of the circumference had failed due to HCF (Tab J-106). The remaining 40 percent failed due to overload, presumably due to the separation of the accessory gearbox from the engine during recovery (Tab J-106).

In summary, according to RRC engineers, the engine subsystem was the primary contributor to the mishap (Tab J-106 and J-114). The failure of the AGB pressured oil line was concluded as the root cause of the incident (Tab J-83). See Figures 12 through 15 (Tab J-106 to J-107). The pressured oil line failed due to HCF that caused a crack allowing pressurized oil to leak out, depleting the oil reservoir in six minutes (Tab J-114 to J-115). The subsequent oil leak, oil quantity faults, oil pressure faults, engine vibration faults, UIFSD, aircraft hull loss, and recovery damage were non-contributory (Tab J-84 and J-114). There was no evidence of any other failed engine component (Tab J-105 and J-114). According to RRC, flight data, hardware in sections, and testing found no evidence that would cause HCF failure such as non-compliant assembly, excessive vibration, or a material anomaly (Tab J-84 and J-114). The cause of HCF was non-attributed and cited to an undeterminable source and combination of higher than normal steady-state and/or vibratory stresses (Tab J-114).

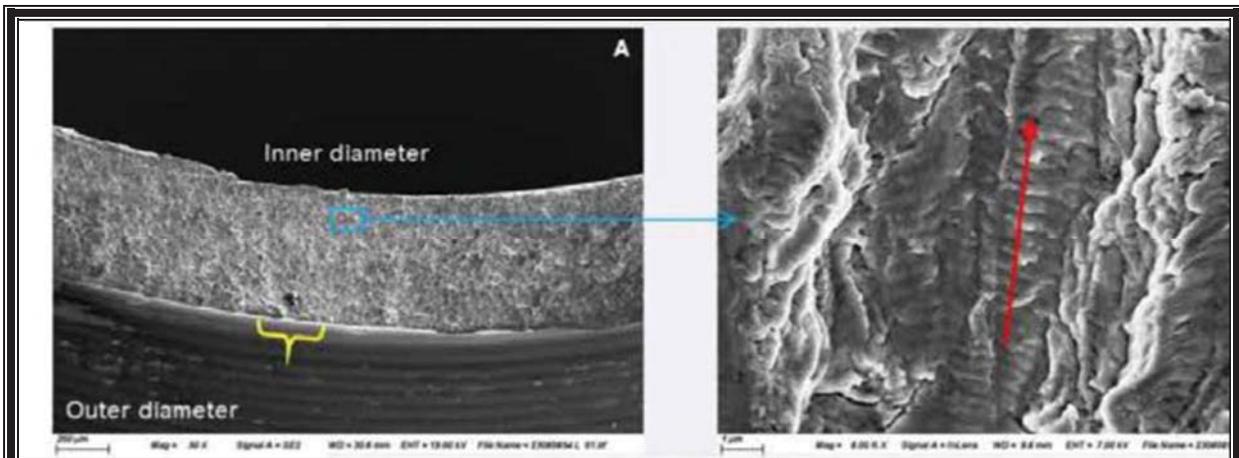
Figure 14: Oil Tube Crack Progression through Tube Wall (Radial Direction) (Tab J-107).

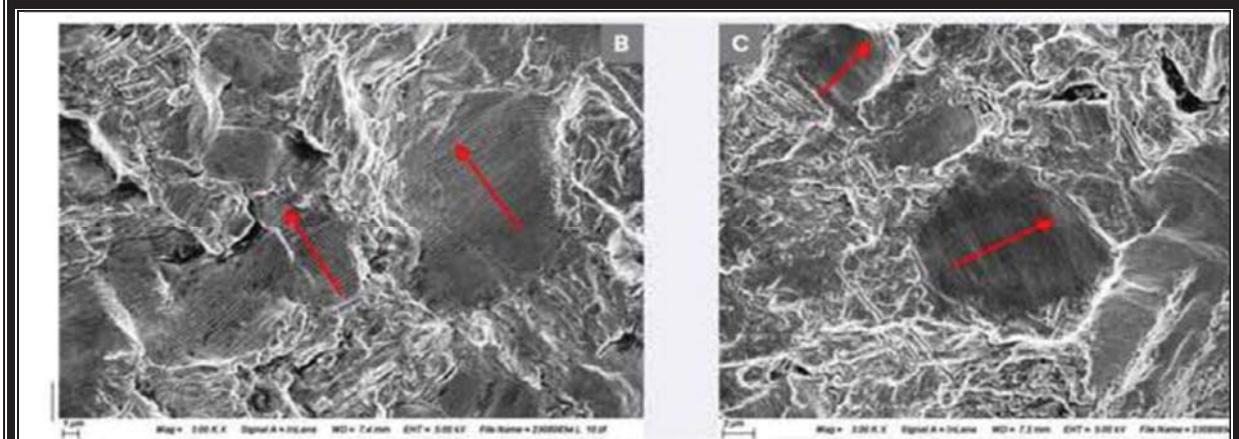
Figure 15: Oil Tube Crack Progression along Tube Wall (Circumferential Direction) (Tab J-107).
