UNITED STATES AIR FORCE
AIRCRAFT ACCIDENT INVESTIGATION
BOARD REPORT

MC-130H T/N 88-0194
SPECIAL TACTICS PARACHUTE MISHAP
23D SPECIAL TACTICS SQUADRON
24TH SPECIAL OPERATIONS WING
HURLBURT FIELD, FLORIDA

DATE OF ACCIDENT: 5 NOVEMBER 2019
BOARD PRESIDENT: MAJOR GENERAL L. KIP CLARK
Conducted IAW Air Force Instruction 51-307

**MC-130H T/N 88-0194
SPECIAL TACTICS PARACHUTE MISHAP
HURLBURT FIELD, FL
5 NOVEMBER 2019**

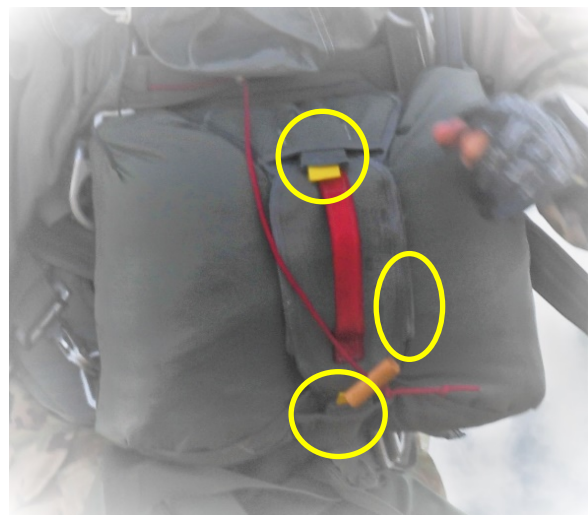
After the participants donned their equipment, the teams reported to a designated STTS cadre member to receive a JMPI (Tabs V-35.3 and CC-168). JMPII conducted the official JMPI on the MJM (Tab V-35.8). He did not place the T-11R tuck tab inserts in the tuck tab pockets (Tab V-35.7 and V-35.11). According to JMPII, the MJM would have inserted his T-11R inserts after his JMPI (Tab V-35.10). Figures 6 and 7 show that the base of the yellow tab on the MJM's top and bottom tuck tab inserts was not flush with the green pockets on his T-11R parachute ripcord assembly before and after MJM's first jump (Tab Z-11 and Z-73). Additionally, Figure 7 shows that the MJM's T-11R parachute has enough loose material on his left side tuck tab so that a second seam was visible after his first jump (Tab Z-11).

Figure 7. MJM first sortie (DZ post jump recovery)
(Tab Z-11)

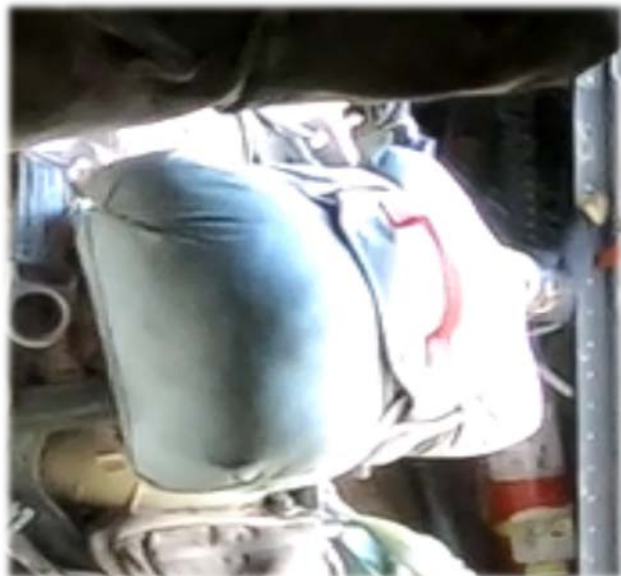
AJM/G stated he and the PJM/S did not review the AFMAN 11-420 in preparation for the ST Rodeo (Tab V-20.16). Photographic evidence of the first sortie shows that the PJM/S allowed AJMs to perform duties in the door with T-11R inserts not fully seated or not present at all (Tab Z-73 to Z-74).

Figure 9. AJM/1B (in-flight) in paratroop door without T-11R inserts (Tab Z-74)

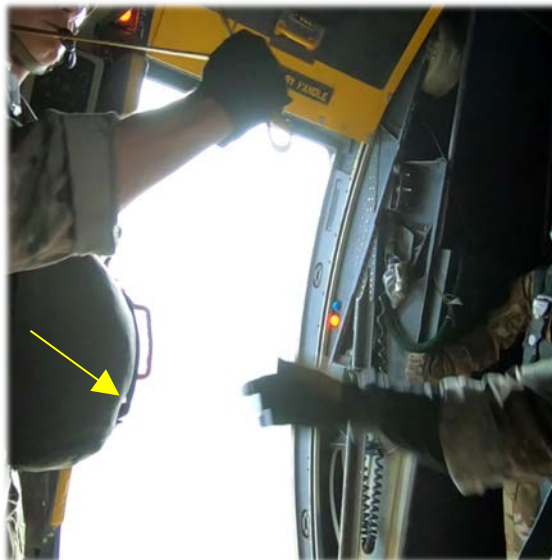
Figure 11. PJM/S receiving static-line from AJM. The lower tuck tab is loose with light showing underneath it (Tab Z-75)

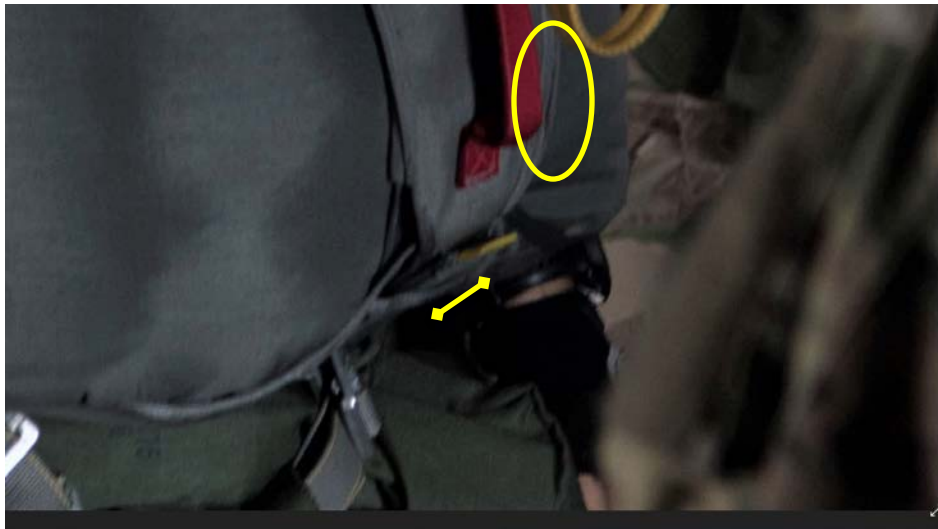
After the 1110L airdrop, the MA made a right hand turn back to the south over the Gulf of Mexico (Tabs P-20 and DD-268). The MC ran the appropriate checklist, and passed the applicable time advisories to the PJM/S and the MJM (Tab V-18.2 to V-18.3). Teams 6, 5 and 4 performed their jumps and Team 3 was next (Tabs P-20 and V-31.11). The MJM directed his three jumpers to stand up, and provided PWAC jump commands up to having the PJM/S take control of his static-line (Tab V-18.2 to V-18.3). A photo of the MJM waiting to pass his static-line to the PJM/S shows his bottom tuck tab insert sticking out approximately one inch from the edge of its pocket (Tab Z-49).

Figure 12. MJM's T-11R parachute just prior to the mishap. The bottom tuck tab insert with approximately one inch between the edge of the pocket and the yellow material and left side tuck tab is loose enough to showing two seams. (Tab Z-49)

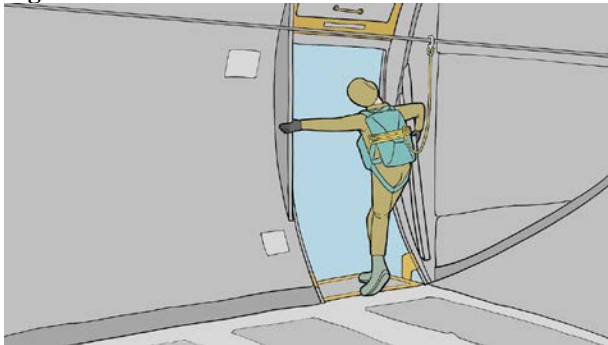
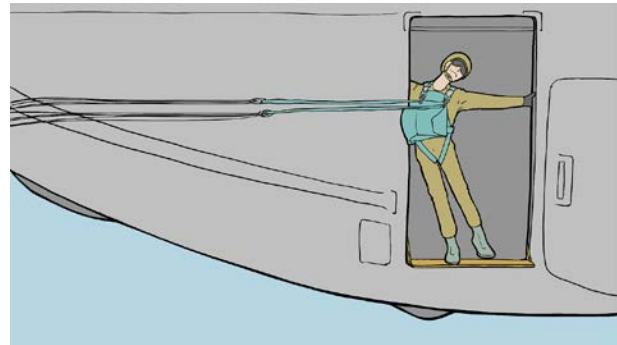
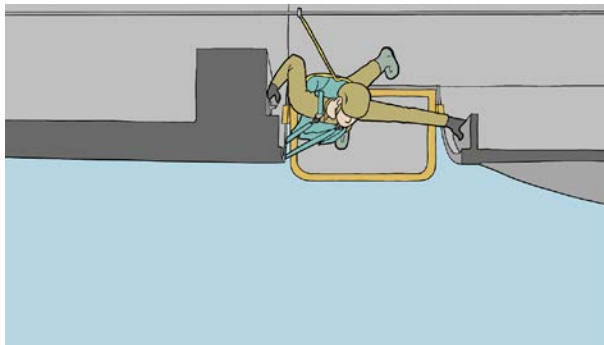
Figure 14:

Upon reserve parachute inflation outside the aircraft, the MJM impacted the aft door frame “violently” and generated a loud noise (Tab V-18.3, V-18.17 to V-18.18, V-20.5, V-33.3, V-33.7, and V-33.17).

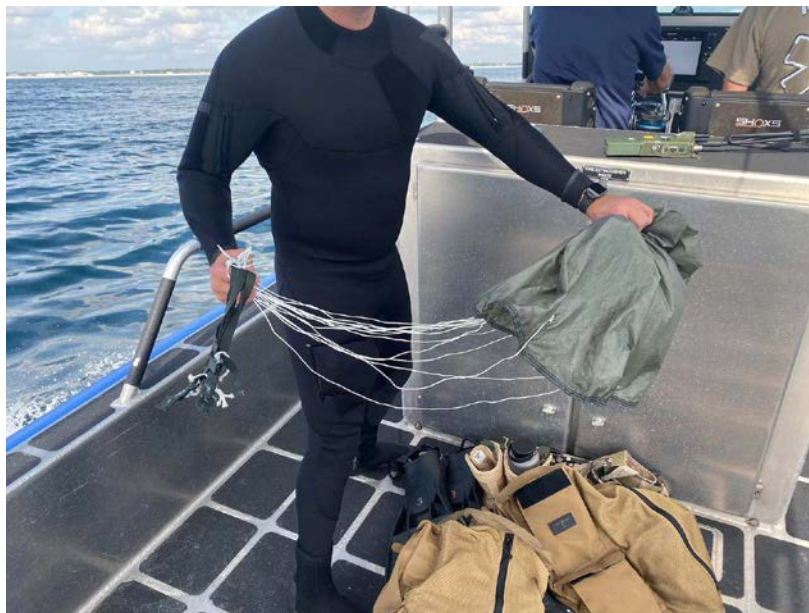
About an hour and a half after the mishap, an Air Force support boat found a T-11R parachute's small pilot parachute extractor floating in the Gulf of Mexico near the coordinates: N 30° 21.13' W 086° 41.2' (Tabs P-4 and Z-21 to Z-25). This point was approximately one-half mile away from the MJM's estimated location of exit from the MA (Tab DD-269 to DD-270). The location was within view of the coast (Tab Z-25).

Figure 21. Recovery of T-11R pilot parachute extractor (Tab Z-25)

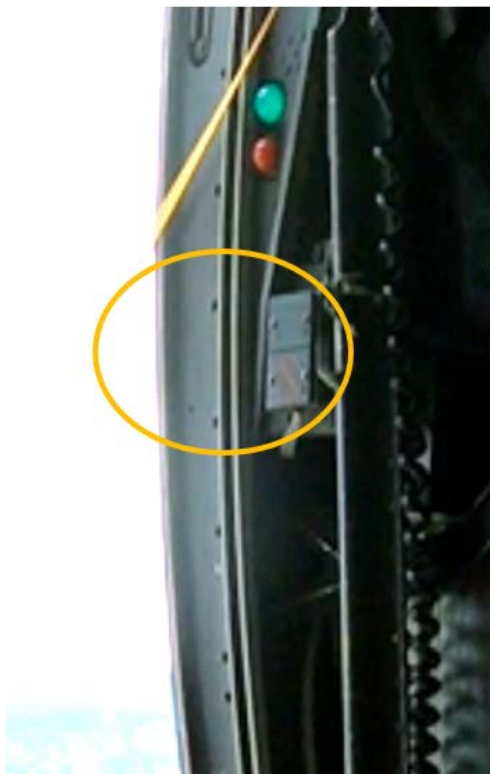
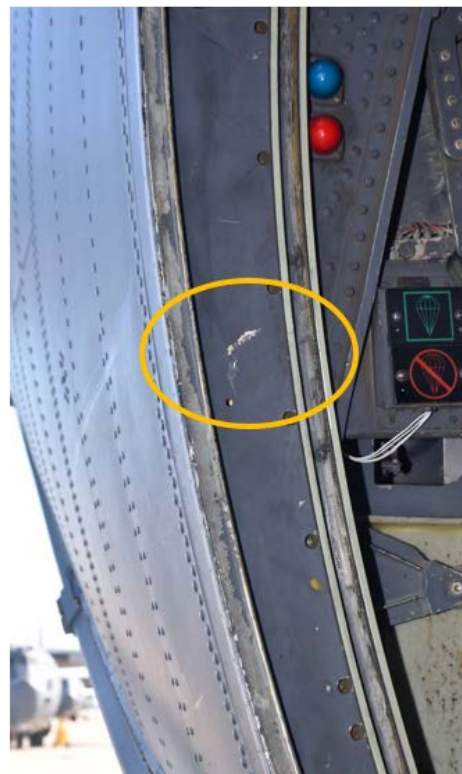
The mishap caused a dent and deep scratch on the right paratroop door's track guard (Tabs K-9 and Z-82). Photographic evidence shows this damage was not present on 5 November 2019 prior to the mishap (Tab Z-82).

Figure 23. Paratroop Door Pre-Mishap
(Tab Z-82)

Figure 24. Paratroop Door Post-Mishap
(Tab Z-82)

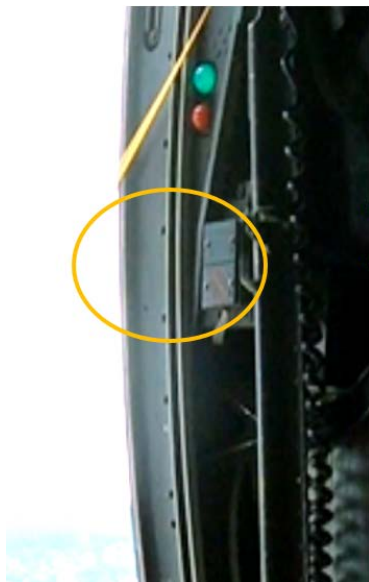
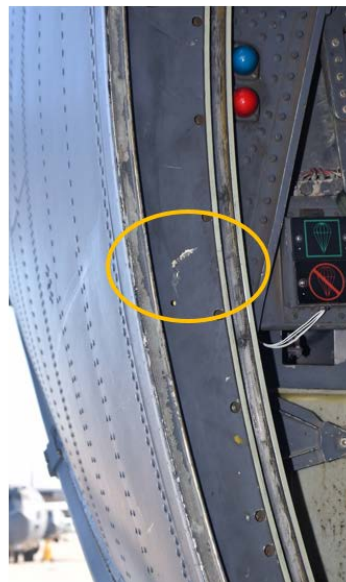
a velocity relative to the aircraft airspeed, which was 130 knots (150 MPH). He hit the aft doorframe with enough force that his equipment dented and scratched the metal door track guard. The preponderance of the evidence indicates the MJM sustained fatal injuries during impact with the aircraft.

Paratroop Door Pre-Mishap

Paratroop Door Post-Mishap

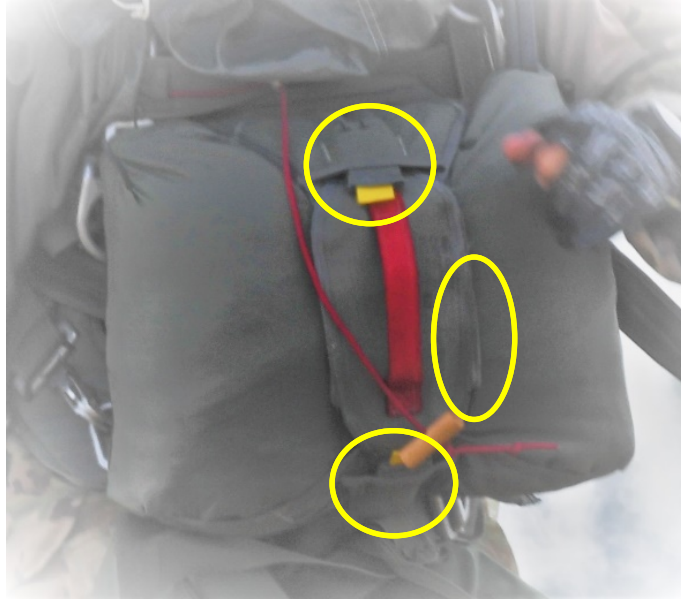
On 5 November 2019, JMPI1 performed the JMPI on MJM and his team before both of their scheduled jumps. On both occasions, JMPI1 did not call attention to the loose material on MJM's left side tuck tab. Also on both occasions, JMPI1 did not follow regulatory guidance and place T-11R inserts into the MJM's T-11R top and bottom tuck tab pockets. Instead, he left the task to the MJM to accomplish himself. Aboard the aircraft, photographic evidence shows several JMs performing duties in the door with incorrect or missing T-11R tuck tab inserts. The lack of JM training on the T-11R Reserve inserts and side tuck-tab was causal to the mishap. The Primary Jumpmaster/Safety (PJM/S) and MJM failed to remedy the situation with the MJM's T-11R Reserve parachute before PJM/S gave him control of the right side paratroop door.

**MJM immediately after his first jump with tuck tab inserts
Improperly seated and loose left side tuck tab**

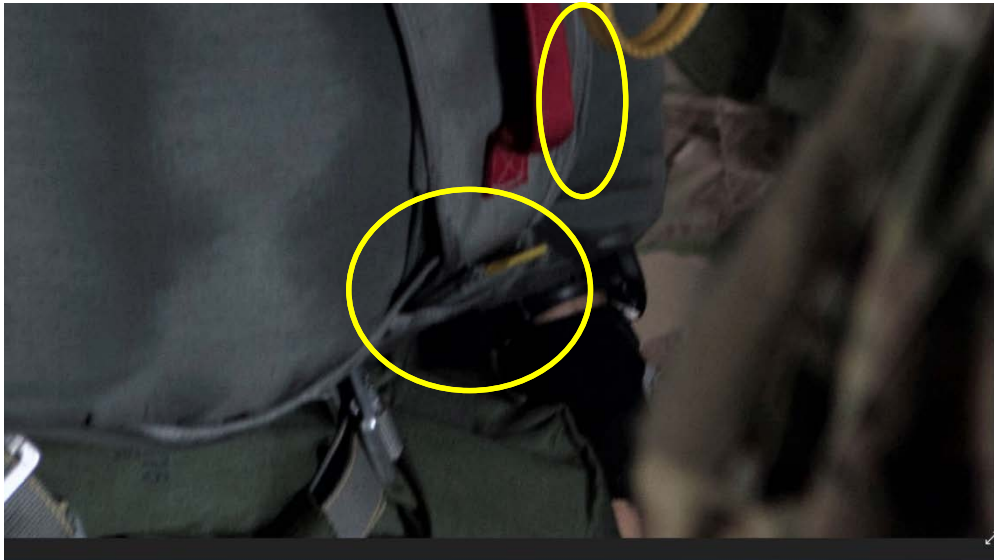
**MJM just prior to the mishap with bottom tuck tab insert
improperly seated and loose left side tuck tab**
