UNITED STATES AIR FORCE
AIRCRAFT ACCIDENT INVESTIGATION
BOARD REPORT

F-16C, T/N 90-0755

**314TH FIGHTER SQUADRON
49TH WING
HOLLOMAN AFB, NEW MEXICO**

DATE OF ACCIDENT: 29 OCTOBER 2019

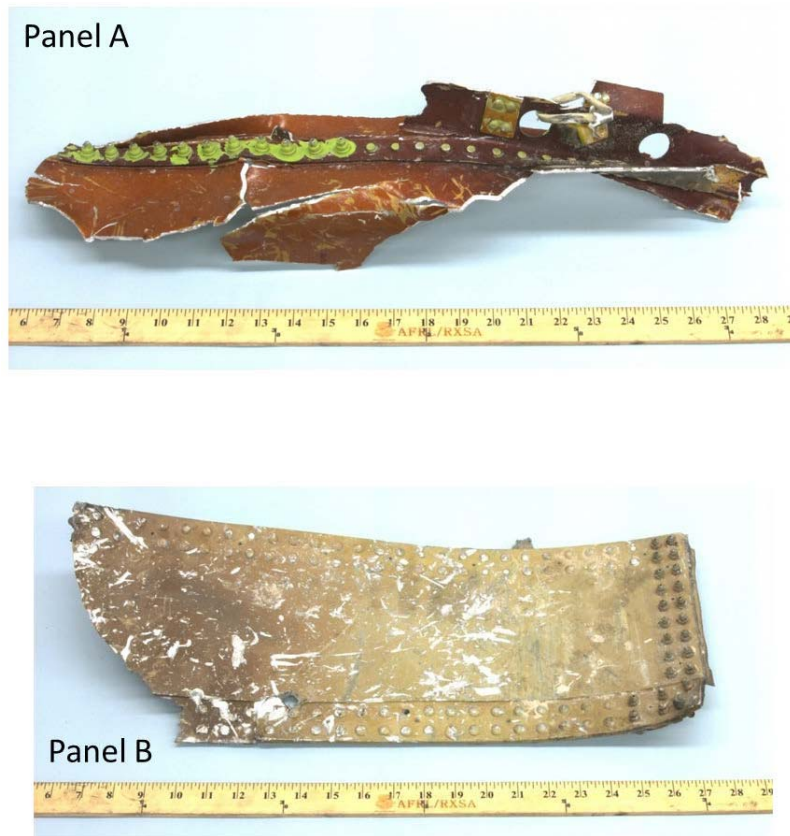
A post-mishap engine bay analysis by the Air Force Research Laboratory confirmed at least two panels were impacted by metal fragments (Tab J-16 to J-17). The first panel was impacted by fragments of IN-718 alloy, which is found in the 8th thru 11th Stage HPC Blades (Tab J-17). The second panel was impacted by both titanium and stainless steel fragments and had a strong odor of jet fuel likely from penetration of the A-1 fuel cell (Tab J-16 and J-17). The most likely source

of the titanium is Ti-8-1-1 (titanium alloy) from either the 1st through 3rd Stage Fan Blades or the 6th Stage HPC Blades (Tab J-17 and J-28). The source of the stainless steel fragment remains undetermined (Tab J-17).

Figure 3 – Impacted MA Panels (Tab J-20)

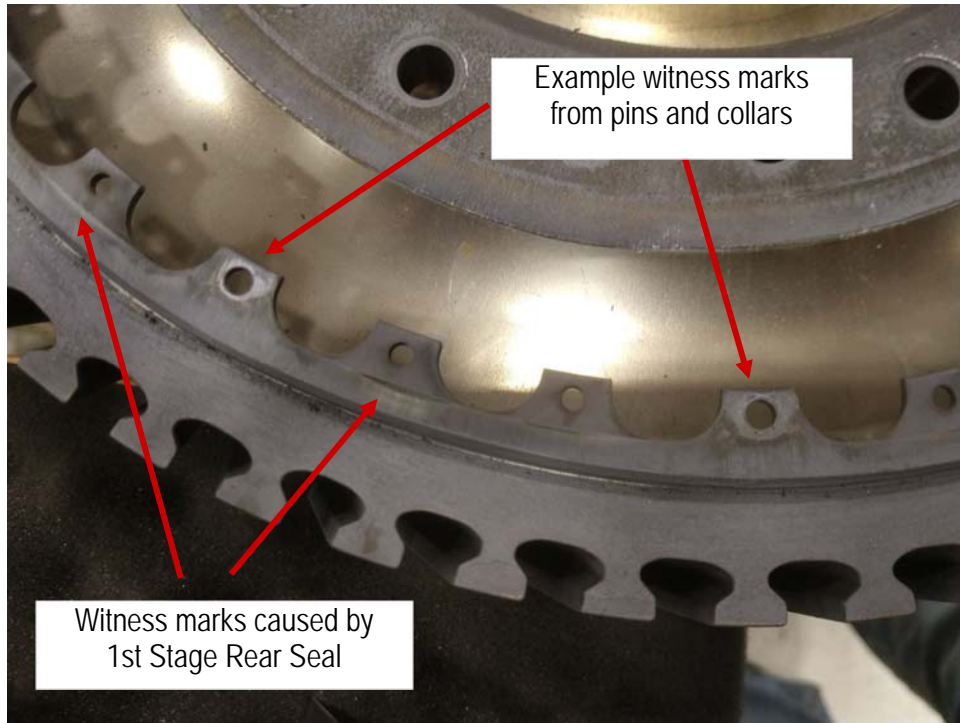
Figure 4 – Example Witness Marks from 1st Stage Rear Air Seal off a normal 2nd Stage Fan Disk Forward Balance Flange [not mishap engine] (Tab J-42)

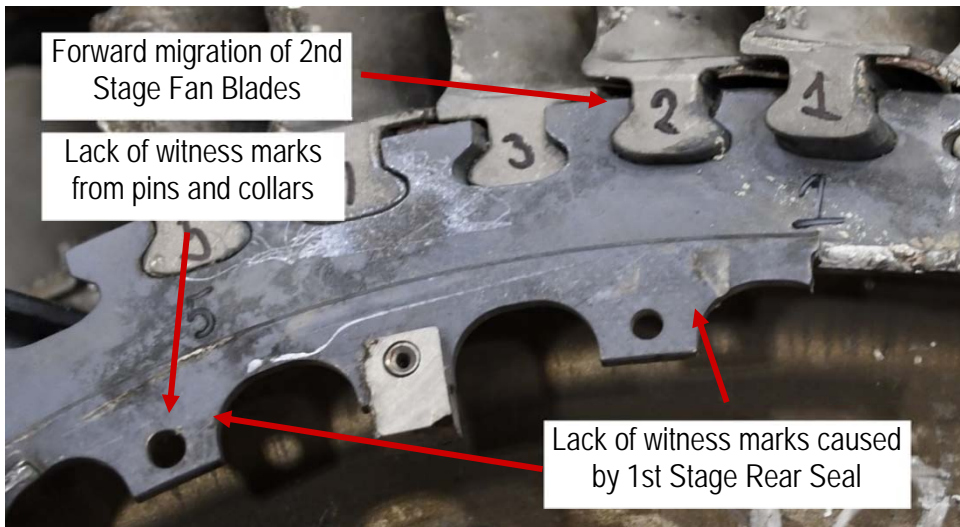
According to analysis performed by Air Force Life Cycle Management Center and Pratt and Whitney, the recovered IFM demonstrated damage consistent with liberation of the 2nd Stage Fan Blades of which nine were never found (Tab DD-9). Although all other air seals were found in the wreckage, the 1st Stage Rear Air Seal was never recovered (Tab DD-8 to DD-10). There were no apparent witness marks on the 2nd Stage Fan Hub radial interface that mates with the 1st Stage Rear Air Seal (Tabs J-74 and DD-29). The dry lubricant on the mounting holes was undisturbed and had no apparent witness marks on the 2nd Stage Fan Disk Forward Balance Flange from pins and collars that would have been installed during assembly or been forcefully removed during ground impact (Tabs J-74, DD-26, and DD-29 to DD-30). There were no apparent witness marks on the forward face of the 2nd Stage Fan Disk Blade Root Platforms from contact with the 1st Stage Rear Air Seal (Tabs J-74 and DD-30). Additionally, analysis showed the 2nd Stage Fan Blades migrated forward as far as .4 to 1.0 inches (Tabs J-74 and DD-9). The 2nd Stage Fan Disk

exhibited multiple lug fractures due to tensile and shear overstresses from the blade forward migration (Tabs J-74, DD-9, and DD-30).

Figure 5 –2nd Stage Fan Disk Forward Balance Flange from Mishap Engine (Tab J-45)

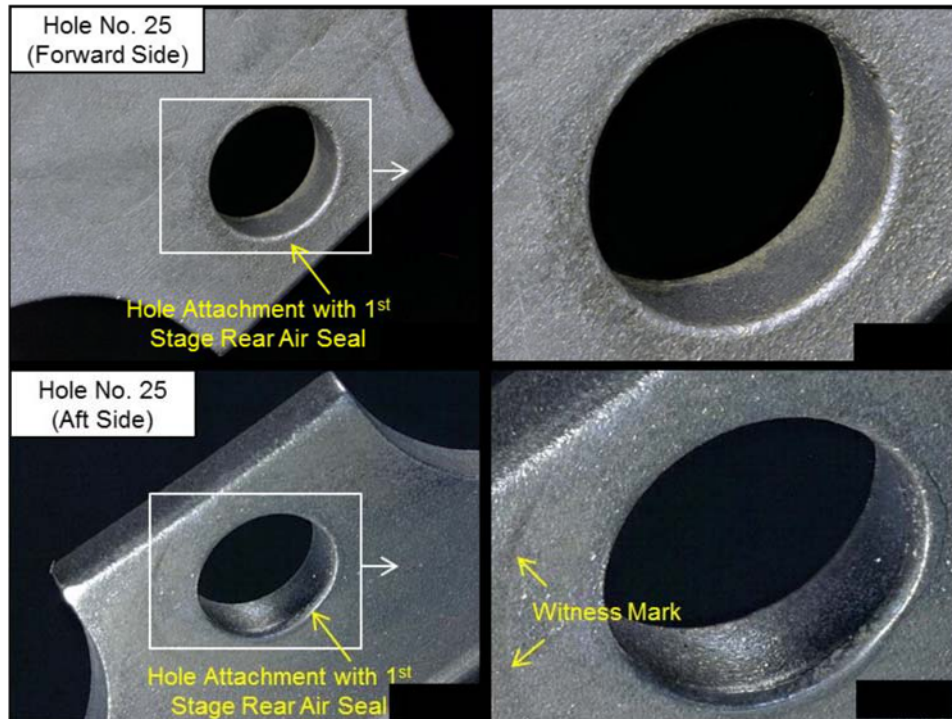
Figure 6 – Undisturbed Dry Film Lubricant and Previous Build Witness Mark Remnants on 2nd Stage Fan Disk Forward Balance Flange from Mishap Engine (Tab DD-26)

Post-mishap engine analysis clearly validates the absence of the 1st Stage Rear Air Seal. There was no evidence of the 1st Stage Rear Air Seal found at the crash site (portions of all other air seals were found). There were no apparent witness marks on the 2nd Stage Fan Hub radial interface that mates with the 1st Stage Rear Air Seal. The dry lubricant on the mounting holes was
