UNITED STATES AIR FORCE
AIRCRAFT ACCIDENT INVESTIGATION
BOARD REPORT

F-16C, T/N 88-0477

LOCATION: Near March Air Reserve Base, California

DATE OF ACCIDENT: 16 May 2019

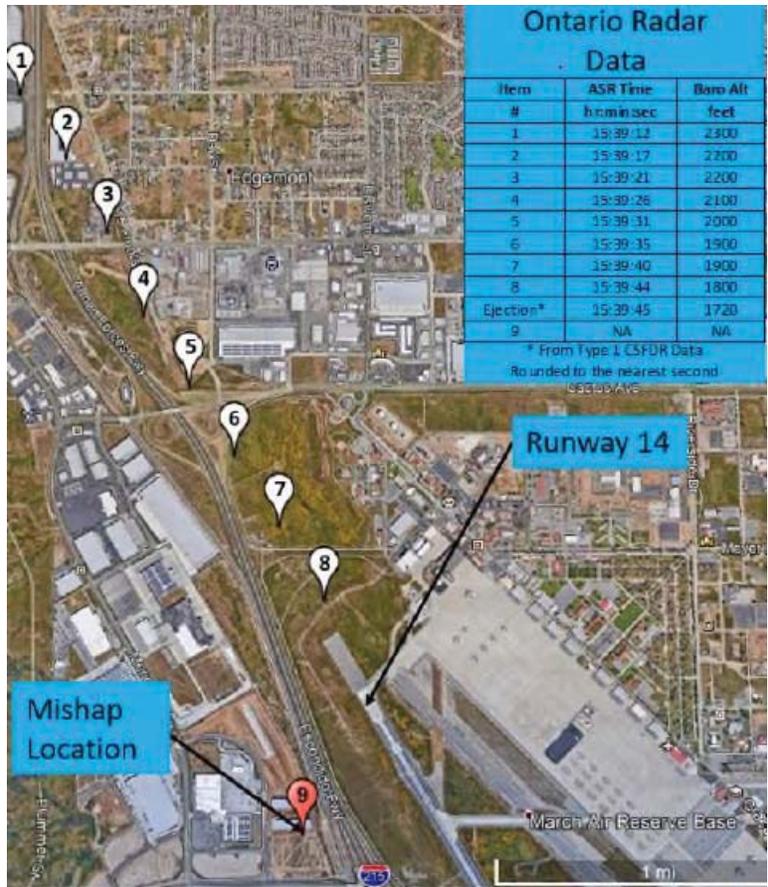
Figure 1. Radar Approach Data (Tabs Z-2 and DD-2)

The MP ejected at 1539L and, immediately thereafter, the MA impacted a commercial warehouse approximately 0.4 NM southwest of the centerline of the approach end of RWY 14, as indicated in Figure 1 (Tabs N-9, Z-2, DD-2, and FF-2). The MA impacted the warehouse at relatively shallow dive angle, with its right wing slightly low, and at a relatively slow speed (Tab FF-2). The impact parameters prevented major aircraft breakup as the aircraft went through the roof and into the building (Tab FF-2). The landing gear was down, the speed brakes were closed, and the engine was still running at the time of impact (Tab FF-2). Burnt warehouse material around the aircraft and light soot on the empennage indicate there was a small post impact fire (Tabs Z-5 and FF-2).

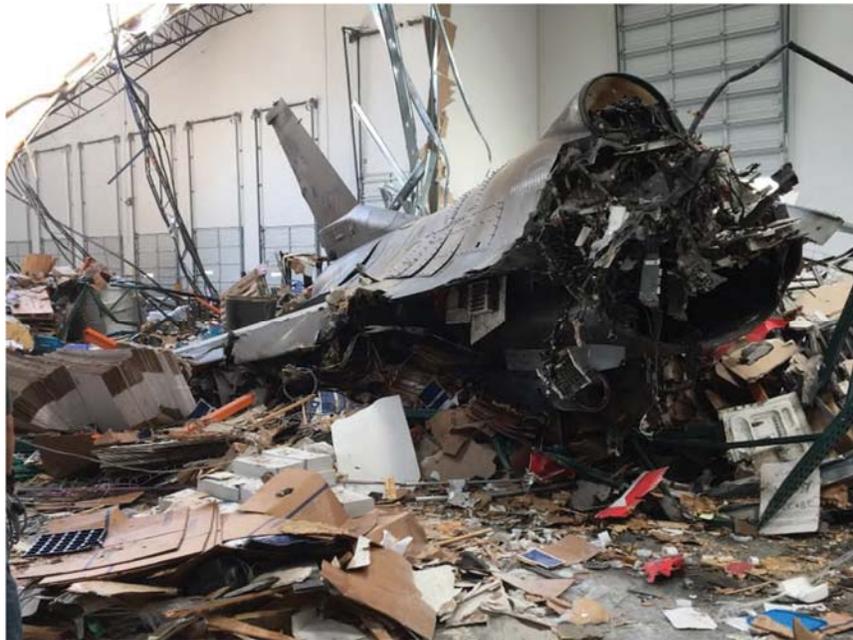
Figure 2. MA Main Wreckage in Commercial Warehouse (Tab Z-5)

The MA impacted a commercial warehouse west of the RWY 14 centerline at March ARB and came to rest inside, as shown in Figure 2 (Tabs Z-5 and EE-2). The MA was in an upright position and relatively level, slightly nose low with an estimated 15 degrees right wing down (Tab EE-2). The crew station of the MA separated from the fuselage on impact (Tab EE-2). During the collision with the warehouse the 370-gallon fuel tanks were destroyed by the impact (Tab EE-2). The left and right wings and right horizontal tail were largely intact (Tab EE-2). There was impact damage to the leading edge flaps (LEF) and the left horizontal tail was severed (Tab EE-2). The vertical stabilizer was intact with minor damage to the top of the rudder (Tab EE-2). The MA's landing gear were extended at impact and the right main landing gear (MLG) and nose landing gear (NLG) were broken but attached (Tab EE-2). All of the MA's primary flight controls were found around the MA (Tab EE-2).

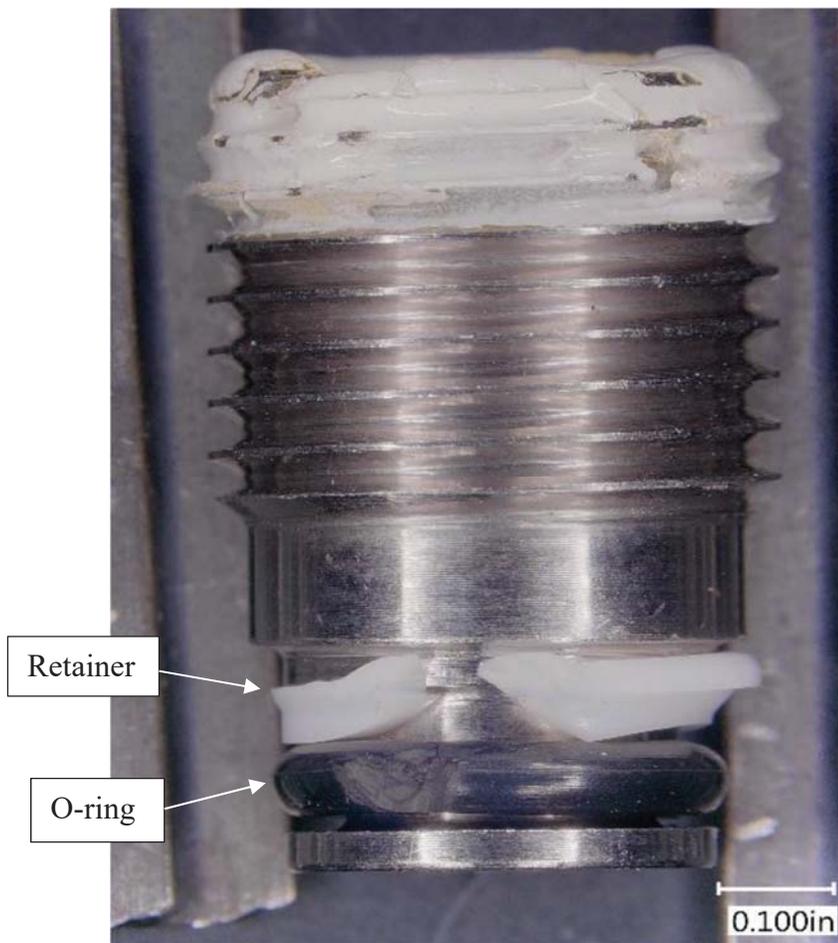
Figure 3: System A ICV screw cap (Tab Z-7)

A post-accident inspection revealed that the screw cap for the system A ICV was not seated properly into the body of the valve (Tabs DD-9 to DD-14, and EE-3). Upon removal of the screw cap from the system A ICV, the retainer was found to be permanently deformed and the ends of the retainer were spread apart as depicted in Figure 3 (Tabs DD-9, EE-3, and Z-7). In addition, a portion of the O-ring was missing and the upper face of the O-ring exhibited several permanent impressions of the underside of the retainer (Tabs DD-9 and EE-3). By rotating the O-ring to line up its impressions with the underside of the retainer, the missing portion lined up with the gap between the retainer ends (Tabs DD-9 and EE-3). The retainer and O-ring were measured and compared to unused items and were determined to be correct parts (Tabs DD-14 and EE-3).

The ICVs from both systems of the ISA exhibited the same mode of failure (Tab EE-3). The retainer on the screw cap had deformed and the ends spread apart (Tab EE-3). Near the gap between retainer ends, fragments had torn away from the O-rings allowing hydraulic fluid to leak out through the threads between the screw caps and the valve bodies (Tab EE-3). The inner threads of both valve bodies exhibited anomalies (Tab EE-3).

The retainer deformed because the screw caps in both of the two ICVs from the ISA were not fully seated as installed within their respective valve bodies (Tab EE-3). High pressure in service caused the retainer to flow into the cavity of the low-pressure side of the seal, leaving the O-ring unevenly supported and subject to progressive degradation (Tab EE-3). Degradation to the O-rings eventually prevented them from sustaining the working fluid pressure, and hydraulic fluid leakage occurred through the gaps in the O-ring and retainer (Tab EE-3).

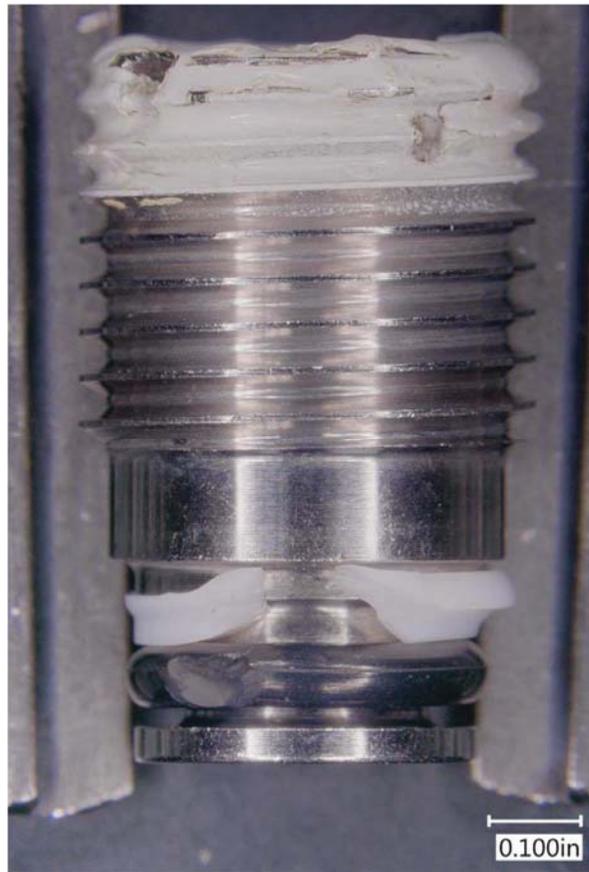
Figure 4: System B ICV (Tab Z-9)

The post-accident inspection also revealed that the screw cap for the system B ICV was not seated properly into the body of the valve (Tab EE-3). The screw cap was removed from the system B ICV and showed similar characteristics as the system A screw cap as shown in Figure 4 (Tabs Z-9, DD-12, and EE-3). The retainer was permanently deformed up over the adjacent ridge with the ends of the retainer spread apart (Tabs DD-12 and EE-3). The upper face of the O-ring exhibited several permanent impressions of the underside of the retainer (Tabs DD-12 and EE-3). A portion of the O-ring was missing (Tabs DD-12 and EE-3). Once again, by rotating the O-ring to line up with the underside of the retainer, the missing portion lined up with the gap between the retainer ends (Tabs DD-12 and EE-3).
