**UNITED STATES AIR FORCE**  
**ABBREVIATED AIRCRAFT ACCIDENT**  
**INVESTIGATION BOARD REPORT**

**MQ-9A, T/N 08-4035**

**DATE OF ACCIDENT: 10 APRIL 2019**

**Abbreviated Accident Investigation, conducted pursuant to**  
**Chapter 12 of Air Force Instruction 51-307**

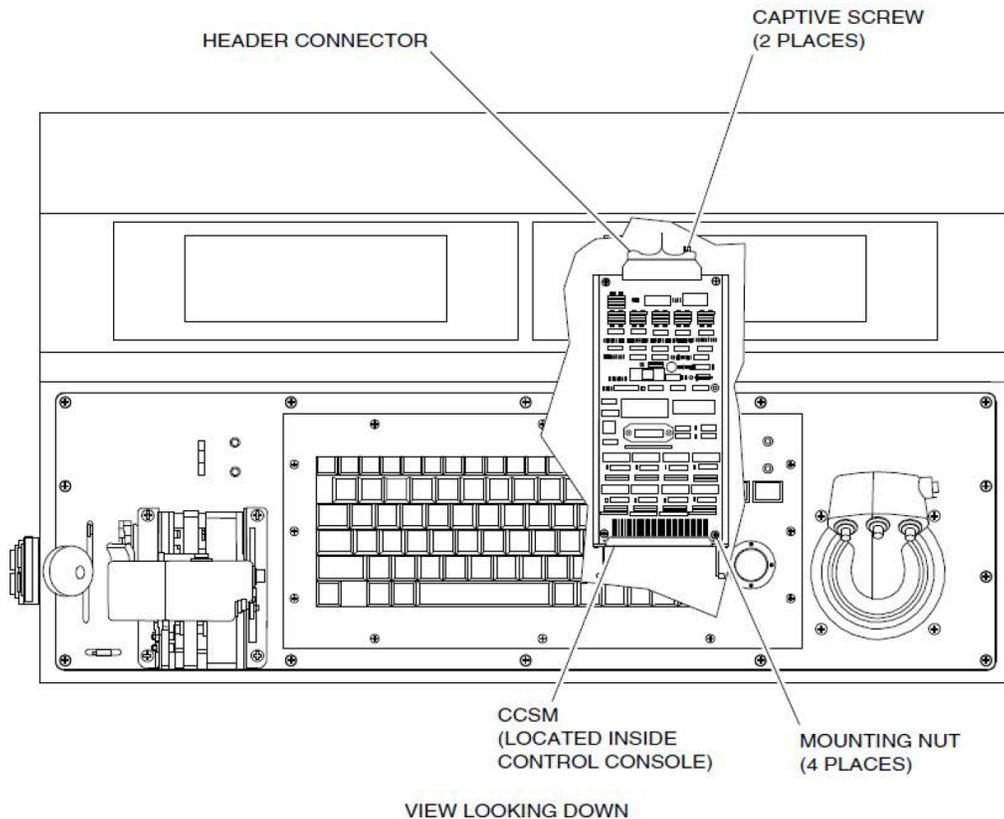
Control Console Serial Module

The MGCS PSO1 CCSM board was manufactured in October 2017 (Tab DD-8). Visual inspection of the CCSM board by General Atomics Aeronautical Systems, Inc. (GA-ASI) found two loose washers and one loose nut resting on the board (Tab DD-7 to DD-8). One of the keyboard case posts located directly above the CCSM board was missing fastening hardware (Tab DD-8). These keyboard posts are part of the keyboard assembly (Tab DD-8). The heads of the screws are located under the keys of the keyboard and are not accessed during normal maintenance (Tab DD-8). The fastening hardware comes installed on the keyboard/trackball assembly Line Replaceable Unit (LRU) (Tab DD-8). The fastening hardware consists of one nut, one washer, and one locking washer (Tab EE-2). None of the fastening hardware in the MGCS is secured with dual anchoring (Tab EE-2). There is no cover protecting the CCSM or cover containing the keyboard/trackball

assembly and its hardware (Tab EE-2). Each of the three pieces of loose hardware on the PSO1 CCSM board appeared to be resting on several pins (Tab DD-8). The flat washer was found between integrated circuits (Tab DD-8). The locking washer did not appear to be touching any visible leads (Tab DD-8).

Diagram displaying typical components of a Block 15 Fixed GCS CCSM (Tab BB-4)

“[i]nspection and testing of the [M]GCS hardware determined that metallic Foreign Object Debris (FOD) – a flat washer, on the PSO1 CCSM board – caused an

electrical short between several pins that convert the analog signals of the control inputs into digital, resulting in erroneous control inputs being transmitted to the [MA]. The electrical short and erratic commands were later replicated on the PSO1 CCSM board with an exemplar washer in the observed position and a test GCS” (Tab DD-3).

GA-ASI concluded that “[t]he flat washer shorted a +5 VDC signal to the analog-to-digital converter, resulting in a specific and repeatable signature in the data logs” (Tab DD-13). Furthermore, “[t]he exact duplication of the erroneous commands on the PSO1 CCSM board with the flat washer in the incident location indicated that the washer shorting pins on the CCSM board caused the erroneous commands” (Tab DD-13). “Among these commands was to close the fuel shut-off valve and feather the propeller, the equivalent of moving the condition lever to ‘Feather/Off’. Because of this, during the mishap flight, the engine shut down and could not be restarted (the fuel shut-off was continually being commanded closed)” (Tab DD-3).

“Conformal coating was present on both the PSO1 and PSO2 CCSM boards; however, the coating near the pins ... on the PSO1 board was slightly eroded, making the pins in that area more susceptible to an electrical short from contact with the FOD. Vibrations and physical manipulation of the CCA drawer may have caused the flat washer to abrade the conformal coating over time. Conformal coating is primarily intended to protect Printed Circuit Boards (PCBs) from moisture and will not withstand prolonged abrasion.” (Tab DD-13).
