UNITED STATES AIR FORCE
AIRCRAFT ACCIDENT INVESTIGATION
BOARD REPORT

T-38C, T/N 65-0395
&
T-38C, T/N 67-4950

25th FLYING TRAINING SQUADRON
71st FLYING TRAINING WING
VANCE AIR FORCE BASE, OKLAHOMA

DATE OF ACCIDENT: 21 NOVEMBER 2019

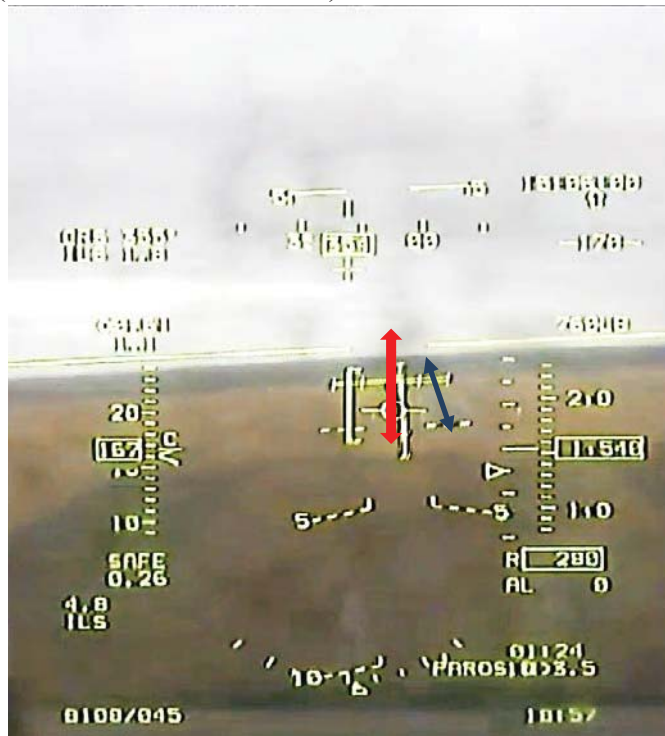
(Figure 1)

Head Up Display (HUD) video indicated MA1’s spacing relative to MA2 was wider than 50 feet between aircraft throughout the majority of the formation approach (Tab Z-17). At 1506:00Z, descending through 280 feet AGL, MIP1 prompted MSP1 to tighten his lateral spacing to ensure MA1 was properly aligned with the runway (Figure 1 – Red Arrow is MA1’s alignment, Blue Arrow is runway,) (Tabs O-10, Z-3 and Z-17).

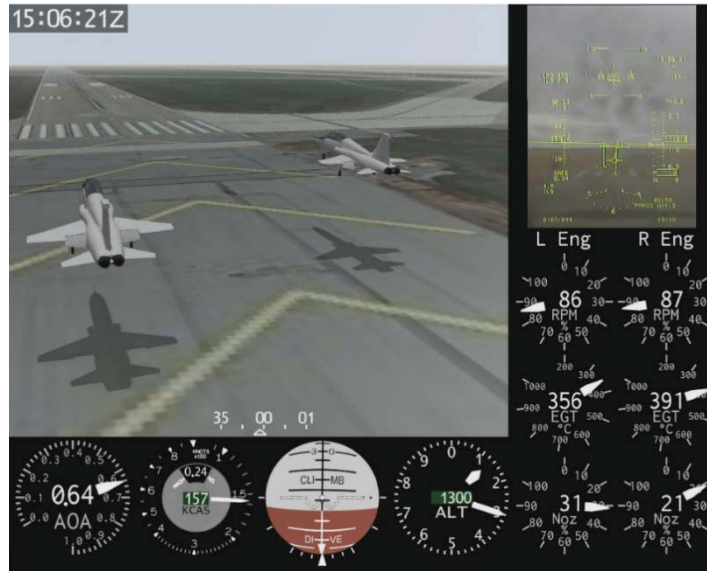
MSP1 subsequently corrected MA1’s alignment to the left half of Runway 35C and maintained appropriate lateral spacing until 1506:15Z, descending through 90 feet AGL (Tab Z-17). At that time, MA1 began to drift towards the left edge of the runway (Tab Z-16). Throughout this period, the speed and pitch of MA1 relative to MA2 appeared to be within normal parameters (Figure 2) (Tab Z-12 and Z-17).

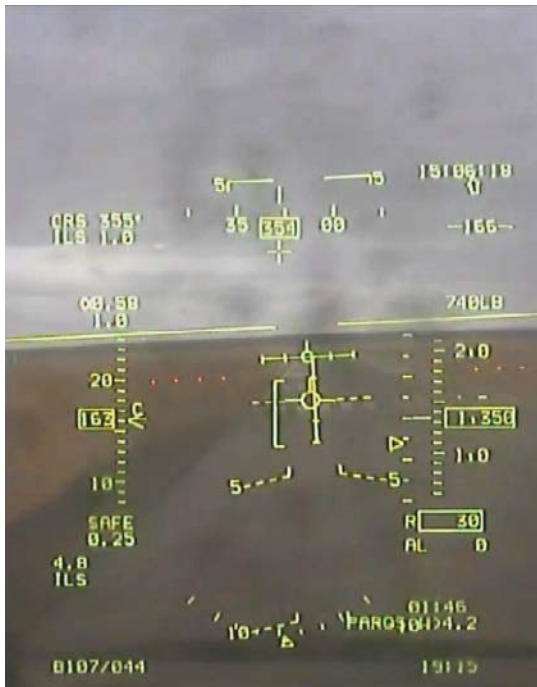
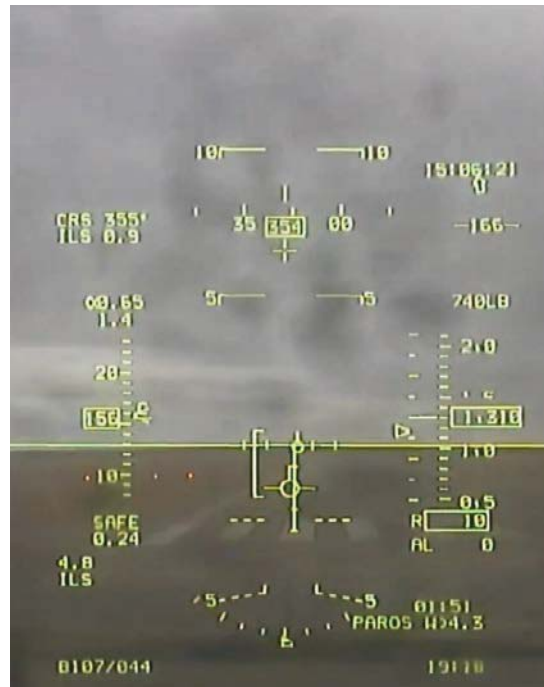
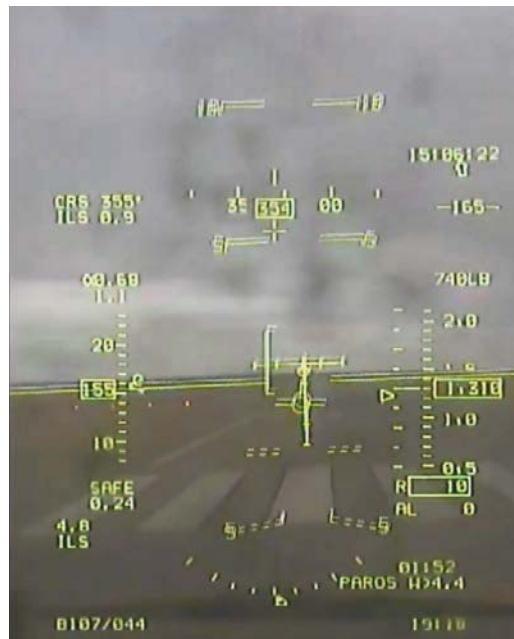
At 1506:22Z, as MA1 crossed the runway overrun, the HUD showed increased pitch consistent with a shift of aimpoint further down the runway in accordance with standard T-38 landing technique (Figure 3 and Figure 4) (Tab Z-4, Z-5 and Z-17). During this shift, however, MA1's HUD video showed a further drift toward the left boundary of the runway so that MA1 was 10 feet wider than planned and continuing to drift left (Tab Z-17). Three seconds later, at 1506:25Z, approximately 600 feet past the runway threshold, MA1's main wheels touched down (Tabs Z-17 and DD-38). HUD video showed MA1 was traveling at approximately 143 knots indicated airspeed (KIAS) on a heading 1 to 2 degrees left of run alignment, with the left main tire approximately 15 feet from the left edge of the runway (Tab Z-17). MA1 briefly settled on its main tires, but then slightly lifted off the runway once more as the result of a premature aerodynamic braking maneuver (Figure 5) (Tabs, V-22.3, Z-10, Z-17, and DD-38).

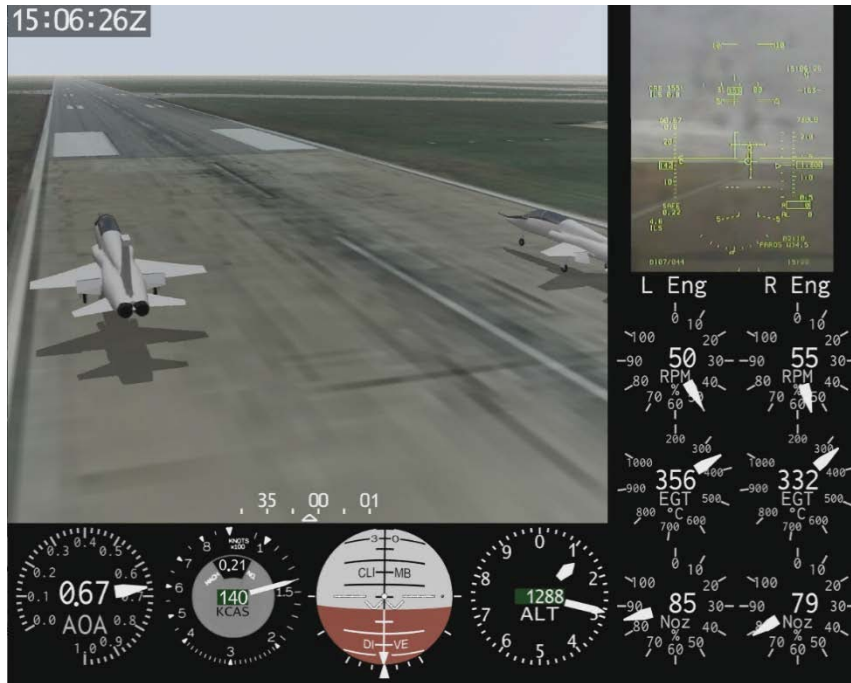
For the next three seconds (1506:25Z to 1506:28Z), MA1 was either slightly off the ground or so lightly planted that there was essentially no weight on its wheels (Figure 6) (Tabs V-22.3 and Z-17). Both of MA1's engines initially remained in the lowest selectable power settings (idle); HUD video showed pitch increasing from approximately 4.5 degrees nose high to 8 degrees nose high attitude (Tab Z-13 and Z-17).

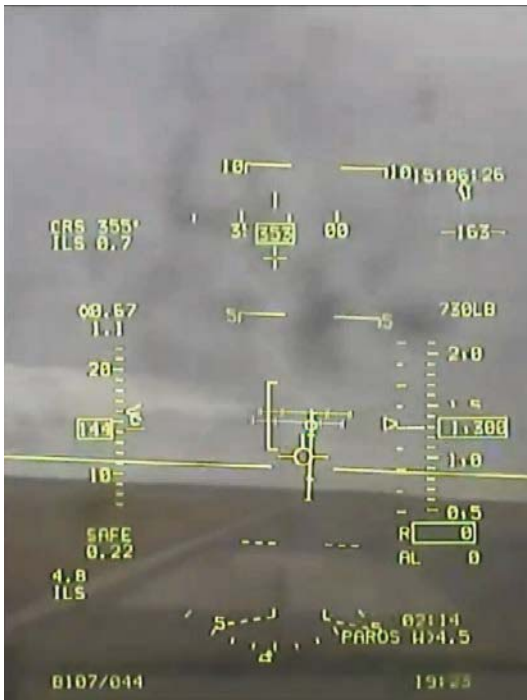
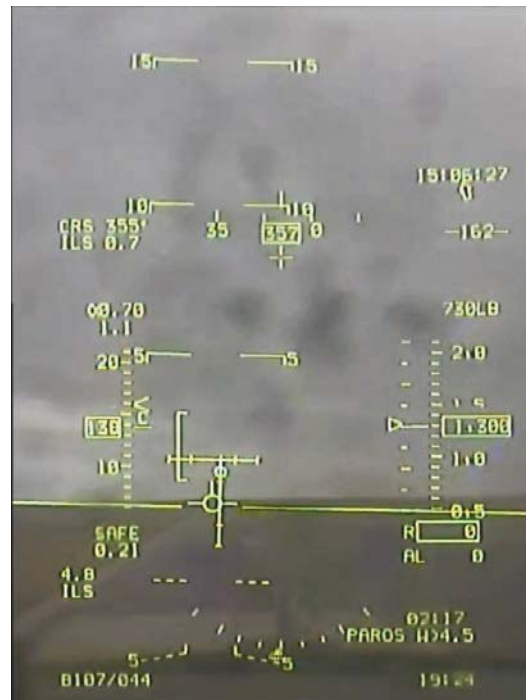
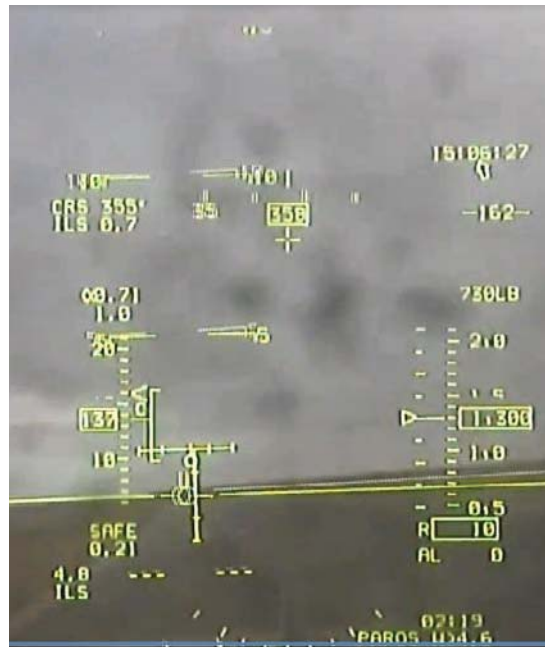
In conjunction with MA1's rising pitch attitude, HUD video showed a very slight left roll followed by right yaw (Tabs Z-17 and DD-38). At 1506:26Z, MA1 yawed from a heading of 353 degrees to 358 degrees (Figure 7, Figure 8 and Figure 9) (Tab Z-6, Z-7, and Z-17). MIP1 verbally directed MSP1 to "go around" (Tab O-10).

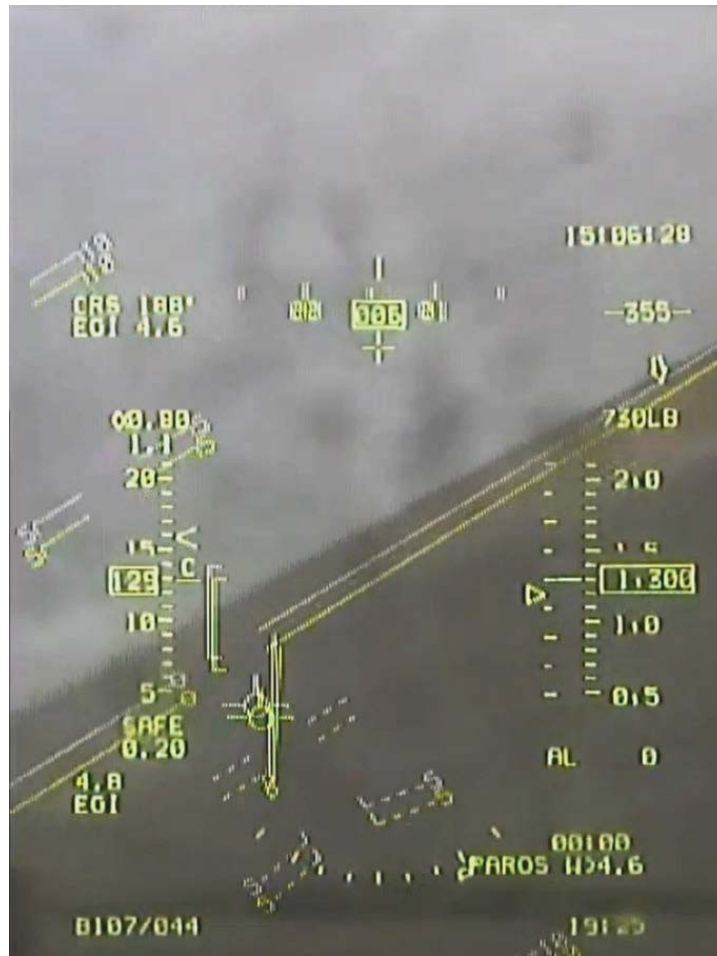
At 1506:27Z, approximately 2 seconds after touchdown, HUD video showed a continued right yaw accompanied by a pronounced right rolling movement (Tabs Z-18 and DD-37). MA1's post-flight engine parametric data indicates the throttles were advanced to full (military) power at this time (Tab Z-18). One second later, at 1506:28Z, MA1's right main wheel forcefully contacted the runway and the aircraft entered a skid, converging with MA2 (Tab Z-18). HUD video showed a heading of 006 degrees, 129 KIAS, 0.80 Angle of Attack (AOA), pitch approximately five degrees nose high, and approximately 30 degrees of right bank (Figure 10) (Tab Z-8 and Z-18).

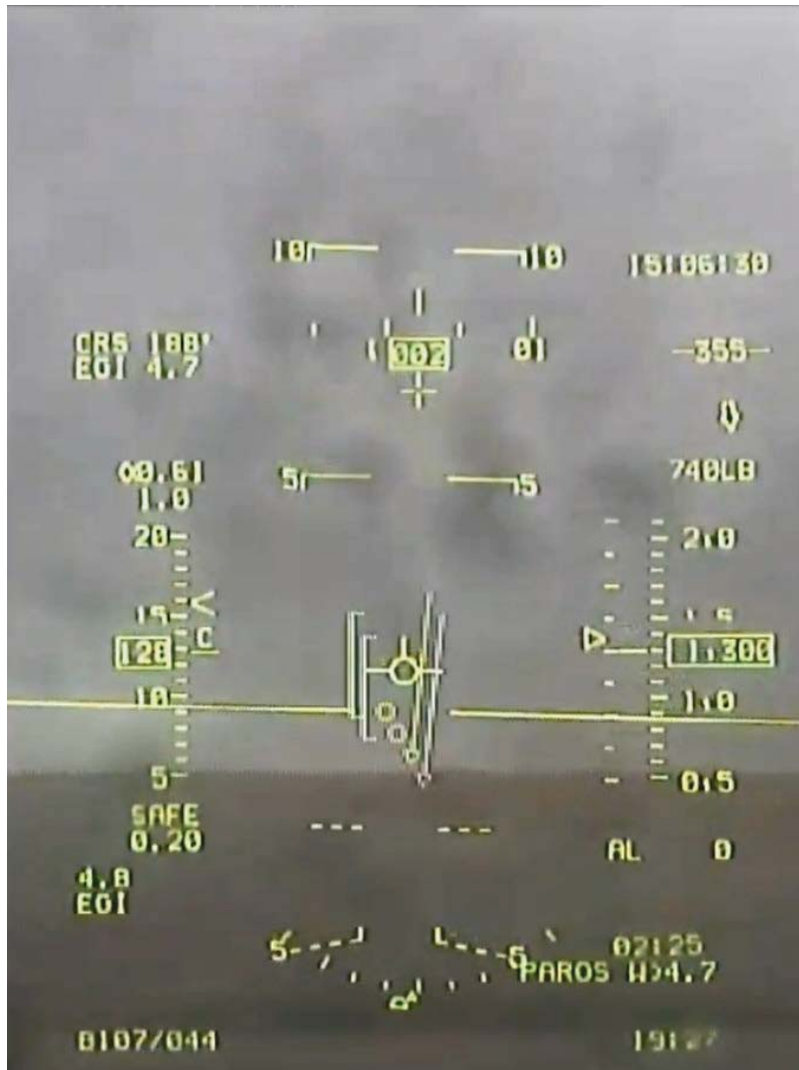
After another second, at 1506:29Z, MA1's nose wheel struck the runway forcefully; all three tires were then on the ground (Tabs V-22.3 and Z-18). HUD video showed MA1 heading 008 degrees, 132 KIAS, 0.79 AOA, near level pitch and slight left bank (Tab Z-18). At this time, MIP1 likely took the controls. (Tab DD-37) At 1506:30Z, in an apparent attempt by the pilot flying MA1 to avoid colliding with MA2, and possibly to affect a safe go-around, MA1's pitch attitude rose rapidly to approximately 8 degrees nose high (Figure 11) (Tab Z-9 and Z-18). HUD video indicated a wings level attitude, 128 KIAS, and 0.61 AOA (Tab Z-18). As AOA indications in the T-38C HUD lag real time conditions by approximately one half second, actual AOA may have been higher (Tab V-22.4).

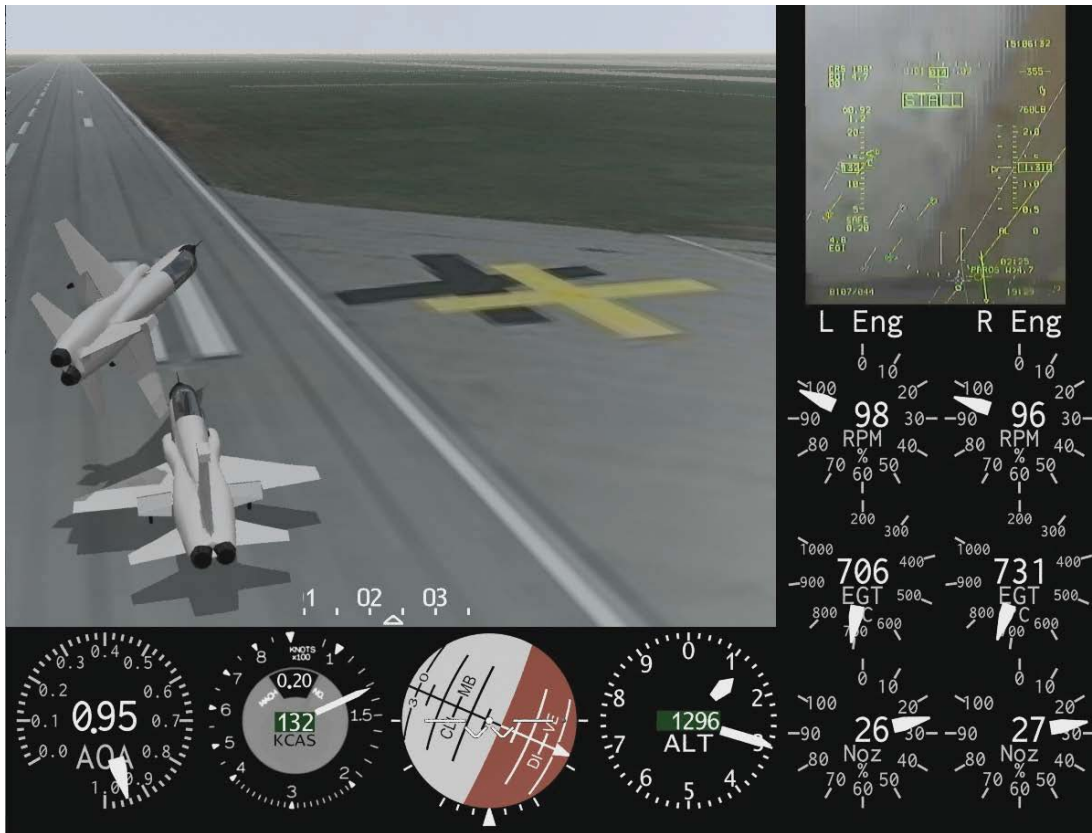
The pilot flying MA1 arrested the skid but MA1 remained on a collision course with MA2 (Tab Z-19). The pilot aggressively pulled back on the stick, attempting to avoid the collision by overflying MA2, but lacked sufficient airspeed to generate enough altitude (Figure 12) (Tabs Z-13, Z-19 and DD-37). MA1's right outboard gear door made contact with MA2's left wingtip, trapping MA2's wing between MA1's right main landing gear tire and the door (Tab DD-8). The contact caused MA1 to roll rapidly right, where its wingtip struck MA2 near the upper wing root (Tab DD-8). There are no available aircraft parameters for MA1 after 1506:32Z (Tab Z-19). At that time, HUD video showed MA1 at 132 KIAS, approximately eight degrees pitch, approximately 45 degrees of right roll, 0.92 AOA, and "STALL" indications (Tab Z-19). MA1 continued to roll to the right, passed over the top of MA2, and impacted the ground upside down with engines in full military power (Tab DD-30 and DD-33). MSP1 and MIP1 were killed on impact (Tab X-3). The total time from when MA1 crossed the runway overrun until impact was approximately eight (8) seconds (Tab Z-12 and Z-14).

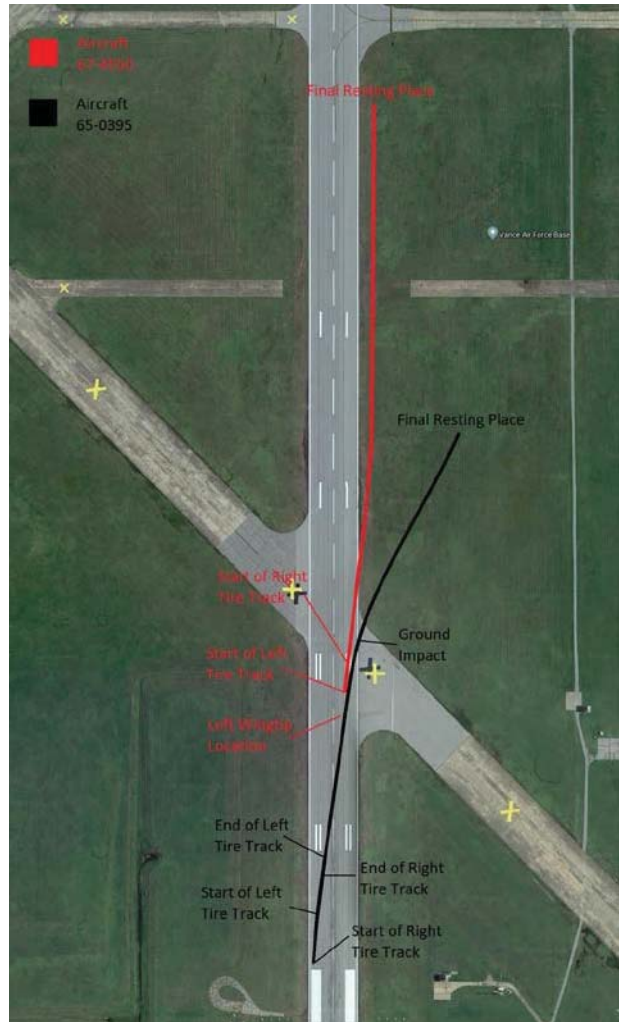
(Figure 13)

Technical analysis determined MA1 struck the ground inverted or nearly inverted slightly to the east of Runway 35C on the remnants of a decommissioned taxiway approximately 2200 feet past the landing threshold (Tab DD-5 and DD-9 to DD-10). MA1 continued to slide on the infield grass to the east of Runway 35C for approximately 700 feet and came to rest approximately 300 feet east of the runway (Figure 13 in black) (Tab DD-5 and DD-10).

After leaving the prepared surface, MA2's right wingtip struck the 6000 feet runway remaining marker on the east side of Runway 35C (Tab DD-10). At 1506:47Z, with MA2 still in motion, MIP2 made an emergency radio transmission on the Vance Tower frequency (Tab O-10). MIP2 was able to slow MA2 to a stop in the grass east of Runway 35C at 1506:50Z and approximately 3500 feet from the approach end (Figure 13 in red) (Tabs O-10, V-5.9, DD-5 and DD-10).

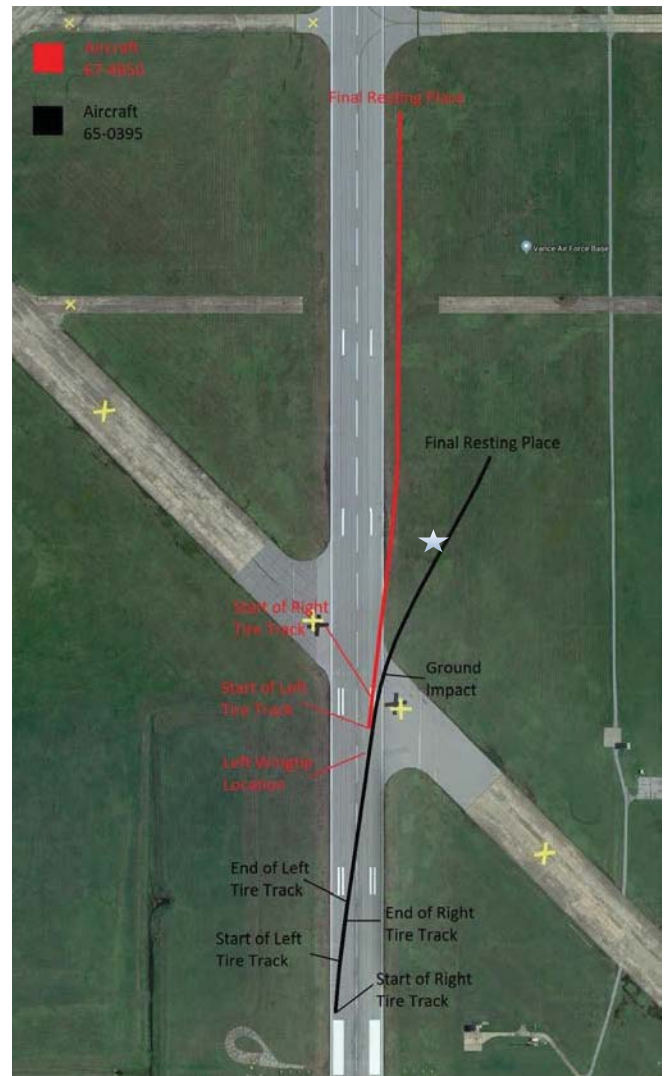
(Figure 14)

MIP1 was found strapped to the rear seat, approximately 325 feet southwest of the aircraft (Figure 14 blue star) (Tabs C-2 and DD-46). MIP1's ejection control handle was found unseated (fired), but engineering analysis concluded MIP1 did not voluntarily initiate ejection for two reasons (Tab DD-46).

First, no portions of the ejection system were activated other than the rear seat (Tabs V-19.3, DD-46 and DD-49 to DD-50). When the aircraft impacted the ground inverted, the top seat latches of both ejection seats yielded, allowing the seats to move freely up and down the guiderails and disengaging them from the gas fittings in the aircraft (Tabs V-19.3 and DD-50). These fittings allow hot gas to flow between the seat and the aircraft in the ejection sequence (Tab DD-49). Once the fittings are disconnected, it is impossible for the seat to reattach (and thus connect with the rest of the ejection system) without human intervention (Tab DD-49 to DD-50). Intact (not fired) cartridges were located in MA1 in both the front and the rear canopy jettison systems, as well as in the front seat (Tab DD-46 to DD-47 and DD-49 to DD-50). The ballistic signal was not passed to the ISS; therefore, the rear seat was disconnected from the gas fittings prior to the handle being dislodged (Tab DD-46 to DD-47 and DD-49 to DD-50).

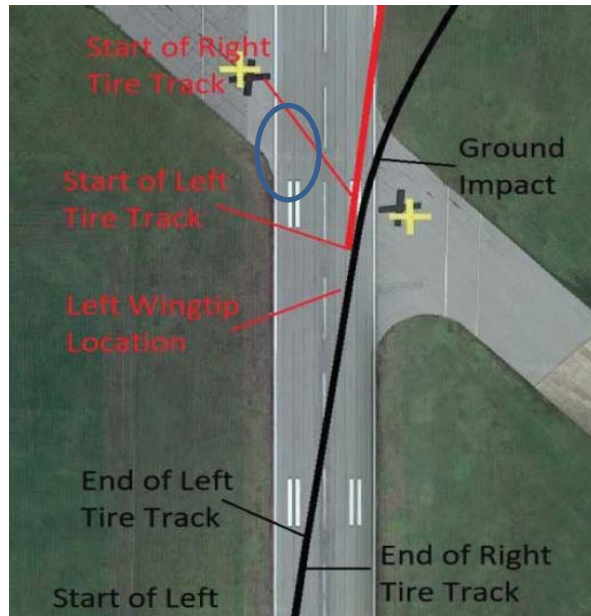
(Figure 15)

During AIB interviews, Vance AFB T-38C Instructor Pilots (IPs) reported a known “bump” on the left side of Runway 35C that can be felt during takeoff roll (Tab V-1.7 and V-2.5). This minor undulation appears to be at the junction of a previously decommissioned and partially removed taxiway approximately 2200 feet from the approach end of Runway 35C (Figure 15 blue circle) (Tab W-3 and W-4). The bump is further down the runway than either aircrafts’ track.

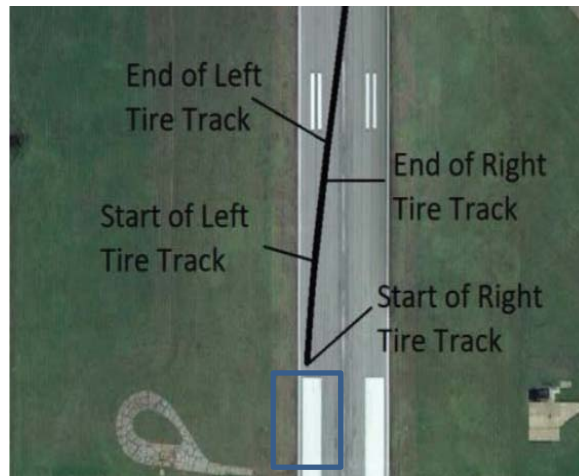
(Figure 16)

Additionally, the 71st Operations Group (71 OG) issued Flight/Crew Information File (FCIF) 19-074 on 4 December 2019 in reference to “a significant crack on Runway 35C” (Figure 16 blue rectangle) (Tabs V-9.5, W-3, and Z-14 to Z-15). Post mishap analysis of tire marks left by MA1 and MA2 showed that neither aircraft touched down until they were past the crack (Tab W-3 and W-4). Additionally, the angle of the tire marks from MA1 is inconsistent with landing in the crack (Tab W-3). Post mishap interviews and HUD review indicated Runway 35C conditions did not affect planning or execution of the MS by the MC (Tab V-1.7 and V-5.7).

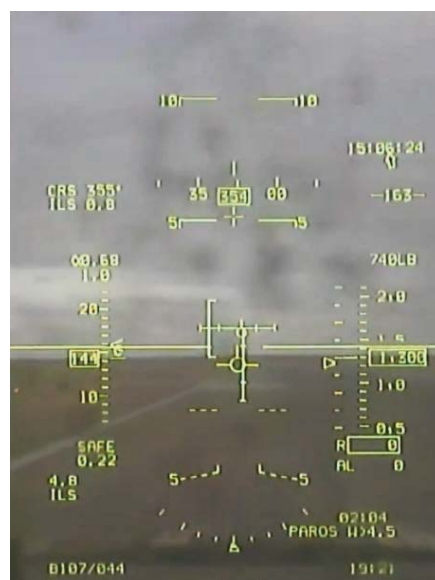
(Figure 1)

MA1 touched down one second after MA2, within one knot of planned landing speed. At touchdown, MA1’s left main tire was approximately 15 feet from the left edge of the runway (Figure 1). Immediately following touchdown, the preponderance of the evidence indicates MSP1 prematurely initiated an aerobrake in an effort to fall behind MA2 before MA2 began its own aerobrake. MA1 retained sufficient airspeed to lift slightly off the runway as MSP1 pulled back on the stick to raise the nose. Less than one second later, noting his close proximity to the left edge of the prepared surface, MSP1 applied right rudder to steer towards the runway centerline.
