**UNITED STATES AIR FORCE**  
**AIRCRAFT ACCIDENT INVESTIGATION**  
**BOARD REPORT**

**F-16CM, T/N 94-0043**

**77TH FIGHTER SQUADRON  
20TH FIGHTER WING  
SHAW AIR FORCE BASE, SOUTH CAROLINA**

**DATE OF ACCIDENT: 30 June 2020**

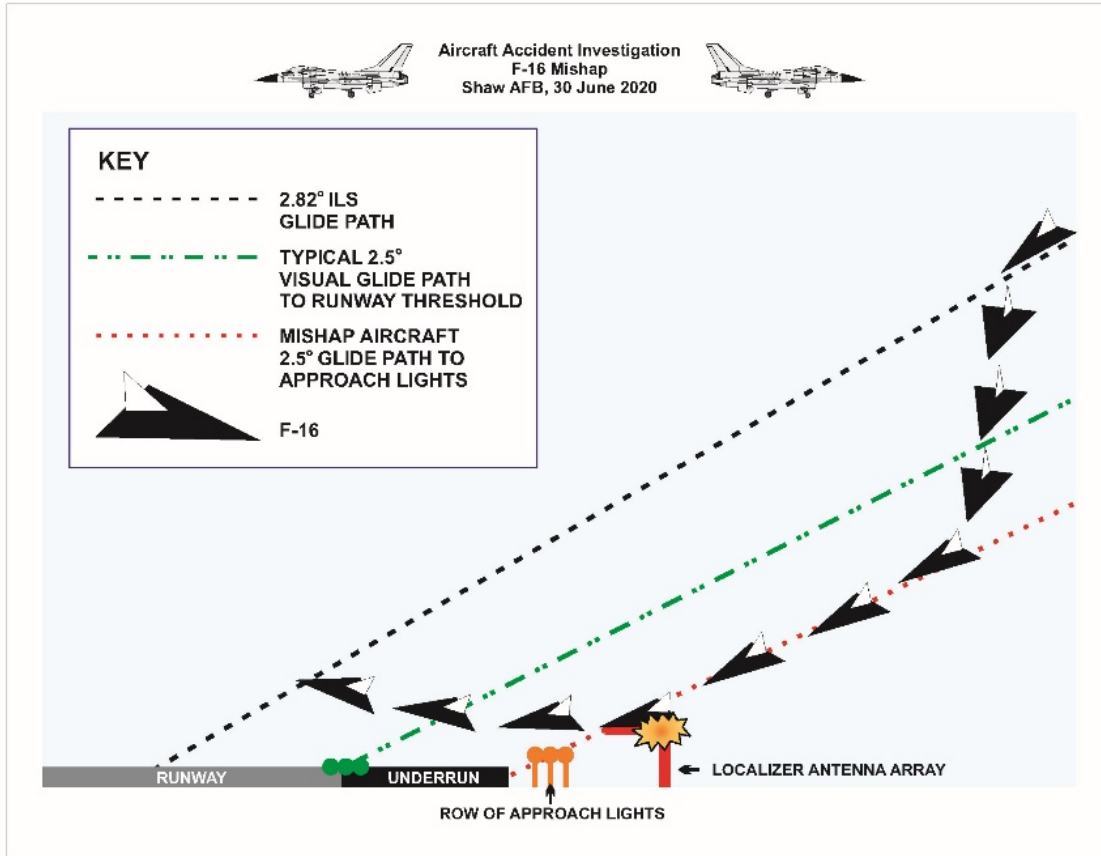
Figure 4: ILS glidepath, Intended glidepath, and MP glidepath (Tab Z-3)

Approximately 1.8 nm from the runway, the MP was established on course with both the localizer and glide slope signals (Tab FF-3). At that point, the MP steepened his descent from the 2.82-degree electronic ILS glideslope to a 4.5-degree descent in order to intercept a 2.5-degree approach using visual cues to land (Tab FF-3). This maneuver is typical, but a pilot should set their aimpoint on or just beyond the green threshold lights, and the MP erroneously set his aimpoint to land at the 1000 FT Light Bar, which is 1,000 feet short of the runway threshold (Tabs BB-100 to BB-101 and FF-3). At approximately 1.8 nm from the runway, the PAPI lights are clearly visible in the MA's Heads-Up Display (HUD) (Tab FF-3). As the MP flew toward the 1000 FT Light Bar, the vertical ILS guidance indicated that he was well below the glide path, and the visual guidance of the PAPIs would have also indicated the MP was well below glide path (Tabs BB-100 and FF-3). The MP did not "declutter" his HUD display, which left aircraft symbology superimposed over the runway environment, and would have made the landing slightly more challenging (Tabs BB-101 and FF-3). The remainder of the MP's approach was stable (attitude, airspeed, and angle of attack were all normal) (Tabs BB-98 to BB-101 and FF-3).

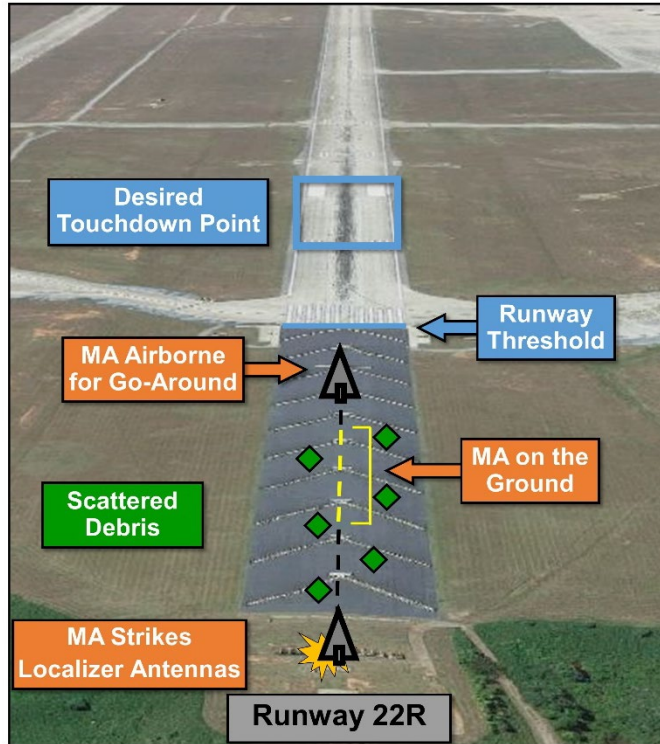
Figure 5: Mishap Aircraft initial landing (Tab Z-2)

At 2226:49L, as the MP began his flare to land, still aiming 1,000 feet before the threshold, the MA's left and right main landing gear (MLG) impacted the two inner-most localizer antennas while traveling at 165 knots (Tabs J-20 to J-21, J-42, and FF-3 to FF-4). The impact damaged the left MLG, rotated the wheel perpendicular to the direction of travel, split hydraulic lines creating a System B hydraulic failure, and severed the left drag brace's front mount from the aircraft body and left it hanging by the rear mount, which was still attached to the wheel (Tabs J-21, J-43, and AA-45). After impacting the localizer antennas, the MP initiated a go-around, but the MA briefly touched down in the underrun, remaining on the ground for approximately 330 feet, and lifting back into the air approximately 470 feet prior to the beginning of runway 22R (Tab J-21).

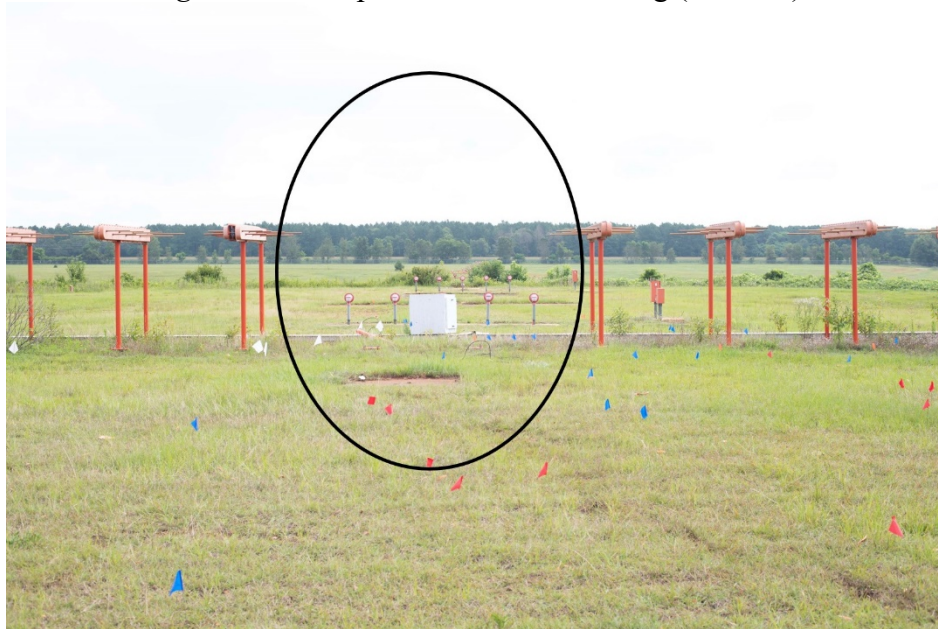
Figure 6: Two missing localizer antennas at the approach end of runway 22R (Tab Z-7)

Due to damage caused to the 04L localizer antennas by the MA (located at the beginning of runway 22R), vertical guidance was not available, and the MP executed a visual approach to 04L (Tabs V-2.4 and AA-67).

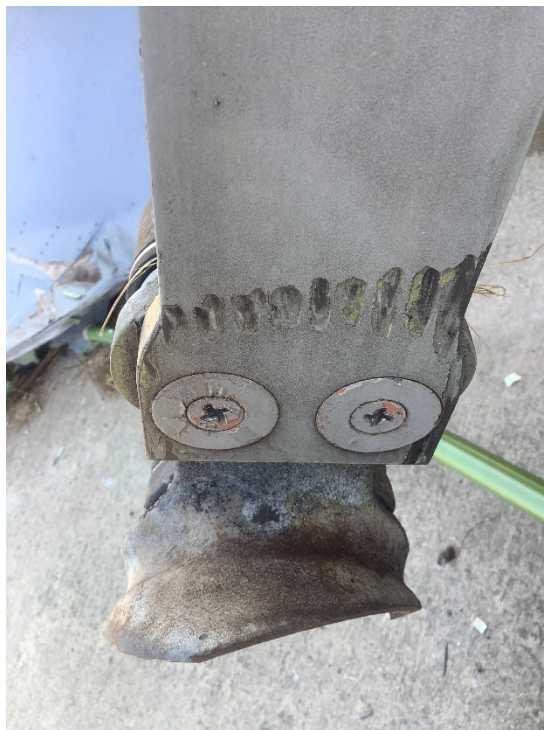
*Figure 9: Cable impact marks on hook shank (Tab Z-12)*

may break prematurely, allowing the hook to pivot to one side before contacting the cable, which would in turn cause the hook to not contact the cable directly perpendicular (Tab J-49 to J-50). The F-16CM flight manual includes a caution to lower the hook while wings level to prevent failure of the bolt, which the MP did properly, but the bolt may have sheared before touchdown, as the aircraft approached the cable, or during the subsequent crash (Tabs J-49 to J-50 and FF-4).

(2) The hook requires some distance between landing on the runway and contacting the cable to stabilize along the ground and “present” itself to the cable (Tab J-50 to J-51). While the MA touched down in excess of the recommended distance, the crash survivable flight data recorder (CSFDR) reported several cycles of the right MLG carrying the weight of the MA, indicating that the aircraft was possibly not stabilized as it approached the cable (Tabs J-50 to J-51 and L-10).

(3) The damaged left MLG may have disturbed the cable as it passed over it in such a way that the hook was no longer properly positioned to engage it (Tab J-51). Data is unavailable to model the likely effects on the cable since there are no known approach-end cable arrestments with damaged and hanging main landing gear components (Tab J-51).

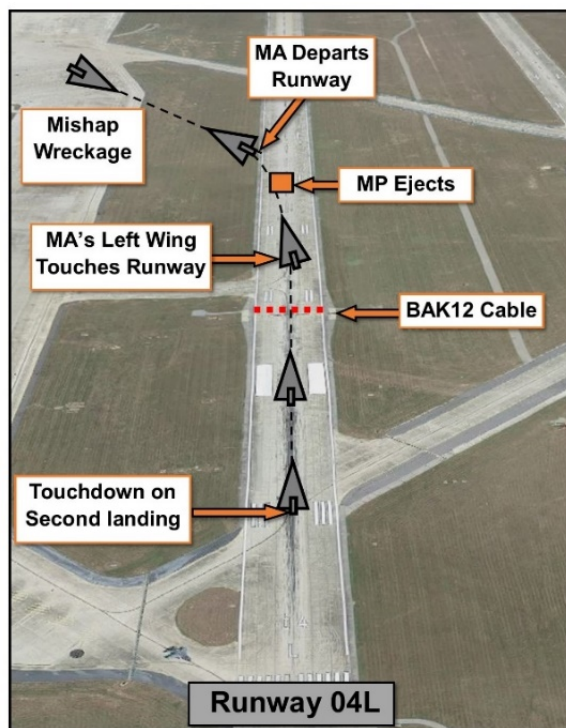
Figure 10: MA ground track on second landing (Tab Z-6)

At 4.5 seconds after touchdown, after traveling approximately 1,108 feet and at 138 knots ground speed, the MA rolled to 14 degrees left bank, indicating the left main gear had failed to support the weight of the aircraft and the left wing had contacted the runway, and the MP commanded full right roll (Tabs J-27 to J-28, J-32, J-43, L-10, and FF-6). Over the next 1.5 seconds, the MA began to drift to the left, and the MP momentarily commanded full nose up while increasing the throttle to afterburner (Tabs J-32 to J-33 and FF-6). The MP then stopped providing flight control inputs to the MA as he activated his ejection seat (Tabs J-33 and FF-6).

The MA continued veering to the left, departed the runway into the grass infield, flipped nose-over-tail, and came to rest upside-down in a large parking apron area (Tab J-23 to J-24).

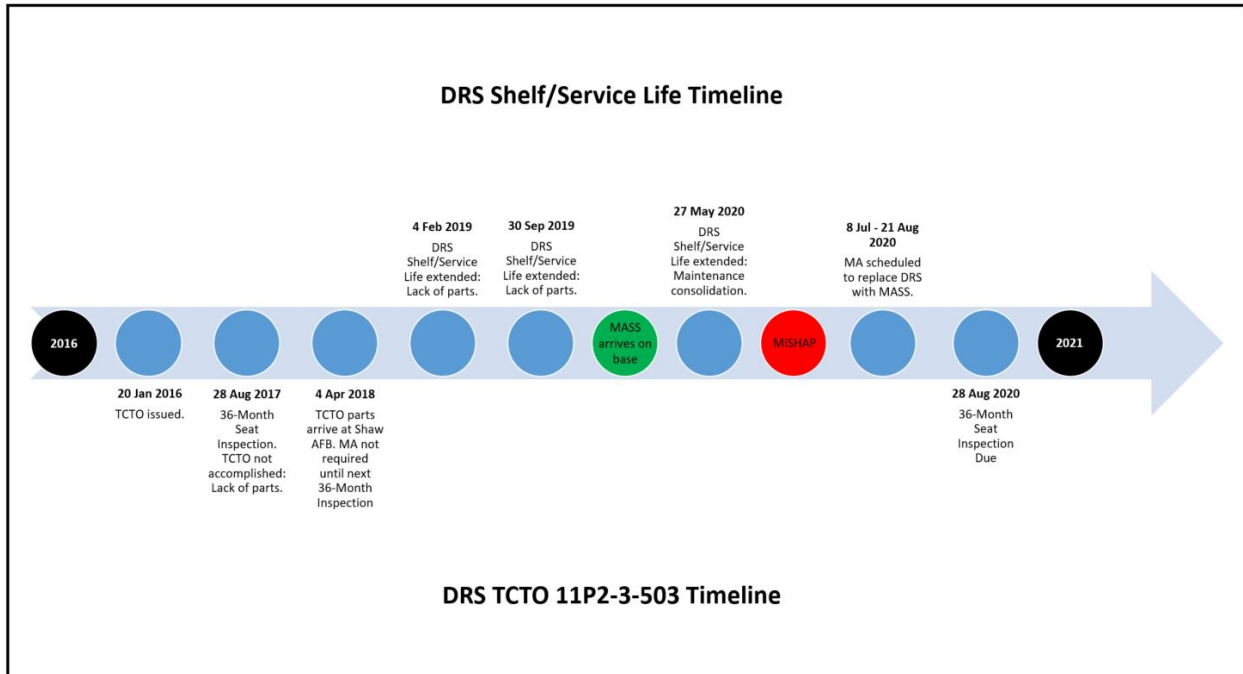
Figure 13: DRS Timeline (Tabs U-69 to 73, U-77 to U-79, U-82, U-87 to U-98, U-99, and Z-15)

There were two related maintenance issues with the MA and the first was that Time Compliance Technical Order (TCTO) 11P2-3-502 (Installation of Shorting Plug on the DRS Electronic Module) was not completed on the MA prior to the mishap (Tabs J-13 and U-82). The shorting plug was designed to prevent noise bias issues observed in channel three of the three-channel system on the DRS (Tabs J-13 and V-18.1 to V-18.2). Two of the three channels must be in agreement for the DRS to function properly (Tabs J-13 and V-18.1 to V-18.2). DRS failure due to channel three noise bias issues have been observed in approximately 9% of all live ejections and sled tests (Tab J-13). TCTO 11P2-3-502 was issued on 20 January 2016 and was to be accomplished during the next scheduled 36-month ejection seat inspection (Tab U-99). The first opportunity to accomplish this TCTO was on 28 August 2017, but was not accomplished due to a lack of available parts (Tab U-99). The TCTO requirement was automatically deferred to the next 36-month seat inspection, which was 28 August 2020 (Tab U-99).

The MA's second maintenance issue was regarding the DRS 10-year shelf/service life which expired as of 28 February 2019; however, the DRS received three temporary shelf/service life extensions approved by the Air Force Life Cycle Management Center (AFLCMC) (Tab U-69 to U-73 and U-77). The first extension was approved on 4 February 2019 due to a lack of available parts, which provided a shelf/service life extension through 30 September 2019 (Tab U-87 to U-92). The second extension was approved on 26 September 2019 due to a lack of available parts, which provided a shelf/service life extension through 30 June 2020 (Tab U-93 to U-98). Once parts became available, the third and final extension was approved on 27 May 2020 for maintenance consolidation efforts, which provided a shelf/service life extension through 31 July 2020 (Tab U-69 to U-73). The MA's DRS was scheduled to be replaced with an upgraded seat sequencer, Modernized ACES II Seat Sequencer (MASS), while the MA was scheduled down for cannibalization maintenance from 8 July 2020 to 21 August 2020 (Tab U-69 to U-73). Installation of the new MASS would negate the required compliance with TCTO 11P2-3-502 (U-81).

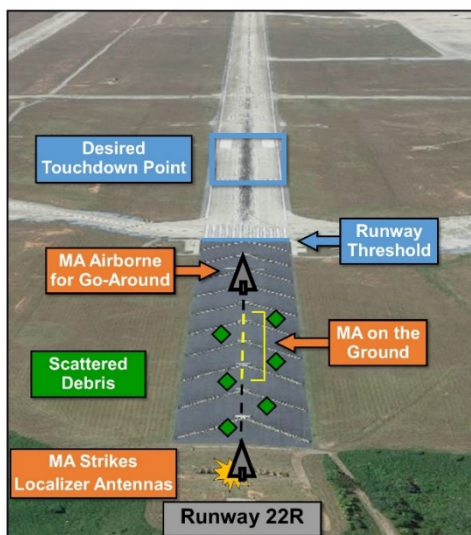
Figure 1: Mishap Aircraft Initial Landing

The mishap flight was planned as a 4-ship night MQT suppression of enemy air defenses mission with pre-strike air-to-air refueling (AAR) from a KC-135 Stratotanker. The first three F-16s of the mishap flight, which included the mishap flight lead (MFL), mishap wingman (MWG), and mishap element lead (MEL) refueled without incident, but the MP was unsuccessful. Therefore, the MEL and MP returned to Shaw AFB due to the MA's lower fuel state and flew the instrument recovery procedure for runway 22R. During the final phase of landing the MA struck the localizer antenna array short of the runway threshold, severely damaging the left main landing gear and hydraulic system. After briefly touching down in the underrun, the MP executed a go-around and alerted the MEL and air traffic control (ATC) personnel of the situation.

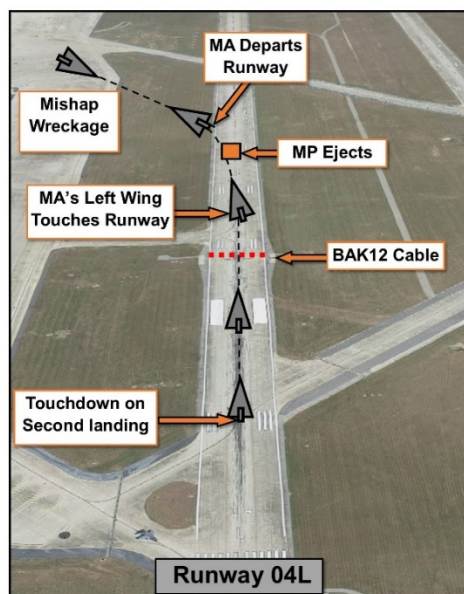
Figure 2: Mishap Aircraft on second landing

An approach-end cable arrestment on runway 04L was attempted following more than twenty minutes of discussion. During the maneuver, the MA tail hook did not catch the cable and the left wing fell to the runway, dragging the aircraft to the left. The MP initiated an ejection, but the ejection seat malfunctioned and the parachute did not deploy. The MP was fatally injured and the MA was destroyed.

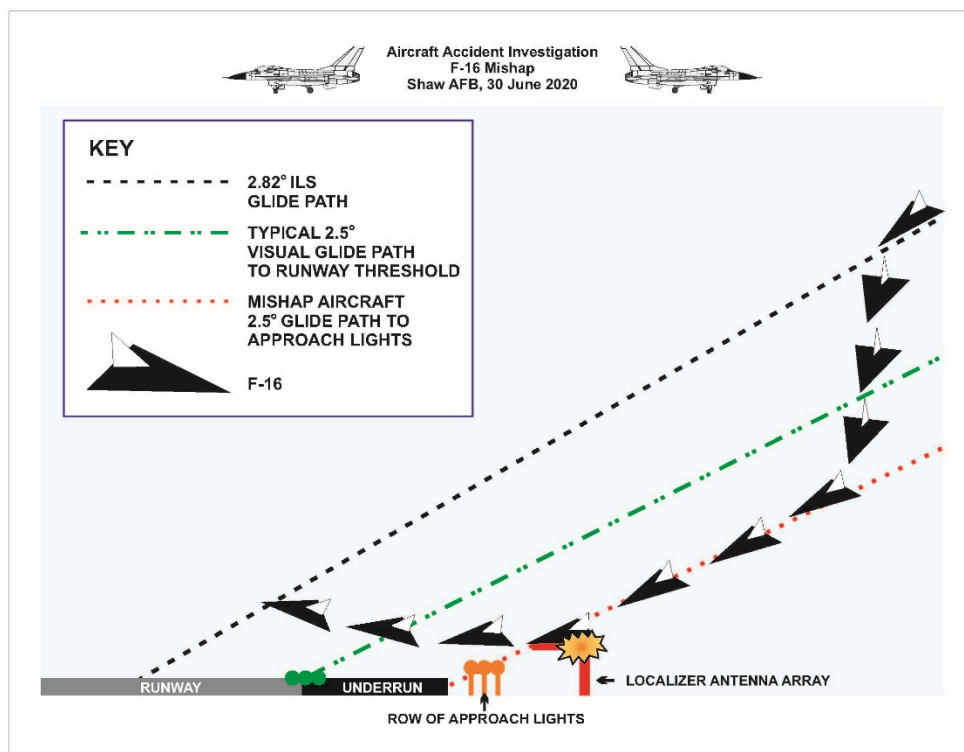
Figure 3: ILS glidepath, Intended glidepath, and MP glidepath

I find by a preponderance of evidence the cause of the mishap was the MP's failure to correctly interpret the ALS and identify the runway threshold during his first landing attempt, which resulted in severely damaged landing gear. Evidence also indicates the MP was not fully engaged on the challenges of flying a night instrument approach due to his unsuccessful attempt to conduct his first ever AAR at night, which is not allowed by Air Force regulations.

On the night of the mishap, all airfield systems were in good working order, to include the procedure known as the Instrument Landing System (ILS) Y 22R, all approach lights, runway identification lights, and the precision approach path indicator (PAPI) lighting system. Based on the cloud ceiling being above 3,000 feet above ground level (AGL) and visibility greater than 10 statute miles (sm), the MA was in visual meteorological conditions during the entire approach. The MP successfully followed the ILS Y 22R, to a point where the MA was on course, on glide path, and the ALS was visible in the MA's Heads-Up Display (HUD). In this case, the ALS and PAPI were identifiable in the HUD at approximately 2 nm. From this point, the MP flew a normal approach, but he mistook the 1000 FT Light Bar for the runway threshold lights, resulting in the MA striking the ILS antennas located 1,076 feet before the runway threshold. Immediately after striking the antennas, the MP executed a go-around and relayed to the MEL and ATC personnel that he "landed short."
