**UNITED STATES AIR FORCE**  
**AIRCRAFT ACCIDENT INVESTIGATION**  
**BOARD REPORT**

**F-16C, T/N 86-0317**

**176TH FIGHTER SQUADRON**  
**115TH FIGHTER WING**  
**TRUAX FIELD AIR NATIONAL GUARD BASE, WISCONSIN**

**DATE OF ACCIDENT: 8 DECEMBER 2020**

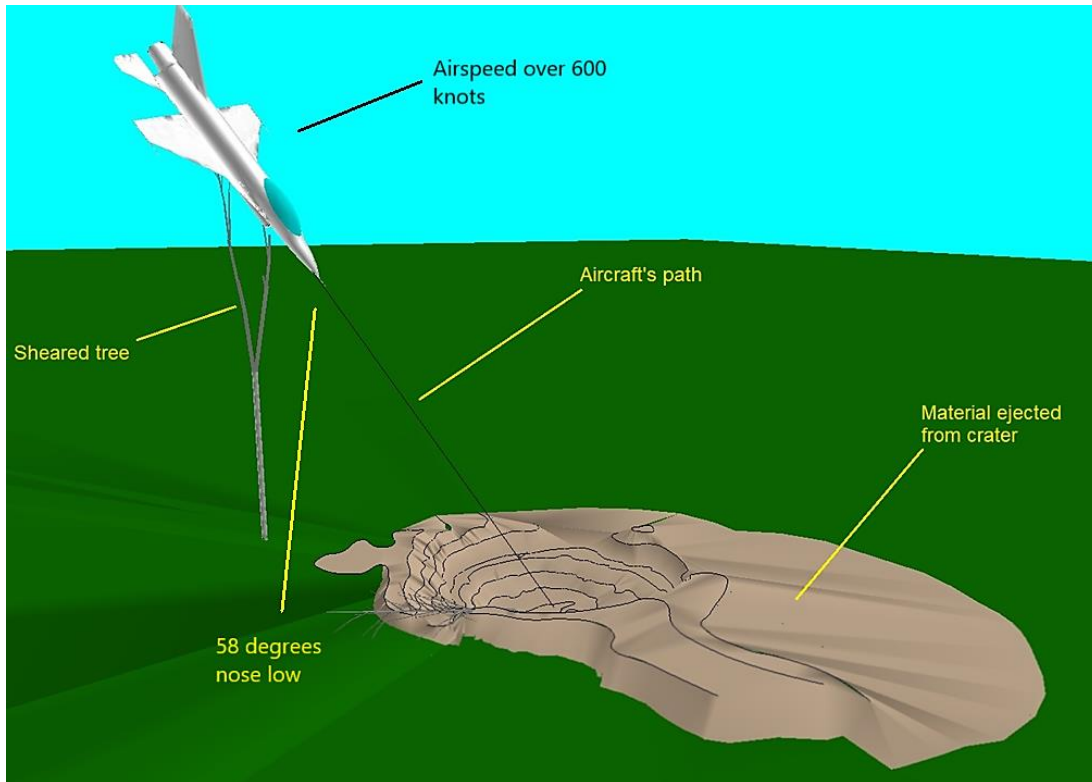
Figure 3: Recreation of MA at Impact (Tab T-27)

The MA impacted the ground in Hiawatha National Forest at 19:17:37L (Tab T-42). The MP did not attempt to eject (Tab J-14). At the time of impact, the MA was approximately 58 degrees nose low, with over 20 degrees of right bank, heading 205 degrees, and traveling over 600 kts (Tabs T-21 to T-38 and T-42). The MA terminated with controlled flight into terrain (Tabs J-14 and T-27). Controlled flight into terrain is described as unintentional flight into the ground and typically the pilot is unaware of the impending impact (Tab J-14). Subject matter expert (SME) analysis revealed the MA's nose and right wing tip both struck the ground, leaving recognizable cratering (Tab T-25). Tree shearing at the mishap site verified the steep AOA and heading at impact (Tabs T-21 to T-38). The impact destroyed the MA, and the MP suffered fatal injuries (Tabs J-14 and O-2 to O-3).

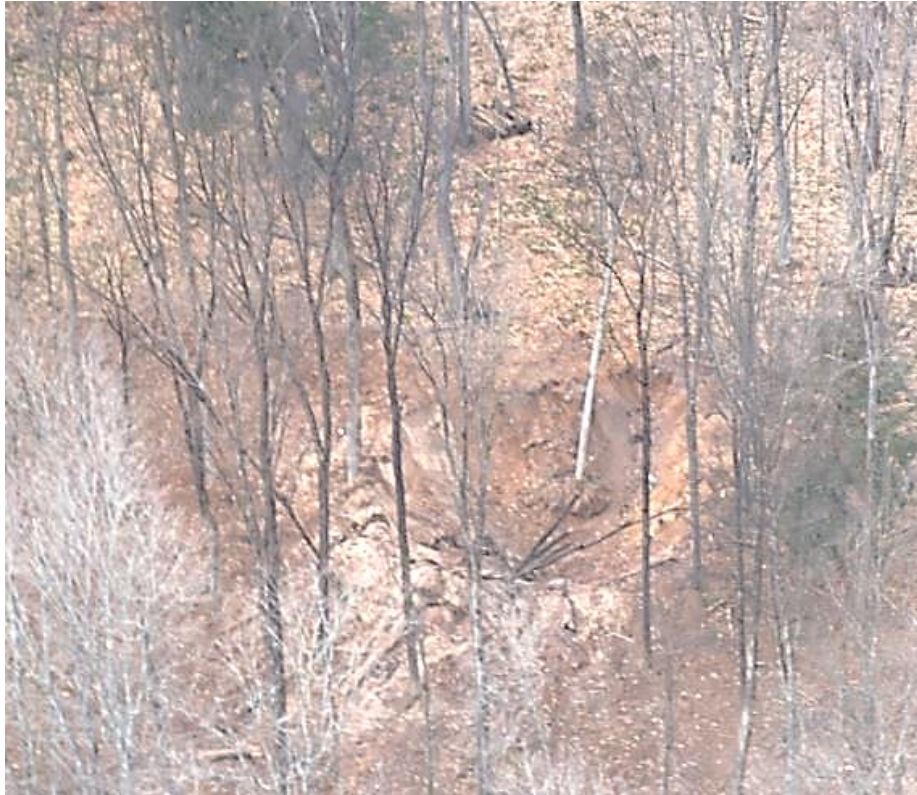
*Figure 4: Overhead View of Mishap Site (Tab S-6)*

Impact with the ground at Hiawatha National Park caused total destruction of the MA (Tabs S-6 and T-42). Initial investigators recovered fragmented parts and secured them for analysis (Tabs J-2 to J-14).

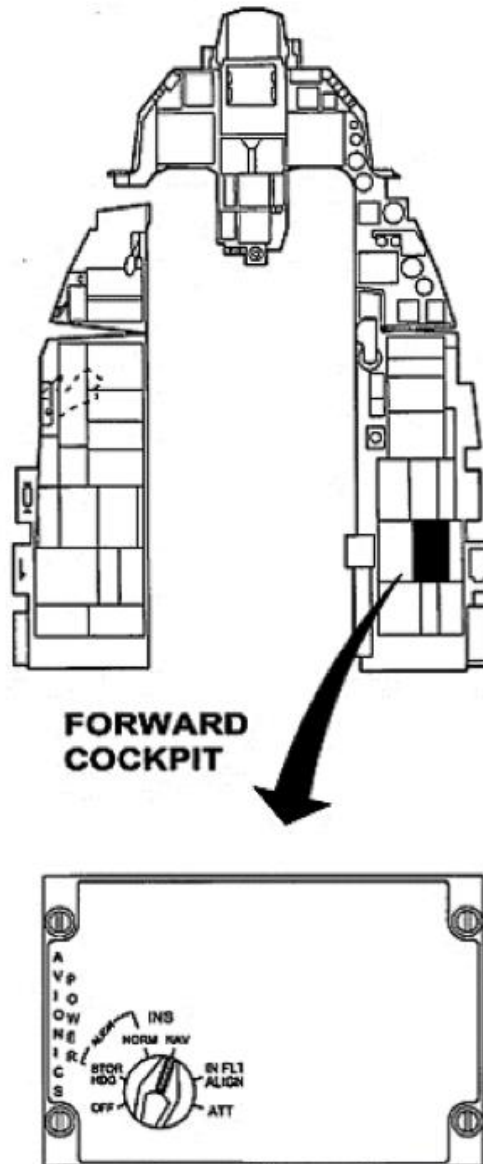
Figure 7: Visual Depiction of INS Switch (Tab X-13)

Figure 7 (below) shows the OFF and INFLT ALIGN positions on the INS knob (Tab X-13).

Due to the destruction of the MA, it cannot be determined how long the MP left the INS knob in OFF and how that would affect the IFA (Tabs T-16 to T-17). Communications confirm, after placing the INS knob to INFLT ALIGN, the MP observed attitude, airspeed, and altitude indications in the PFD (Tab T-41). The MP also confirmed the HUD had no FPM or attitude indications (Tab T-41). The destruction of the MA prevented an assessment of how long it took the MP to regain primary flight instruments in the PFD (Tab T-41).

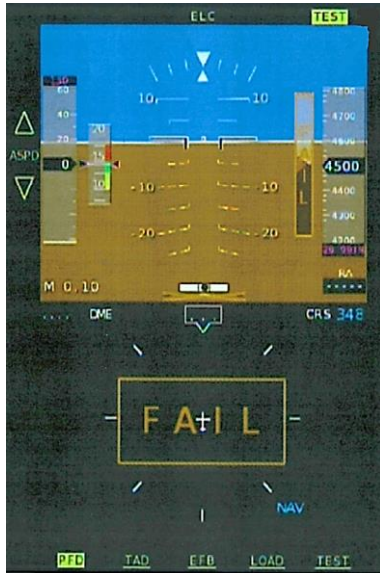
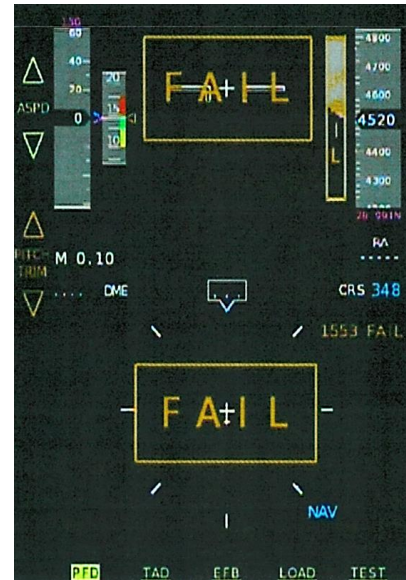
Figure 8: Simulated PFD and HUD in INS INFLT ALIGN Position with GPS NTRK (Tab T-17)

The EGI system was not recovered intact, leaving it unknown what position the MA's INS switch was placed in during the mishap event (Tab T-41). Figure 8 (below) provides a simulation of the cockpit displays when the INS is in the INFLT ALIGN position prior to a completed alignment (Tabs T-15 to T-19). Figure 9 (below) provides a simulation of the cockpit displays when the INS is in the OFF position (Tabs T-17 to T-18). In either switch position (OFF or INFLT ALIGN), primary flight data available to the MP is reduced (Tab T-17).

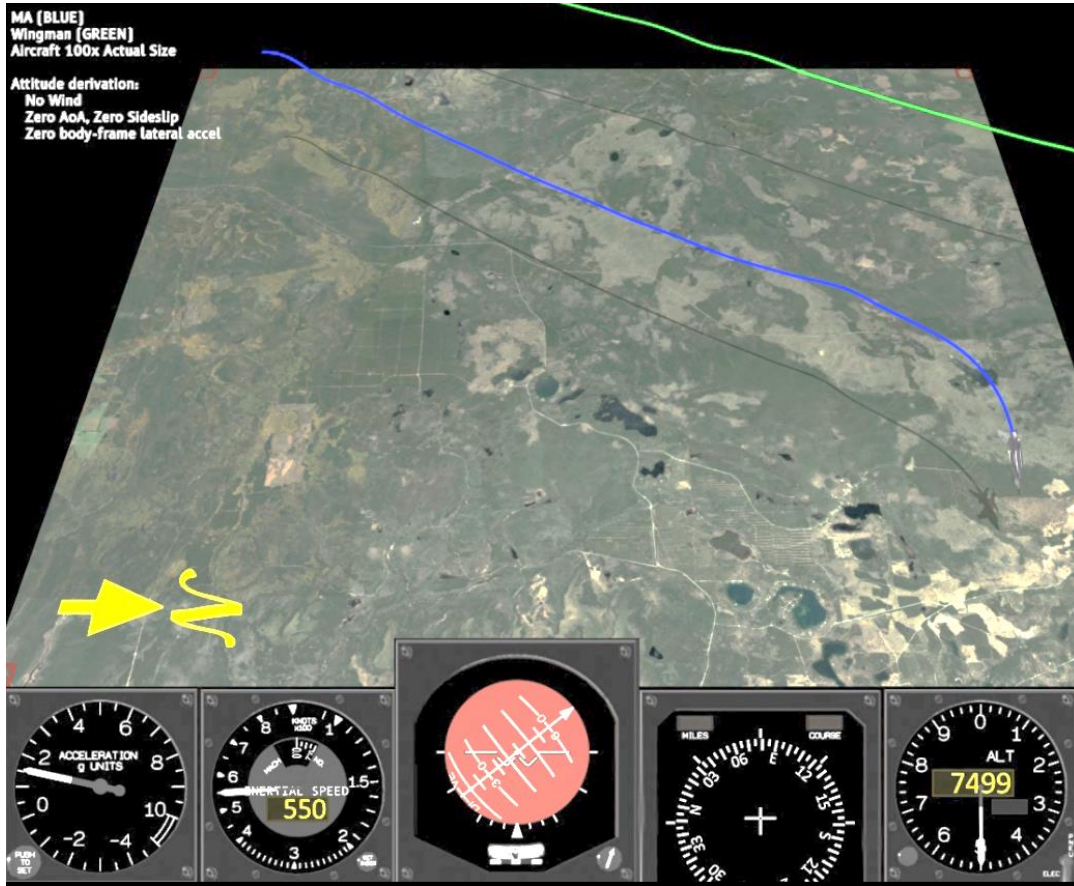
Figure 10: Simulated Flight Path (Tab T-42)

Recreation of the mishap event showed the MA at one point in a 45 degree descent at 7,500 ft MSL and 550 kts (Tab T-42). According to TO 1F-16C-1, *Dive Recovery Chart*, had the MP

recognized the unusual attitude and immediately initiated a wings level, high G pull to the horizon in idle thrust and speedbrakes fully extended, the MP would have recovered (Tab BB-4).

Recreation shows the MP pulling an estimated maximum of 4Gs (Tab T-42). Under the previously stated conditions, the MP's exertion of 4Gs would have increased the altitude lost in the recovery (Tab BB-4). Due to a lack of recoverable evidence, the MP's thrust and speedbrake settings are unknown throughout the mishap event (Tab T-42). However, at speeds above 350 kts, thrust settings above idle will generally increase the altitude required to recover (Tab BB-26). Additionally, recreation shows the MA continued in an increasingly steeper dive, up to about 90 degrees, and the MA's airspeed increased to over 600 kts (Tab T-42). These conditions would exponentially increase the altitude lost during an attempted recovery (Tab BB-4).

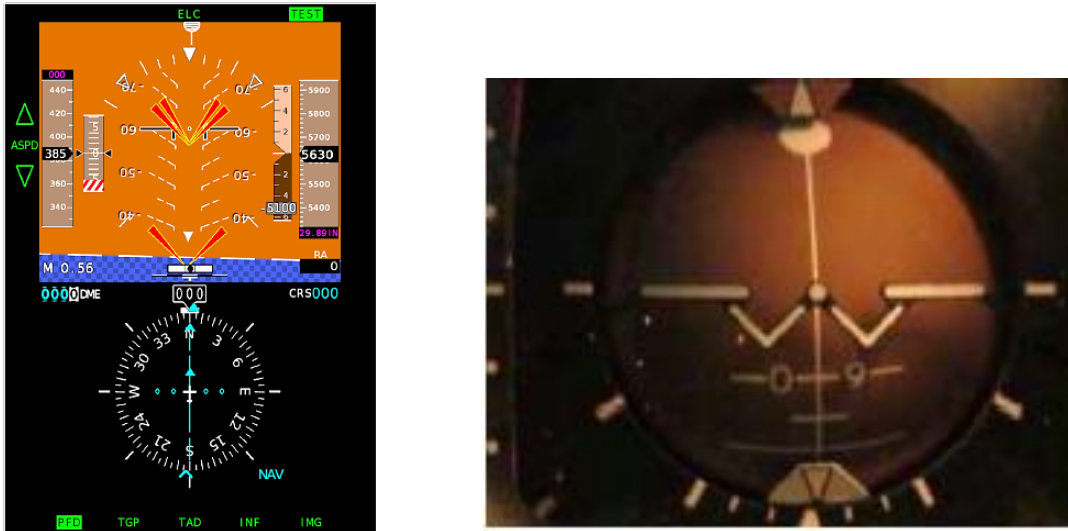
Figure 11: PFD and Standby ADI in Steep Dive with INS INFLT ALIGN (Tabs T-15 and T-20)

In an extreme unusual attitude with complete flight instruments available to the pilot in the PFD, two chevrons appear on the PFD to provide the pilot another visual cue the aircraft is in a steep climb or dive (Tabs BB-10 to BB-11). Additionally, a dashed horizon line is presented at the edges of the PFD to aid the pilot in recovering toward the horizon (Tab T-15). This is in contrast to the standby ADI, which is the basic instrument always available to the MP (Tabs T-16 to T-17). What was displayed to the MP in the PFD at the time of the mishap cannot be established (Tab T-43). Nonetheless, if attitude information was displayed to the MP, the chevrons would have appeared

in an indicated steep dive (Tab T-15). Prior to the mishap event and confirmed through radio communications, the MP verified the standby ADI was available (Tab T-40). Figure 11 (below) depicts a PFD and standby ADI in a steep dive, similar to what the MP may have encountered if the INS was in the INFLT ALIGN position with attitude information present in the PFD (Tabs T-15 and T-20). Figure 12 (below) depicts a PFD and standby ADI in a steep dive, similar to what the MP would have encountered if the INS was in the OFF position (Tabs T-18 and T-20).

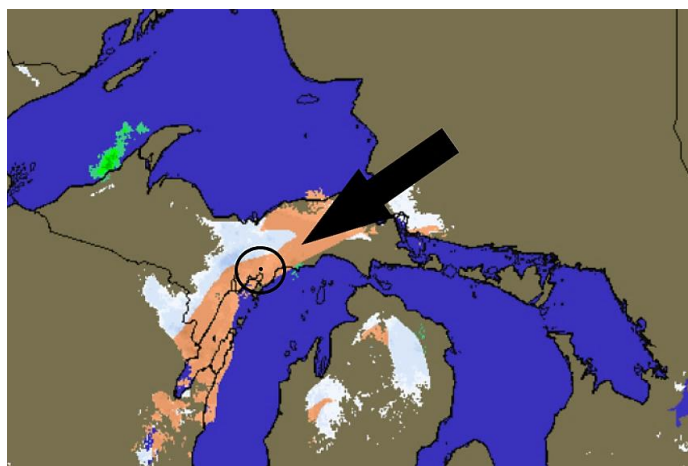
Figure 14: Local Precipitation at 18:20L (Tab F-7)

Illumination conditions at Hiawatha National Forest were low (Tab F-8). Further, the areas surrounding Hiawatha National Forest experienced moderate rain and light snow (Tab F-7). Figure 14 (below) shows the precipitation in the areas surrounding the mishap site (Tab F-7).

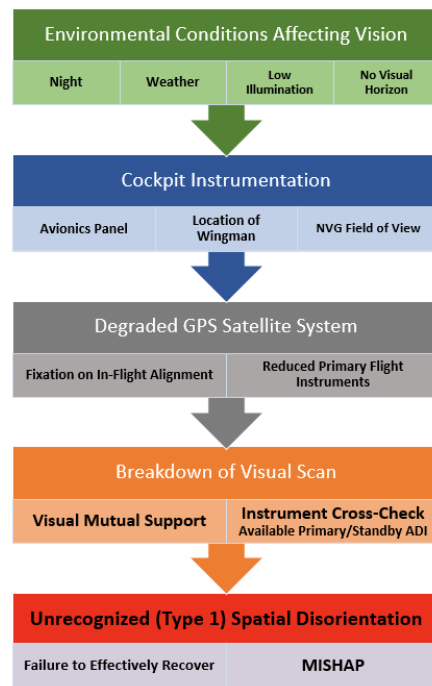
Figure 18: Mishap Critical Point Progression (Tab Y-56)

In addition to these sensory illusions, the MP likely experienced a visual illusion (a false horizon), further preconditioning the outcome of spatial disorientation (Tab Y-50). Pilots rely heavily on visual cues during flight, rather than nonvisual orientation signals (Tab Y-50). This is termed visual field dependence (Tab Y-50). The MP's exposure to this greater potential for visual field dependence and visual illusion, in conjunction with entering worsening weather, increased darkness of the outside environment, vestibular illusions, degraded instruments, and fixation may have led to a breakdown of visual scan culminating in unrecognized spatial disorientation (Tab Y-16).

The MP's actions are consistent with an individual experiencing unrecognized spatial disorientation (Type 1) (Tab Y-16).
