**UNITED STATES AIR FORCE**  
**GROUND ACCIDENT INVESTIGATION**  
**BOARD REPORT**

**Polaris Ranger Model 800 Crew All-Terrain Utility Vehicle**  
**VIN: 4XAWH76A8D2707361**

**386TH EXPEDITIONARY LOGISTICS READINESS SQUADRON**  
**386TH AIR EXPEDITIONARY WING**  
**ALI AL SALEM AIR BASE, KUWAIT**

**TYPE OF ACCIDENT: Motor Vehicle Fatality**

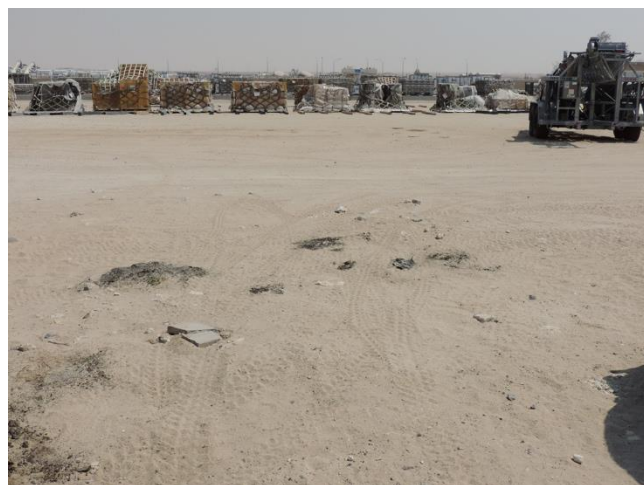
When the MVO initially started the MV, the MVO pulled out of where the MV was parked, turned right and "opened up" as the MV traveled south down a straightaway section of the lot until reaching the south end where the mishap occurred (Tab R-160, R-164, R-182, and R-184).

**Figure 7 – MV's Tracks Pulling out of Terminally Parked Location (Tab S-9)**

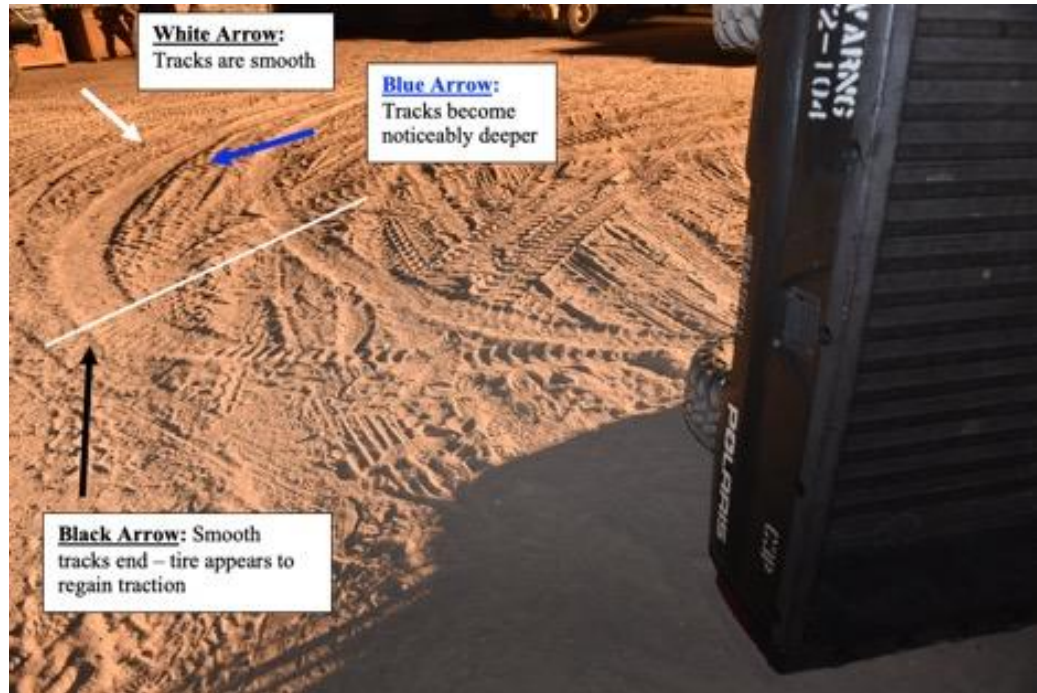
**Figure 10 – Depth and Smoothness of MV Tire Tracks (Tab Z-11)**

becoming smooth after executing approximately 90 degrees of the turn, which INV2 evaluated as the moment when danger was first detected by the MVO and likely when he slammed on the brakes and caused the vehicle to “drift” (note: drifting is when the rear tires swing out past the front tires of the vehicle and is caused by excessive speeding, braking, and turning all at the same time) (Tab V-24.6, V-24.16, and V-24.20 to V-24.21). In noting the depth of the tracks,

INV1 and INV2 also observed the abruptness of the angle of the turn being suggestive of a tight

and fast turn, especially for the type of vehicle being driven and the sand surface being driven on (Tab V-21.4 to V-21.5, V-24.10, and V-24.19). Multiple sources who observed the tracks on scene remarked on the apparent sharp nature of the turn that was being attempted (Tab V-16.5, V-18.3, V-20.9, V-21.4 to V-21.5, V-21.14 to V-21.15, V-23.4, V-24.10, V-24.20, V-25.4, V-28.4, and V-28.9). Approximately 120 degrees into the turn, there were no longer two tracks indicating a vehicle traveling on four (4) wheels, but instead only one set of tracks leading up to where the MV was resting on its passenger side (Tabs O-11, S-13, and Z-11). Based on the track measurements and tire marks, INV2 later calculated the speed of the MV to be between 25 and 35 mph (Tabs O-17, O-19, V-24.5, 24.10, and V-24.18). The speed limit in all areas near the cargo lot and the flight line was 5 mph (Tabs V-2.24, V-4.16, V-15.13, Z-13 and Z-15).

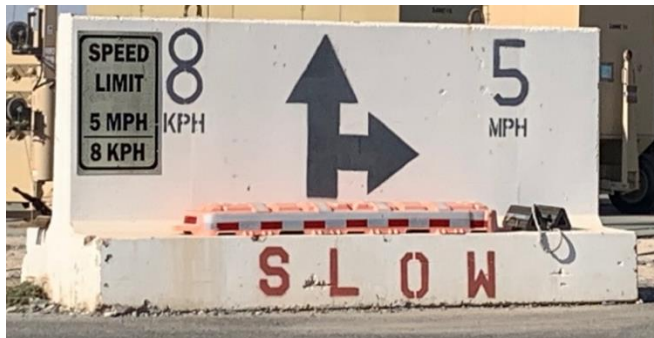
**Figure 11 – Speed Limit Sign in W Pad (Tab Z-13)**

In accordance with 386 AEWI 31-218, the speed limit on ASAB is 12 mph unless otherwise posted (Tab BB-46). In and around the 386 ELRS facilities, including W Pad, the posted speed limit is 5 mph (Tab Z-13 and Z-15). The Polaris Owner's Manual states operators should "never operate at excessive speeds. Always travel at a speed proper for the terrain, visibility and operating conditions, and your experience" (Tab BB-130). Additionally, the Owner's Manual states "always follow proper procedures for turning. Practice turning at slow speeds before attempting to turn at faster speeds. Never turn at excessive speeds" (Tab BB-130). The Owner's Manual also warns operators to "avoid sharp turns or turns while applying heavy throttle" (Tab BB-128). Lastly, operators should "reduce speed and use extreme caution when carrying passengers" (Tab BB-128). 386 AEWI 31-218 states the maximum speed limit for an OGMVC (i.e. a Polaris Ranger) is 25 mph, however, "drivers will obey all speed limits indicated in this instruction" (Tab BB-50). While calculations made by INV2 estimated the MV was traveling at a speed between 25 and 35 mph, the MVO also indicated he was traveling too fast for the turn and the terrain (Tabs O-13, O-15, R-139, V-24.5, V-24.10, V-24.18, and V-29.4).

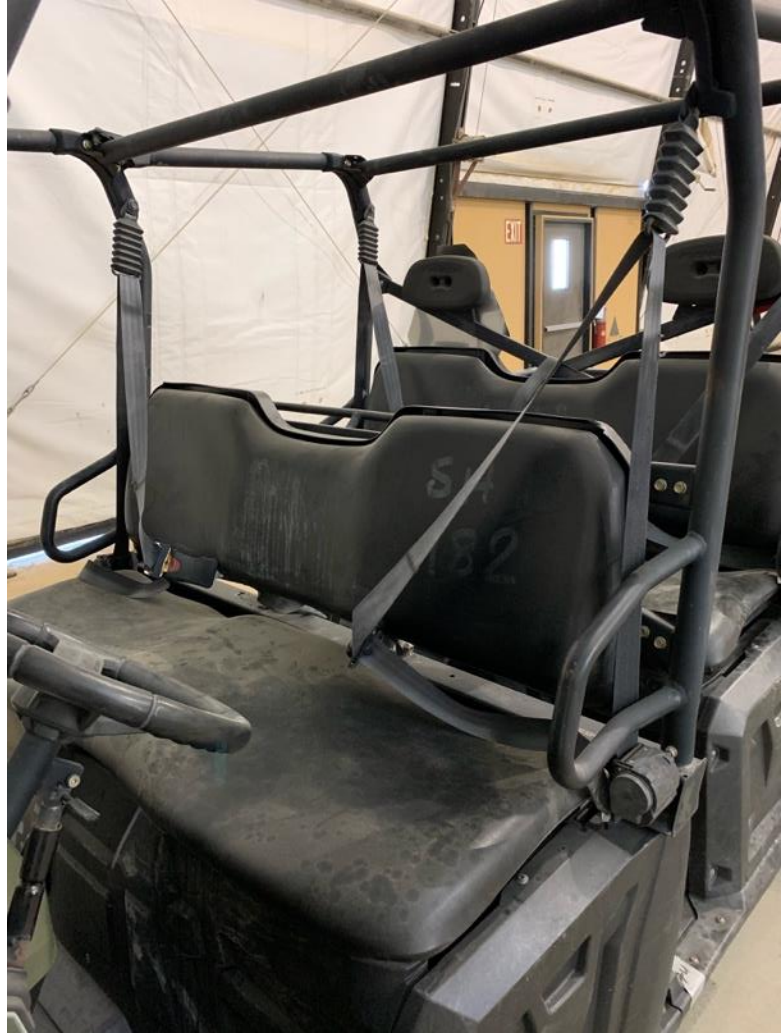
Both the MVO and the MA violated these regulations when they failed to wear their seatbelts (Tabs R-165, V-21.6, V-28.3, and DD-9). During inspection of the MV, the GAIB tested the seat belts to determine whether or not they were in working condition. Despite slight fraying in several locations on the seat belts, the

**Figure 18 – MV Post-Mishap with All Shoulder Straps Securely Fastened (Tab Z-27)**

GAIB was able to securely fasten all four (4) shoulder seatbelts on the MV (Tab Z-27 and Z-29). The Polaris Owner's Manual also states that "riding in this vehicle without using the cab nets increases the risk of serious injury or death in the event of an accident or overturn. Always use cab nets while riding in this vehicle." (Tab BB-131). There were no cab nets installed on the MV at the time of the mishap (Tab S-19).

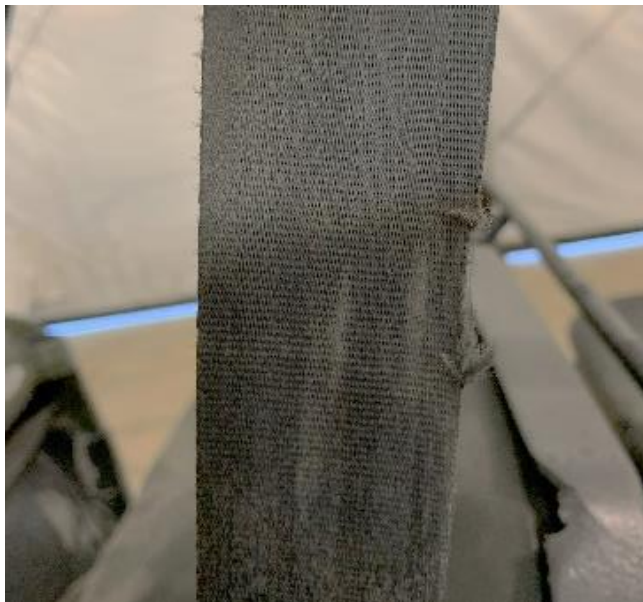
**Figure 19 – Fraying on MV Seatbelt (Tab Z-29)**
