UNITED STATES AIR FORCE
ABBREVIATED AIRCRAFT ACCIDENT INVESTIGATION
BOARD REPORT

MQ-9A, T/N 15-4295

**108th ATTACK SQUADRON
174th ATTACK WING
HANCOCK FIELD AIR NATIONAL GUARD BASE, NEW YORK**

DATE OF ACCIDENT: 25 JUNE 2020

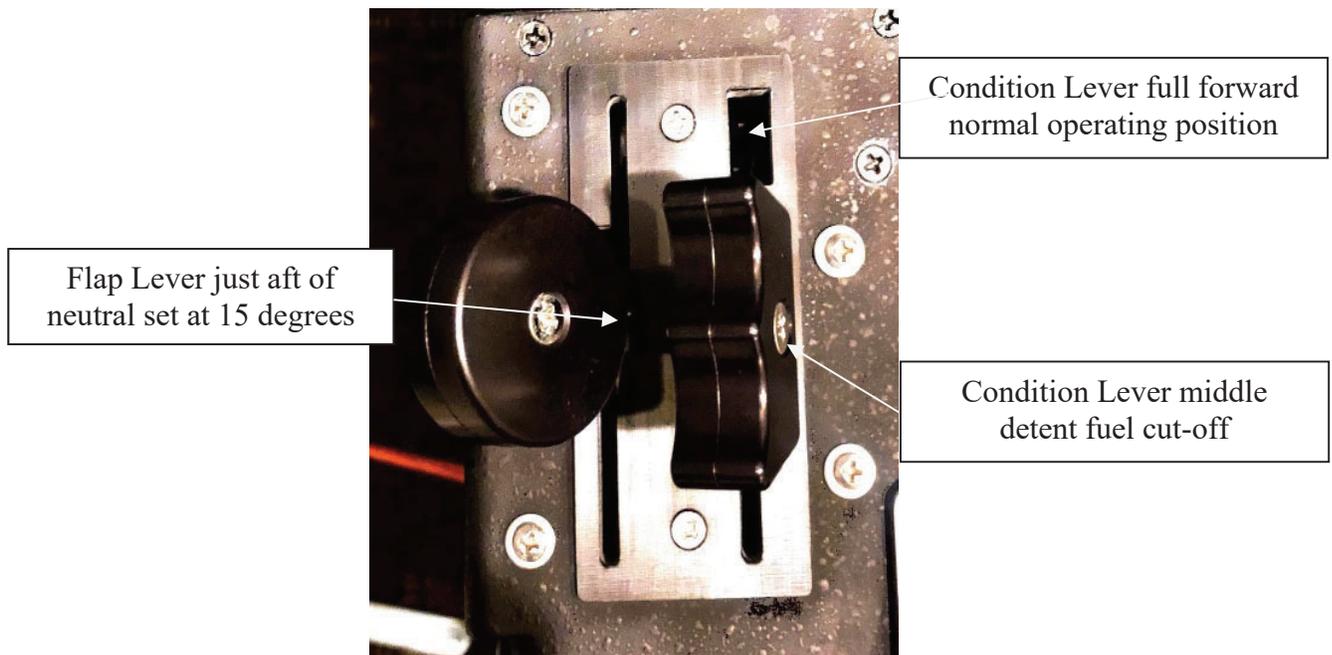
Figure 5. Flaps 15 and Condition Lever middle detent fuel cut off Example (Tab DD -10)

At 13:24:13Z the MP rotated the nose of the MA to put it into a climb attitude and began climbing out for departure (Tabs K-3, V-14.6, EE-5, and EE-8 to EE-9). The takeoff proceeded as normal up to about 150 feet AGL (Tabs K-3, V-12.1, V-14.5, EE-5, and EE-8 to EE-9). At about 150 feet Above Ground Level (AGL) the MC began running the after takeoff checklists (Tabs K-3, V-11.1, DD-3 to DD-4, EE-5, and EE-8 to EE-9). One of the after takeoff checklist steps calls for retraction of flaps from 15 degrees to 0 degrees by moving the Flap Lever forward to the middle neutral position, see figure 3 above (Tab DD-4). The MP pulled the Condition Lever aft or back to the middle detent position instead of moving the required Flap Lever forward to the neutral position (Tabs V-12.5 and EE-8 to EE-9). The MP's action resulted in the Condition Lever being in the middle detent position (fuel cutoff) and Flap Lever just aft or back of the neutral position leaving the Flaps at 15 degrees instead of the required 0 degrees, see figure 5 (Tabs V-12.5 DD-3 to DD-4, and EE-8 to EE-9).

At 13:24:21Z the “Check Condition Lever” warning message was displayed on the HUD when the MP pulled the Condition Lever aft or back to the middle detent position (Tabs K-3 and V-12.6). The “Check Condition Lever” warning message is designed to alert a crew if the Condition Lever

is not fully forward (Tab DD-4). The “Check Condition Lever” message on the HUD was not observed by either the MP or MSO (Tab V-11.1 and V-12.6). The recorded data also shows the Engine Revolutions Per Minute (RPM) rolling back at the same moment that the Condition Lever was pulled to the middle detent position (Tabs DD-3 and EE-8 to EE-9). Approximately 44 seconds after takeoff, the engine completely lost power as a result of the MP pulling the condition lever aft or back to the middle detent position, see figure 5 (Tabs K-3 and EE-8 to EE-9).

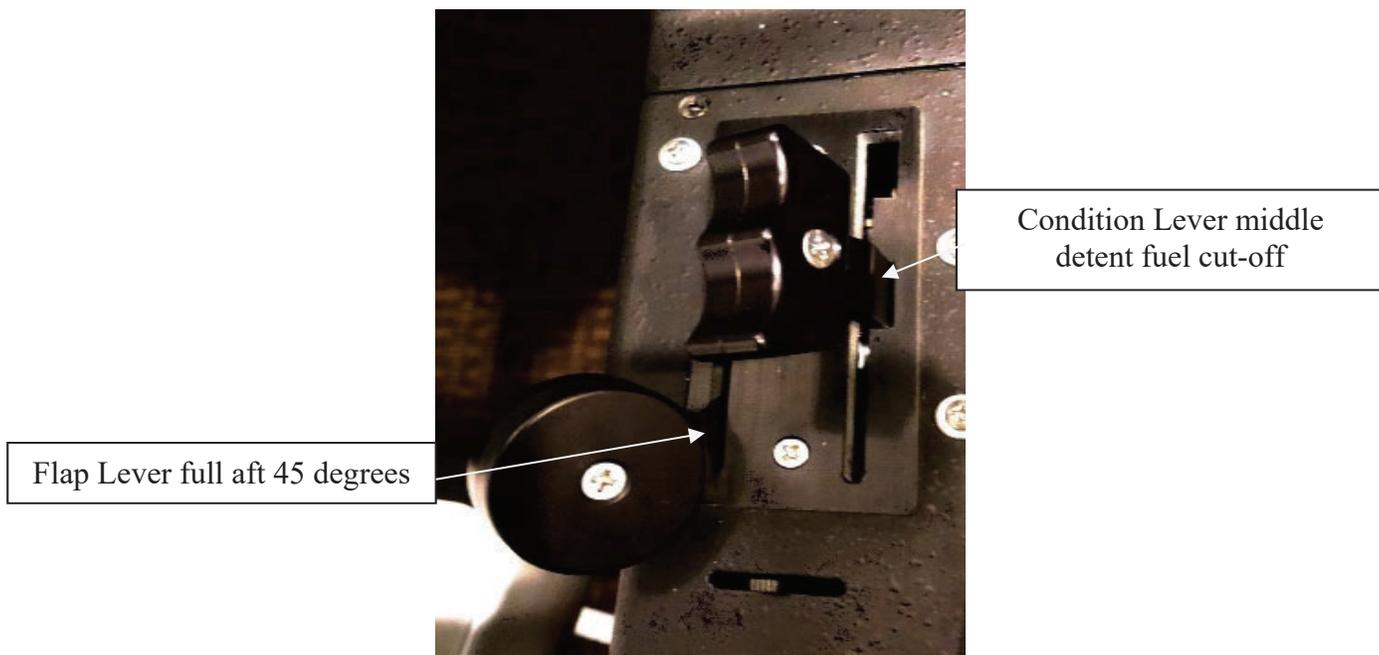
Figure 6. Flaps 45 degrees and Condition Lever middle detent fuel cut off Example (Tab DD -6)

At 13:24:25Z an “Engine Out Detected” warning message was displayed in addition to an audible warning (Tabs K-3 and V-12.6). The first indication to the MC that the engine was no longer running was a drop in airspeed which engine status was confirmed by the “Engine Out Detected” warning and alarm (Tabs V-11.1, V-12.6 and EE-6). In response the MSO stated “Engine Out Detected, Engine Out Detected” (Tabs V-12.6 and EE-6). At that point the MC began running the Critical Action Procedures (CAPs) for an engine failure (Tabs V-11.1, V-12.7, and EE-6). As part of the CAPs, the MP established a glide configuration and began assessing the surroundings for an adequate place to land (Tab V-12.7). The CAPs also call for pulling the Condition Lever – aft or back, as required (Tab V-12.7). The MP continued to misidentify the appropriate lever and pulled the Flap Lever to full aft or back, see figure 6, which extended the Flaps to a mechanical stop of 45 degrees creating more drag (Tabs V-12.7, DD-3, EE-8 and EE-9). The Condition Lever was left in the middle detent position and was not brought to full aft or back in accordance with the CAPs (Tabs V-12.7, DD-3, EE-8 and EE-9). Figure 6 below shows what the controls looked like at that time. (Tab DD-6)

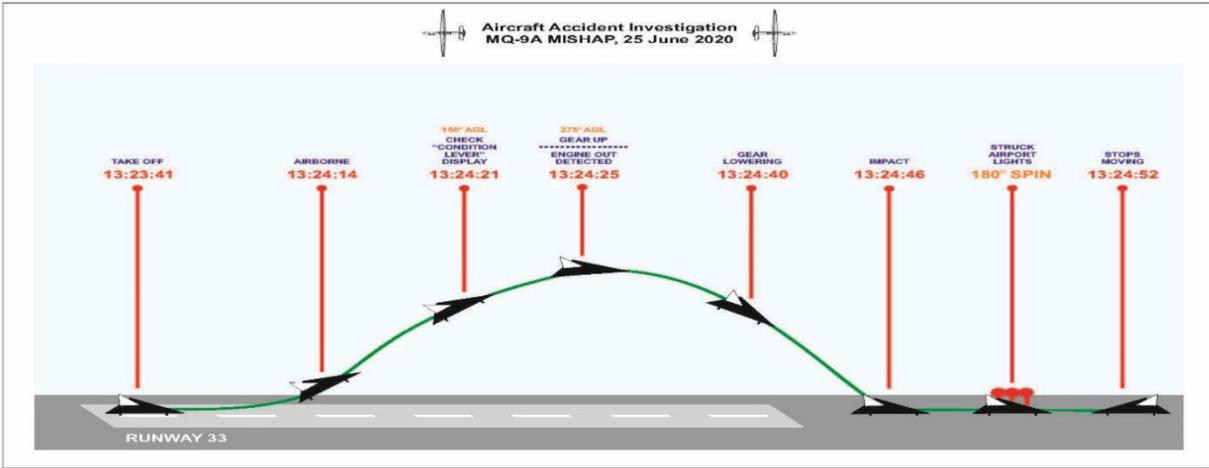
Figure 7. Accident Timeline Graphic (Tab DD-12)

At 13:24:46Z the MA impacted the ground (Tab K-3): After ground contact the MA struck an airport runway light, spun 180 degrees, and came to a rest at 13:24:52Z (Tabs K-3, Q-5, Q-10, and S-10). The impact was 21 seconds after the loss of engine power resulting in the MA

coming to rest approximately 600 feet off the departure end of runway 33 (Tabs K-3, Q-5, and S-10). The total time elapsed from takeoff until the MA came to a stop was one minute and eleven seconds, see figure 7 (Tab K-3).

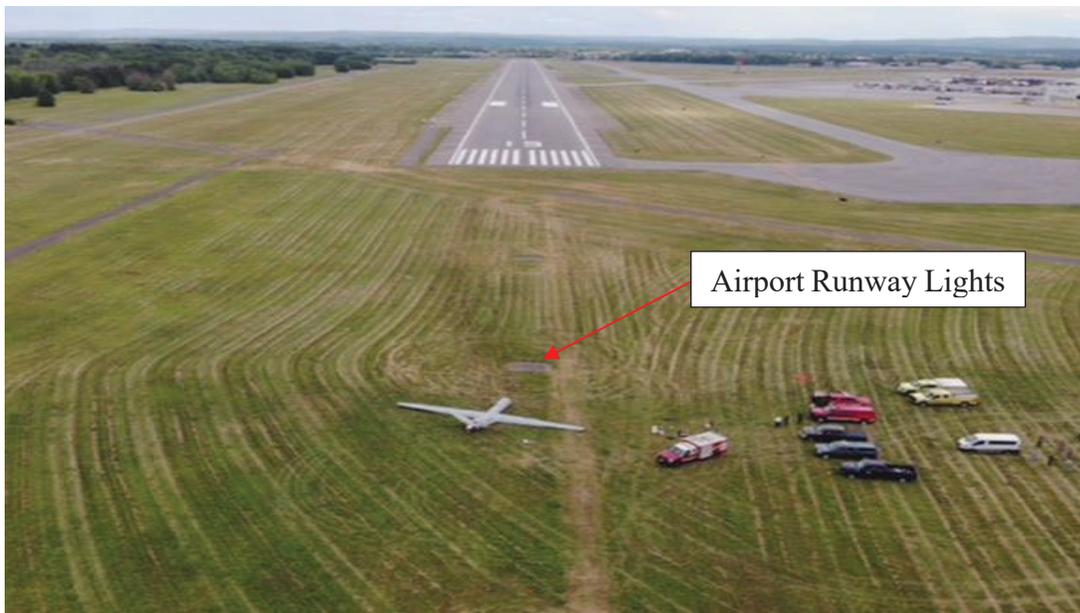
Figure 8. Syracuse Hancock International Airport Departure End of Runway 33 (Tab S-10)

Upon impact the MA struck an airport runway light causing it to spin 180 degrees and come to a rest approximately 600 feet from the departure end of runway 33 of Syracuse Hancock International Airport, see figure 8 (Tabs Q-5, Q-10, and S-10). The MA was significantly damaged on impact resulting in a damage of government property valued at \$6,085,179.00 (Tabs Q-6 and EE-10 to EE-11).

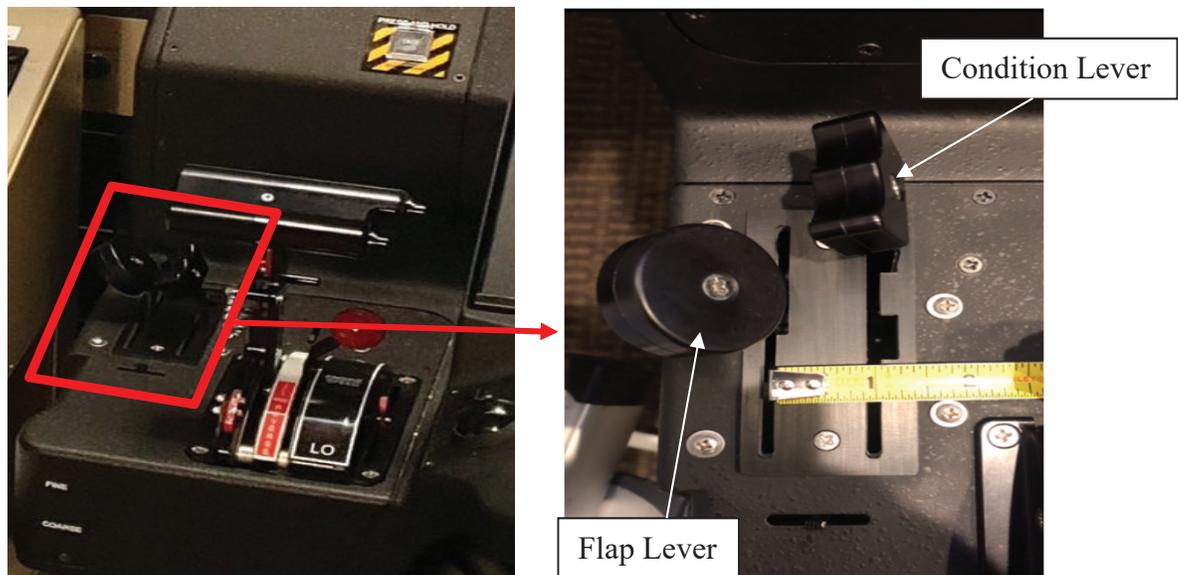
Figure 10. Throttle Quadrant and Condition Lever Example (Tab DD-5 and DD-11)

The design layout of the Control Console places the Flap Lever and the Condition Lever, forward and left of the Throttle Quadrant (Tab DD-11). The Flap Lever and Condition Lever are located approximately an inch apart, without labels, markings, and are the same color, see figure 10 (Tab DD-3 to DD-5).

The Condition Lever is the second lever from the left on the GCS control console (Tab DD-3). The Condition Lever controls the stop/feather servo, which is mechanically linked to the feather valve and the fuel shutoff valve (Tab DD-3). The full forward position of the lever provides for normal engine running operation (Tab DD-3). The detent position closes the fuel shutoff valve and shuts down the engine (Tab DD-3). The full aft or back position mechanically feathers the propeller, closes the fuel shutoff valve, and shuts down the engine (Tab DD-3). The Flap Lever is the first lever from the left on the control console and commands the position of the flaps (Tab DD-3). It is normal to position the flaps to 15 degrees for takeoff (Tab DD-4). When the Flap Lever is placed to the middle, or null position, the flaps retract to 0 degrees, the neutral position (Tab DD-3). The neutral position is the normal position after takeoff (Tab DD-3 to DD-4). The Condition Lever and Flap Lever are not normally actuated in-flight unless accomplishing a takeoff, landing, or in an emergency situation (Tab DD-4).

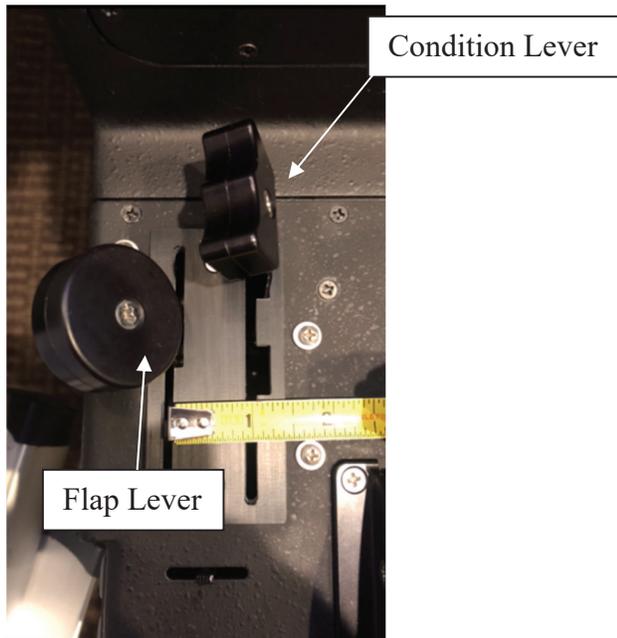
Figure 11. Flap Lever and Condition Lever Example (Tab DD-5)

HFACS PE204 Controls and Switches are Inadequate: is a factor when the location, shape, size, design, reliability, lighting or other aspect of a control or switch are inadequate (Tab BB-12). The design of the pilot GCS Throttle Quadrant places the Condition Lever and the Flap lever in close proximity, with a lack of markings, and are the same color, see figure 11 (Tab DD-4).

The Condition Levers normal operating position is full forward and is without any safety guard (Tab DD-4). The next position that the Condition Lever is capable of being placed in is the middle (fuel cutoff) position (Tab DD-4).

The design layout of the Control Console places the Flap Lever and the Condition Lever in close proximity, within an inch, with very different functions without labels, markings, color differentiation, or a safety guard. The Condition Lever is without any safety guard at its forward (normal operation) position. The next position that the Condition Lever is capable of being placed in is the middle (fuel cutoff) position. These levers could easily be mistaken by an inexperienced, fatigued, or confused crewmember.
