**UNITED STATES AIR FORCE**  
**AIRCRAFT ACCIDENT INVESTIGATION**  
**BOARD REPORT**

**C-130H3, T/N 94-6706**

**LOCATION: AL TAJI ARMY AIRFIELD, IRAQ**

**DATE OF ACCIDENT: 8 JUNE 2020**

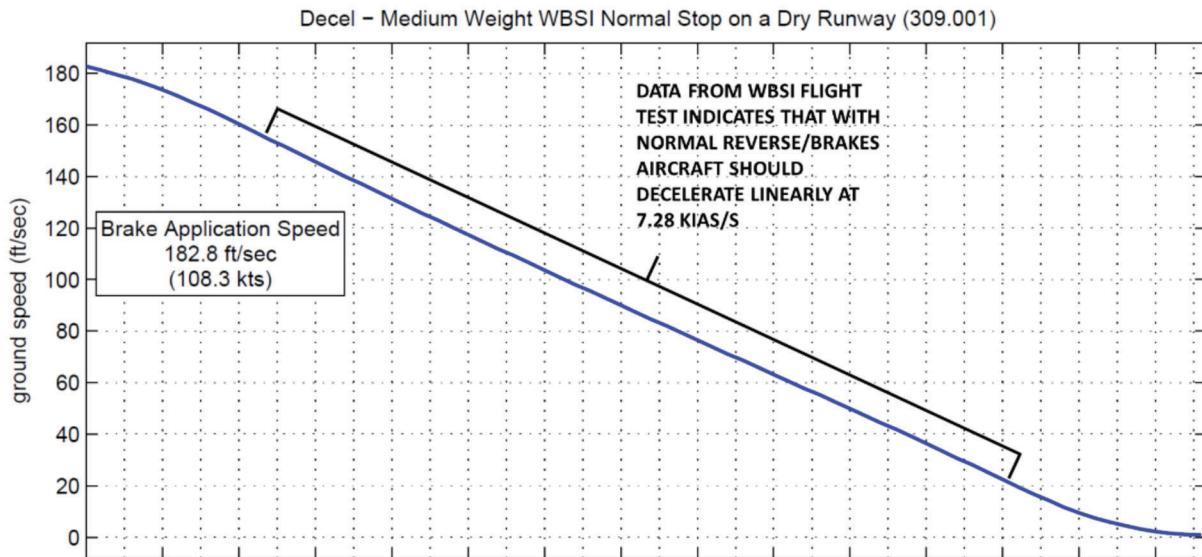
Figure 5. WBSI Flight Test Data (Tab J-20)

The brake system was initially focused on because during the CVR replay from the MA, the MCP1 and MP were struggling to get adequate braking (Tabs J-19 and N-7). Evaluation of the deceleration of the aircraft revealed that the aircraft slowed down at two significantly different rates with deceleration between touchdown (5482.00 seconds) and application of REVERSE (5495.00) a much slower rate than between application of REVERSE and the end of the runway (5500 seconds) (Tab J-19). Between 5482 seconds (aircraft touchdown per the CVR and DFDR data) and 5495 seconds (REVERSE) the pitch angle oscillates between 0 degrees and -2 degrees while the aircraft decelerates from 146 KIAS to 122 KIAS (Tab J-19). When the aircraft throttles are brought into REVERSE at 5495 seconds, the aircraft decelerates from 122 KIAS to 60.7 KIAS at the end of the runway at 5502 seconds (Tab J-19). As the MA travels the 594 feet from the end of the runway to the concrete barrier, it decelerates to 23.5 KIAS and then impacts the concrete barrier at 5511 seconds (Tab J-19). Figure 5 is a depiction of the typical deceleration of an aircraft from the wheel brake system improvement (WBSI) flight testing with throttles in REVERSE and full braking applied. Typical deceleration during this flight test was 7.28 KIAS/s. (Tab J-20).

REVERSE to End of Runway. When this flight test data (in green) is plotted against the deceleration that the MA experienced (in orange) between REVERSE and the end of the runway in Figure 6a, the MA slows down at rate comparable to flight test data. Conclusion from this assessment of brake performance is that the brake system was working normally. MA experiences abnormal pitch oscillations while decelerating between touch down and REVERSE which is also an indication that the weight of the aircraft was not fully on the wheels (Tab J-21).
