**UNITED STATES AIR FORCE**  
**AIRCRAFT ACCIDENT INVESTIGATION**  
**BOARD REPORT**

**T-38A, T/N 64-13304**

**LOCATION: SACRAMENTO MATHER AIRPORT, CALIFORNIA**

**DATE OF ACCIDENT: 18 FEBRUARY 2021**

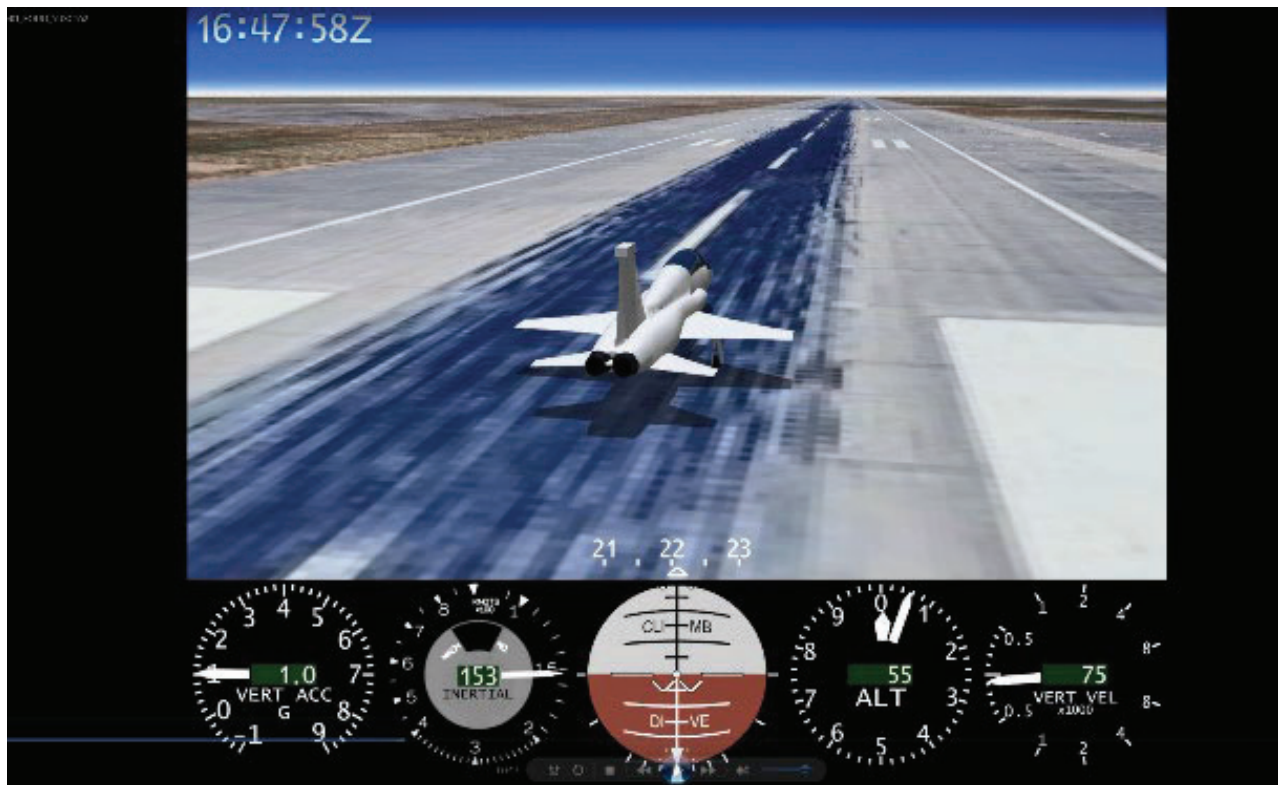
The MLG touched down at approximately 153 knots and approximately 1,000 feet past the approach end of Runway 22L at 0848L (Tabs V-5.8, Z-2, and AA-6). In accordance with normal procedures, once the MP felt the MLG touch down the MP advanced the throttles to MIL and lowered the nose slightly (Tabs V-5.8 and BB-32). Following initial touchdown, when the MP perceived the MA had begun to climb, the MP raised the landing gear lever (Tab V-5.8 to V-5.9).

Figure 1: T-38A animation of suspected touchdown point (Tab Z-2)

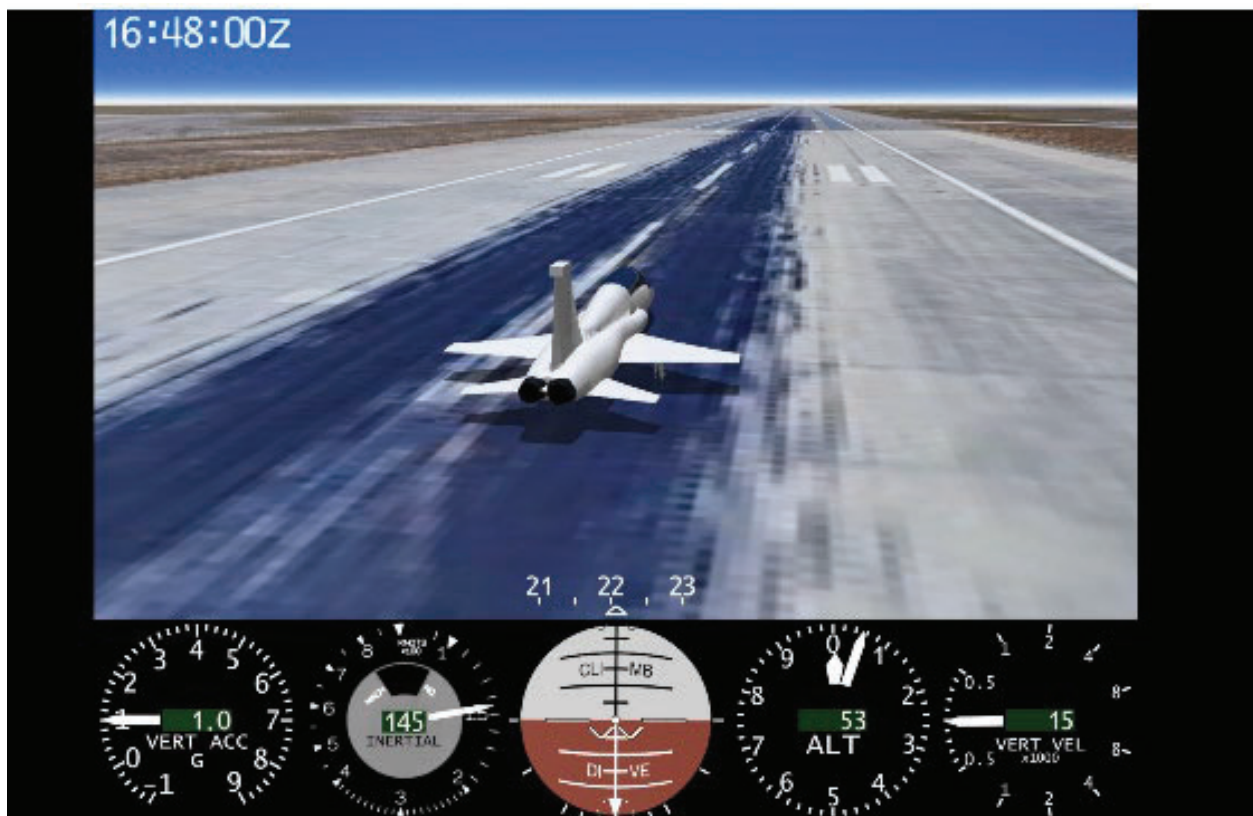
As the landing gear started to retract the MP felt the MLG tires “tapping” on the runway (Tab V-5.9). The MP described this feeling as the MLG tires alternating contact with the runway between the left and right MLG tires (Tab V-5.9). The MA then began to sink, at which point the MP put the landing gear lever back down (Tab V-5.9). This caused the landing gear retraction sequence to

Figure 2: T-38A animation of touchdown +2 sec (Tab Z-3)

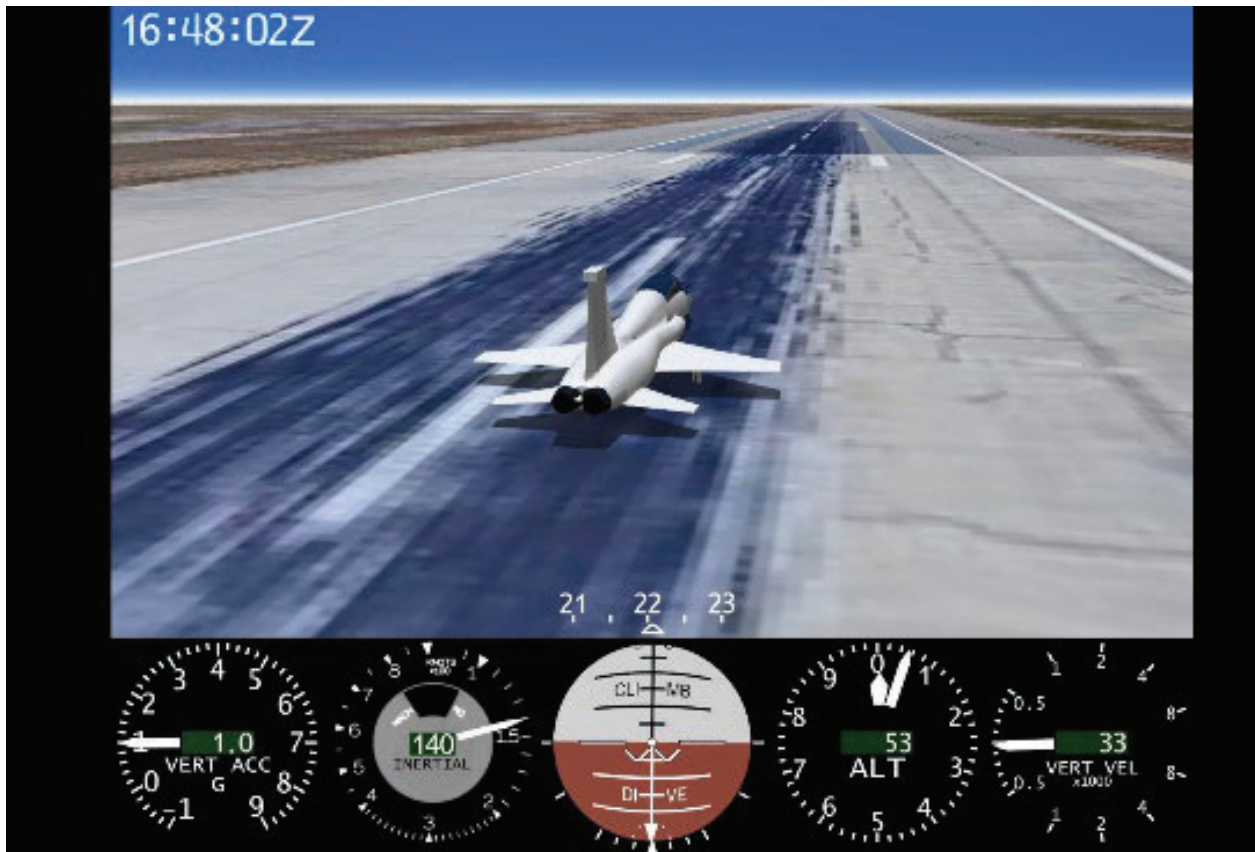
As the MA descended the MLG doors contacted the runway, then the partially retracted MLG wheels touched down at an approximate angle of 12 degrees open (Tab EE-32 and EE-34). The MA fuselage continued to descend, compressing the MLG under its weight and impacting the runway surface (Tab EE-41). According to extrapolated GPS data, approximately 5 seconds elapsed between initial wheel touchdown and MA impact (Tab Z-2 to Z-4). Upon recognition that the MA had impacted the runway, both the MP and the MIP selected idle power (Tab V-5.9 and V-6.8). The MIP verbally commanded the MP to place the throttles in “off” after the MA impacted the runway and started sliding on its fuselage, an action that can only be accomplished from the front cockpit (Tabs V-6.9 and BB-12). The MP initially struggled to shut off the throttles due to a stuck throttle guard (Tab V-5.9). Once the MA came to a stop, the MP was able to shut off the throttles (Tab V-5.9). The MIP directed aircraft egress actions and directed the MP to place the fuel shut-off switches to “off” (Tab V-6.8 to V-6.9).

Figure 3: T-38A animation of ground impact of MLG doors and MLG (Tab Z-4)

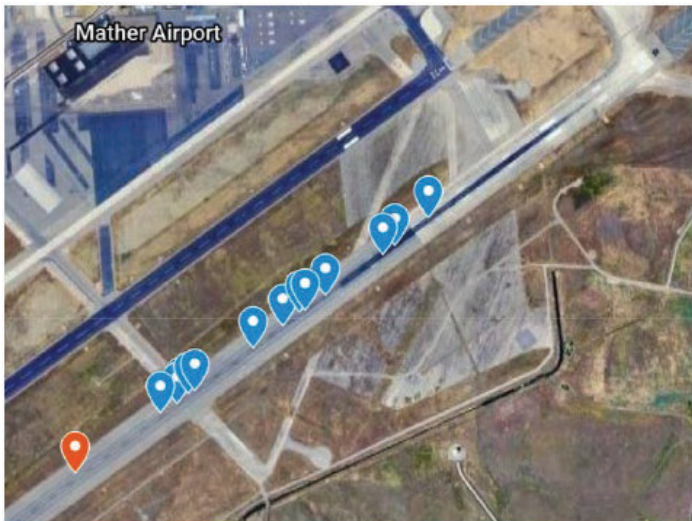
At approximately 0848L, the MA's MLG wheels came into contact with the runway during the retraction sequence, approximately 2,320 feet from the approach end of Runway 22L (Tabs V-5.9, Z-4, EE-10, EE-19, EE-21, and EE-41). As the MA settled onto the runway, the weight of the MA forcibly collapsed the MLG, causing a hydraulic system failure that prevented the MLG from completing the retraction sequence to a locked position (Tab EE-17 and EE-19). The MA slid on its fuselage for approximately 3,850 feet, during which a fire ignited in the right MLG bay and both MLG doors were sheared off (Tab EE-19 and EE-31). The MA came to rest approximately 6,170 feet from the approach end of the runway with the fire still burning. (Tab EE-19 and EE-21).

Figure 4: Mishap points of interest (Tab EE-20)

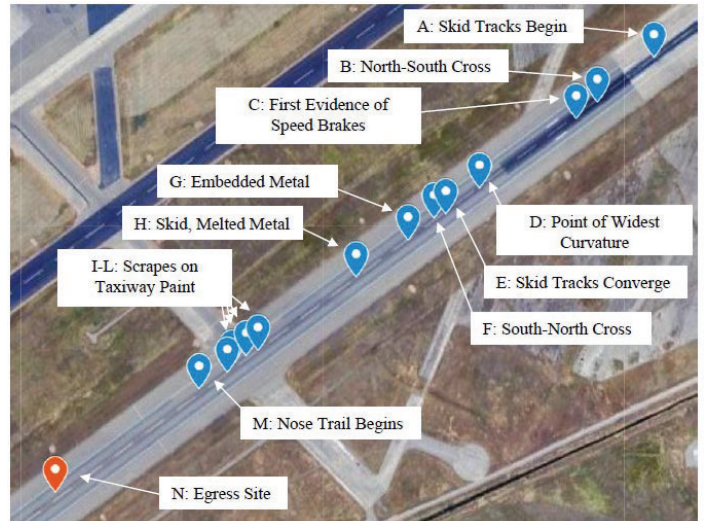
Figure 5: Details of points of interest (Tab EE-20)
