**UNITED STATES AIR FORCE**  
**AIRCRAFT ACCIDENT INVESTIGATION**  
**BOARD REPORT**

**T-38C, T/N 68-8099**

**DATE OF ACCIDENT: 19 FEBRUARY 2021**

**EXECUTIVE SUMMARY  
UNITED STATES AIR FORCE  
AIRCRAFT ACCIDENT INVESTIGATION**

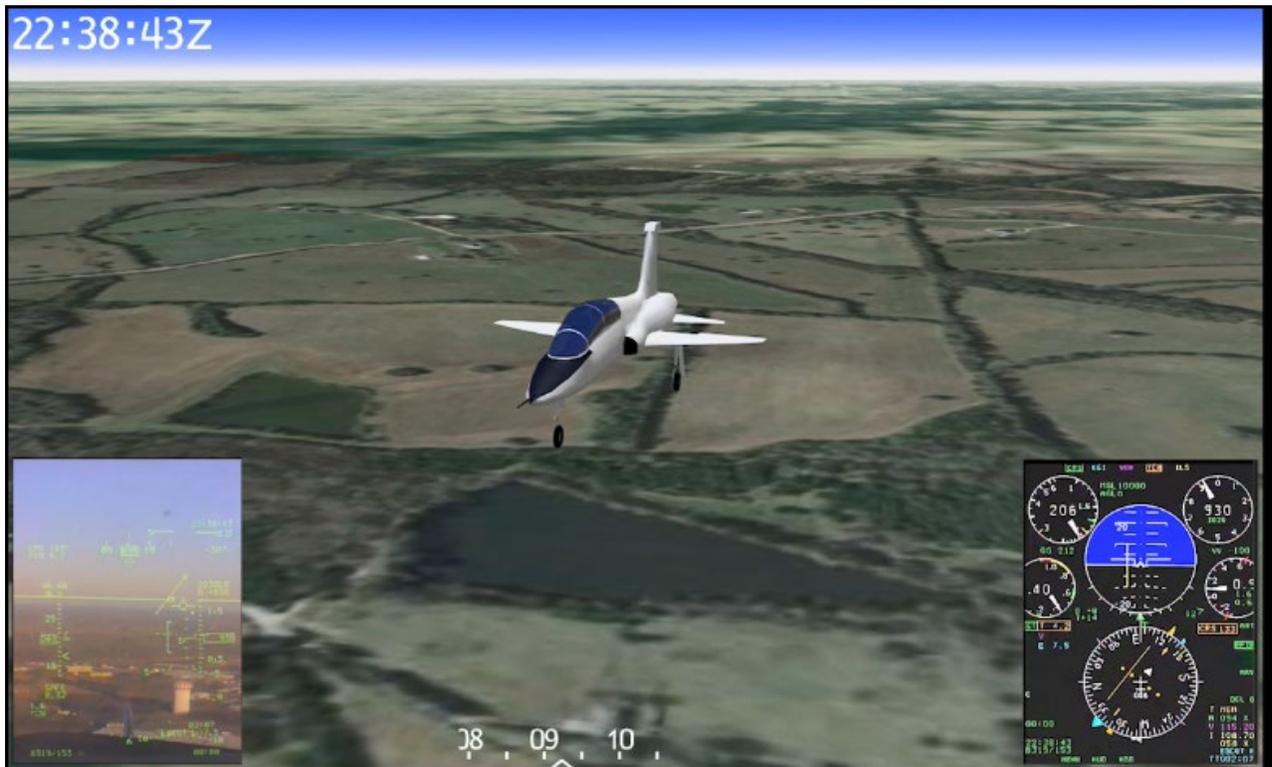
Figure 1 (Tab EE-3)

At 2238:43Z, the MA was abeam RWY 28 approach end threshold, on heading 095, at 930 feet MSL, flying 207 KCAS and displaced 1.9 NM from the runway (Figure 1). The MA was approximately 70 feet above the MDA, 15 KCAS above the final turn airspeed of 192 KCAS, and 0.4 NM wider than the desired 1.5 NM runway displacement (Tabs GG-35 and II-5).

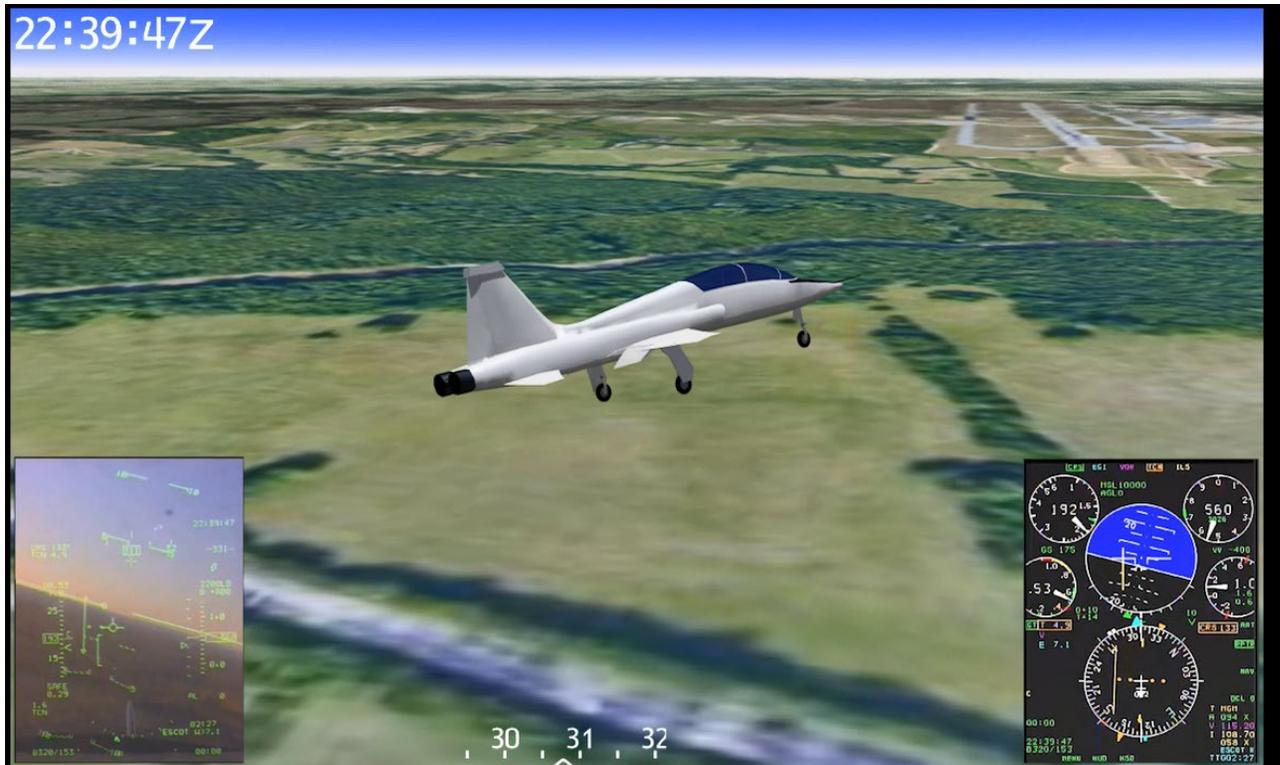
Figure 2 (Tab EE-8)

At 2239:47Z, the MIP stated, “See the runway, there you go,” and the MSP started a 30-35 degree left bank turn to align with RWY 28 as the MA decelerated through 192 KCAS at 400 feet per minute sink rate (Figure 2) (Tabs HH-16 and II-6).

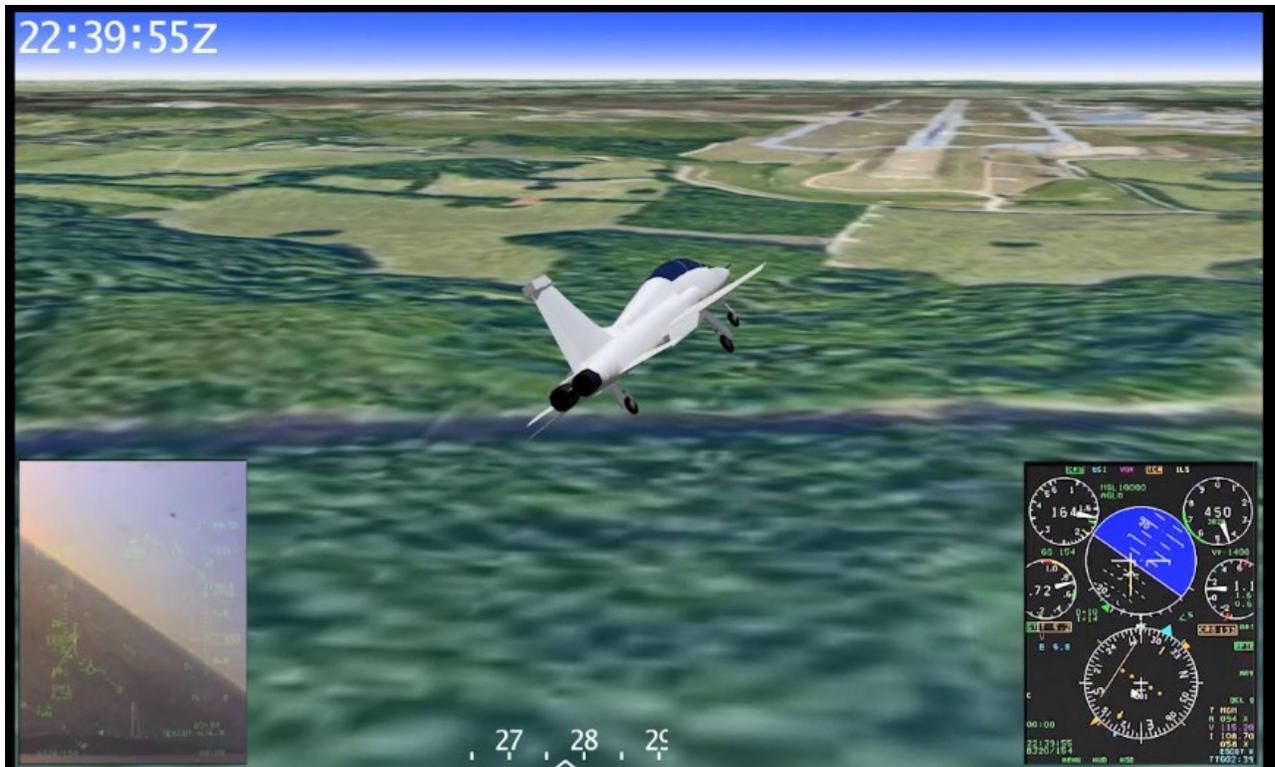
**Figure 3** (Tab EE-10)

At 2239:55Z, the MIP calmly stated, “Just a little bit...” and truncated the end of his statement (Tabs HH-16 and II-6). At this point, the MA was on heading 278, at 450 feet MSL, in approximately 36 degrees of left bank, throttles in idle, and decelerating through 164 KCAS at 1,400 feet per minute sink rate (Figure 3) (Tab II-6). In addition, at this time of day, on a heading of 278, the setting sun was in the MC’s field of view, likely affecting the MSP’s ability to discern the information displayed on the heads up display and the MC’s ability to acquire the runway (Tab II-6).

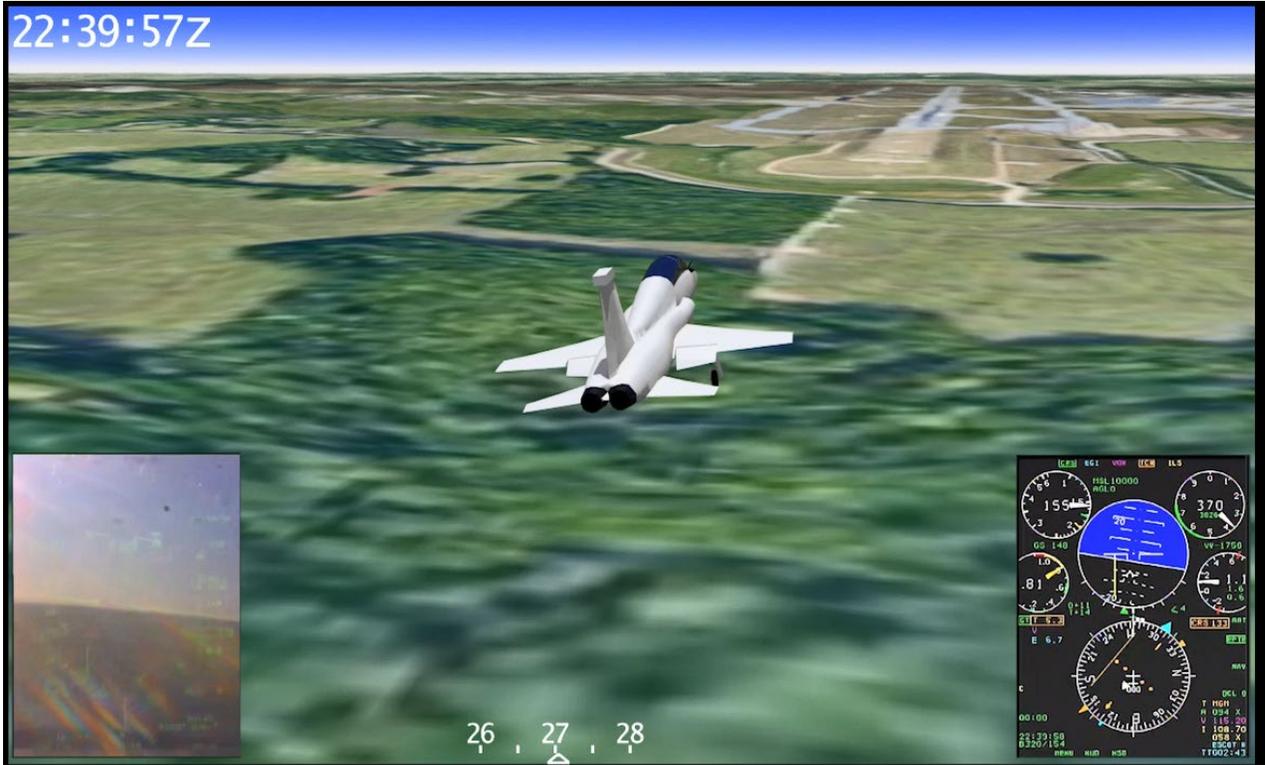
Figure 4 (Tab EE-11)

At 2239:57Z, the MIP advanced the throttles to maximum afterburner while continuing the attempted recovery (Figure 4) (Tab II-6). At this point, the engines were accelerating from idle to 66% revolutions per minute (RPM) with the MA's airspeed at 155 KCAS and a 1,750 feet per minute sink rate) (Tab II-6).

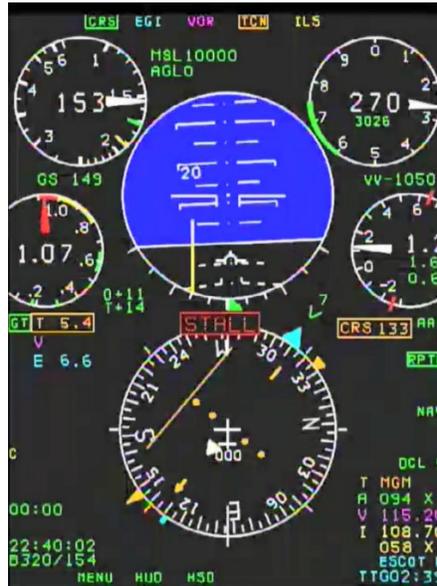
Figure 5 (Tab EE-14)

At 2240:02Z, the MIP continued the approach to stall recovery, but the MA continued to descend due to its energy-deficient state (Tab II-6). The airspeed remained low, and the engines continued to accelerate (Tab II-6). The MA's airspeed was 153 KCAS, 11 degrees nose high pitch attitude, 5 degrees downward flight path, 1,050 feet per minute sink rate, 2 degrees right angle of bank, throttles in maximum afterburner, gear down and locked, and 60% flap setting (Figure 5) (Tab II-6).

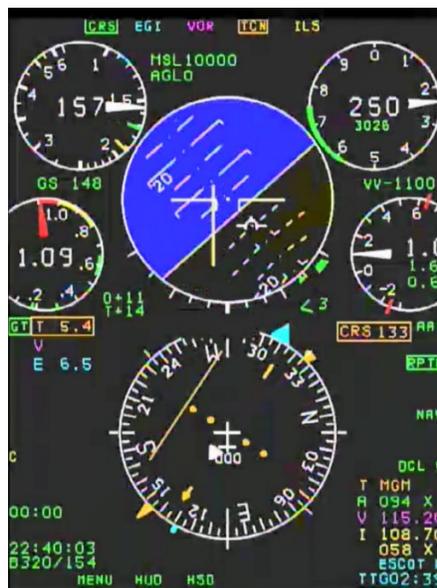
Figure 6 (Tab EE-15)

At 2240:03Z, the MA airspeed was 157 KCAS, 5 degrees nose high pitch attitude, 5 degrees downward flight path, 1,100 feet per minute sink rate, 43 degrees right angle of bank, throttles in max afterburner, gear down and locked, and 60% flap setting (Figure 6) (Tab II-6).
