UNITED STATES AIR FORCE
AIRCRAFT ACCIDENT INVESTIGATION
BOARD REPORT

MQ-9A, T/N 12-4203

LOCATION: UNDISCLOSED LOCATION IN AFGHANISTAN

DATE OF ACCIDENT: 20 JUNE 2021

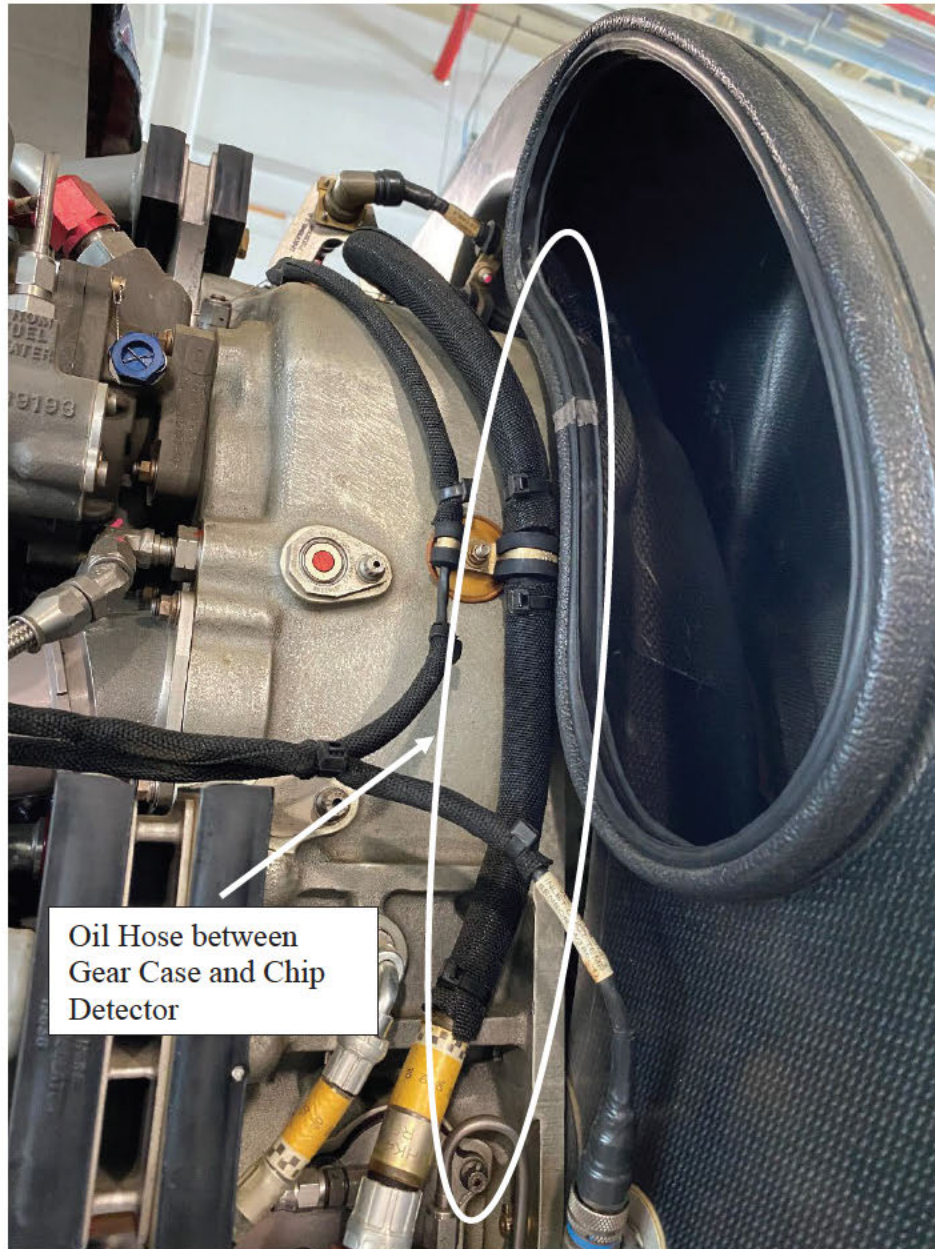
Due to the location of the wreckage, on-site evaluation could not be performed (Tab J-4). However, the manufacturer was able to produce a technical report based on data log information, videos, and historical oil related mishaps involving other MQ-9A aircraft (Tab J-4). The specific cause of the oil leak could not be determined but a most likely location of the oil leak was identified as the oil hose on top of the engine between the gear case and the chip detector (Tab J-4). This determination was made based on rate of oil loss and no visual indications of an oil leak (Tab J-4). Oil leaks from this location during flight have shown that oil leaking from this hose will be drawn out to the propeller spinner cone, preventing oil accumulation and, therefore,

preventing leaks from the bottom of the engine compartment (Tab J-4). This hose was inspected 93 hours prior to the mishap flight during the 200/400 hour airframe inspection (Tab J-6). This hose is replaced during the 3,000 hour Hot Section Inspection and the 6,000 hour engine overhaul engine had flown 2,483.8 hours since the last overhaul (Tab J-6).

Oil Hose Between Gear Case and Chip Detector (Tab S-3)
