UNITED STATES AIR FORCE
AIRCRAFT ACCIDENT INVESTIGATION
BOARD REPORT

RQ-4B BLOCK 40, T/N 08-2035

LOCATION:
6.8 MILES NORTH OF GRAND FORKS AIR FORCE BASE, NORTH DAKOTA

DATE OF ACCIDENT: 6 AUGUST 2021

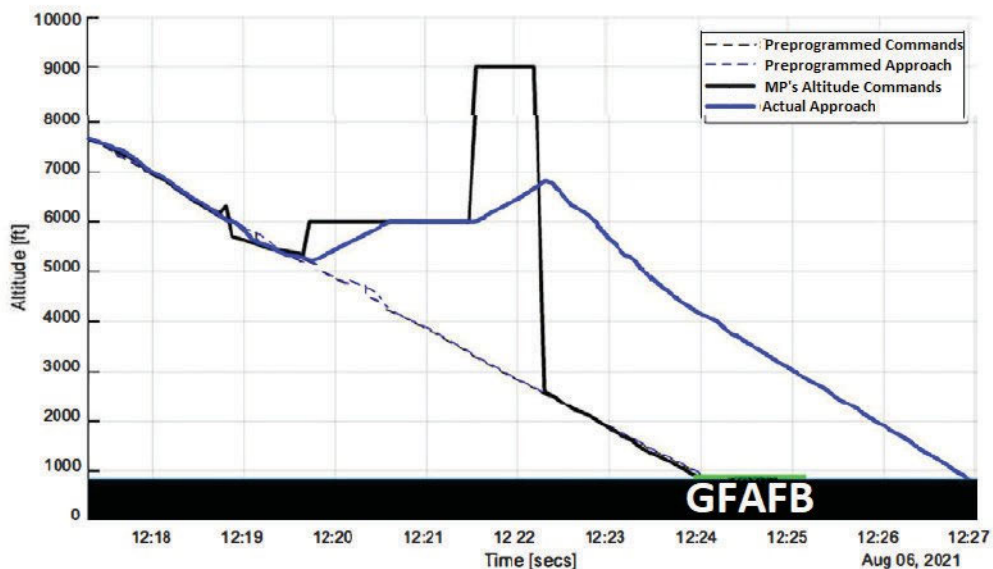
(Tabs J-18 and Z-20)

J- 17). The MIP continuously instructed the MP to issue an altitude command to the MA (R-32). The MP attempted to give the MA five more altitude commands, but the commands were rejected (Tab J-19). The MP and MIP believed that the MA had an incomplete link with the MLRE, causing it to not accept the MLRE commands (Tab V-1.9 and V-2.26). However, the MA was receiving the commands, but rejecting them due to the MA’s preprogrammed go-around/missed approach route (Tab L-4 and BB-21). An aircraft on a go-around/missed approach route will fly the route and commit to landing on the second approach, unless another route is commanded (Tabs V-12.1 and BB-31). After crossing the FAF, the MA’s programming attempted to steer the aircraft down at a steeper angle to meet the required landing waypoint on the airfield (Tab J-17). However, the maximum descent rate of 1,800 feet per minute was not sufficient to account for the MA’s 4,000- foot altitude deviation at the FAF (Tab J-17). The MA, having no additional preprogrammed go-around/missed approach route options, continued in its maximum descent rate, overflew the GFAFB airfield, and impacted the ground 6.8 miles north of the GFAFB airfield along the runway centerline (Tab J-17 and J-21).

FINAL SEQUENCE PIOR TO MA'S FINAL TRANSMISSION

SIMULATION OF THE MISHAP STARTING FROM THE SAME CONDITIONS AS THE MA

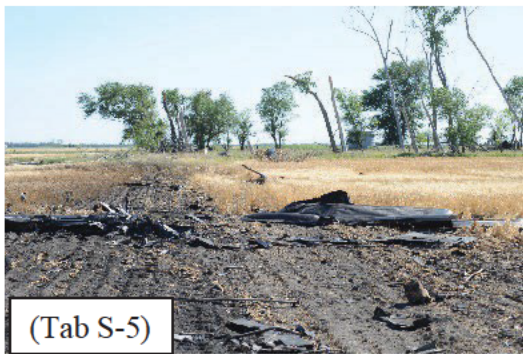
(Tab S-5)

At 0829L, GFAFB FD confirmed two fires with black smoke approximately 8 miles west of initial coordinates and were attempting to access the site of the fires (Tab DD-8). The actual impact site was non-government property, specifically a barley farm field, and a National Defense Area was initiated (Tab V-11.2 to V-11.3, V-11.11 to V-11.14, and DD-11). After arriving, GFAFB FD established incident command (IC), and civilian fire departments aided (Tab DD-8). 319 SFS established a perimeter

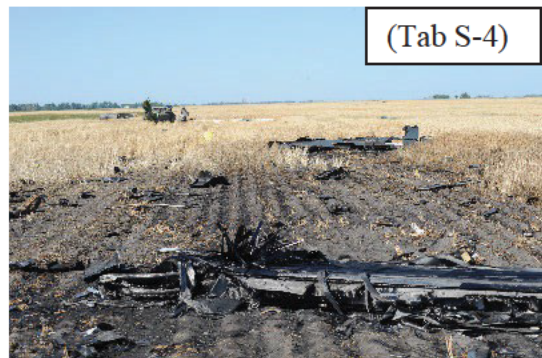
(Tab S-4)

At 0907L, GFAFB FD began fire suppression efforts (Tab DD-8). The crash site was approximately 300 feet east to west by 450 feet north to south, with a secured perimeter of 1000 feet around (Tab V-11.7 and DD-8). The MA made impact with a line of trees at the south end of the site before impacting the ground (Tab V-11.6 to V-11.7). By 0925L, the main sections of the aircraft fire were extinguished and attention was placed on cooling smaller aircraft pieces within the debris field (Tab DD-8). At 1255L, Bioenvironmental

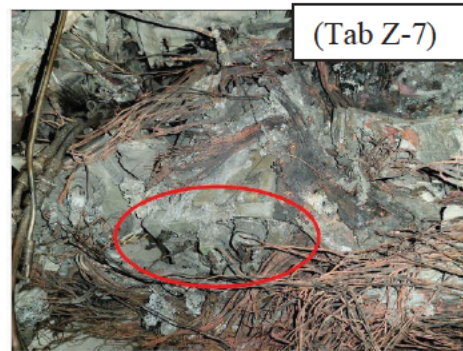
The engine, fuselage and various airframe sub-components were recovered and returned to GFAFB (Tabs S-3 to S-7 and V-11.10 to V-11.11). Due to a fuselage fire, the integrated mission management computer (IMMC) was rendered unusable; however, the stores management unit (SMU) was sent to Northrop Grumman (NG) for further analysis (Tabs J-28 to J-34 and S-3 to S-7). NG was unable to retrieve any usable data from the SMU due to severe heat damage caused by a fuselage fire (Tabs J-28 to J-34). Due to a corrupted drive and the loss in communication with the MA there were limited MMCE C2 system logs for review (Tabs U-100 and V-8.12). The available logs from the MLRE and MMCE showed no faults indicating structural failure or abnormal aircraft behavior (Tab L-3 to L-12). The MA's impact with the ground and the subsequent fuselage fire resulted in significant damage to the airframe (Tab S-6 and S-7). The available evidence indicates no inflight damage to the aircraft structure, or primary or secondary control surfaces (Tab J-20).

MELTED MIMMC
