UNITED STATES AIR FORCE
ABBREVIATED AIRCRAFT ACCIDENT INVESTIGATION
BOARD REPORT

MQ-9A, T/N 15-4301

**9TH ATTACK SQUADRON
49TH WING
HOLLOMAN AIR FORCE BASE, NEW MEXICO**

DATE OF ACCIDENT: 6 DECEMBER 2021

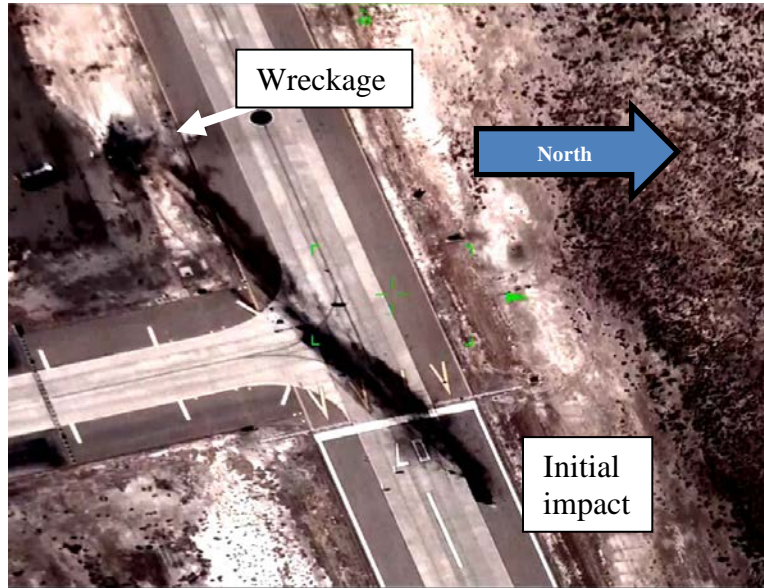
Figure 3 (Tab Z-16)

The MA impacted approximately 50' north of centerline on the approach end of runway 070 (Figure 3 Tab Z-16). It exploded and continued to simultaneously disintegrate and move southwest approximately 435' until stopping south of taxiway golf and west of taxiway lima (Figure 3 Tab Z-16, Figure 4 Tab Z-17). The MA was destroyed, resulting in damage costs of one aircraft's portion of a complete MQ-9 unit (which consists of four aircraft with sensors, one ground control station, and one Predator Primary Satellite link costing a combined \$56.5 million) (Tabs A-5 and DD-18).

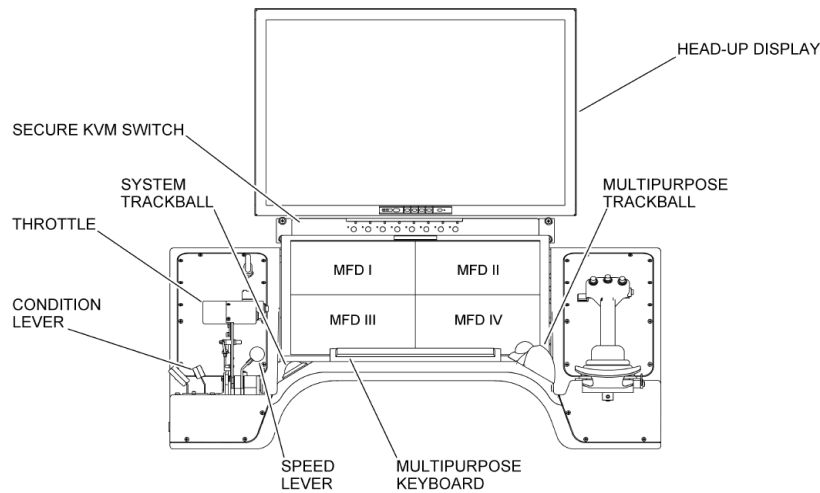
Figure 5 (Tab Z-18) below shows the layout of the GCS Control Console with the Throttle Quadrant to the pilot's left.

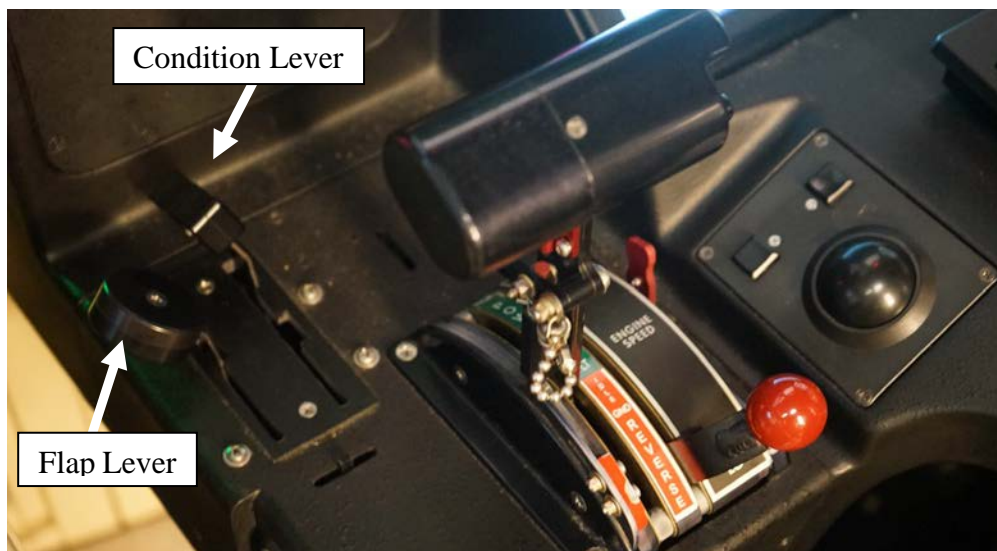
Figure 6 (Tab Z-19)

The design layout of the Control Console places the flap lever and the condition lever, forward and left of the Throttle Quadrant (Figure 6 Tab Z-19). The flap lever and condition lever are close together, without labels, markings, and are the same color (Figure 6 Tab Z-19).

HFACS PE204, Controls and Switches are Inadequate, is a factor when the location, shape, size, design, reliability, lighting or other aspect of a control or switch are inadequate (Tab BB-69). The design of the pilot GCS Throttle Quadrant places the condition lever and the flap lever in close proximity, with a lack of markings, and are the same color (Figure 6 Tab Z-19). There have been at least two other United States Air Force (USAF) MQ-9A accidents caused by a pilot unintentionally moving the condition lever (Tab CC-7).

The flap lever and the condition lever have very different functions. Yet they are close together, without markings, color differentiation, or any safety guard. The condition lever has no safety guard at its full-forward/run position. The next position that the condition lever is capable of being placed in is the detent/stop position. These levers could easily be mistaken by a nonproficient crewmember.
