UNITED STATES AIR FORCE
GROUND ACCIDENT INVESTIGATION
BOARD REPORT

**M1165A1 High Mobility Multipurpose Wheeled Vehicle (HMMWV),
S/N 337321**

**284th Air Support Operations Squadron
184th Wing
McConnell AFB, Wichita, Kansas**

TYPE OF ACCIDENT: Motor Vehicle Fatality

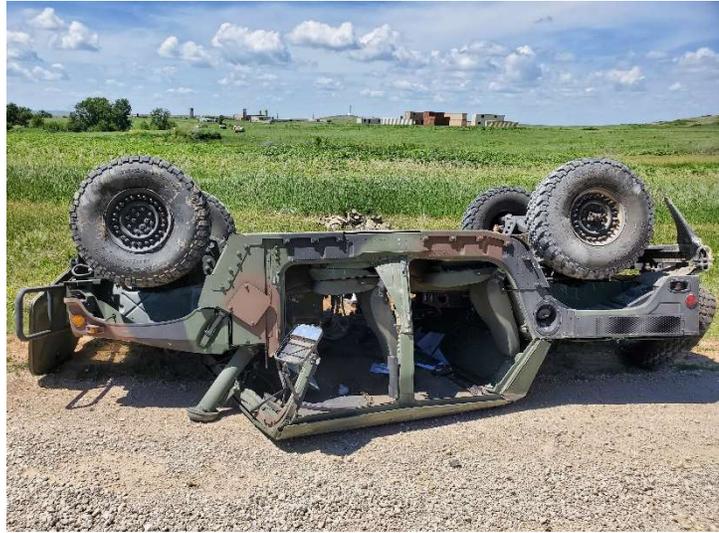
Figure 1 - Mishap Vehicle at Mishap Site (Tab Z-2)

in the front passenger (right) seat (Tabs R-5 and V-3.13). At approximately 1355 local time (L) while traveling on Parsons Road from the Range Control Tower (RCT) toward an OP called Soldier's Cap (SC), MV rolled over and came to rest on its roof, facing the opposite direction from which it had been traveling (see Figure 1) (Tabs R-5, R-60, R-62, and DD-31 to DD-32). During the rollover, all three MT members were ejected from MV (Tabs R-5, V-3.17, V-7.24, X-2 to X-4, GG-4, and GG-6). MVO and MA2 survived and MA1 died from mishap injuries (Tab X-2 to X-4).

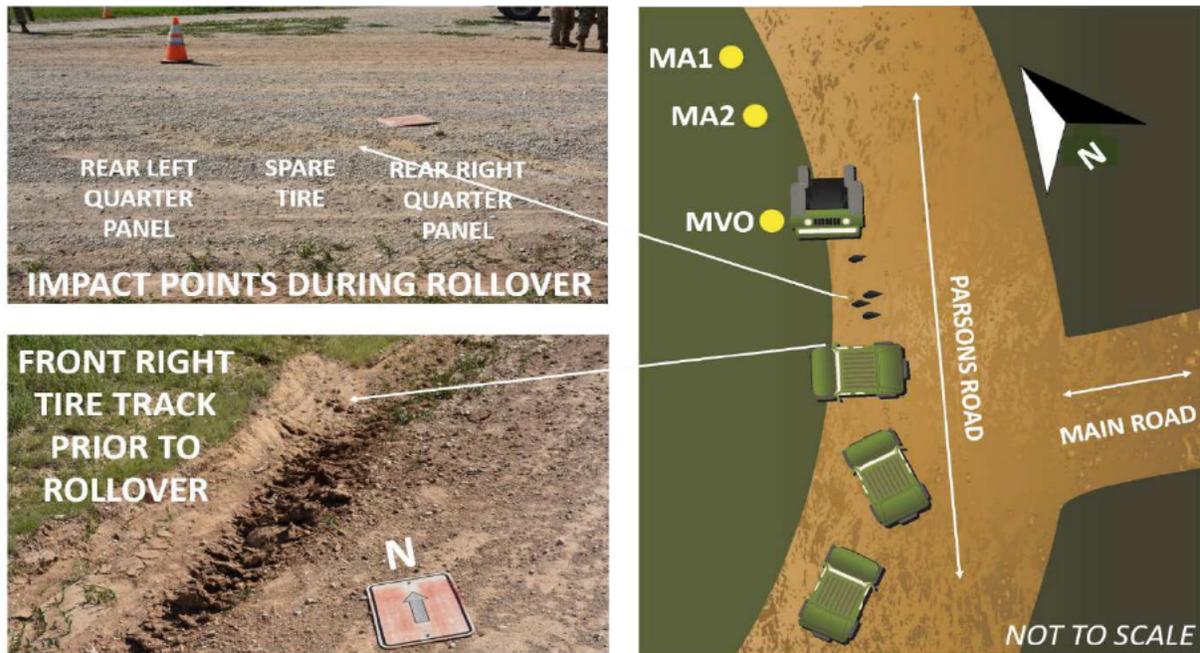
Figure 5 - Mishap Reconstruction (Tabs Z-5, GG-5 to GG-6, and GG-13 to GG-14)

At approximately 1355L, MT approached the intersection of Parsons Road and Main Road (see Figure 5) (Tabs R-5, R-60, V-3.15, DD-32, GG-2 to GG-3, and GG-6). This portion of Parsons Road is slightly uphill (heading northeast), with a broad, sweeping left turn to the north approaching SC (Tabs V-3.6, V-4.2 to V-4.3, V-7.17, V-7.26, V-10.12, V-11.5, Z-4 to Z-5, and GG-2 to GG-3). Contrary to local safety guidance, MV entered the turn on the left side of Parsons Road and began to skid sideways for approximately 100 feet (see Figure 5) while rotating

counterclockwise (Tabs R-5, V-3.15 to V-3.17, V-7.7, V-11.33, CC-9, GG-5 to GG-6, and GG-13 to GG-14). As MV became perpendicular to the road, the front right tire furrowed in the dirt north of the road surface (see Figure 5), causing MV to roll over one and one half times (Tabs R-5, V-3.15 to V-3.17, GG-5 to GG-6, and GG-13 to GG-14). During the rollover, all four passenger doors detached from MV (Tabs V-3.21, V-3.31, V-4.11, and V-7.23). MV contacted the road surface four times during the rollover (see Figure 5), first hitting the rear right quarter panel, then the spare tire, then the rear left quarter panel, and finally the roof before coming to rest (see Figure 6) (Tabs GG-5 to GG-6, and GG-13 to GG-14). MV became partially airborne during the rollover, coming to rest facing the opposite direction (southwest) from which it had been traveling (Tabs EE-7, GG-5 to GG-6, and GG-13 to GG-14). The speed limit on Parsons Road is 45 miles per hour (mph) (Tab V-4.2). There is insufficient evidence to determine the speed MV was traveling at the time of the mishap (Tabs EE-3 and EE-7 to EE-8).

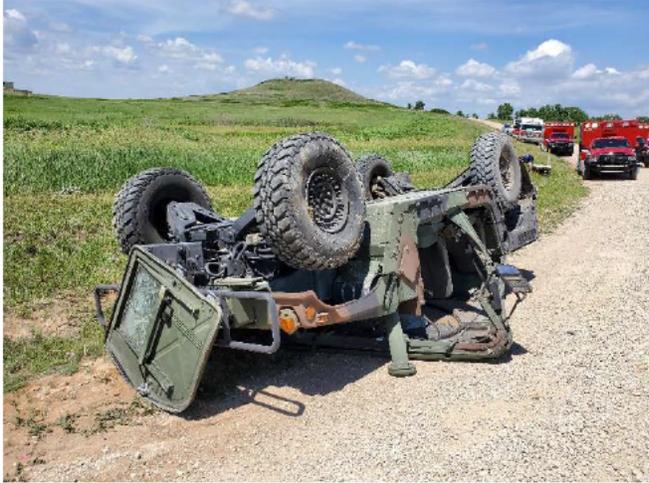
Figure 6 - Mishap Vehicle at Mishap Site (Tab Z-5)

MV's brake pads were normal and serviceable prior to the mishap (Tab U-35). However, as a result of the mishap, MV sustained significant structural damage to its rear quarter panels, B-pillars (support posts connecting the roof to the body of the vehicle), cab assembly, and roof (Tabs Z-2, Z-5, and GG-5 to GG-6).

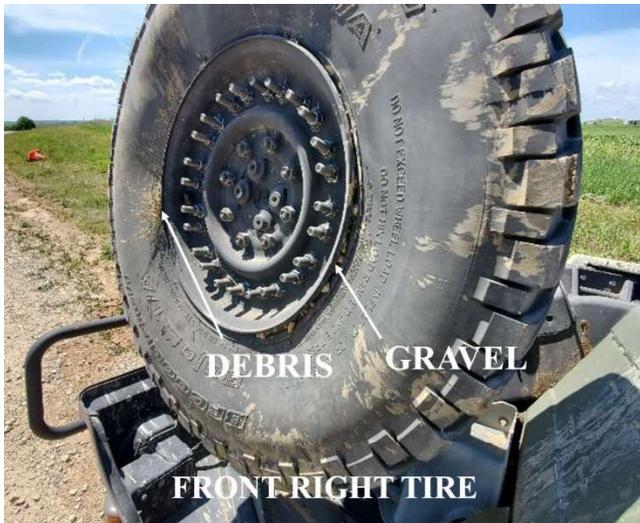
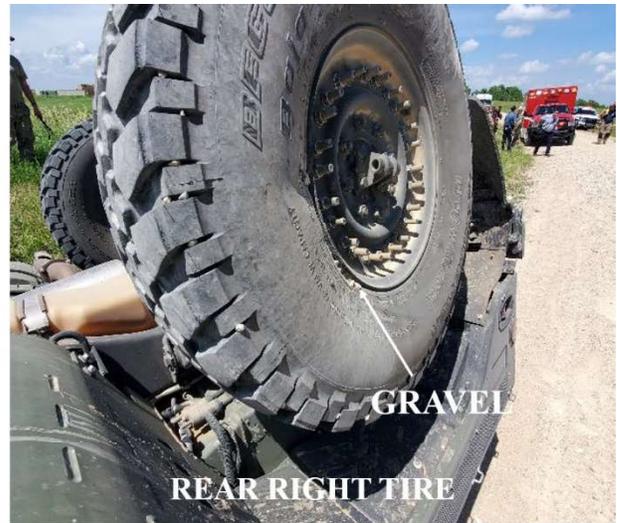
Figure 7 – Front Right Tire with Broken Bead and Rear Right Tire with No Broken Bead (Tab Z-6)

During the mishap, MV's tire bead on its front right tire broke (Tabs U-47, U-49, and Z-6). The term "bead" is used to describe where the edge of the tire sidewall and the inner lip of the rim seal the pressurized air in the tire (Tabs U-47 and U-49). Once MV entered the turn and began to skid, the weight and momentum of MV bore down on the front right tire, driving it into the ground perpendicular to the road, briefly breaking the bead (Tabs U-47, U-49, and Z-6). Once the bead broke, air in the tire was released allowing debris, rocks, grass, and dirt to lodge between the rim and tire during the skid (see Figures 7 and 8) (Tabs U-47, U-49, and Z-6). Gravel also lodged in the rear right tire during the skid (see Figure 7) (Tabs U-49 and Z-6).

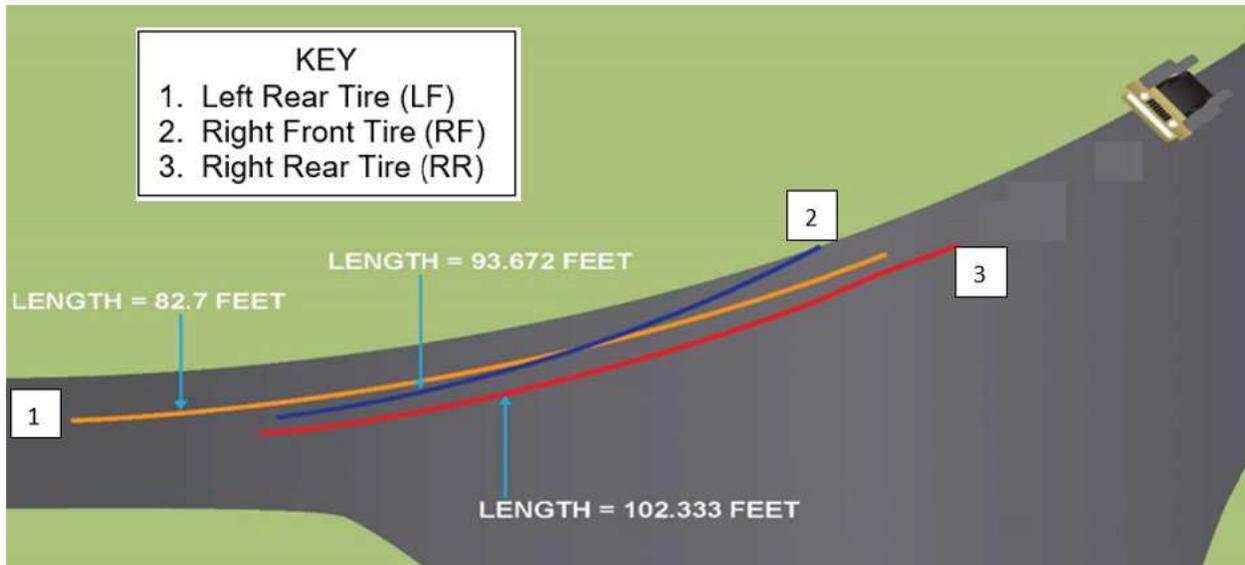
Figure 9 – Illustration of Tire Tracks at Mishap Site (Not to Scale) (Tabs Z-6, GG-5 to GG-6, and GG-13 to GG-14)

Saline County Sheriff's Office conducted a tire track analysis of Parsons Road at MS and produced a report (Tabs Z-6 and GG-2 to GG-14). The report showed that the rear left tire track crossed the front right tire track during the mishap sequence (see Figures 9 and 10) (Tabs Z-6 to Z-7 and GG-12 to GG-14). This indicated MV skidded sideways and rotated counterclockwise for approximately 100 feet on the left side of Parsons Road at MS (Tabs Z-6 to Z-7, GG-3, GG-6, and GG-13 to GG-14). The report and photographs showed no evidence of heavy braking and documented three tire tracks in the road (Tabs Z-6 to Z-7, GG-5 to GG-6, and GG-13 to GG-14). Once MV began its initial skid and rotation, MVO would not have regained control of MV through any braking (Tab EE-4).
