UNITED STATES AIR FORCE
ABBREVIATED AIRCRAFT ACCIDENT INVESTIGATION
BOARD REPORT

B-2A, T/N 89-0129

**393d BOMB SQUADRON
509th BOMB WING
WHITEMAN AFB, MISSOURI**

DATE OF ACCIDENT: 14 SEPTEMBER 2021

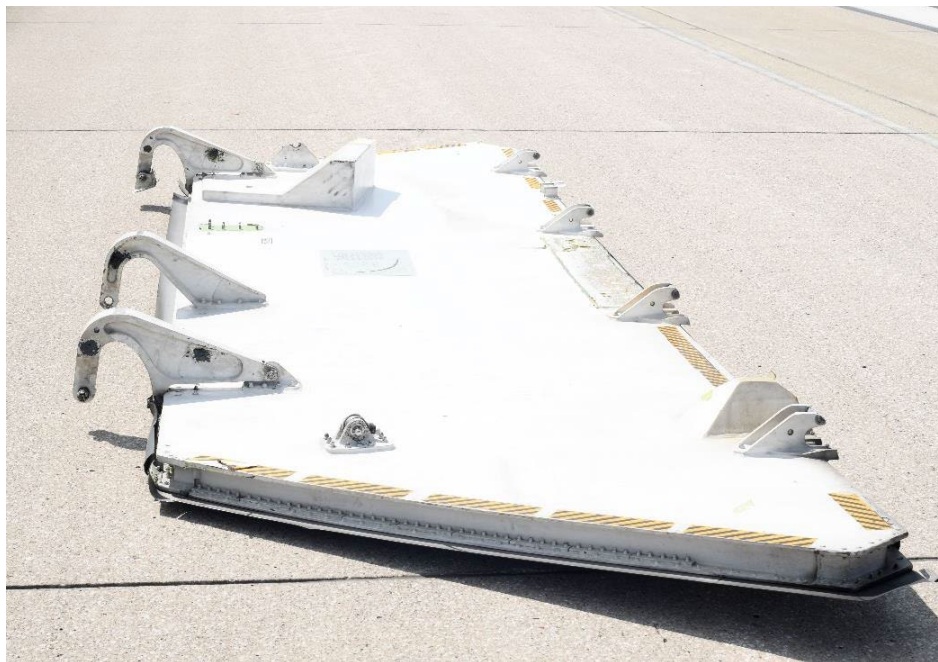
At the same time (0019:27L - 13 seconds after the final touchdown), the LMLG door came in contact with the prepared surface approximately 4,300 feet from the runway threshold (Tab S-16). At this time, the MA was travelling at approximately 109 kts ground speed with wings level (Tab DD-49). The LMLG door dragged along the runway surface for approximately 750 feet before it separated from the MA, damaging the undersurface of the wing (Tab S-16). During separation, the forward hydraulic actuator for the LMLG door ripped the forward hydraulic arm attachment point off the door. Simultaneously, the rear hydraulic actuator for the LMLG door suffered a catastrophic failure at the door attachment point. The failure of these actuators allowed the LMLG door to rotate outboard until the four door hinges failed and the door completely separated from the MA. Of the four hinges, three were torn from the left wall of the LMLG well and remained attached to the door as it proceeded to slide down the runway. The second hinge from the front of the door was similarly ripped off the left wall of the LMLG well, but also completely separated from the gear door, coming to rest approximately 770 feet from where the LMLG door initially contacted the runway (Tab S-16). From this point, the LMLG door continued to slide along the runway, coming to rest approximately 900 feet from where it first contacted the prepared surface (Tab S-16).

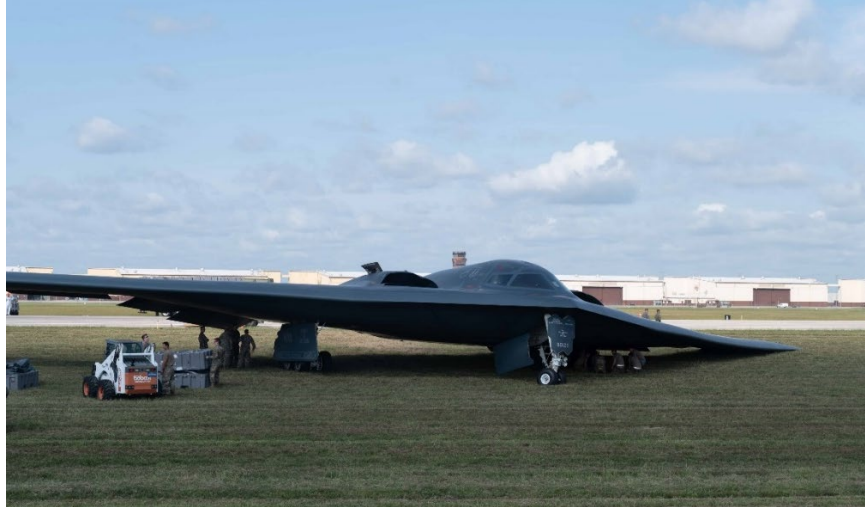
The MA sustained damage in the following areas: the Left Main Landing Gear (LMLG) door, the skin under the left wing, the left lower wingtip light, the left lower rudder, LMLG door actuators, the LMLG's retract actuator, the LMLG door mounts, and left elevator composite damage. There is also the potential for internal left wing structural damage, which will require further engineering assessment (Tab DD-41).

The Mishap Aircraft, depicted where it came to rest east of the Whiteman AFB runway.

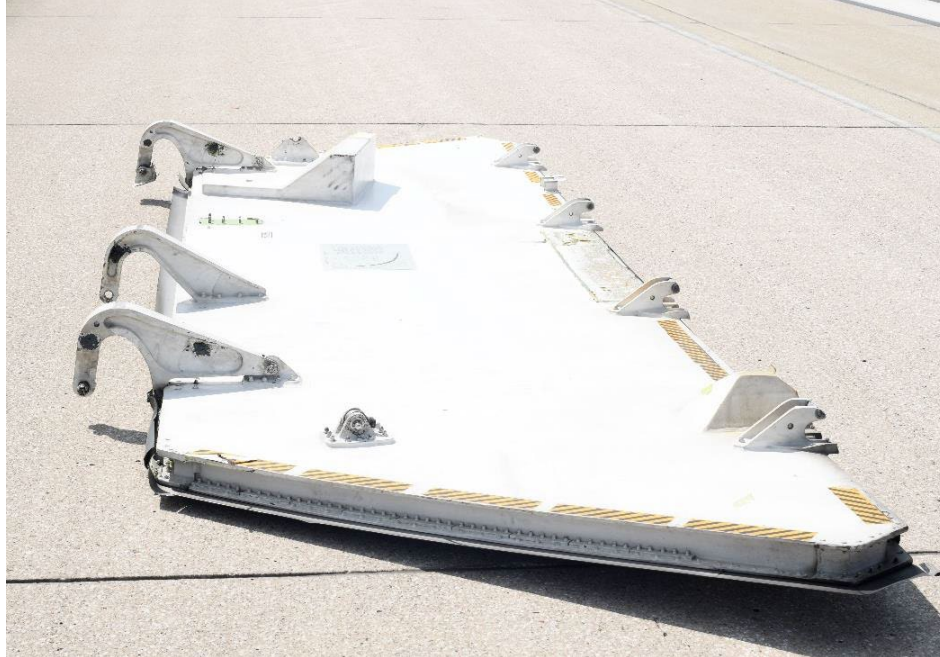
(2) Left Main Landing Gear (LMLG) Door

Upon collapse of the LMLG on rollout, the LMLG door contacted the runway, damaging the lower blade seals, door lock points, LMLG tire bumpers, forward LMLG door actuator attachment point, aft LMLG door actuator, all door hinges, and upper blade seals.

The Mishap Aircraft's LMLG door depicted on the runway following the mishap.

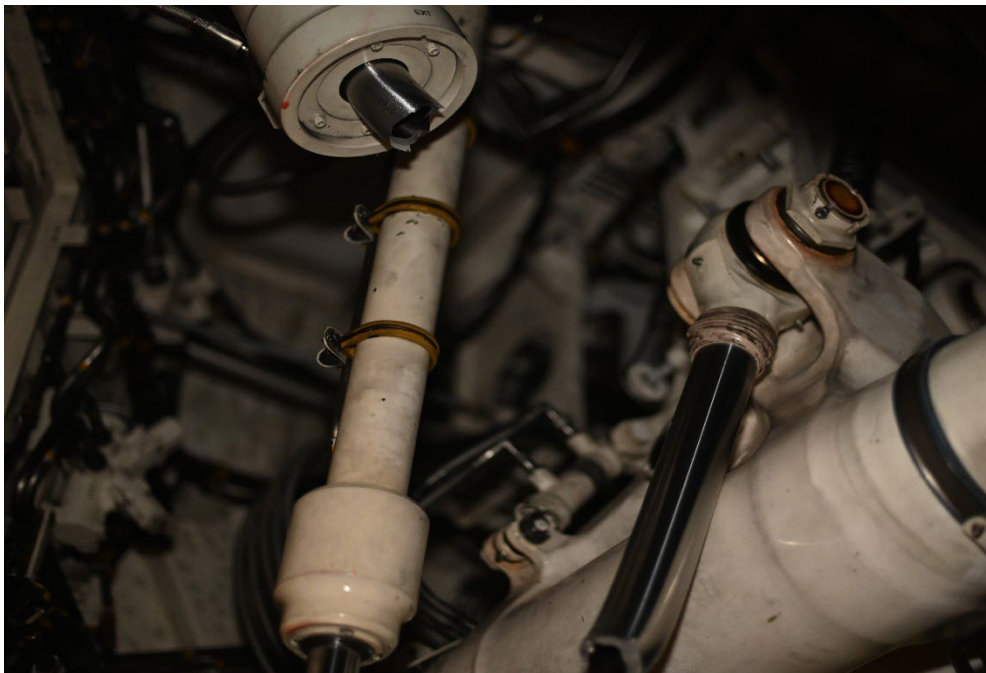
(3) LMLG Retract Actuator

Upon collapse of the LMLG on rollout, the LMLG retract actuator, which was in its “locked out” state, suffered a structural failure due to its inability to support the weight of the MA as the collapse occurred.

The LMLG's broken retract actuator piston depicted following the mishap.

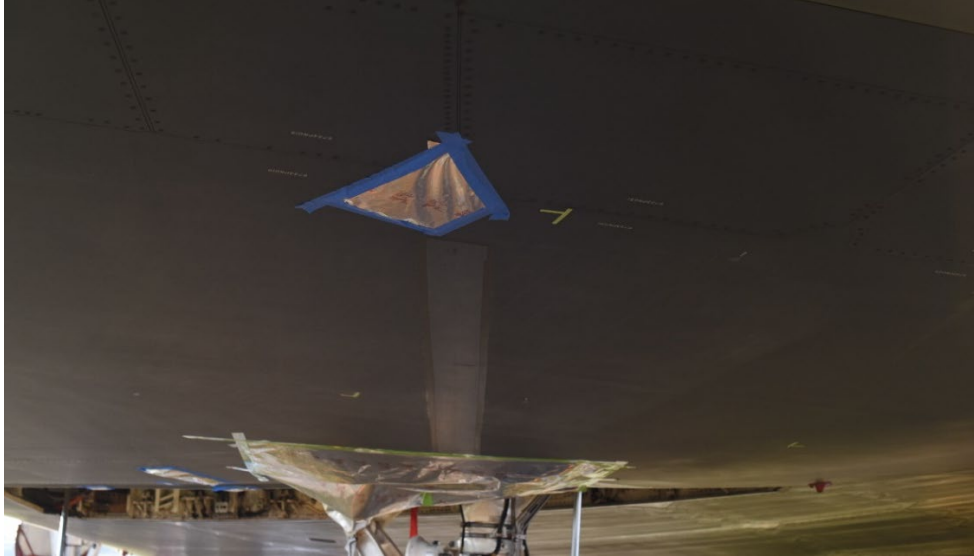
(4) Left Lower Skin

Upon collapse of the LMLG during the landing, the LMLG door separated from the MA. As it separated, it made contact with and damaged the skin on the underside of the MA's left wing.

Damage, covered with barrier paper, to the skin on the underside of the Mishap Aircraft's wing.

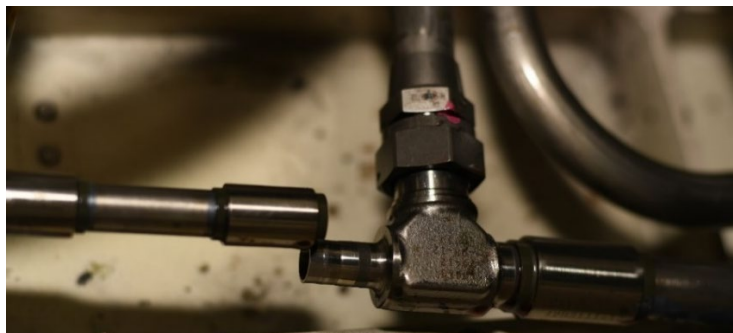
Air Force Research Laboratory (AFRL) personnel at Wright-Patterson AFB, Ohio conducted an analysis of the CryoFit component that failed, which resulted in a loss of hydraulic pressure in the MA's #1 and #4 hydraulic systems. The analysis identified a metal fatigue-related "microcracking" in the CryoFit, which appears to have led to the CryoFit sliding off the tube to which it connected. The cause of separation is still under investigation (Tabs J-33 to J-58).

The CryoFit coupling is shown separated from the hydraulic line from which it was connected to prior to failure.

The failure of a CryoFit coupling resulting in the loss of hydraulic fluid in the #1 and #4 hydraulic systems

A hydraulic CryoFit coupling on a high-pressure hydraulic line in the RMLG wheel well failed during landing gear extension. This failure was likely caused by a metal fatigue induced "microcrack" identified by engineering analysis after the mishap.

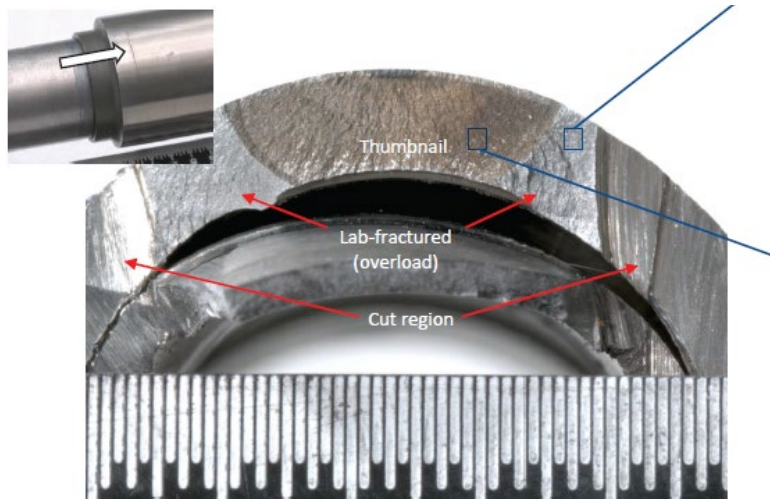
This laboratory image depicts the CryoFit with the blue lines indicating areas of metal fatigue.

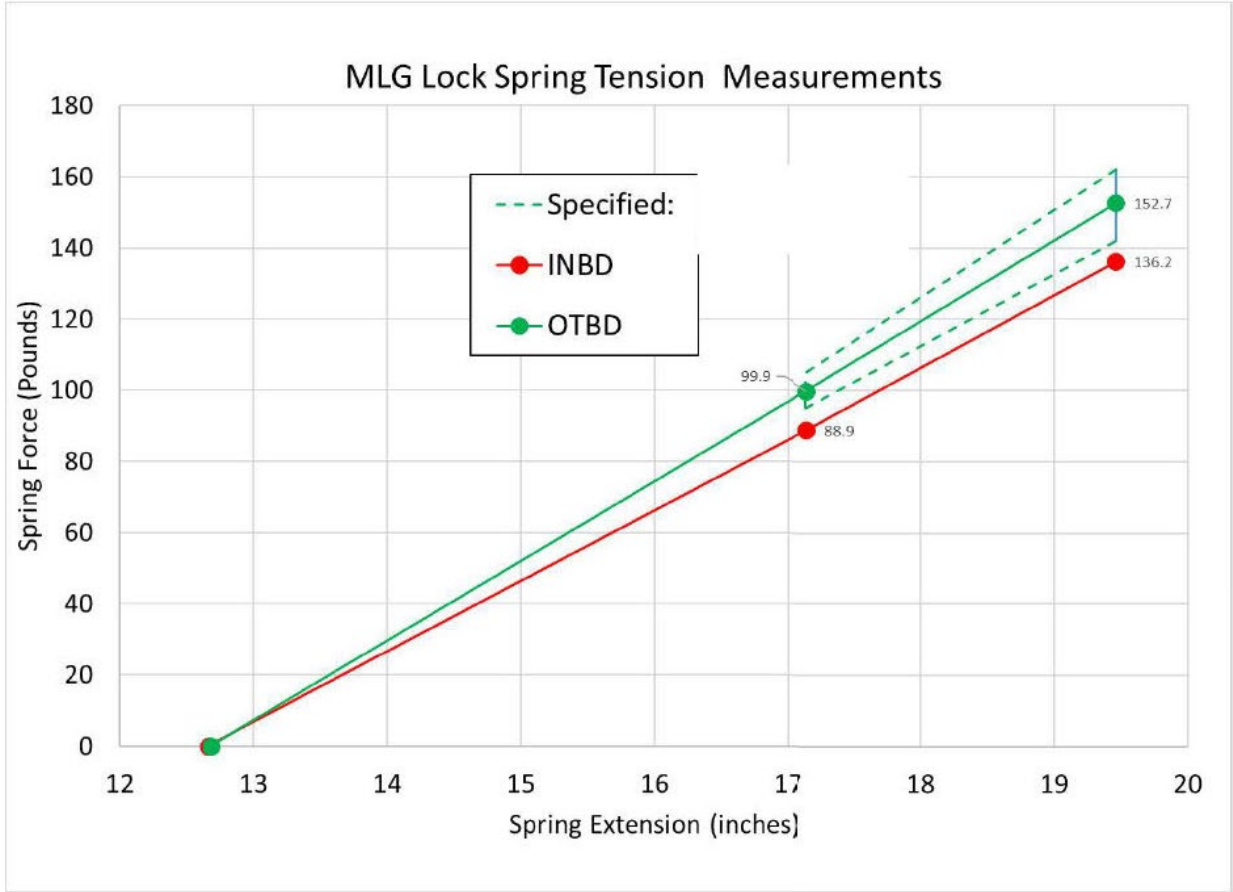
AFRL personnel at Wright-Patterson AFB also conducted an analysis of the LMLG's lock link springs. As depicted in the chart below, they assessed the amount of tension, in pounds (lbs), the springs produced at various extension lengths in comparison with the allowable tension tolerance the springs are designed to produce. The AFRL analysis found that, when fully down and locked, the inboard LMLG lock link spring produced 88.9 lbs of tension, which is below the spring's designed tension of 100 lbs and outside the ± 5 lb tolerance established for the spring at that extension. When at maximum extension, the inboard LMLG lock link produced 136.2 lbs of tension, which is below the designed tension of 152.7 lbs and outside the ± 10 lb tolerance established for the spring at that extension. Thus, at the two positions tested, the inboard spring produced approximately 11.1% and 11.0% less tension, respectively, than the designed specification. Further, the spring produced 6.4% and 4.6% less tension than the minimum allowable tolerance for the component (Tabs J-17, J-26, J-28).

The chart below illustrates the analyzed spring tensions for the LMLG lock link springs. The inboard spring (INBD) is the spring closest to the centerline of the MA, while the outboard (OTBD) spring is closest to the wing tip of the MA. The dotted section depicted on the chart is the allowed spring tension tolerance for the lock link springs. The chart indicates that while the OTBD spring is within tolerances, the INBD spring was providing below tolerance (weaker) tension at both tested positions (Tab J-26).

A chart depicting the results of AFRL testing of post-mishap tension strength for the LMLG's two lock link springs. Note the inboard spring tested below the required tolerance range.

I find, by a preponderance of the evidence, that the cause of the mishap was the failure of the MA's LMLG lock link springs to apply sufficient pressure on the lock link assembly to prevent it from folding, which resulted in a LMLG collapse during the MA's landing. The failure of the lock link springs resulted in the LMLG retracting into the LMLG well while the MA was travelling down the runway. The collapse caused a structural failure of the LMLG hydraulic retract actuator and caused the violent separation of the LMLG door as the MA settled onto its left side. The settling of the MA then caused the failure and separation of the lower half of the left rudder and caused extensive lower left wing damage as the MA continued its landing roll down the runway, resting on the NLG, RMLG and the left lower rudder/wing tip.

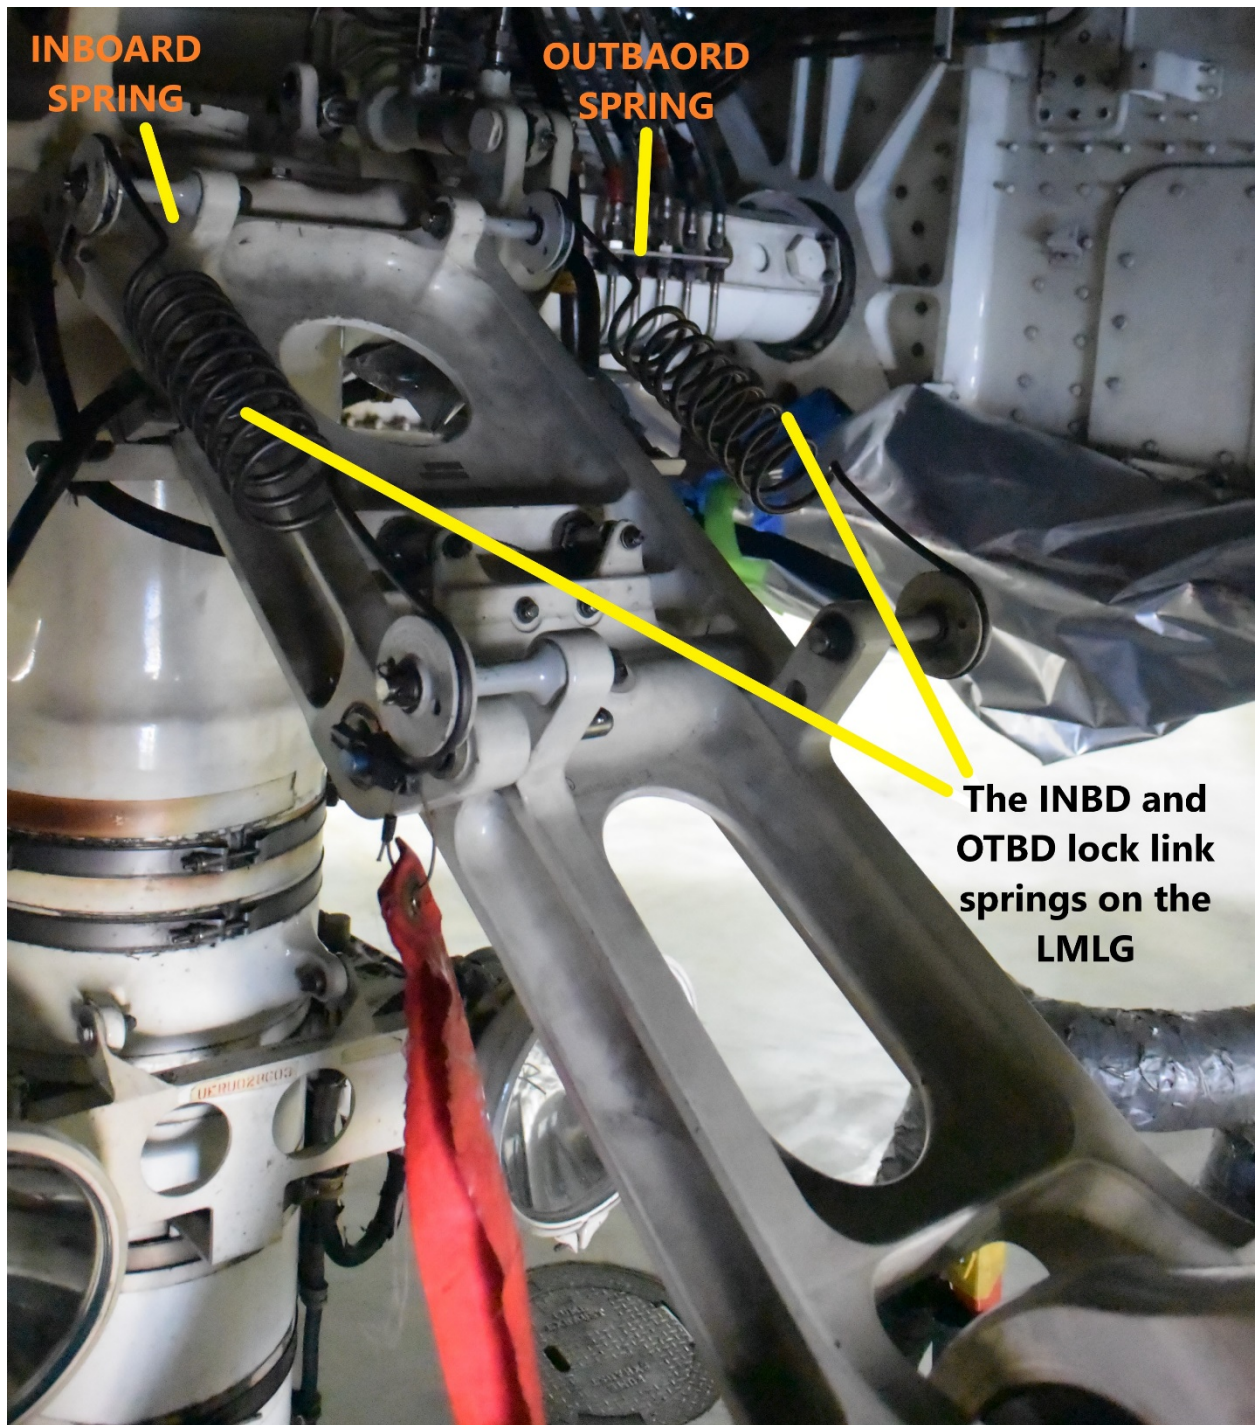
The Mishap Aircraft's LMLG lock link depicted following the mishap.

Since 2018, B-2As going through programmed depot maintenance (PDM) have had their lock link springs removed and replaced. The MA had not been through depot since this change in procedure, and a thorough search of the MA's maintenance records found that the springs had not been replaced in the last ten years. No evidence could be found that the springs had ever been replaced.
