UNITED STATES AIR FORCE
AIRCRAFT ACCIDENT INVESTIGATION
BOARD REPORT

T-38C, T/N 68-8121 & T/N 70-1586

LOCATION: LAUGHLIN AIR FORCE BASE, TEXAS

DATE OF ACCIDENT: 19 NOVEMBER 2021

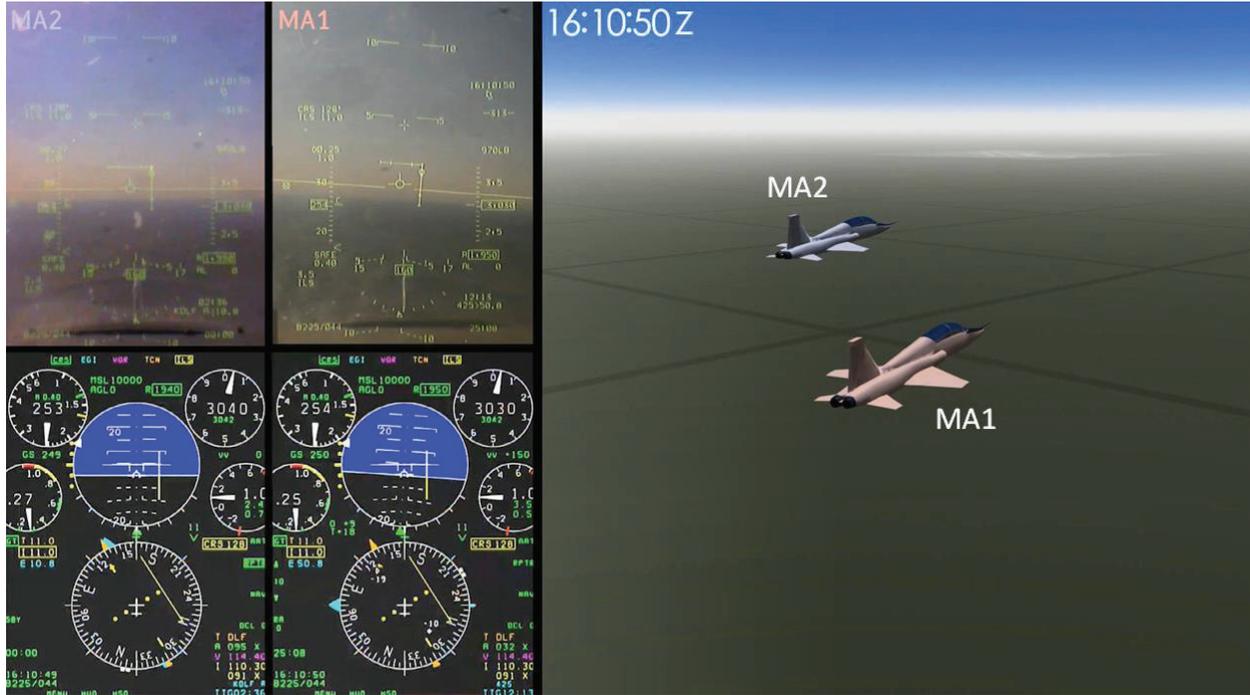
Figure 1 - (Tabs Z-2 and AA-9)

At 10:10:07L, when realizing that MA1 is on the right side of the formation, MSP states, "*Oh, excuse me, I need to put him on the left side, he's going to Lariat*" (Tab AA-8 and AA-23). MIP2 responded to MSP with a technique of keeping MA1 on the right side, saying, "*Say we have to go around and he's, like both of us? We actually want to be on the left so we can pull...*" at which

point MSP interrupts MIP2 and says “*But he’s still going into Lariat?*” (Tab AA-8 and AA-23). MIP2 then states, “*Ya it’s fine*” (Tab AA-8 and AA-23). See Figure 1 showing MA2 and MA1’s relative positions at this point during the MS.

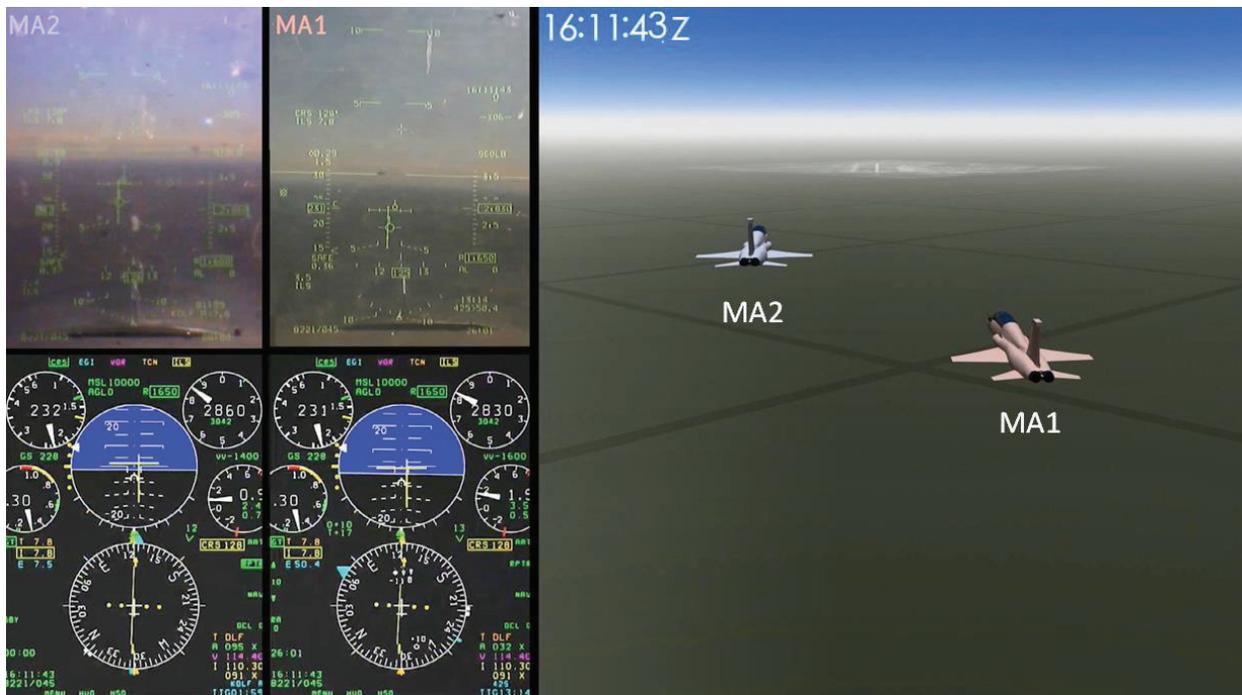
Figure 3 - (Tabs Z-4 and AA-9)

At 10:11:40L, after the turn to align to the 13C localizer, MSP rocked MA2’s wings as a visual signal for MA1 to move to the fingertip position (right side) (Tab AA-8 and AA-24). There was also some instruction from MIP2 to MSP over MA2 intercom about being a stable lead, use of throttle settings, and lowering the landing gear (Tab AA-8 and AA-24).

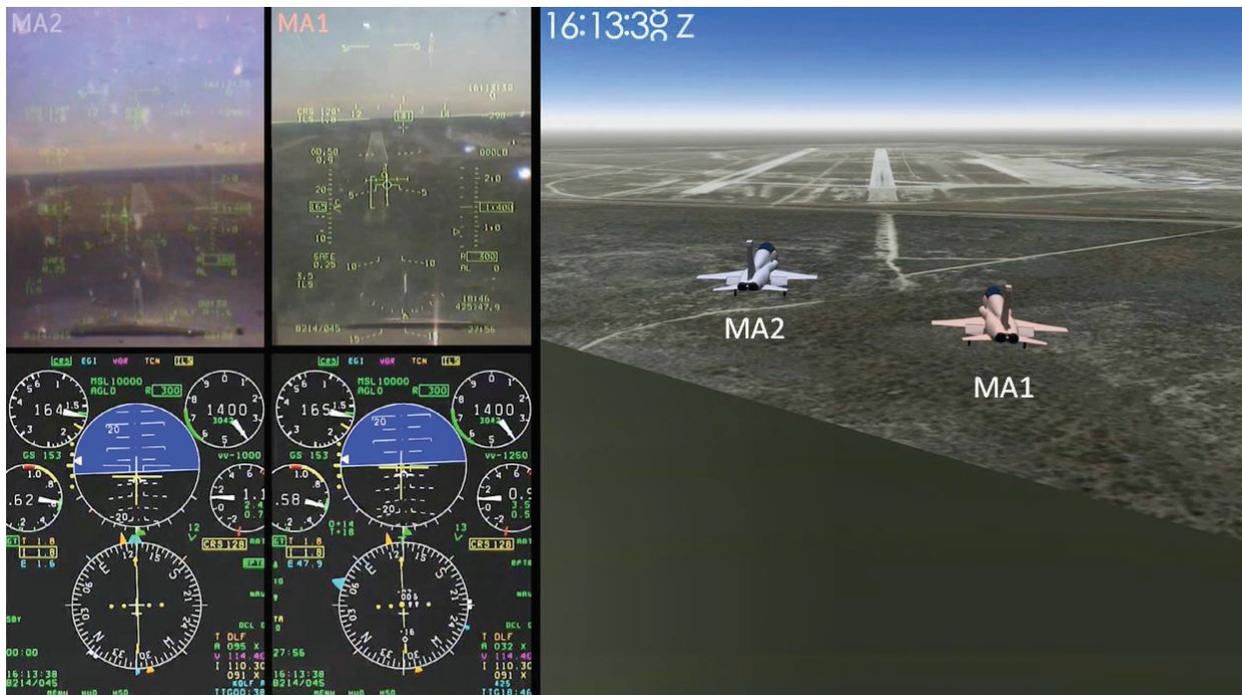
Figure 6 - (Tabs Z-5 and AA-9)

At 10:13:39L (250 feet AGL) MIP2 started a series of prompts to MSP regarding glide path correction and airspeed corrections (Tab AA-9). MSP had let MA2 get slower than final approach speed by two knots calibrated airspeed (KCAS) (Tab AA-9 and AA-25). It is unknown what visual cues, if any, MIP2 or MSP saw after the “cleared off” call because neither pilot was, or could be, interviewed; however, based on other unit pilot interviews and the board’s simulator replications, MIP2 would have seen MA1 descend after the “cleared off” call, which would have been an immediate indication that there was confusion between the aircraft (Tabs V-2.17, V-10.17, V-14.22, V-14.34, and AA-14). At this time, MIP2’s communications were focused on instructing MSP on landing the aircraft (glide path and airspeed). Based on the positions of the aircraft, MIP2 would have been able to see MA1 descending and preparing for landing, which would have been alarming and prompted immediate action. Therefore, evidence indicates that MIP2 was not looking at MA1 after the “cleared off call” (Tab AA-9 and AA-14).

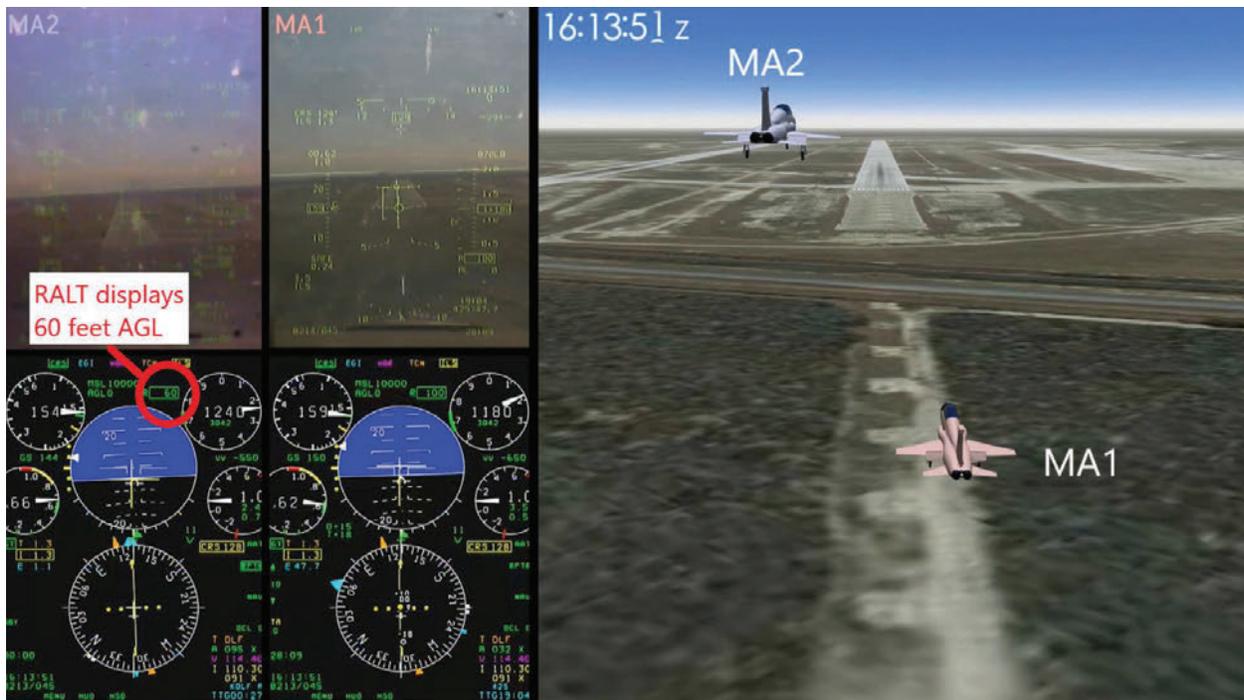
Figure 10 - (Tabs Z-8 and AA-9)

Also at 10:13:50L, MA2’s Radar Altimeter (RALT) indicated 150 feet AGL, then shortly (10:13:51L) showed 60 feet AGL, prior to switching back to 150 feet AGL (Tab AA-9 and AA-25). MA1’s RALT at this moment read 90 feet AGL. The board determined the momentary RALT deviation of MA2 was due to MA1 being 60 feet under MA2 (Tab AA-9 and AA-25).

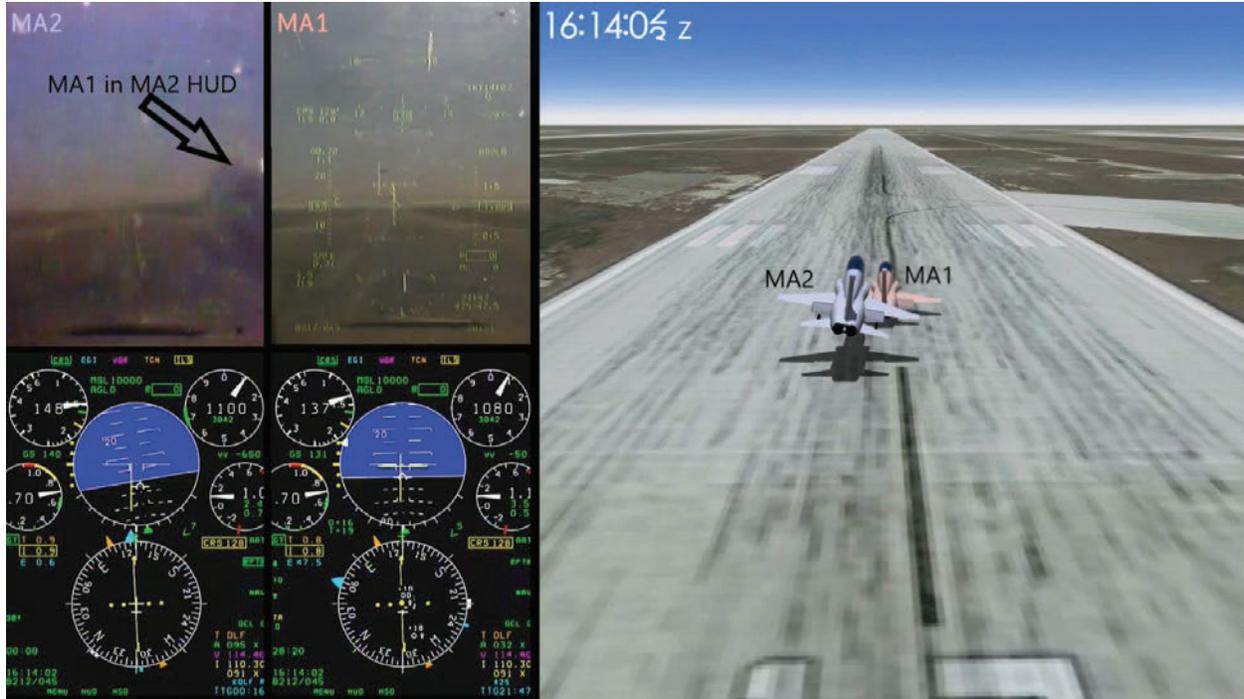
Figure 21 - (Tab Z-13 and AA-9)

At 10:14:02L, MA2's nose landing gear impacted MA1's left horizontal stabilizer at 148 Knots Calibrated Air Speed (KCAS), approximately 10 KCAS faster than MA1 (Tab AA-9).
