UNITED STATES AIR FORCE
AIRCRAFT ACCIDENT INVESTIGATION
BOARD REPORT

B-2A, T/N 90-0041

393d BOMB SQUADRON
509th BOMB WING
WHITEMAN AIR FORCE BASE, MISSOURI

SUMMARY OF FACTS AND STATEMENT OF OPINION
B-2A, T/N 90-0041
WHITEMAN AFB, MISSOURI
10 DECEMBER 2022

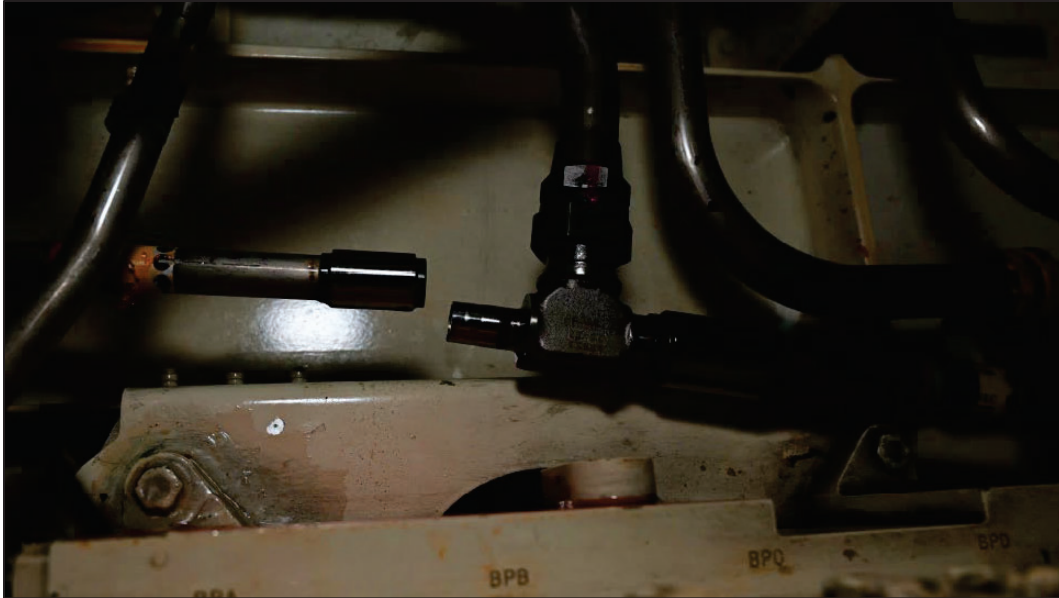
At 1424:30 CST, MP1 placed the landing gear handle to the down position at approximately 200 Knots Calibrated Airspeed (KCAS), below the B-2A's prescribed gear limit speed (Tabs V-1.3 to V-1.4, V-2.6, and CC-83 to CC-85). Placing the landing gear handle down transmits electrical control signals to hydraulically actuate the gear extension sequence (Tab CC-83 to CC-85). Prior to lowering the landing gear handle, all indications were optimal, and the landing gear extension sequence began normally. The LMLG, RMLG, and NLG doors unlocked as designed (Tab CC-83 to CC-85). However, as the sequence valve hydraulic lines were pressurized in preparation for actuating the RMLG Unlock Actuator, the Truck Position Sequence Valve CryoFit® coupling (i.e., Mishap CryoFit® Coupling (MCC)), failed as depicted in Figure 5 below (Tab CC-83 to CC-85).

Figure 5: Failed MCC in RMLG Wheel Well (Tab S-14)

The MCC failure expelled the 1/2-inch diameter MCC from its compatible T-fitting, preventing hydraulic pressure from reaching the RMLG sequence valve circuit, which would have unlocked the RMLG. This failure created an opening in the MLG hydraulic circuit, causing hydraulic fluid to be pumped overboard rapidly (Tab CC-83 to CC-85). This loss caused an immediate drop in pressure in the primary hydraulic system (Tab CC-83 to CC-85).

Failure of the RMLG MCC occurred in flight immediately after the MC placed the Landing Gear Handle Down, sending pressurized hydraulic fluid overboard and depleting the primary and backup hydraulic systems as the PSLUs commanded the switching valves to utilize each system (Tab CC-86).

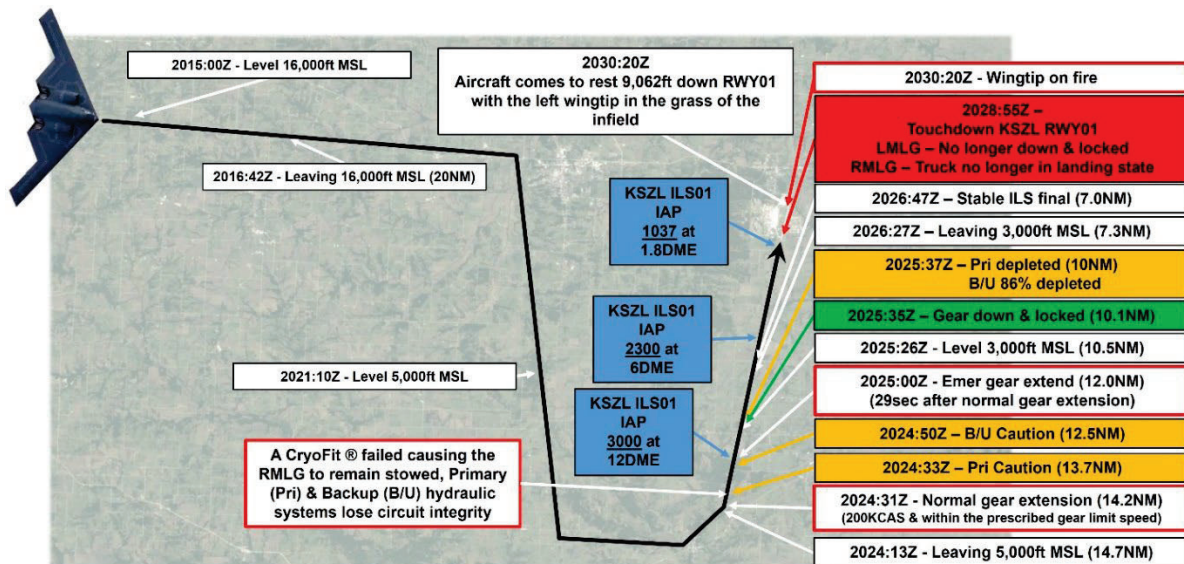
Figure 6: MA's Flight Path with Sequence of Events (Tab CC-85)

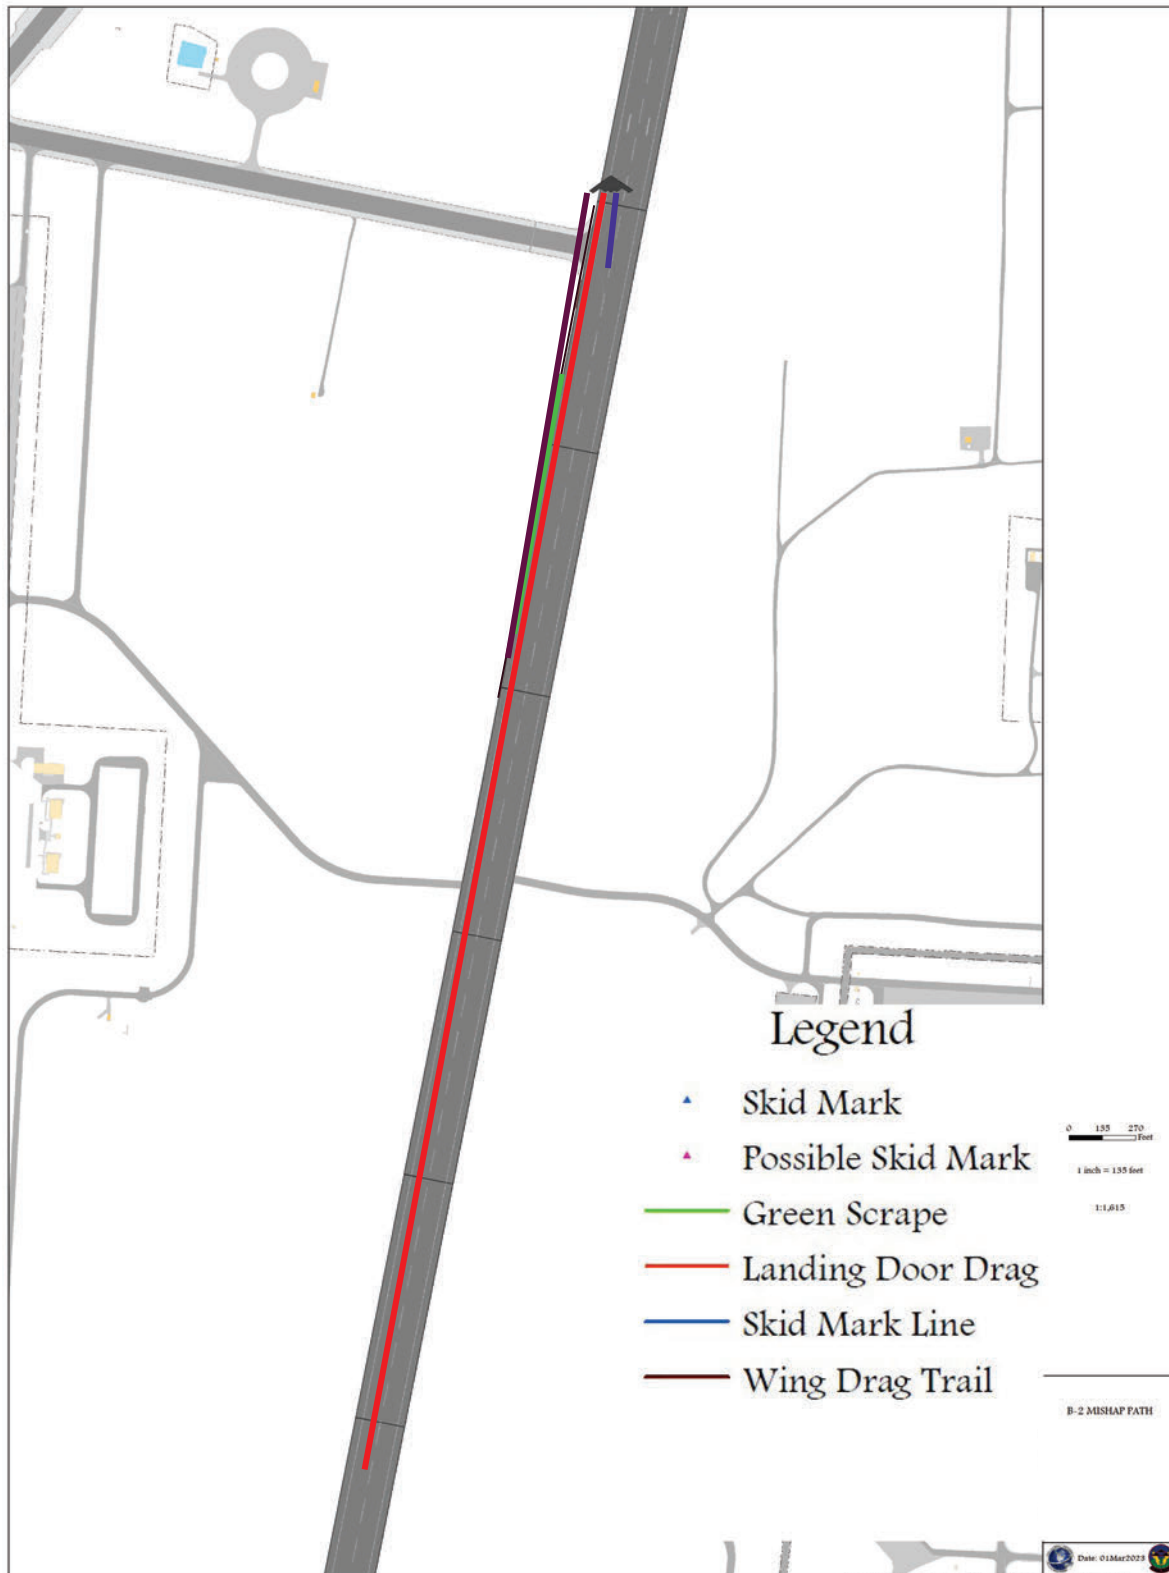
On touchdown, the LMLG Lock Link Assembly failed to stay locked in the overcenter position, causing the LMLG to collapse under the aircraft’s weight (Tab CC-85). As shown in Figure 7, approximately 3,750 ft down the runway, the aircraft’s weight transferred to the LMLG door due to the LMLG collapsing and folding into the LMLG wheel well (Tabs S-4 to S-6, S-11, S-13, V-3.7, and Z-23).

Approximately 8,750 ft down the runway, as shown in Figure 7, the left wingtip and rudder assembly were dragged across taxiway Bravo (Tab Z-23). The concrete surface of Taxiway Bravo eroded the left wingtip to such a degree that the fuel tank within the wing ruptured and caused a fire to ignite on taxiway Bravo (Tabs N-5 and V-12.6).

Figure 7: Runway Diagram Depicting Drag and Fire Damage (Tab Z-23)

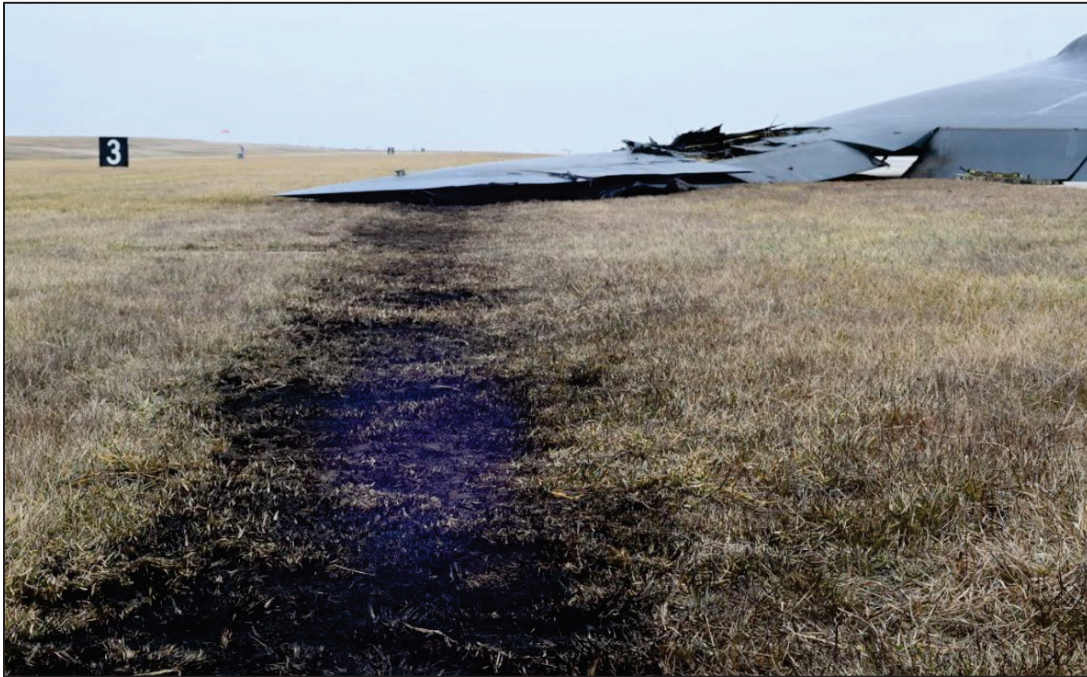
Figure 8: Photograph of Drag and Fire Damage (Tab S-3)

As the left wingtip was being dragged, the concrete of taxiway Bravo wore down the under skin enough to rupture the left surge fuel tank, igniting it (Tabs S-8 to S-9, V-5.5, and V-10.5). This fire caused a small explosion from the left surge fuel tank (Tabs S-8 to S-9, V-5.5, V-10.5, and V-12.4 to V-12.5). The fire spread to the left outboard fuel tank, which caused a larger second explosion from the top of the left wing as seen in Figure 8 above (Tabs S-3, V-12.4 to V-12.5, and V-12.9).

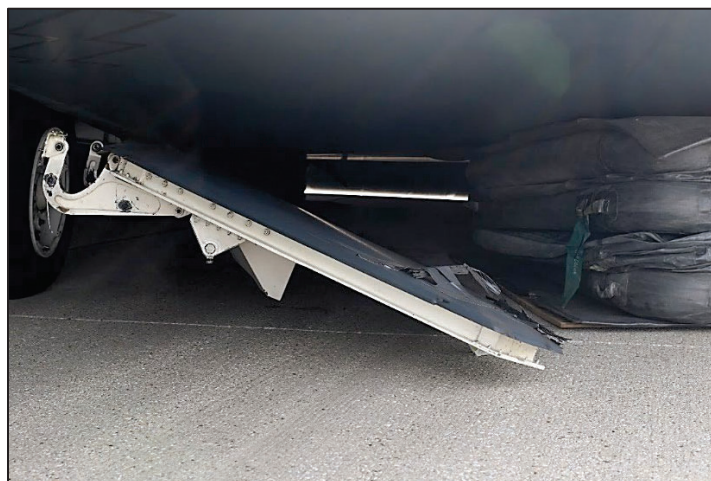
The LMLG door was damaged when it was dragged across the runway after the LMLG collapsed upon landing (Tab S-11). After the MA came to rest, the weight of the left side of the aircraft bent the door outwards towards the left wingtip (Tab S-4 to S-6, S-11, and S-13). This broke the forward door mount and forward door actuator and bent and damaged the aft door actuator, as seen in Figure 9 below (Tab S-11).

Figure 9: Damage to LMLG Door (Tab S-11)

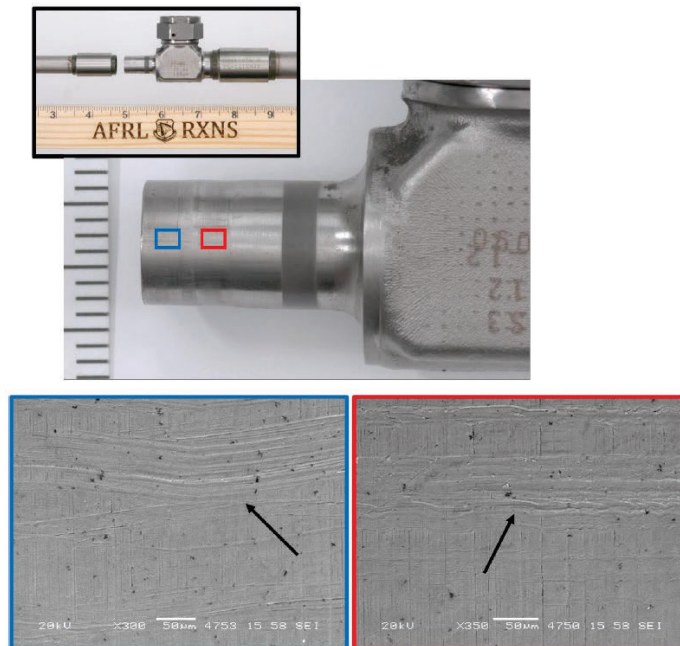
Visual inspection, Computed Topography (CT), and scanning electron microscopy were used to analyze the MCC (Tab CC-86). These techniques revealed no notable surface or internal flaws nor any evidence of microcracking (Tab CC-86). However, witness (i.e., drag) marks on the exterior of the T-fitting were observed using scanning electron microscopy (Tab CC-86). The witness marks were continuous in nature, relatively linear, and present around the entire circumference with similar frequency, as seen in Figure 10 below (Tab CC-86). There was no evidence of multiple starts or stops, which suggests that the expulsion likely occurred during a single event (Tab CC-86).

Figure 10: Witness Marks on the T-Fitting after MCC Expulsion (Tab CC-86)

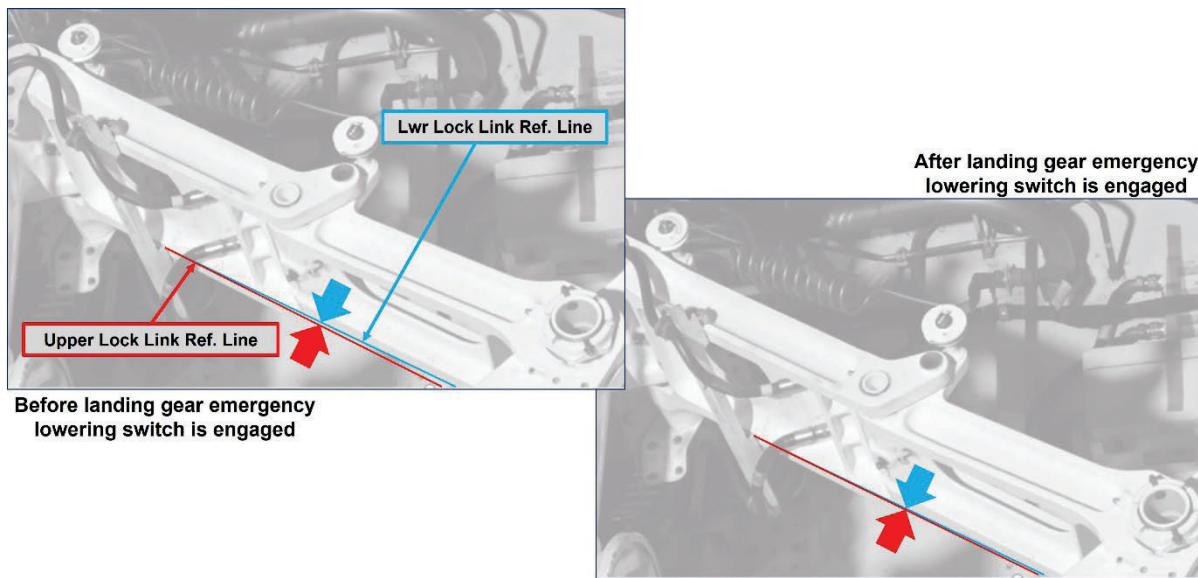
The Emergency Bypass Valve closing and blocking the high pressure to the LMLG sequence valves caused the Lock Actuator to retract an unknown distance in the unlock direction, breaking the integrity of the LMLG Lock Link Assembly which had held the LMLG down (Tab Z-25 to Z-27). Despite the slight retraction, the LMLG Locked Proximity Sensors remained within a gap tolerance and continued to report as down and locked to the MA's MDU Status Page and Landing Gear Panel that indicated the LMLG was down and green (i.e., safely locked in the landing position) (Tabs V-1.4 to V-1.5, V-1.8, V-2.8 to V-2.9, and CC-88).

Figure 11: The light blue line is a reference line highlighting the lower edge of the Lower Lock Link and remains in a fixed position. The red line is referencing the bottom edge of the upper Lock Link. The red line moves closer to the light blue line in the second frame immediately following the Emergency Lowering Switch. These screenshots from the video of testing conducted during the AIB that demonstrate that the MLG Lock Actuator retracted an unknown distance, moving the Lock Link Assembly from its overcenter position, causing a loss of integrity because the MA's LMLG was already down and locked when the pressure was removed by the Emergency Bypass Valve (Tab Z-27).

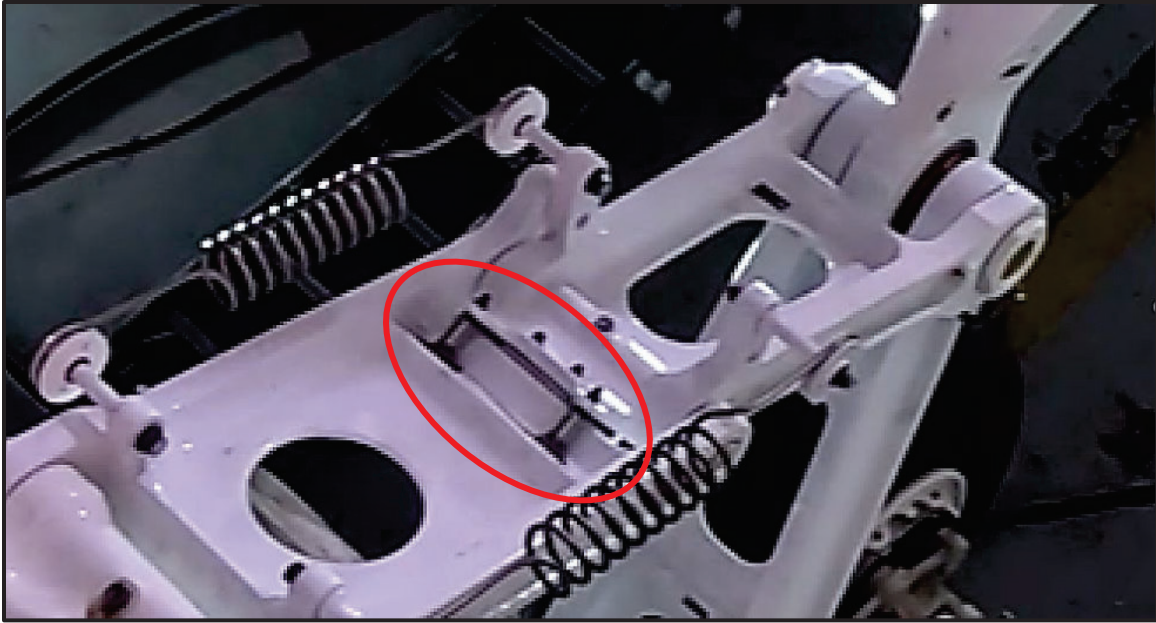
The MLG Lock Link Assembly will indicate down and locked or up and locked when the lock links are overcenter and resting on a mechanical stop. Although the MLG Lock Link Assembly may no longer have integrity when resting on its mechanical stop, if the distance between the sensor and the target falls within the rig tolerance (seen in Figure 12, below), the proximity sensors still report “target NEAR” (i.e., locked) (Tab CC-88). This tolerance allowed the MA's LMLG Lock Link Assembly to lack integrity but still indicate down and green (i.e., safely locked in the landing position) on the MDU Status Page and Landing Gear Panel (Tab CC-88).

Figure 12: MLG Primary and Alternate Locked Proximity Sensors (Tab Z-25 to Z-26)

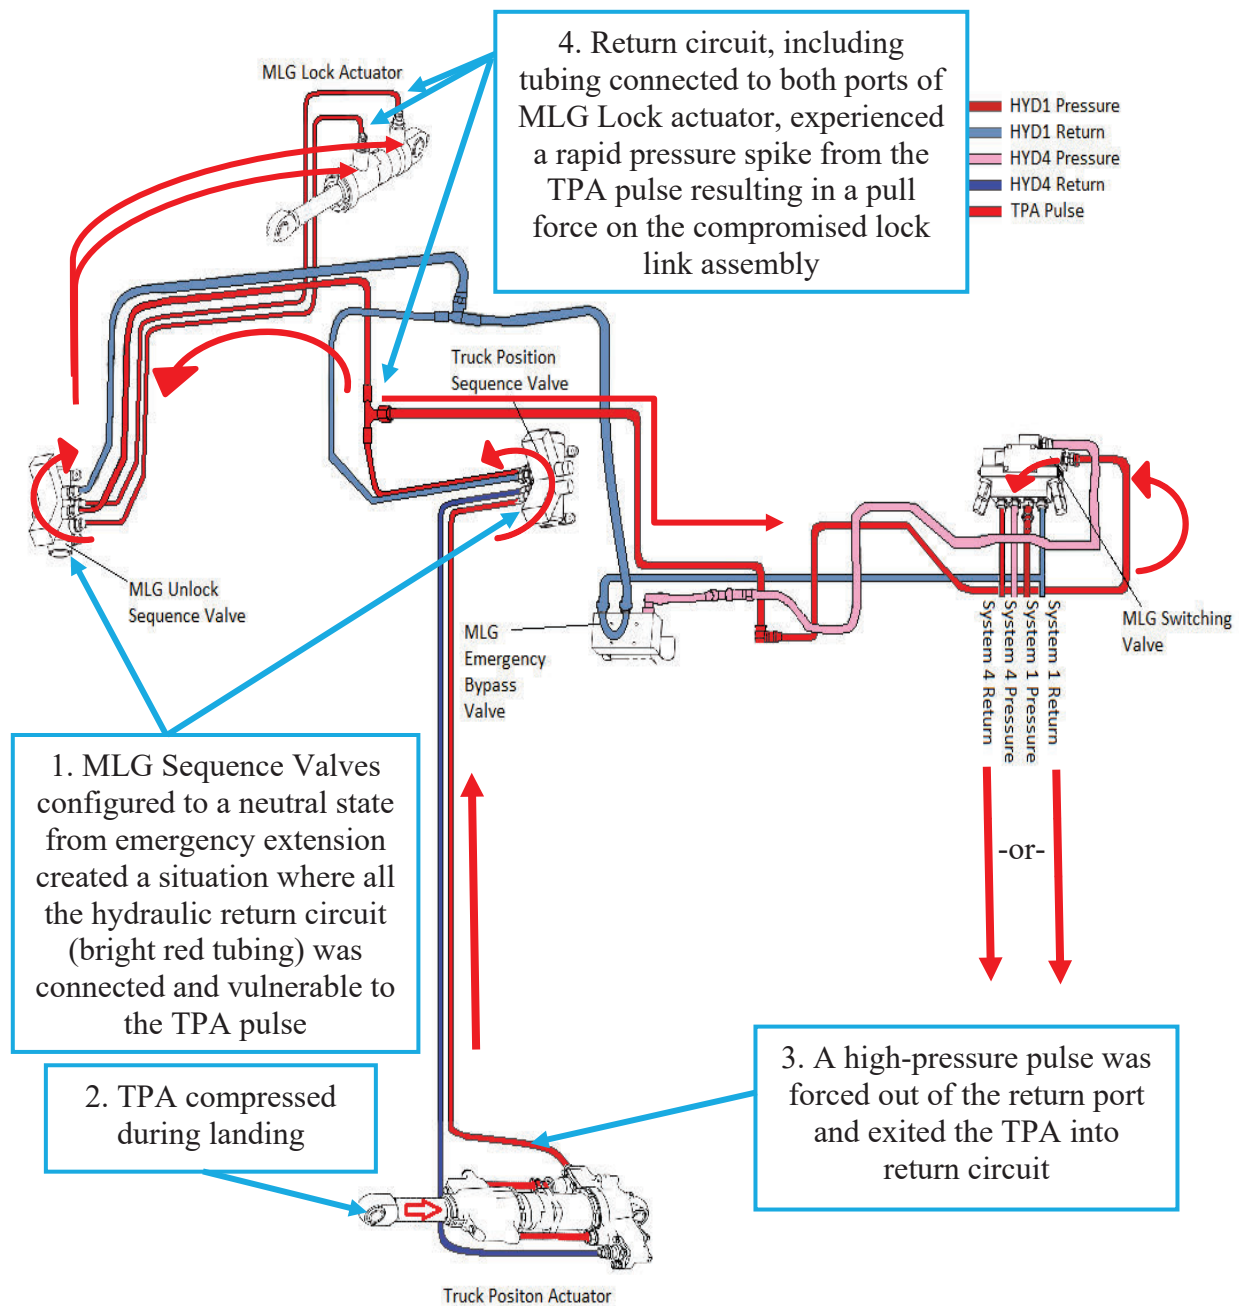
The second event that caused further lack of integrity of the LMLG was an unintended TPA pressure pulse upon landing. The TPA compressed approximately two inches under the weight of the aircraft upon landing (Tab CC-88 to CC-89). During this compression, there are additional restrictors and check valves which enable and control internal hydraulic fluid flow within the actuator (Tab CC-88 to CC-89). Hydraulic fluid inside the TPA is forced out of the return port and into the common return circuit due to the different dimensions and characteristics of the two sides of the actuator (Tab CC-88 to CC-89). The pulse from the TPA impacts the MLG Lock Actuator which is connected to this common return circuit through the MLG sequence valves when they shuttle to a neutral configuration (Tab CC-88 to CC-89). A higher pressure fluid inside the TPA during compression was released into the common return circuit due to the internal relief valves specification (Tab CC-88 to CC-89). The fluid flowed rapidly into the return circuit and back to the system reservoir (Tab CC-88 to CC-89).

Figure 13: TPA Pulse and Common Return System Layout (Tab CC-89).

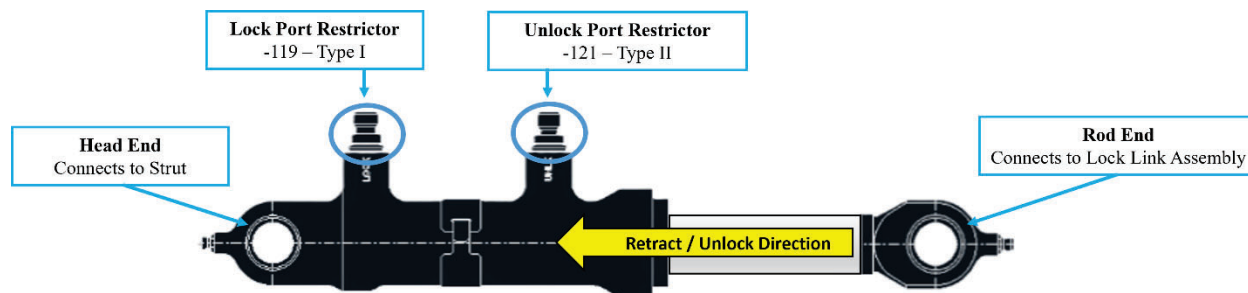
from the up/stowed and down/locked positions (Tab CC-89). The Lock Actuator has a Type I restrictor on the lock port and a Type II restrictor on the unlock port (Tab CC-89). The unlock Type II port is less restrictive than the lock Type I port (Tab CC-89). Upon landing, both restrictors received a simultaneous pulse, and this design created a pull force in the unlock/retraction direction (i.e., greater pressure on the rod end versus the head end of the Lock Actuator), which retracted the actuator, overcame the LMLG lock link assembly spring force, and collapsed the LMLG (Tab CC-89).

Figure 14: MLG Lock Actuator highlighting the specifications of the installed restrictors (Tab CC-89).
