UNITED STATES AIR FORCE
AIRCRAFT ACCIDENT INVESTIGATION
BOARD REPORT

F-35A, T/N 15-5197

**421ST FIGHTER SQUADRON
388TH FIGHTER WING
HILL AFB, UTAH**

DATE OF ACCIDENT: 19 OCTOBER 2022

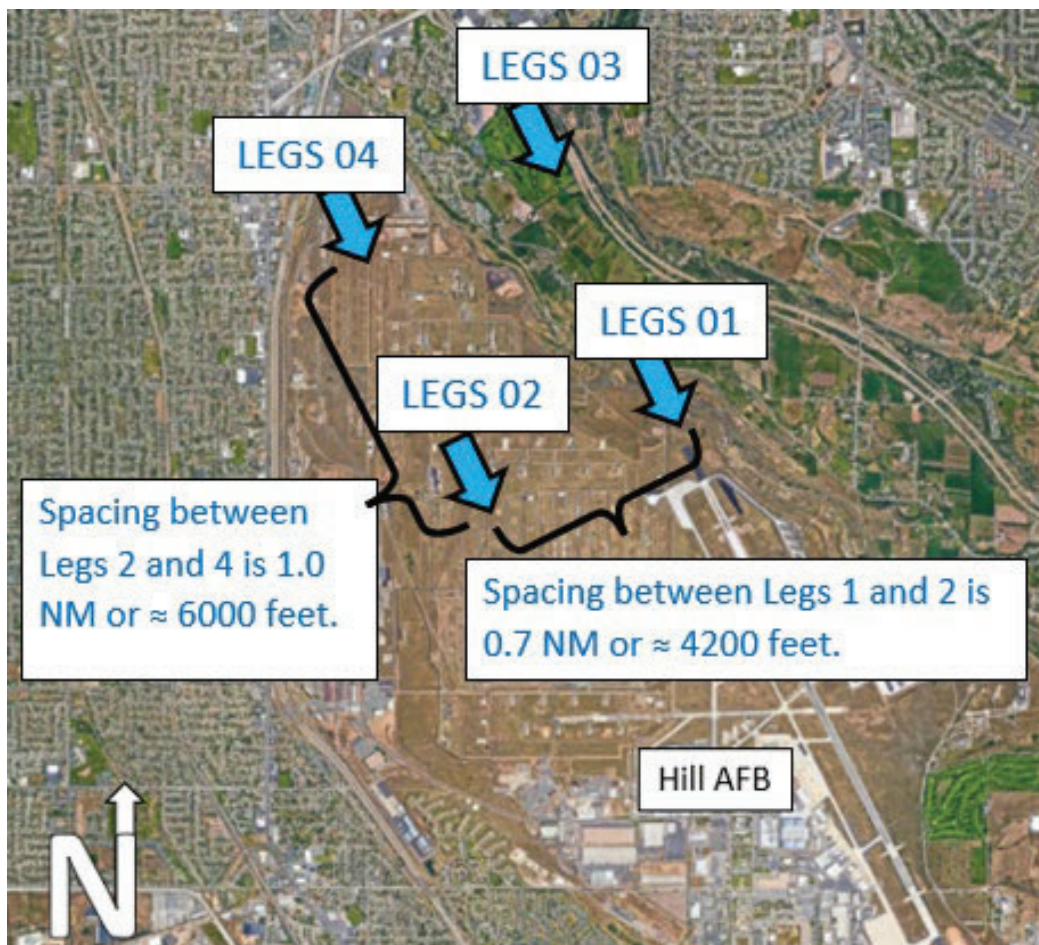
Figure 1: Formation Spacing arriving at Hill AFB (Tab Z-2.1)

At 17:56:26, Legs 04 relayed the weather information to the MF (Tab CC-1.3). When Legs 04 relayed the weather, Legs 04 did NOT state that wake turbulence procedures are in effect (Tab CC-1.3). While Legs 04 should have relayed this information, based on the reported light winds, all pilots in the MF should have known wake turbulence procedures were in effect and landing distances increased (Tab CC-1.3). Pilots are responsible for wake turbulence separation when maintaining visual separation or operating under visual flight rules (Tab BB-2.17).

Legs 02 and Legs 03 were not aware wake turbulence procedures were in effect (Tabs V-1.1.4 and V-3.2.4). As the MF announced the intention to land, the Hill AFB Tower noted to the entire MF at 18:07:29L that the current winds were at 5 knots (TAB CC-1.3). This is enough information for all pilots in the MF to know they must increase pattern and touchdown spacing in accordance with wake turbulence procedures (Tab CC-1.3). Legs 02 set the normal spacing (3,000 ft) behind Legs 01 (Tab V-3.2.3). According to available data, Legs 02 was approximately 5,000-6,000 ft behind Legs 01 (Tab CC-1.3). Legs 01 and Legs 02 did not encounter any wake turbulence or atmospheric disturbances and landed uneventfully (Tabs V-3.2.3 to V-3.2.4, and CC-1.3).

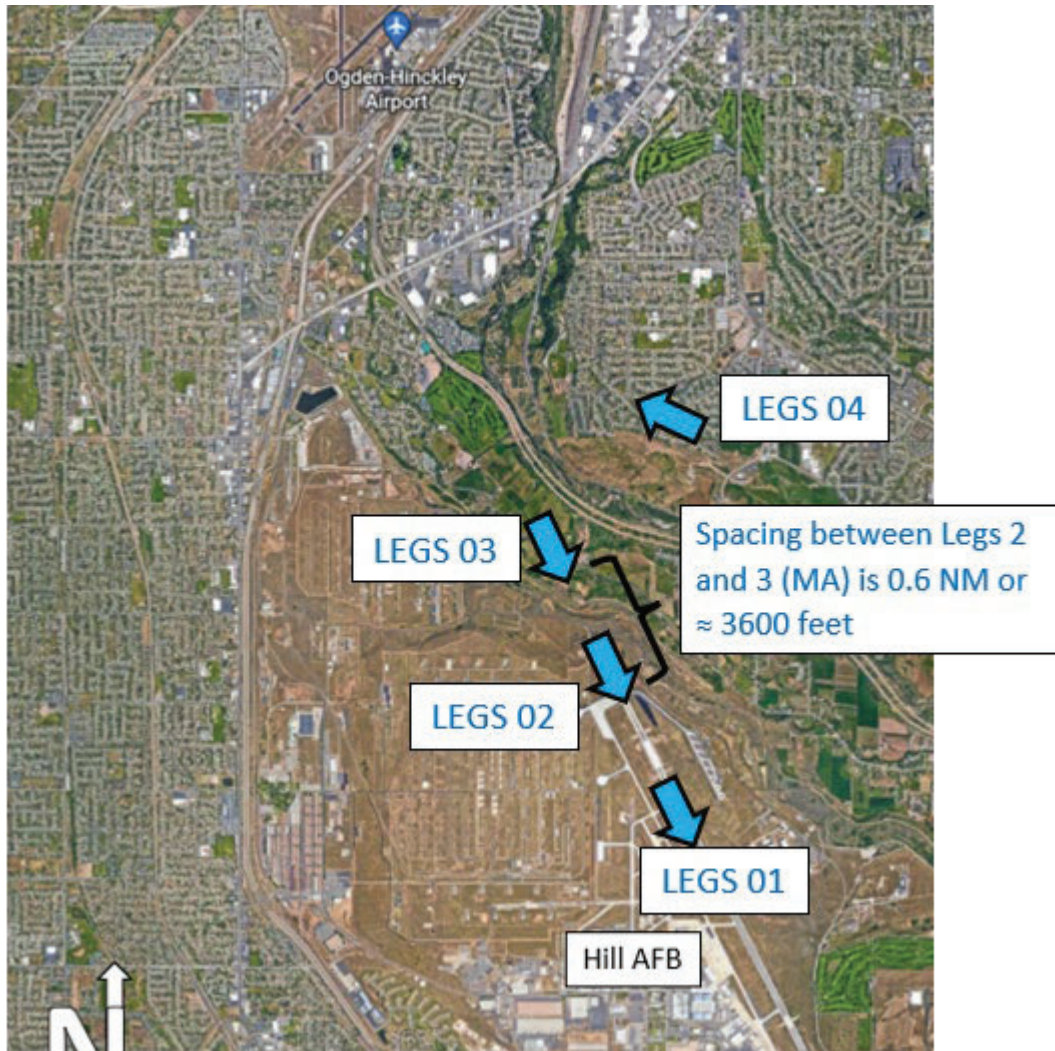
Figure 3: Approximate Aircraft Spacing just prior to Legs 02 Touchdown (Tab Z-4.1)

Legs 03 initiated his normal landing procedures approximately 3000-4000 ft behind Legs 02 (Tabs V-1.1.4 and CC-1.3).

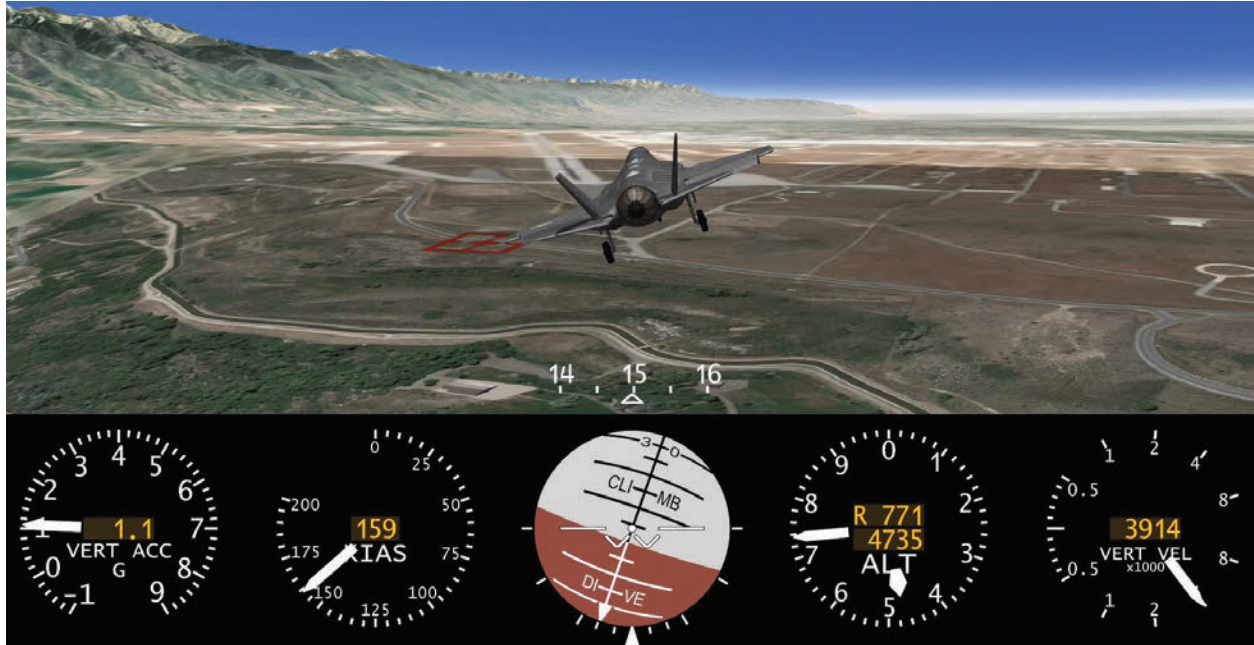
The MP testified that when he rolled out on final approach, he felt a distinct “burble” (or rumbling) on the MA (Tab V-1.1.5). Most F-35 pilots interviewed for this investigation and the AIB’s F-35 Pilot Member, regularly experience wake turbulence while flying the aircraft (Tabs V-2.1.6, V-4.2.5, and CC-1.2). Based on available data, the MA was in disturbed air, called wake turbulence, for 3 seconds from 18:08:27L to 18:08:30L (Tab J-1.19).

Figure 4: MA at 18:08:27 rolling out on final and felt “burble” (Tab S-6.1)

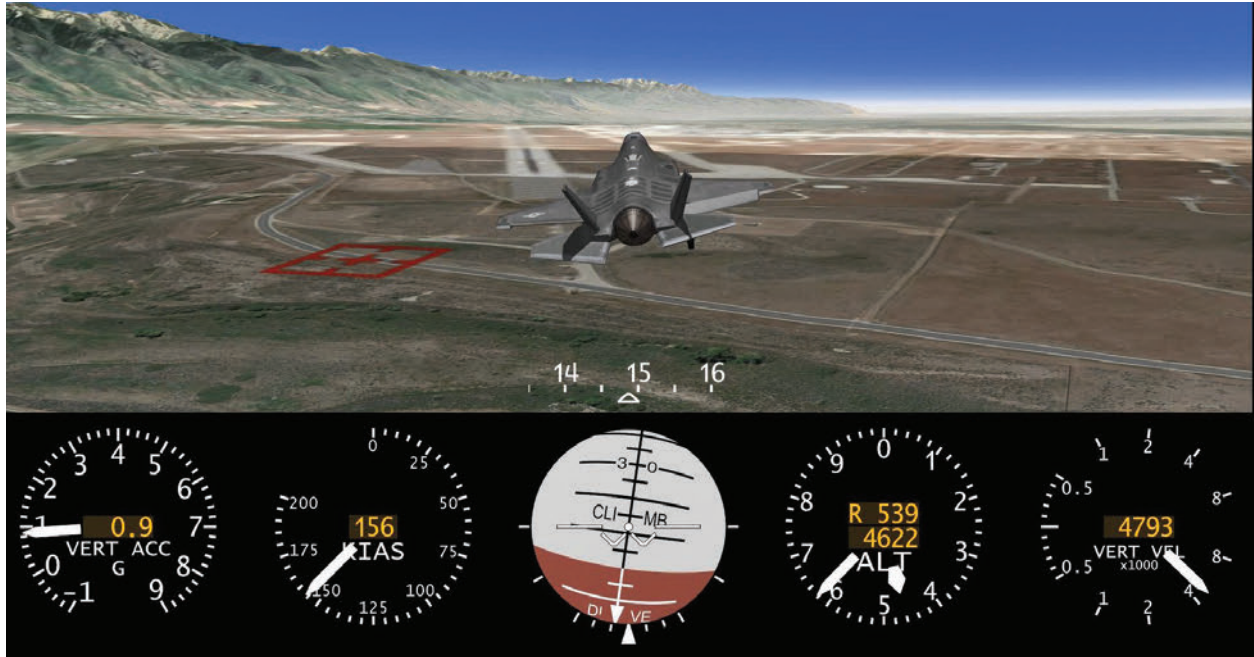
The MP noted, and the CSMU verified, an AIR DATA DEGD (degrade) integrated caution advisory or warning (ICAW) at 18:08:29L (Tabs J-1.42 and V-1.1.5). This ICAW, with a visual and audio notification to the MP, indicated one or more air data sources were degraded and was the first indication to the MP that there was something out of the ordinary occurring with the MA (Tabs J-1.42 and V-1.1.5). The F-35 enterprise has over 600,000 flight hours and this is the first known occurrence where wake turbulence had this impact on the air data system (ADS) (Tabs V-2.1.6 and CC-1.2).

Figure 5: MA at end of 18:08:30 (Tab S-6.1)

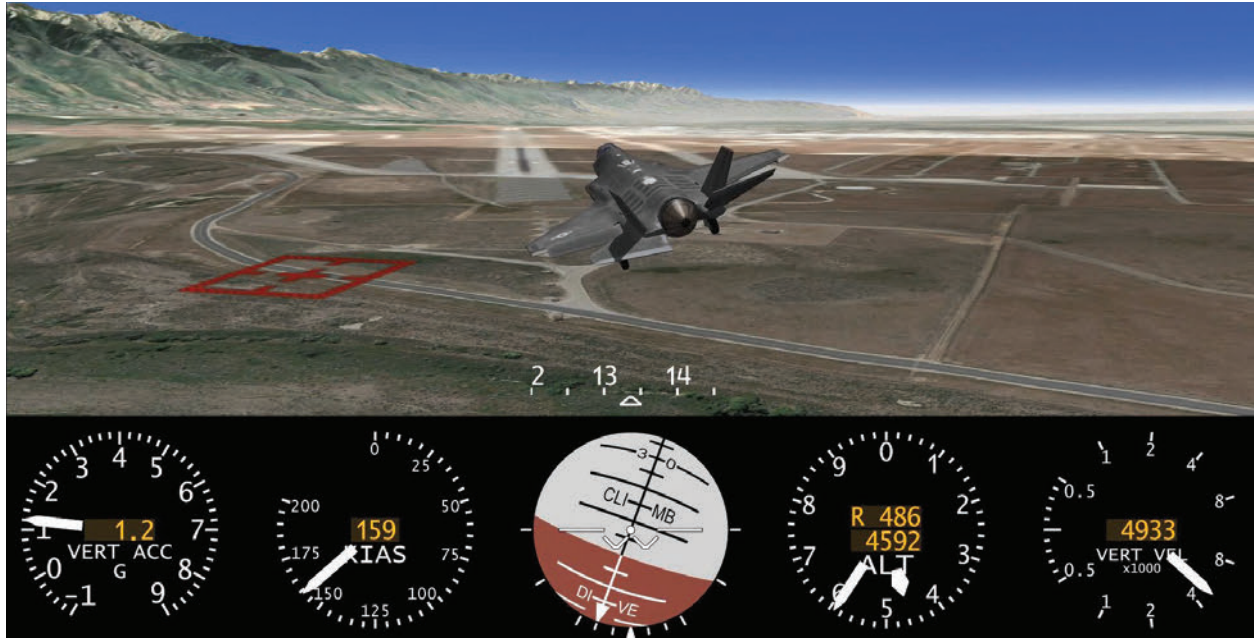
After selecting full afterburner power, the MA continued to not respond as expected to MP inputs (Tab V-1.1.5). At approximately 18:08:33L, 3 seconds after the MA exited the wake turbulence, the MA banked sharply with the left-wing down (Tab J-1.22). The MP re-applied full roll stick at approximately 18:08:35L to counter the aggressive MA bank to the left (Tabs J-1.22 and V-1.1.5).

Figure 6: Wing drop at 18:08:33L (Tab S-6.1)

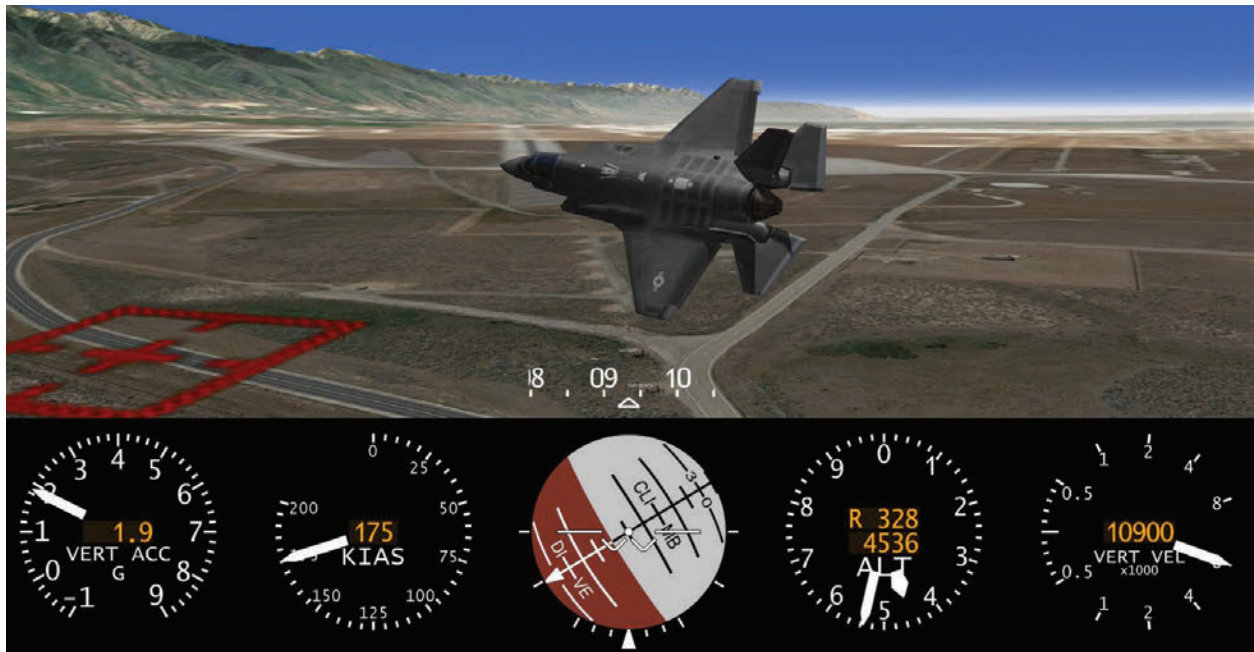
With the MA responding erratically to the inputs of the MP, the MP released control of the MA at approximately 18:08:36L to eject from the aircraft (Tabs J-1.22 and V-1.1.6).

Figure 7: MA flight condition at ejection initiation (18:08:36L) (Tabs J-1.22 and S-6.1)

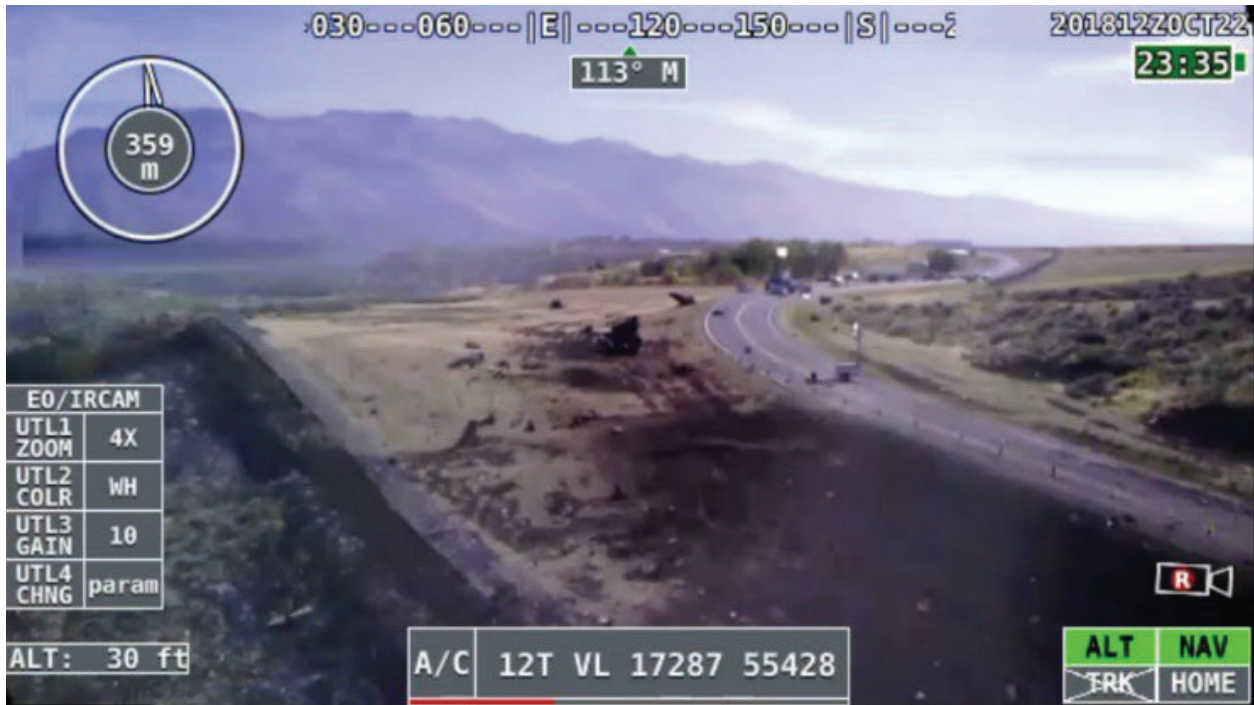
The MP ejected at approximately 18:08:36L, the MA continued into the terrain just north of the approach end of RWY 14 at Hill AFB in full afterburner with the left wing striking the ground first (Tab J-1.22 and J-1.48).

Figure 9: MA at impact site (Tab S-4.1)

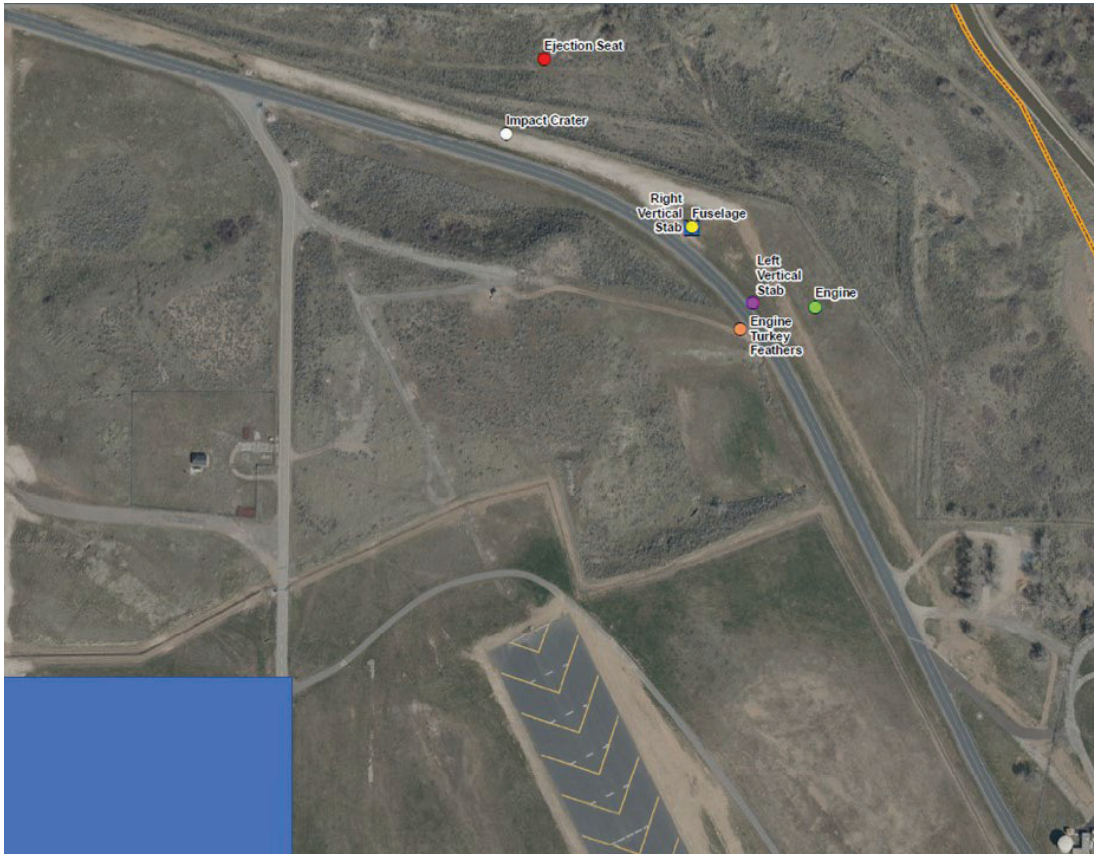
The debris field fanned out with most of the aircraft disintegrating within airfield boundaries (Tab J-1.9). Parts of the cockpit, canopy and ejection seat were located just outside the airfield boundary fence line (Tab J-1.9).

Figure 10: MA debris field on approach end to RWY 14 (Tab S-1.1)

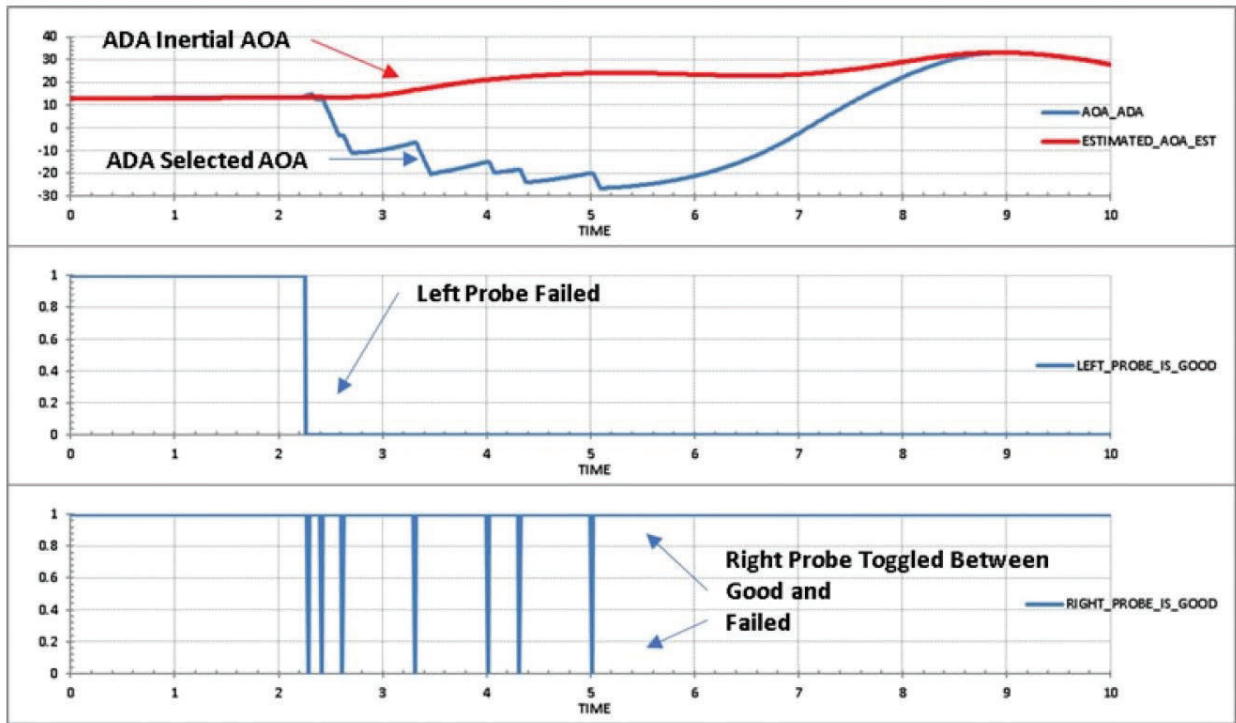
Each time the right probe was intermittently excluded, the ADA switched between primary and back up sources to determine flight conditions (Tabs J-1.29 and V-2.1.5). With each transition, a value referred to as a “sump,” was added to the on-board model to smooth flight control movements while switching between primary and backup (Tabs J-1.29 and V-2.1.7). “Sump” values nominally decay over four seconds, assuming there is a single transition between sources (Tab J-1.30). During the right probe’s multiple, short-duration, readings outside of input limits, the ADA switched between primary and backup sources multiple times without time for the sump value to decay (Tab J-1.30). Each time this transition occurred the sump values added together (Tab J-1.30). The sum of the sump values from the multiple transitions resulted in the on-board model’s estimation of aircraft conditions, differing from the aircraft’s actual conditions to the point the MP was no longer able to control the MA (Tabs J-1.30 and CC-1.2). Based on CSMU data, the aircraft was not correctly responding to pilot inputs in the final seconds prior to ejection and departed controlled flight at 18:08:34 (Tab CC-1.2). This data is evidenced in the angle of sideslip (AOSS) values at 18:08:34 and after, approximately 2 seconds prior to MP ejection at 18:08:36L (Tabs J-1.15, J-1.22, and CC-1.2).

Figure 17: Post Flight Analysis Simulation of ADA divergence (Tab J-1.31)

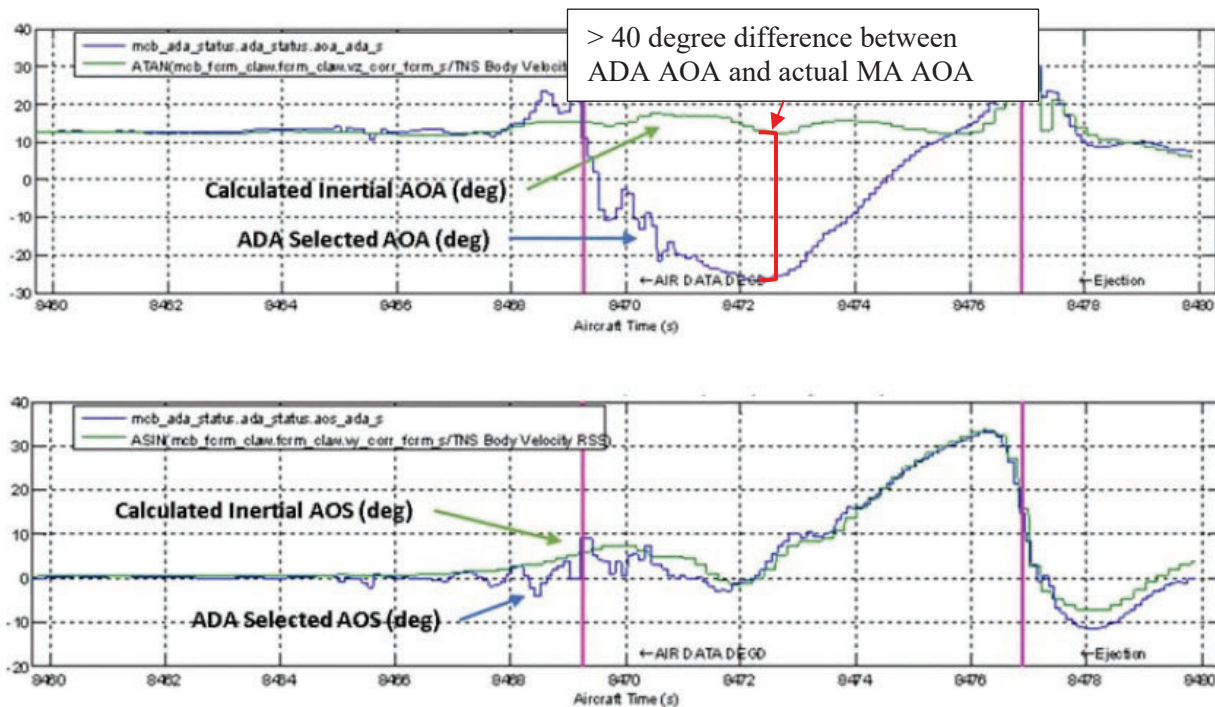
Figure 18: CSMU Recorded Evidence of ADA divergence (Tab J-1.26)

The control laws of the F-35 rely on receiving accurate air data, and with the on-board model predicted flight conditions and the physical flight conditions differing by more than 40 degrees, the flight control surface commands generated by the CLAW were incorrect for the current conditions (Tab J-1.31 to J-1.32).

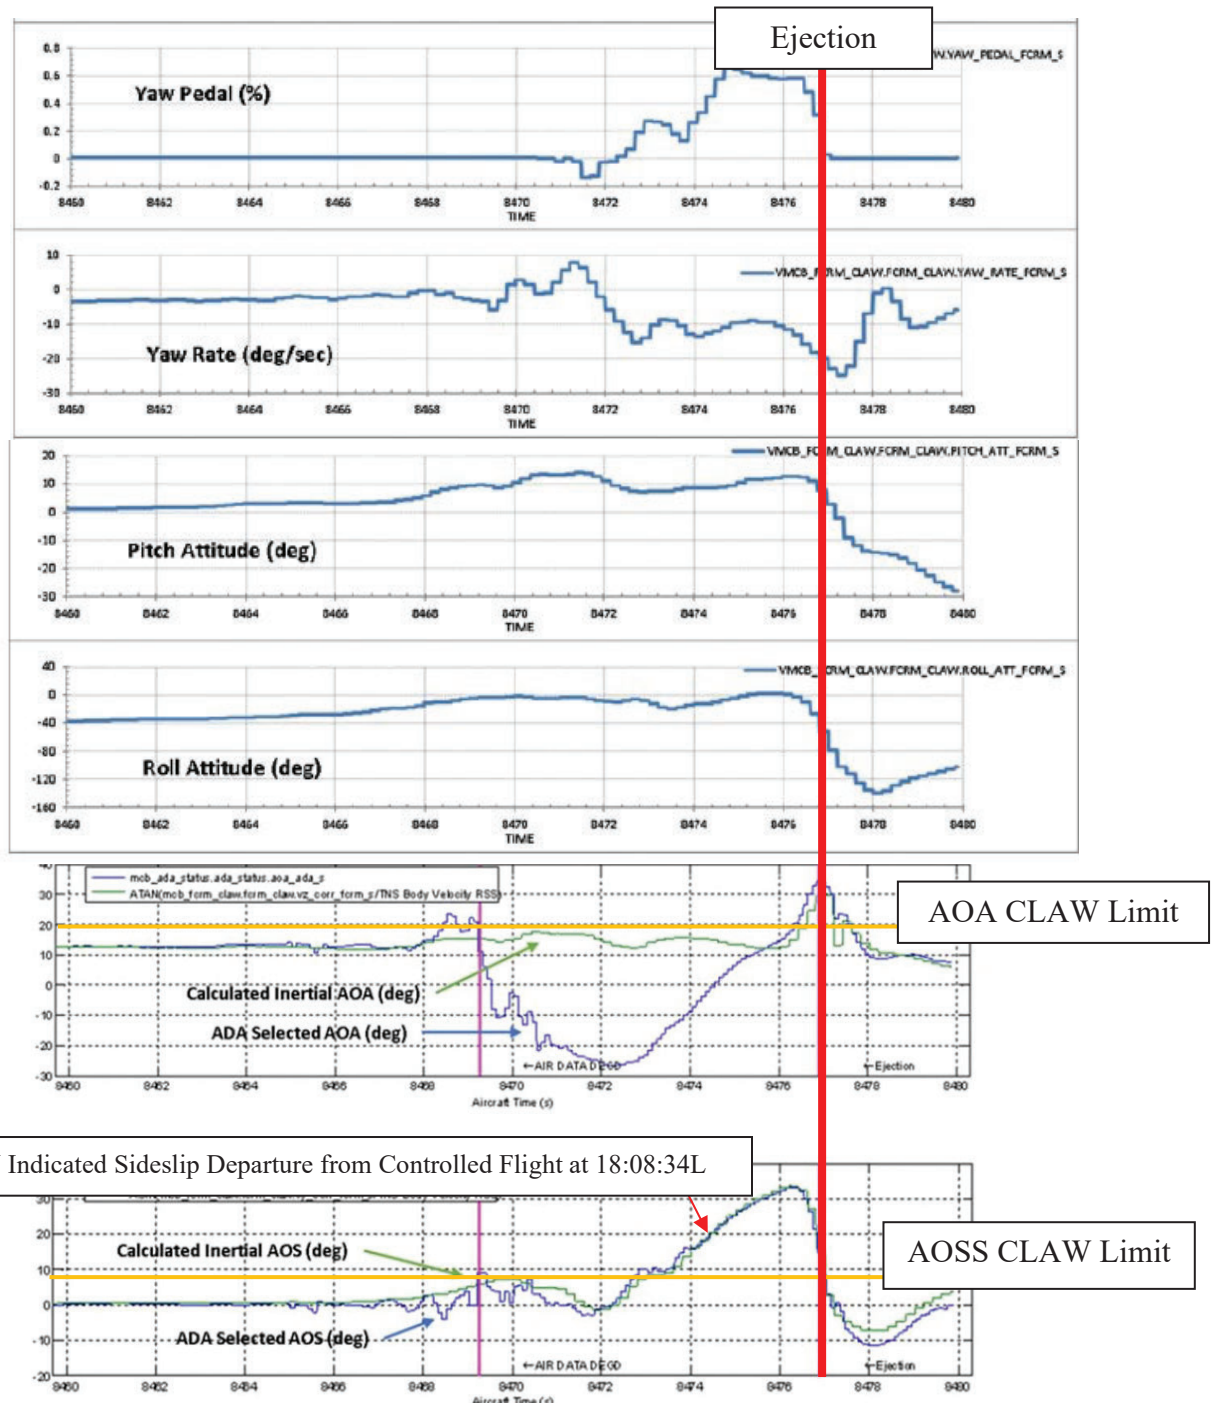
The following technical charts from the CSMU validates witness testimony, demonstrates the impact of the erroneous data supplied by the ADA, and verifies that the MA was out of control at the time the decision to eject was made (Tabs J-1.15, J-1.74, V-1.1.6, V-2.1.3, and CC-1.2).

Figure 19: MA Parameters prior to 2nd Disturbed Air through Impact (Tabs J-1.21 and J-1.26)
