UNITED STATES AIR FORCE
AIRCRAFT ACCIDENT INVESTIGATION
BOARD REPORT

F-16CM, T/N 89-2142

LOCATION: BEAUREGARD PARISH, LOUISIANA

DATE OF ACCIDENT: 23 MARCH 2022

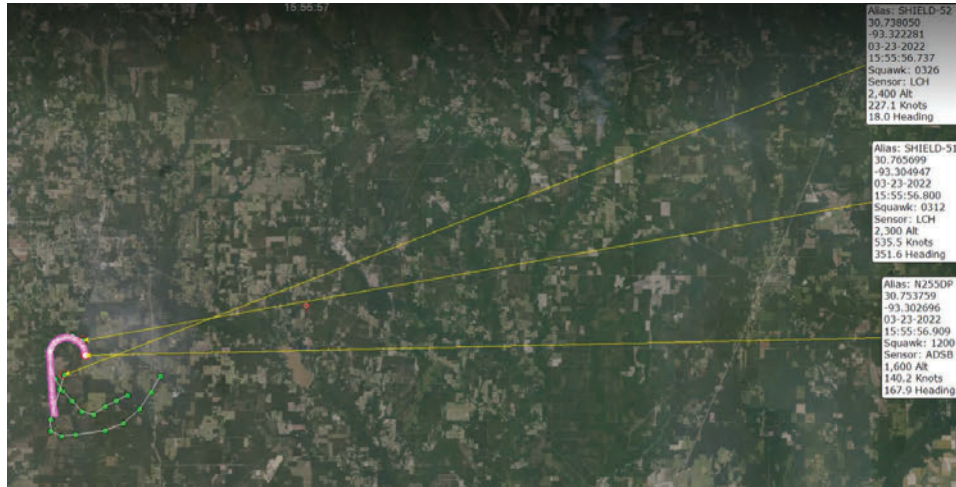
Figure 5: GA aircraft turning into MFL and collapsing range between MFL and MP (Tab AA-3)

The GA aircraft's north to south holding pattern complicated the intercept geometry for the MF by compressing the range between the MFL and MP (Tabs R-27 to R-28 and AA-3). At 10:54 a.m., Fort Polk Control gave their first radio call highlighting the proximity of the GA aircraft to the MF (Tab N-4). At this time, the MF had visually acquired the GA aircraft and was approaching 1.2 NM of the GA aircraft (Tabs N-4 and AA-3). Based on attempting to maintain position behind the GA aircraft, the MFL flew below the required minimum airspeed for approximately 90

seconds. The MFL did not recognize or correct these minimum airspeed violations (Tabs V-2.29 to V-2.30 and AA-3).

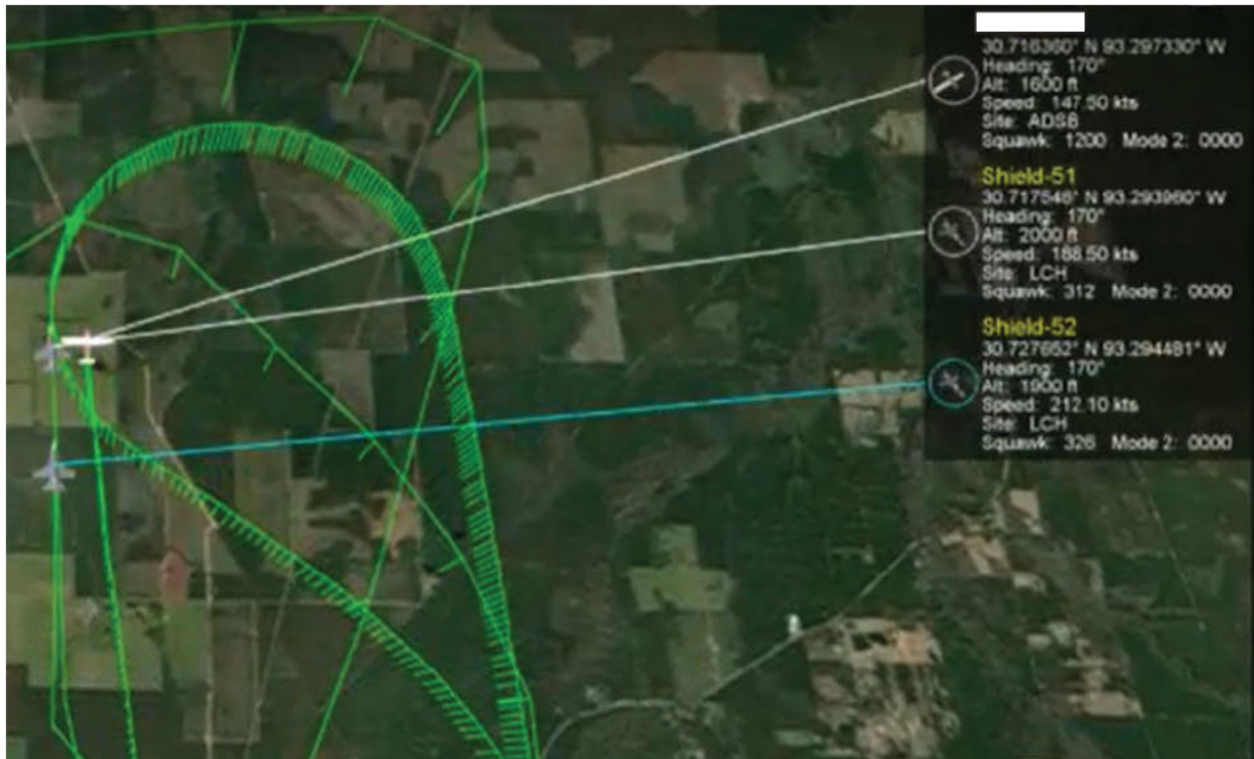
Figure 6: Intercept geometry with MP in trail of MFL (Tab AA-3)

The geometry and turns of the GA aircraft resulted in an approximate 0.7 NM trail separation between MP and MFL, with the MFL flying at 166 knots, below the minimum airspeed training requirements (Tabs V-2.35 to 2.36 and AA-3). There is no definitive data to capture the MP's exact airspeeds at this time, but the Seat Data Recorder (SDR) recorded two instances of the MA flying below the minimum airspeed requirements for training (Tab AA-7). The MFL read the first five of six digits of the GA aircraft's T/N over the interflight radio to the MP (Tab V-2.34 to V-2.36). Unable to get the remaining identifier of the T/N, the MFL then initiated a climbing turn above the GA aircraft to the northeast, to proceed to the MF's planned air-to-air refueling training event (Tabs V-2.34 to V-2.36 and AA-3 to AA-4).

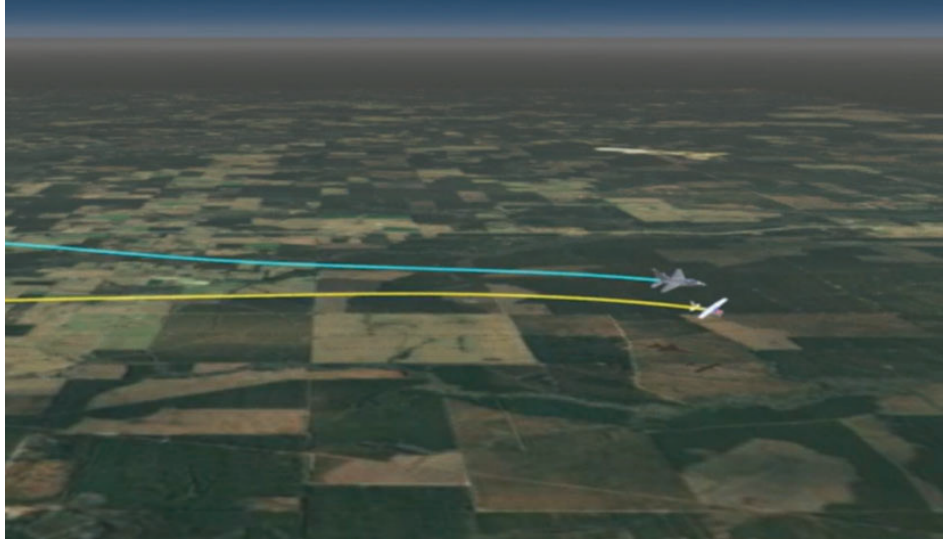
Figure 7: MP intercept of the GA aircraft just prior to stall (Tab AA-3)

As the MFL flew north in a right bank turn, the MP continued his intercept to read the last digit of the GA aircraft's T/N (Tabs R-25 and V-2.34 to V-2.36). As the MP closed in, the GA aircraft that was heading north to maintain its holding position turned right to head south back to Lake Charles (Tabs R-25 and V-1.38). The MP followed the GA aircraft through the right turn, reading the final digit of the T/N at 10:57 a.m. (Tabs V-1.38 and AA-3). Upon MP verbalizing the final digit, the MFL "terminated" the exercise at 10:57 a.m. (Tab V-1.38). The MA SDR shows a stall warning indication occurred at 10:57 a.m., with the MA flying below minimum airspeed (Tabs L-4 and AA-3). The MA was approximately 300 feet above the GA aircraft at this time, as opposed to the 1,000 feet required when executing an intercept from the side or front (Tabs R-24 to R-25 and V-4.46).

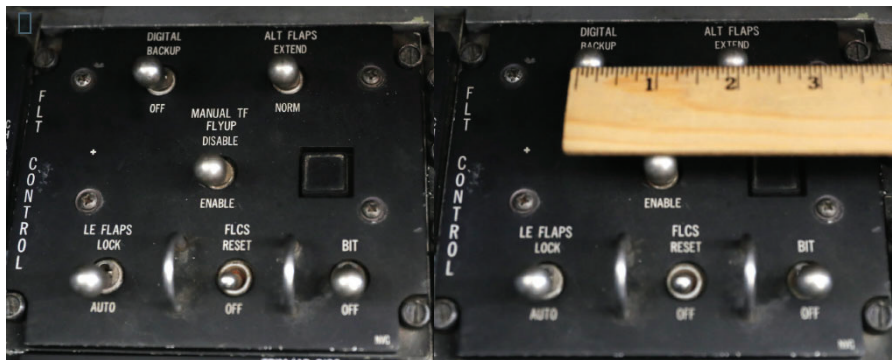
Figure 8: Flight Control Panel, proximity and similarity of DBU and ALT Flaps switch (Tab Z-3 to Z-4)

The MP testified that because he had completed the intercept and was climbing in altitude above the GA aircraft, he went to raise the trailing edge flaps by flipping the Alternate Flaps (ALT Flaps) switch from EXTEND to NORM (Tab V-1.38). The ALT Flaps extend switch is used to manually lower the trailing edge flaps in the F-16 to improve the slow speed handling by increasing lift and allowing a higher power setting (Tab V-6.10). However, the SDR reveals that the MP did not alter the ALT Flaps switch, but selected the Digital Backup (DBU) switch instead (Tab AA-3 and AA-6). Upon transition to DBU, F-16 flight control laws default to their false (not active) state, irrespective of the actual airspeed (Tab J-78). Thus, with the selection of DBU, the trailing edge flaps automatically began retracting, irrespective of the actual ALT Flaps switch position (Tab J-78). This retraction created a momentary loss of lift (Tab J-78). In this critical phase of flight, the rapid and sudden, but expected and normal, movement of the trailing and leading edge flaps when selecting DBU caused the aircraft to shudder (Tab AA-8). This shudder, unanticipated by the MP, was normal and indicative of a correctly operating flight control system (FLCS) responding to the selection of DBU (Tab AA-3).

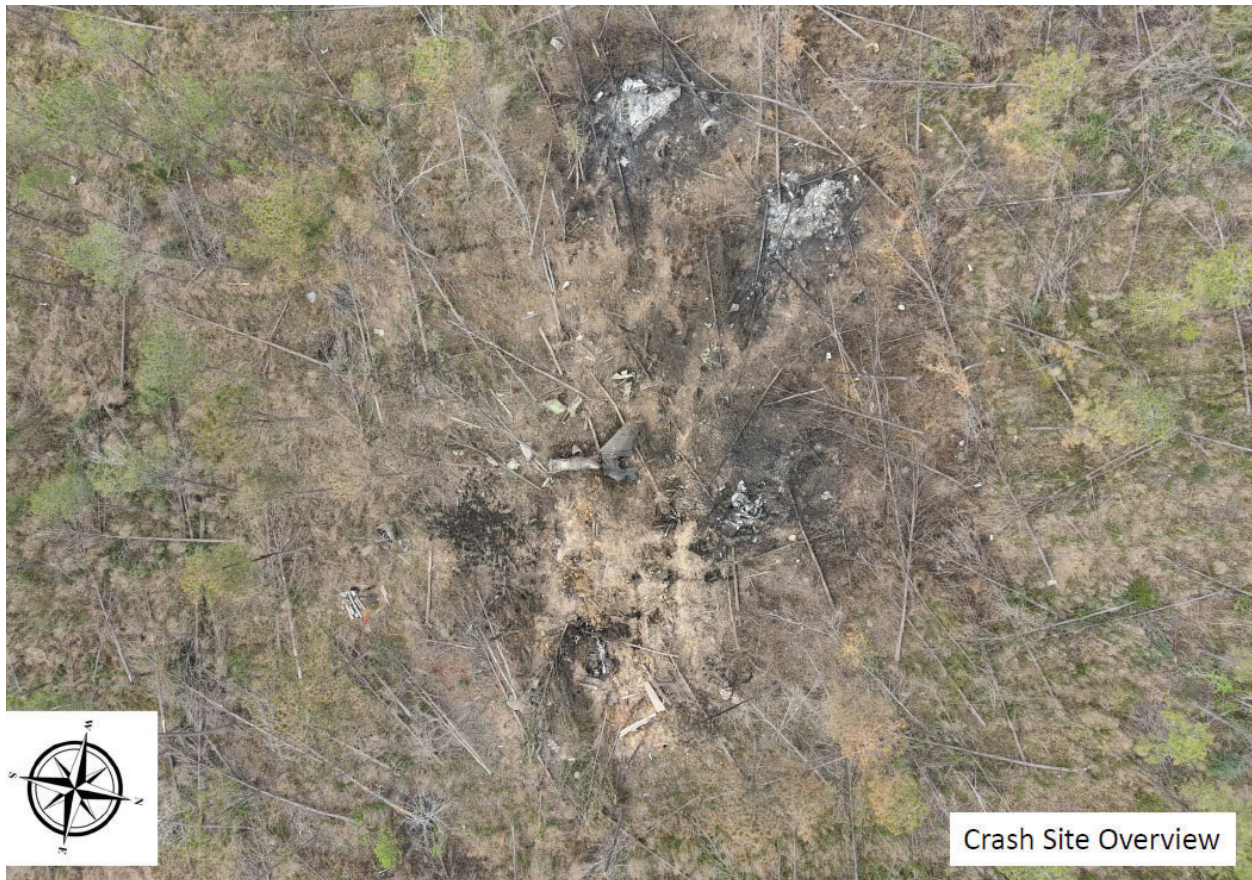
Figure 9: Crash Site Overview (Tab S-2)

The MA impacted the ground at approximately 10:57 a.m. in a sparsely wooded area, approximately 154 NM east-northeast of Ellington Field and was destroyed upon impact (Tabs J-74 and S-10). Based upon impact site analysis, and the major aircraft components being upright, the MA impacted the terrain at a steep angle while in an upright orientation (Tab J-73 to J-74). The limited distribution of aircraft wreckage towards the west from the shallow initial impact crater indicates a low speed, low energy impact from the east (Tab J-73). Impact analysis concluded that the MA impacted the terrain in a steep, slow, upright approach and possible rotation (Tab J-74).

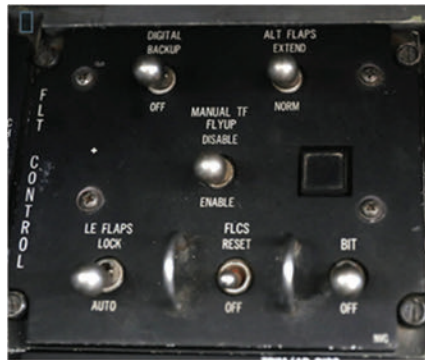
Figure 12: Picture of Flight Control Panel and Proximity of the switches discussed (Tab Z-3)

The SDR shows that 4 seconds prior to ejection, the DBU was manually selected in the cockpit (Tabs J-72 to J-73, AA-3 to AA-4 and AA-7). The MP testified that upon completion of the intercept of the GA aircraft, he climbed in altitude away from the GA in order to rejoin with MFL (Tab V-1.38). As the MA climbed away from the GA, the MP went to raise the trailing edge flaps by moving the ALT Flaps switch from EXTEND to NORM (Tab V-1.38). However, the MA's SDR revealed a stall warning occurred, caused by an extremely slow airspeed (Tabs J-79 and AA-7). Rather than moving the ALT Flaps switch to NORM, the SDR definitively shows a manual selection of the DBU switch to BACKUP, while the intended ALT Flaps switch action remained unchanged in the EXTEND position (Tab J-72 and J-79 to J-80).
