**UNITED STATES AIR FORCE**  
**GROUND ACCIDENT INVESTIGATION**  
**BOARD REPORT**

**M1097A2 High Mobility Multipurpose Wheeled Vehicle  
S/N 157874**

**TYPE OF ACCIDENT: MOTOR VEHICLE FATALITY**

**DATE OF ACCIDENT: 24 JUNE 2022**

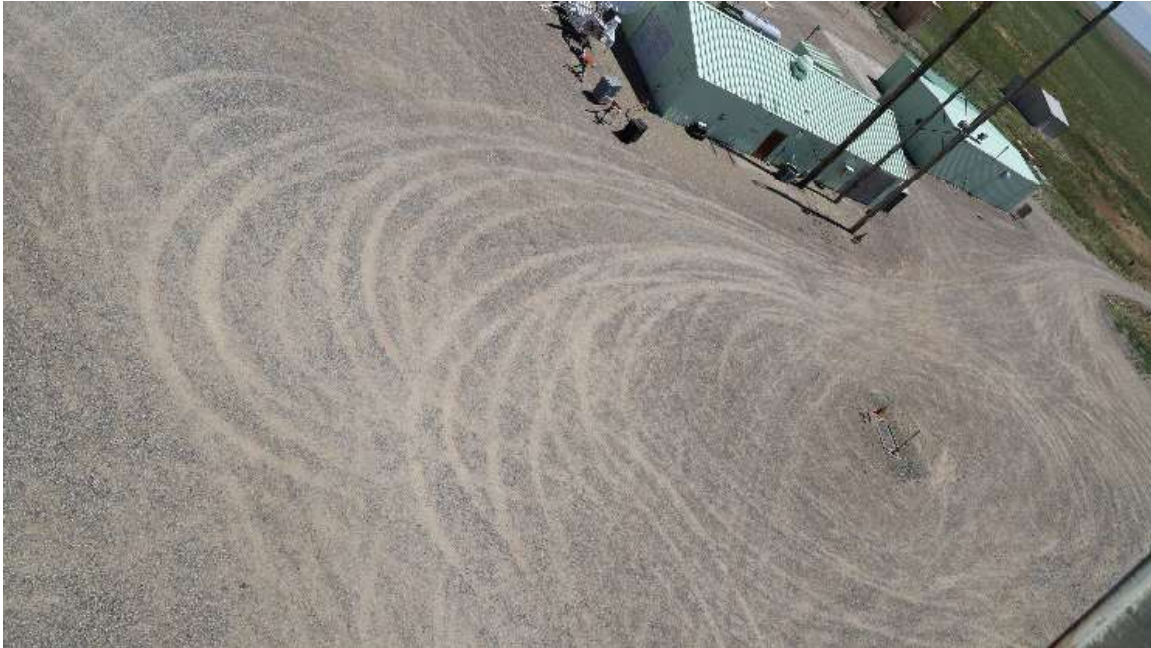
**Figure 2 – Tire Tracks as seen from Range Tower (Tab S-26)**

During the unescorted HMMWV trip, MC2 drove an M1097A2 HMMWV, Serial Number (S/N) 157874, with MC1 and MVO as passengers, to travel from the main range building to the range tower (Tabs R-10 and S-25). Around 1120L, MC2 drove in numerous tight circles at an accelerated speed near the range tower (Tab R-61). MC2 rotated out as the driver and MC1 began driving around the range tower (Tab R-10). MC1 also drove in numerous tight circles at an accelerated speed near the range tower (Tab V-1.6). MC1 rotated out as the driver and MVO began driving (Tab R-10). MVO drove in numerous tight circles at an accelerated speed (Tab V-1.6). The Range Tower Officer (RTO) noticed Mishap Team (MT) driving in tight circles at an accelerated speed and attempted to stop them by shouting at them from atop the range tower (Tab V-6.5). MT did not hear RTO (Tab R-11 and R-22). At approximately 1124L, RTO radioed Site Manager (SM) with a request that someone direct the cadets to drive in a safer manner (Tab R-61). At the range tower, MT changed drivers multiple times, allowing MVO, MC1, and then MC2 to operate Mishap Vehicle (MV) (Tab R-21). Before starting back for the main range building, MT swapped drivers one final time (Tab R-21).

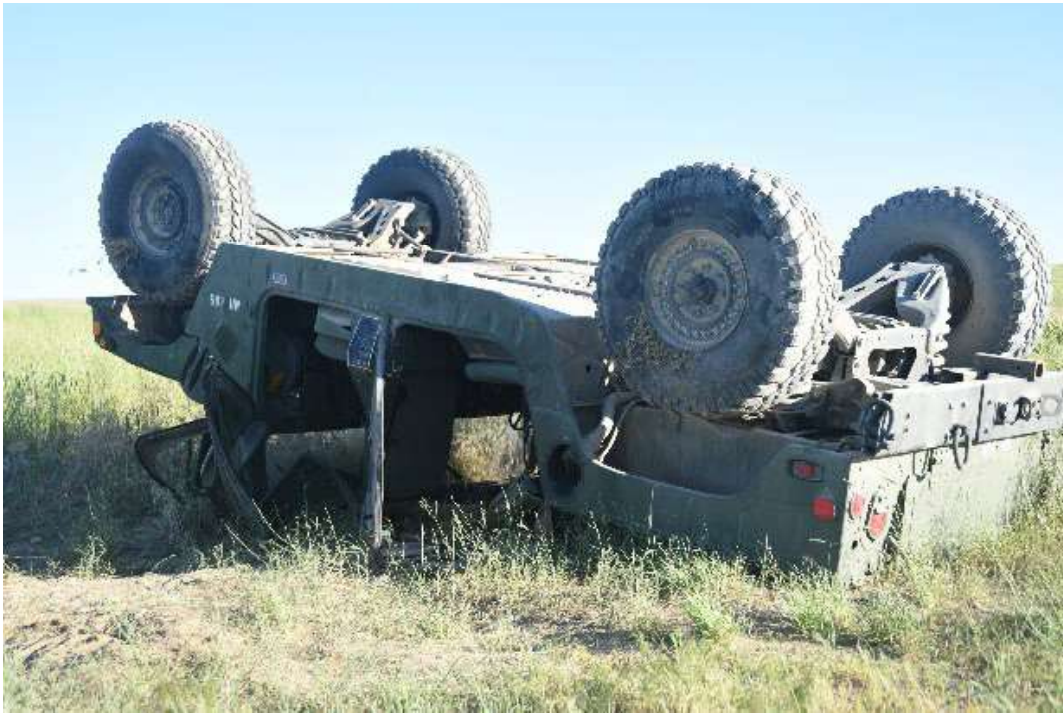
**Figure 3 – MV at Mishap Site (MS) (Tab S-10)**

MV overturned about a third of a mile from the main range building (Tab S-2). The portion of the service road where the mishap occurred is flat (Tab S-24). The road returning to the main range building from the range tower has a slight bend to the right with a downhill portion followed by a slight uphill portion (Tabs S-2 and S-24).

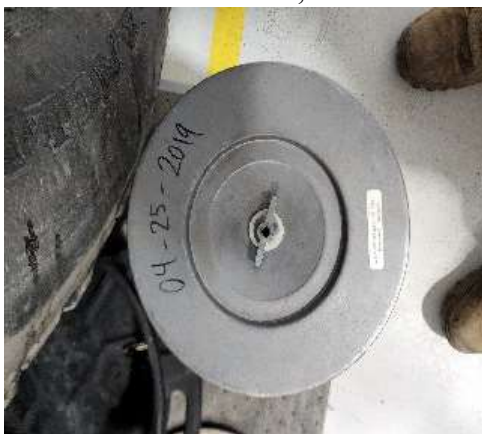
**Figure 5 - Air Filter (Tab S-31)**

On the air filter and oil filter, the date 25 April 2019 was handwritten (Tabs S-31 and S-32).

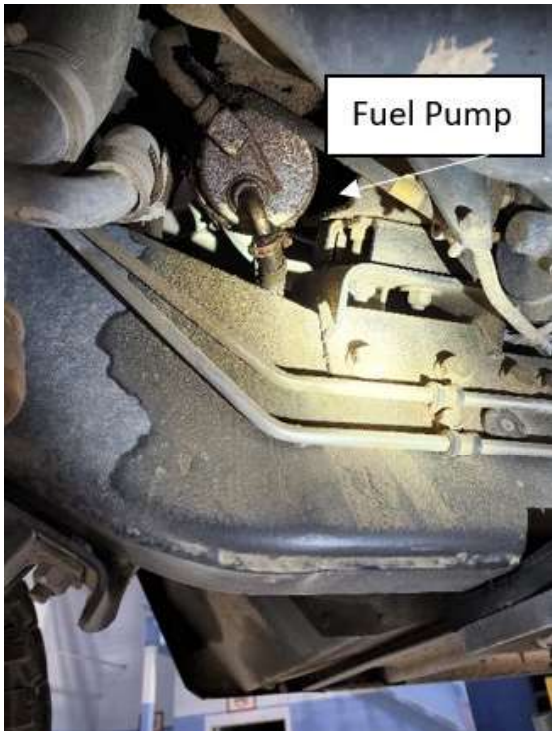
**Figure 8 - MV Fuel Pump (Tab S-33)**

First, the driver side (left) mirror assembly on MV was improperly mounted (Tabs S-26 and BB-15). The mounting hardware was stripped out and could no longer attach to the vehicle (Tab S-26). Self-tapping screws attached the driver side (left) mirror assembly to the frame of the windshield (Tab S-26). The self-tapping screws were pulling from the frame of MV and at risk of falling off (Tab S-26). Second, the lighting system and horn were inoperable (Tab BB-15). According to AFI 24-302, para. 9.16.2.4, both the lighting and horn systems are considered safety items that would have prevented MV from being used until the systems are repaired (Tab BB-12). Third, a review of the fuel pump showed it and the surrounding components were dripping wet with diesel fuel, indicating that the pump had been leaking prior to mishap (Tab S-33). Finally, the front passenger side (right) tire on MV should not have been utilized (Tab S-35). The passenger side (right) front tire on MV is a Goodyear Load Range “D,” while the remaining three tires are BF Goodrich Load Range “E” (Tab S-34 to S-37). Load Range “D” and “E” tires should not be mixed on the same vehicle and that is explicitly noted on the tires (Tab S-35). Mixing tires of differing load ranges negatively affects handling (Tab U-3).

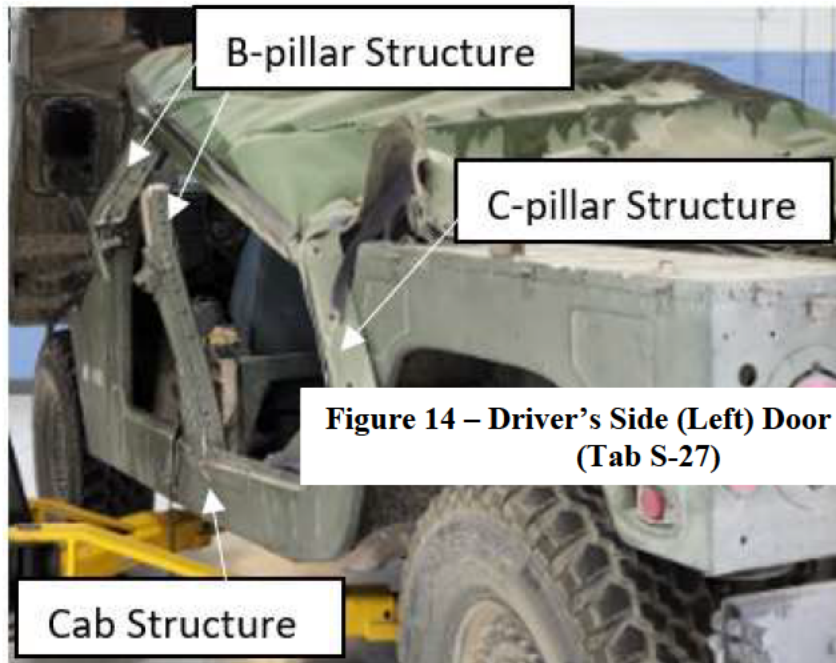
**Figure 14 – Driver's Side (Left) Door Structure (Tab S-27)**

Using the Vehicle Preventive Maintenance and Inspection (PM&I) checklist via AF Form 4354, an inspection was performed on MV IAW AFI 24-302, para. 1.8, after the mishap (Tab BB-9, BB-15, and BB-16). SCBR contractors marked range vehicles when the vehicles were delivered (Tabs S-27 and V-7.3). MV was marked “MH 669” (Tab S-27).

The B-pillar damage compromised the operability of the seatbelt retractor, so it is undetermined whether the retractor was operable at the time of the mishap (Tab S-27 and U-2). Regardless, no seatbelt could be pulled from the retractor after the mishap, which means the seatbelt was fully retracted at the time of the mishap (Tab U-2). This was further confirmed when the seatbelt that was cut by the safety investigation board lined up with the other half in the retracted position (Tab U-2). During the post-mishap assessment, the plastic housing of the front driver side (right) seatbelt buckle was broken off (Tab U-2). When attempting to fasten the cut seatbelt into the buckle, it fastened approximately 50% of the attempts and required additional attempts to fully fasten (Tab U-2). Had it buckled in every attempt, then it is highly likely that the buckle would have been operational prior to the mishap (Tab U-2).

As observed after the mishap, the brake pads on MV had sufficient pad material and would be considered serviceable (Tab BB-15). As a result of the damage to the B-pillar, MV sustained significant damage to its canvas top, center B-pillar cross-over support structure, rear C-pillar cross-over support structure, cab structure, and doors (Tab S-27). The passenger side (right) front door was crushed (Tab S-28). While damaged based on the pillars bending, there were no holes in the canvas top (Tab S-28).

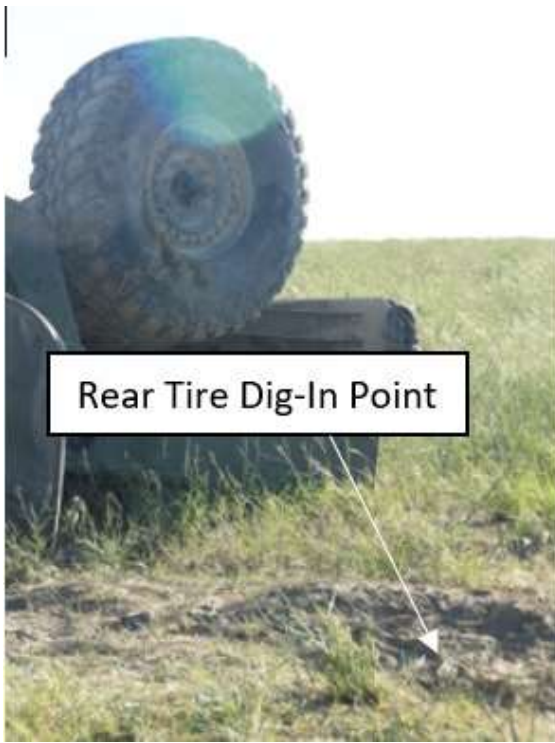
**Figure 17 - Tire Dig Point (Tab S-8)**

The front and rear passenger side (right) tires of MV broke bead, which released air from the tire and collected debris (Tab S-12 to 13). The term “bead” is used to describe the point where the edge of the tire sidewall and the inner lip of the rim seal the pressurized air in the tire (Tab S-5).

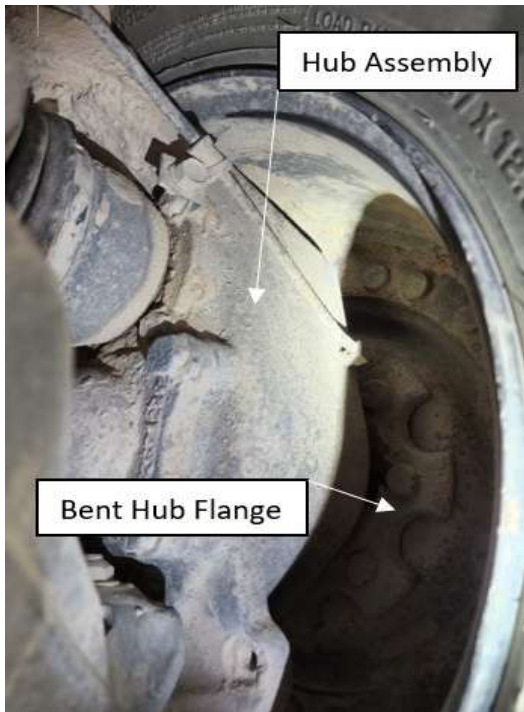
**Figure 21 - Hub Assembly (Tab S-34)**

MV's steel wheel hub was bent as a result of the mishap (Tab S-34).

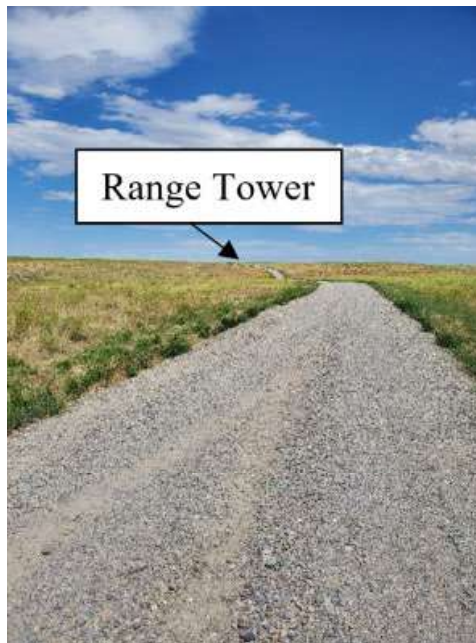
**Figure 23 – Picture of Road Segment between Range Tower and Range Building (Tab S-24)**

The range roadways are gravel roads (Tab R-21). The road on which the mishap occurred was most recently graded on 1 June 2022 (Tab V-4.12). The road is mostly straight between the range tower and the main range building (Tab S-2 and S-21). The road returning to the main range building from the range tower has a slight bend to the right with a downhill portion followed by a slight uphill portion (Tab S-2 and S-24).
