UNITED STATES AIR FORCE
ABBREVIATED AIRCRAFT ACCIDENT
INVESTIGATION BOARD REPORT

MQ-9A, T/N 16-4332

489TH ATTACK SQUADRON
432ND WING
CREECH AIR FORCE BASE, NEVADA

DATE OF ACCIDENT: 28 SEPTEMBER 2022

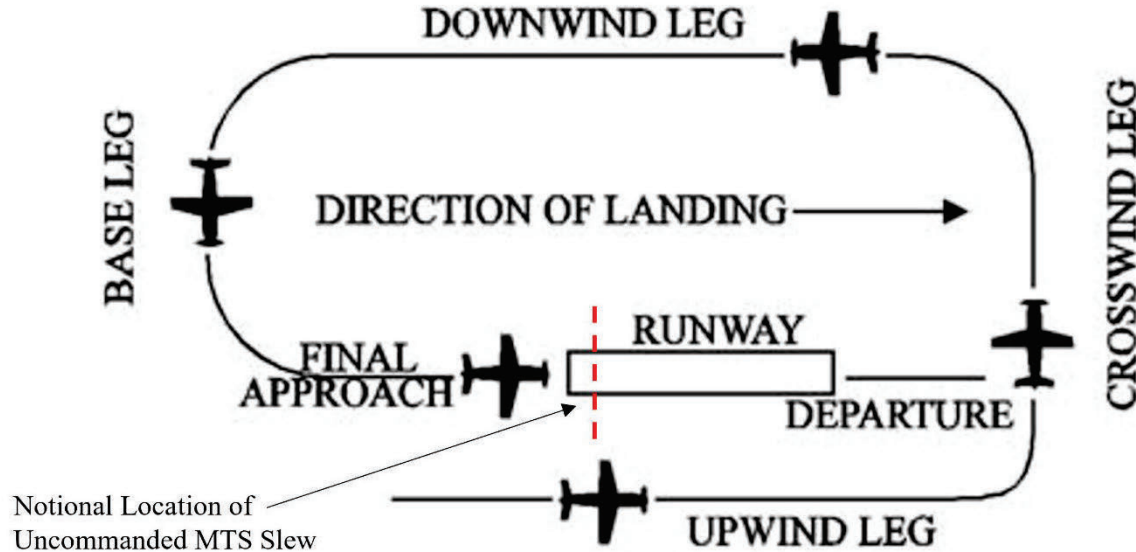
Components of a Traffic Pattern (Tab Z-10)

Prior to the mishap, the MC completed several approaches utilizing the Mishap Aircraft's (MA) forward-looking nose camera (NC) to the runway (Tab V-1.1). During the downwind leg, in preparation for the mishap touch and go approach, the MP requested the MSO to switch the MP's HUD to the multi-spectral targeting system (MTS) (Tab V-4.1). The "downwind leg" is the flight path parallel to the landing runway in the direction opposite the landing direction (Tab BB-63).

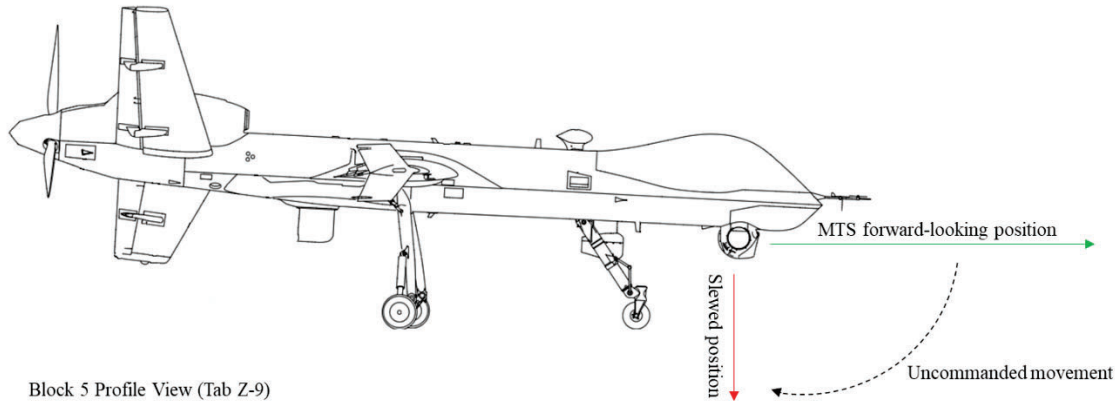
Block 5 Profile View (Tab Z-9)

On final approach to the runway, the MA was descending on glide path when the MTS slewed rapidly downward from its original forward-looking position (Tab DD-3).

The MP pitched the MA up for a nose high attitude but reduced the throttle to flight idle due to disorientation from the uncommanded MTS movement (Tabs V-1.2 and DD-3). The MP then called, “Going around” (Tabs V-1.2 and DD-3). The MA climbed away from the runway utilizing the remaining kinetic energy (Tab V-1.2). While the MA was climbing, the MIP utilized the MSO’s view of the NC to maintain awareness of the aircraft’s attitude and positive rate of climb (Tab V-2.2). Once the MIP verified the MA was climbing, the MIP directed the MSO to switch the MP’s view back from the MTS to the NC (Tab V-2.2). As the MSO was reconfiguring the MP’s primary video source, the MISO called out, “Airspeed,” as the instrument-indicated airspeed was rapidly decaying below stall speed (Tab V-4.2). The MIP heard the airspeed callout and leaned forward to check the physical position of the throttle (Tab V-2.2). The MIP called, “Throttle, throttle forward, throttle forward,” which was also repeated by the MSO (Tab V-4.2). The MP immediately applied full throttle, but the MA had slowed to more than 10 knots below stall speed and began descending toward the runway (Tabs V-1.2 and DD-5).
