UNITED STATES AIR FORCE
ABBREVIATED AIRCRAFT ACCIDENT INVESTIGATION
BOARD REPORT

F-16CG, T/N 89-2035

**555TH FIGHTER SQUADRON
31ST FIGHTER WING
AVIANO AIR BASE, ITALY**

DATE OF ACCIDENT: 2 MARCH 2022

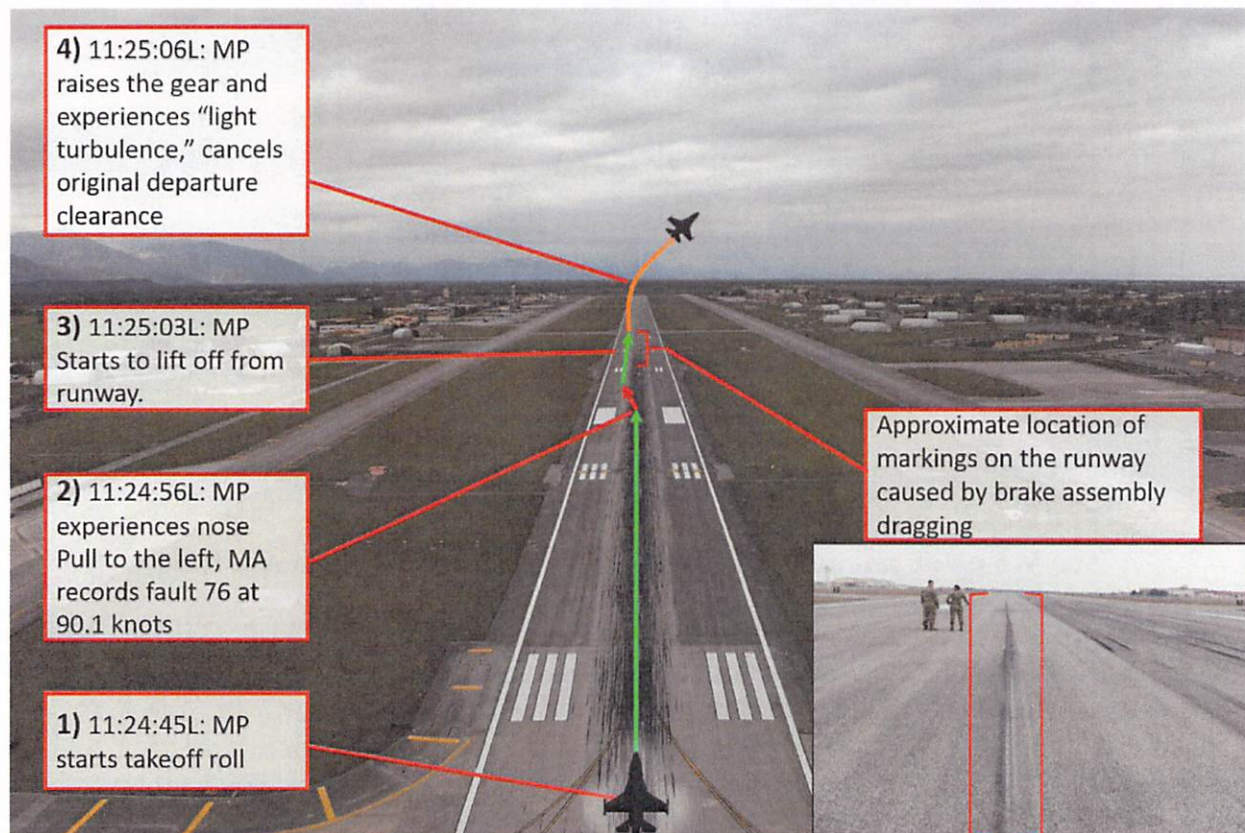
Approaching 90 knots, failure of the outboard bearing caused subsequent torque on the axle nut, forcing failure of the axle nut anti-rotation tab (Tabs L-3 to L-4, EE-4, and EE-10 to EE-11). Failure of the anti-rotation tab caused the axle nut to back off the axle, leaving the wheel unsecured (Tab EE-4 and EE-10 to EE-11). Unsecured, the wheel began to separate from the axle and landing gear assembly (Tab EE-9). Coincident with the initial separation, at 11:24:56L, as the aircraft passed 90.1 knots, the MA's data system recorded a fault with the wheel speed sensor (Fault #76), which indicated an "Open circuit in the left wheel speed transducer wiring, seen by both [left brake] channels (1/Primary and 2/Backup)" (Tab L-3 to L-4). Simultaneously, MP experienced a yaw, or pull, to the left that caused the nose of the aircraft to point three degrees from centerline (Tabs N-3 and V-1.3). MP assessed the yaw was equivalent to a slight crosswind and, at 11:24:59L, while exceeding 130 knots, MP fully corrected the yaw and the MA ran parallel to the runway centerline, offset to the left by approximately one "[F-16] ship length" (Tabs N-3 and V-

**Figure 2 (Tabs L-3 to L-4, N-3, V-1.4 to V-1.5, and Z-6)
The MA's takeoff sequence and runway damage**

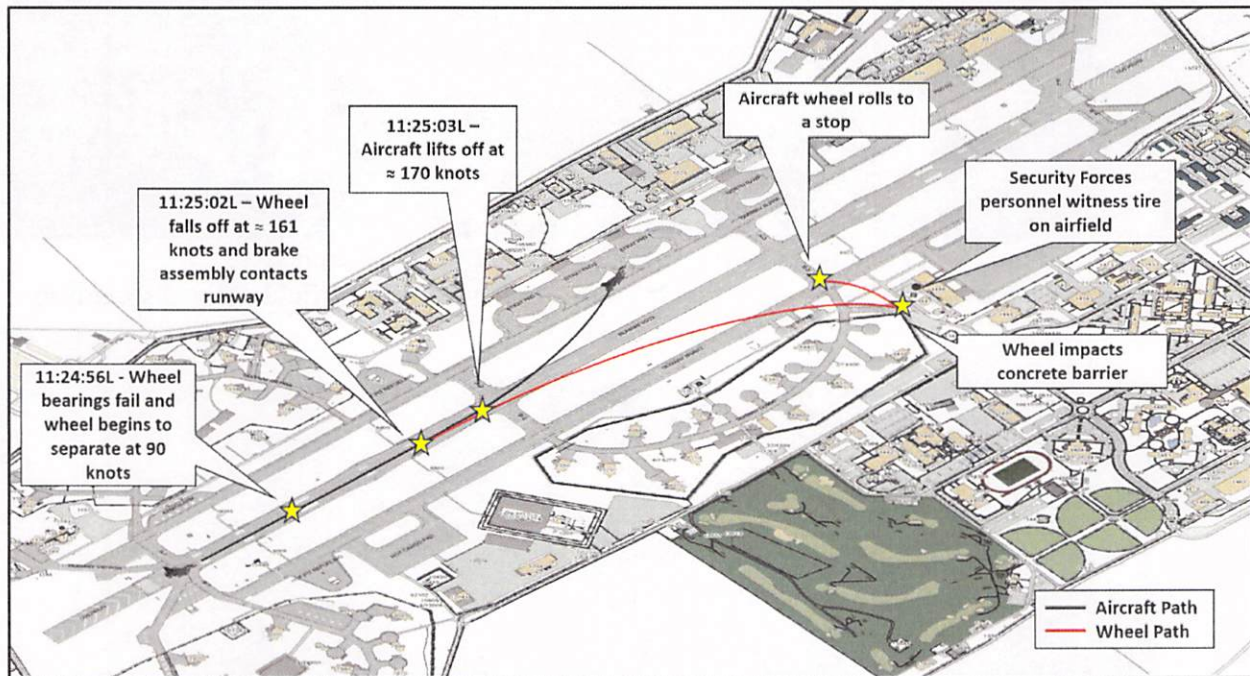
approximately 500 feet east of Bravo and Bravo 3 taxiway intersections (Tab R-48 and R-53). Almost immediately after hearing both jets from the MS takeoff, MSF1 and MSF2 heard a loud “thump” between their post and the East Aircraft Gate of Tower Loop (Tab R-48 to R-49 and R-53). Looking in the direction of the noise, MSF1 and MSF2 observed a knocked over concrete barrier and a tire approximately 50 to 80 feet in the air (Tab R-48 to R-49 and R-53). The tire landed near the East Aircraft Gate and continued to roll until settling on taxiway B3 (Tabs R-48 to R-49, R-53, and Z-17). MSF2 contacted the base security center to stop any aircraft movement on the field and report what happened (Tab R-48 to R-49 and R-53). Approximately five minutes later, airfield management personnel arrived in a truck to collect the tire (Tab R-48 to R-49 and R-53). MSF1 noted the inside of the wheel was “sharp” and it “appeared to be stripped or cross-threaded” (Tab R-48 to R-49).

Figure 3 (Tabs L-3 to L5, N-3, R-48 to R-49, R-51, R-53, Z-6, and Z-17)
Approximate positions of the dislocated wheel from the MA during takeoff

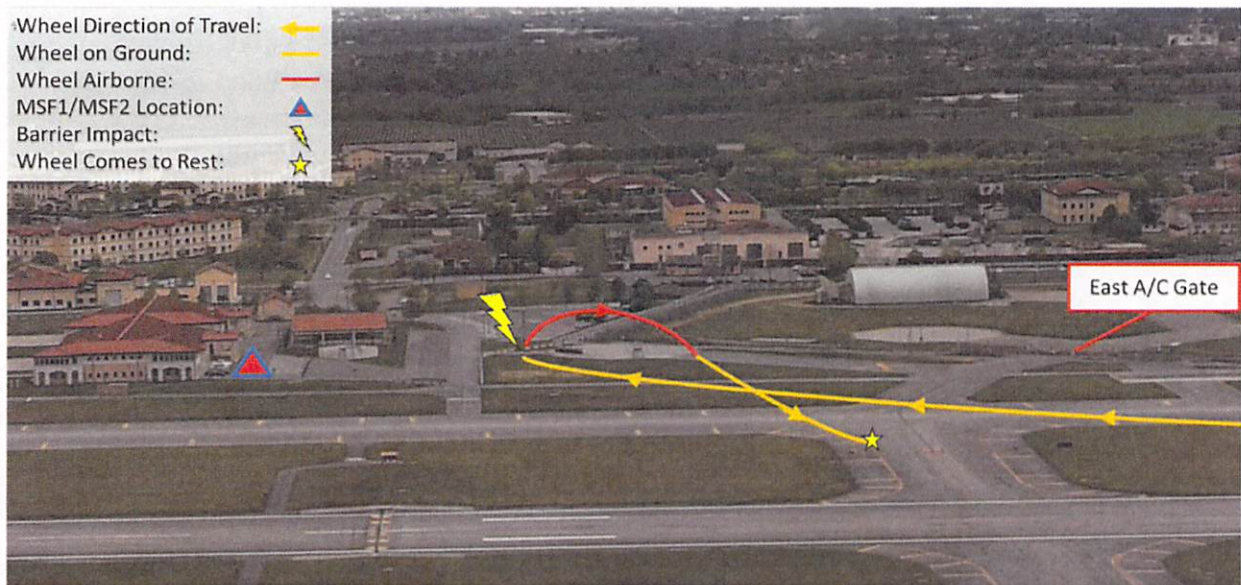
Figure 4 (Tabs R-48 to R-49, R-51, R-53, Z-6, Z-17, and Z-19)
Second perspective of the MA's wheel as it bounced around the airfield after dislocating from the MA

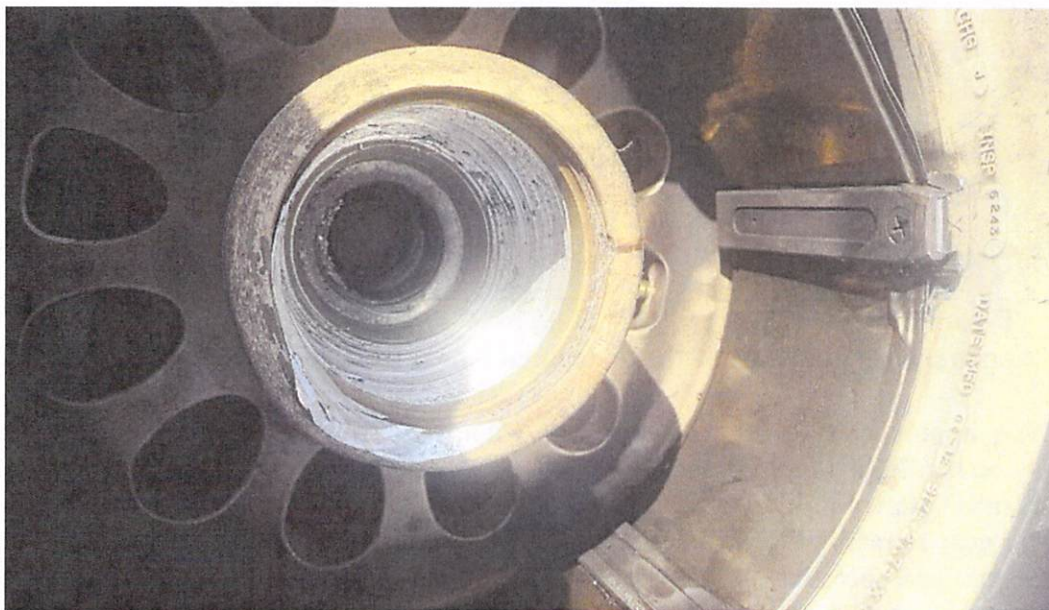
Figure 5 (Tabs R-38 and Z-7)
The wheel from the MA as it appeared at the time of recovery from the airfield

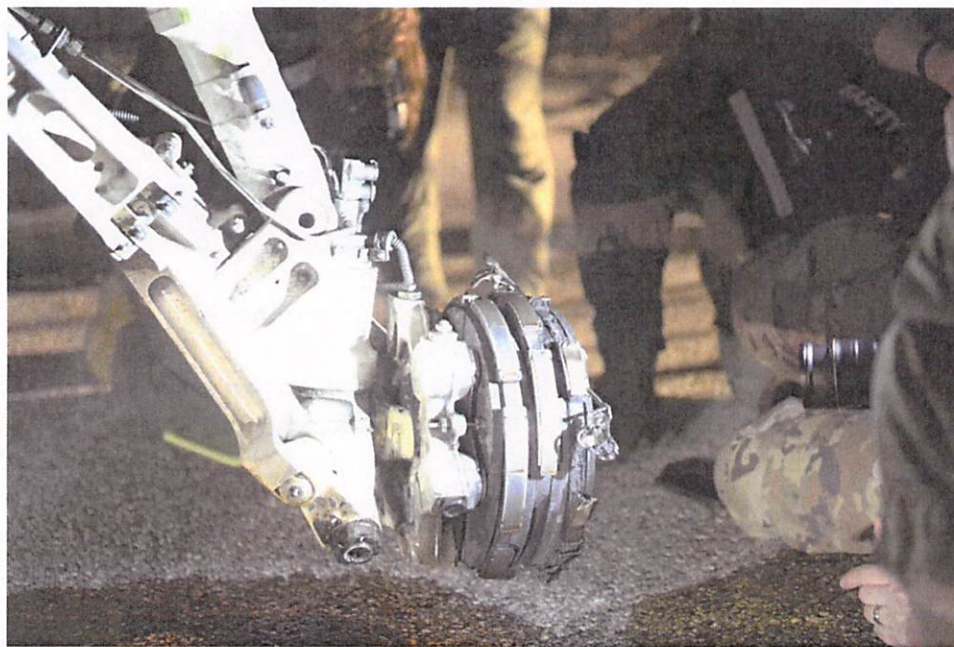
Figure 8 (Tab Z-8)
The remaining brake assembly after the MA lost the left wheel

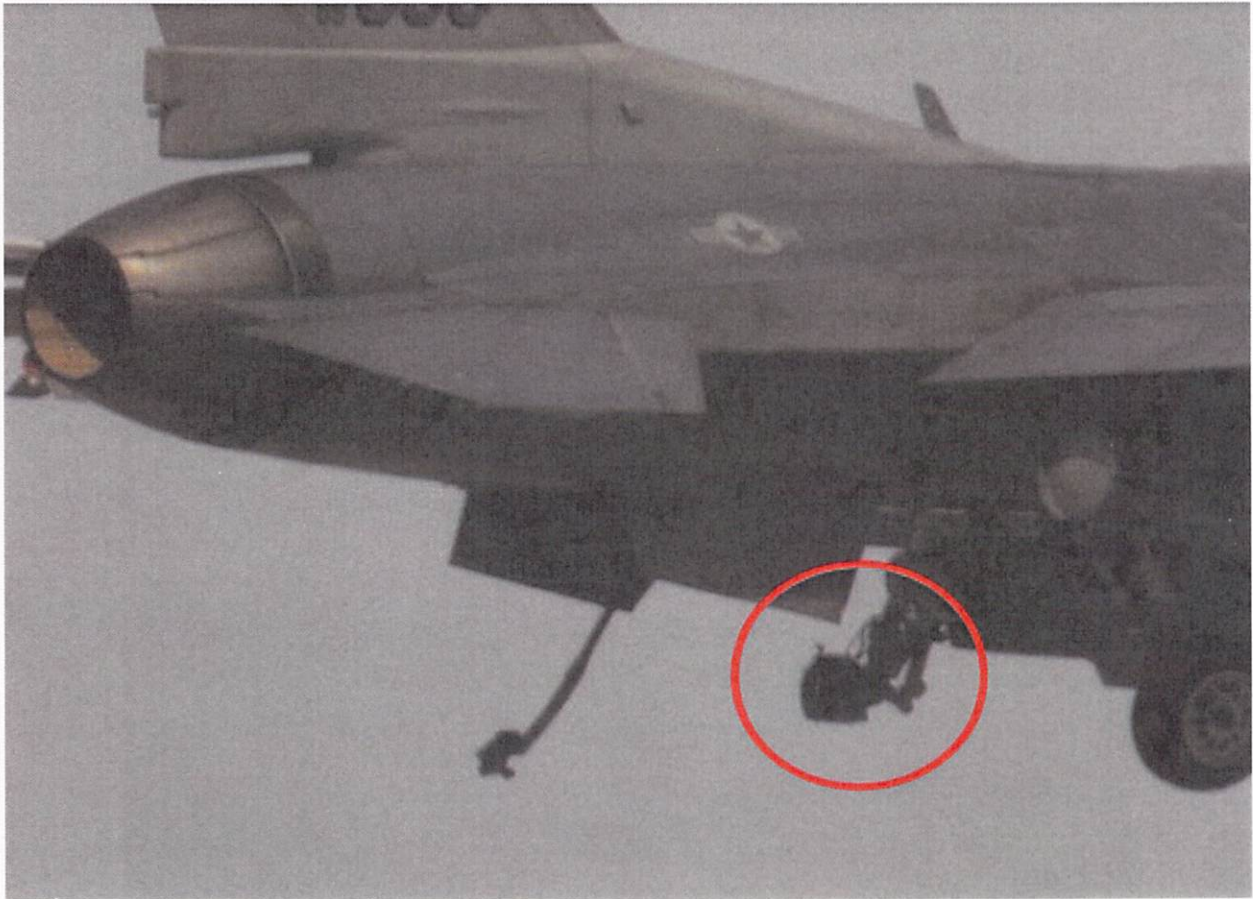
Figure 9 (Tab Z-8)

The remaining brake assembly after the MA lost the left MLG as seen airborne

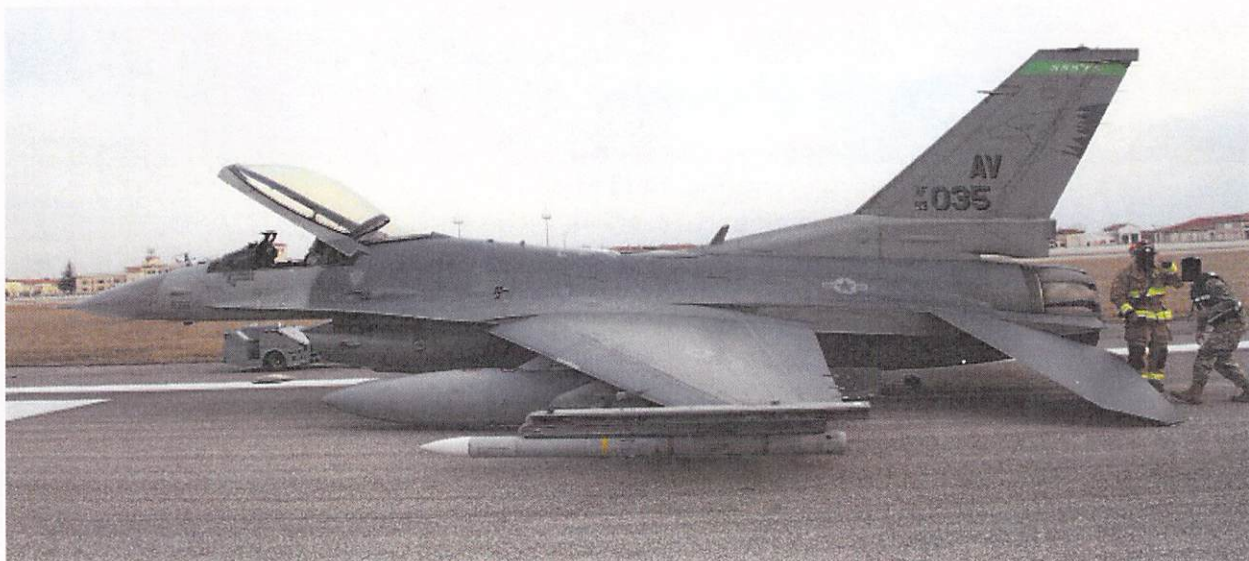
Figure 13 (Tab Z-5)
The MA after MP completed the landing and exited the cockpit

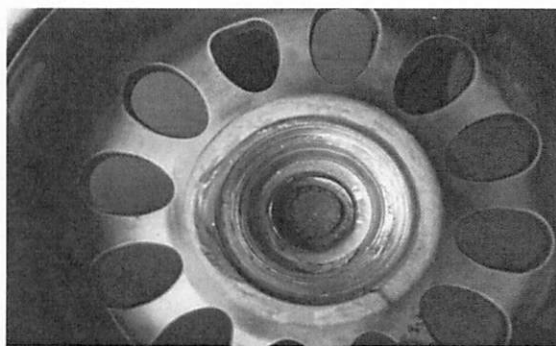
The mishap wheel assembly sustained significant damage to the inside of its inboard bearing hub, exterior of hub, and its six drive keys (Tabs S-9, Z-7, Z-10, EE-7, and EE-16). Once the wheel assembly separated from the MA's axle, it traveled down the active runway then crossed taxiway Bravo where it struck a concrete barrier, bounced into the air, and rolled back onto the taxiway where it came to a stop (Tabs Z-17 to Z-19).

Figure 15 (Tab Z-10)
The left MLG wheel assembly pictured after the mishap

Air Force Research Laboratory (AFRL) personnel at Wright-Patterson AFB conducted analysis of the left wheel assembly that separated from the MA during takeoff (Tabs EE-4 through EE-26). The analysis identified severe damage to the inner hub diameter with a significant amount of aluminum removed (Tab EE-7). With the hubcap removed, analysts observed flakes of metallic debris matching that of the wheel hub material (Tab EE-7). The wheel nut was loose under the hub cap with its anti-rotation tab still secured to the nut via both fasteners and safety wire, however, the feature that rotationally locks the nut to the axle was fractured, causing the wheel to come off the MA (Tab EE-7).

The outboard bearing remained inside the MA wheel assembly and was not free-spinning as is typical, but instead lodged into the bearing cup (Tab EE-7). The bearing cage was severely damaged and in two pieces with all 21 rollers present, but damaged (Tab EE-7). Additionally, the spacer, which is installed prior to the axle nut and features a key designed to rotationally lock the spacer to the axle, was found friction welded to the outboard bearing cone, with its locking key fractured, in the MA wheel assembly (Tab EE-8).

(Tab EE-8). The burr is consistent with secondary damage from the axle as the wheel came off, but no spalling, chipping, corrosion, or other similar damage was noted on the rolling surface of the cup (Tab EE-8). The analysis was inconclusive whether the lack of grease in the bearing cup was caused by heat and friction during the mishap or inadequate grease applied during installation (Tab EE-9).

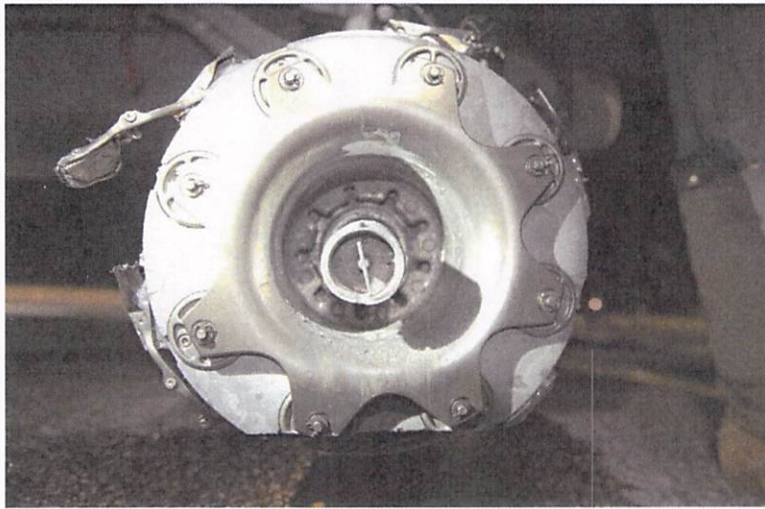
Prior to takeoff, the wheel assembly separated from the axle assembly, resulting in the left brake assembly contacting the runway (Tabs S-7, Z-8, Z-11, Z-18, EE-9, and EE-14). As a result, the

brake assembly sustained significant material loss, resulting in a flat spot where it contacted the runway (Tabs S-7, Z-8, Z-11, Z-18, EE-9, and EE-14).

Figure 16 (Tab Z-11)
The left MLG brake assembly after the mishap

Additionally, the left brake assembly was visually examined by AFRL personnel at Wright-Patterson AFB (Tab EE-9). All damage observed on the brake assembly was consistent with secondary damage (Tab EE-9). The brake assembly was ground flat on the bottom side consistent with the weight of the aircraft on the brake when the brake assembly was damaged (Tab EE-9).

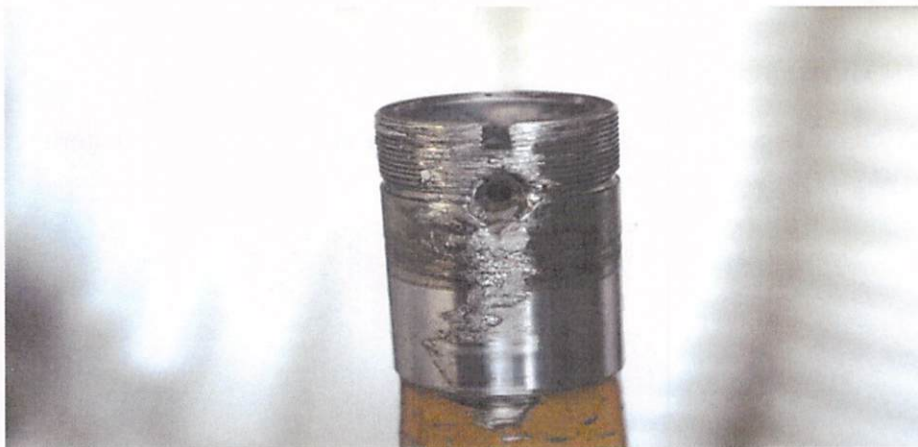
The left main landing gear axle assembly sustained damage near the outboard bearing lower surface, as well as the axle threads (Tabs S-8, Z-11, and EE-24).

Figure 17 (Tab Z-11)
The left MLG axle after the mishap

AFRL personnel at Wright-Patterson AFB also conducted an analysis of the left axle assembly through visual and stereo-optical examination (Tab EE-9). Discoloration was observed on the axle assembly, mostly on the bottom (Tab EE-9). Color variations within this region appeared to be oriented perpendicularly to the axle, suggesting the cones rotated on the axle (Tab EE-9).

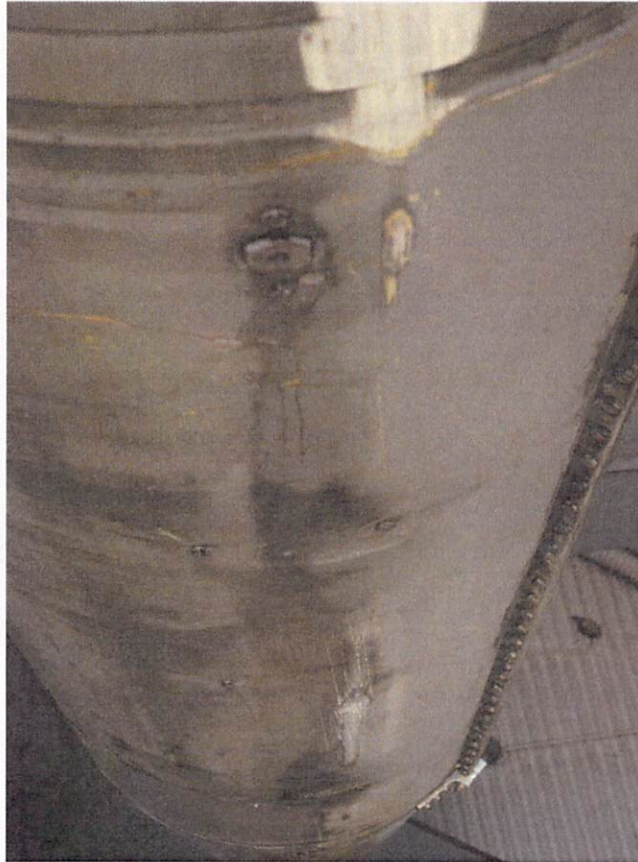
As a result of the gear-up landing, the left external fuel tank sustained multiple scrapes on its lower side due to contact with the runway surface (Tab Z-12).

Figure 18 (Tab Z-12)
The left external fuel tank after the mishap

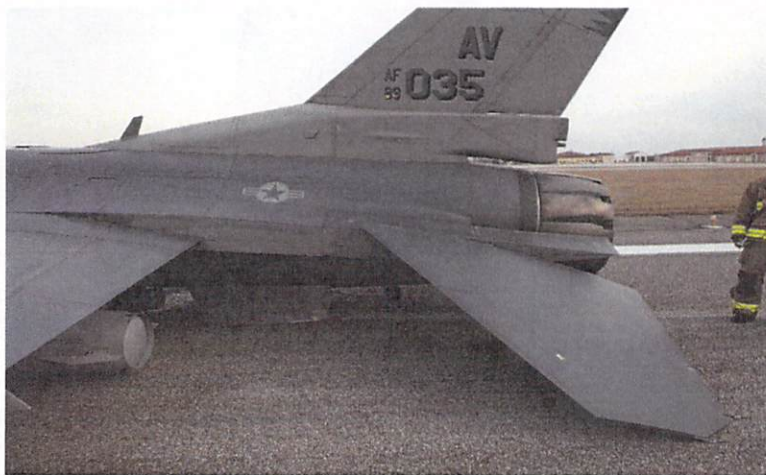
When the MA came to a stop, the lower trailing edge surface of the left horizontal stabilizer contacted the runway surface (Tab Z-13).

Figure 19 (Tab Z-13)
The left horizontal stabilizer after the mishap

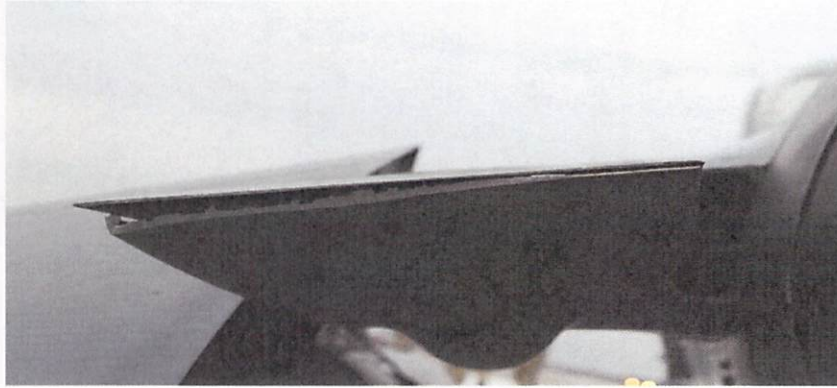
With the speed brakes opened to help reduce airspeed and ground speed, the left speed brake assembly lower portion contacted the runway surface resulting in the loss of material (Tabs S-6 and Z-13).

Figure 20 (Tab Z-13)
The left speed brake assembly after the mishap

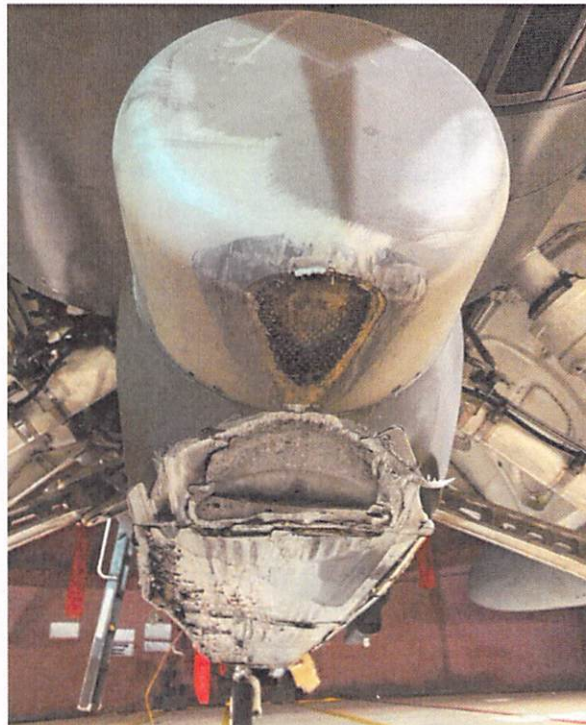
The ECM pod is located on the lower most center position of the aircraft (Tabs S-6 and Z-14). As a result of the gear-up landing, the ECM Pod supported all the aircraft weight, resulting in significant material loss and damage (Tabs S-6 and Z-14).

Figure 21 (Tab Z-14)
The ECM pod after the mishap

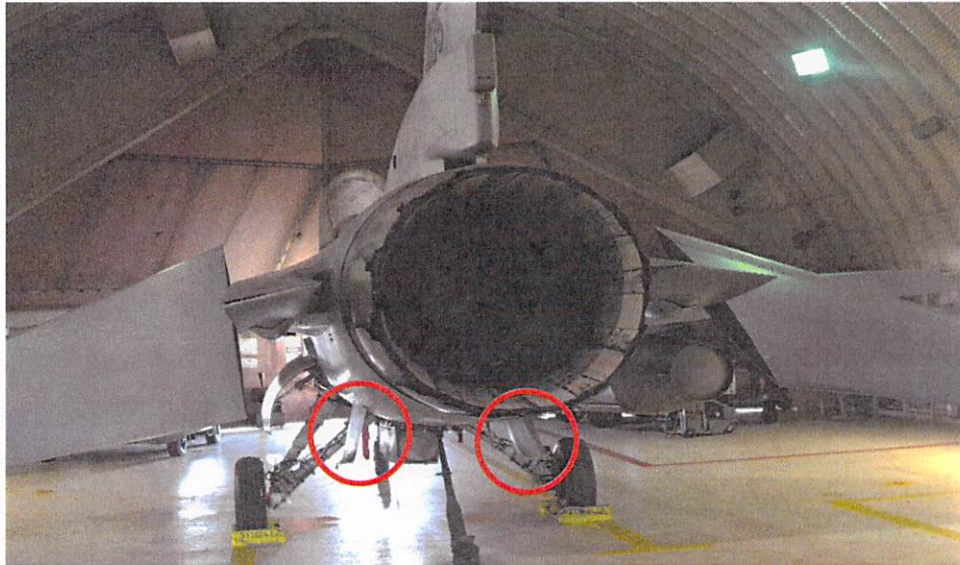
Much like the ECM Pod due to the gear-up landing, both left and right ventral fins contacted the runway surface and ground down significantly, sustaining damage and material loss (Tab Z-15).

Figure 22 (Tab Z-15)
The left and right ventral fins after the mishap
