UNITED STATES AIR FORCE
AIRCRAFT ACCIDENT INVESTIGATION
BOARD REPORT

T-38C, T/N 65-0466

DATE OF ACCIDENT: 7 NOVEMBER 2022

SUMMARY OF FACTS AND STATEMENT OF OPINION
T-38C, T/N 65-0466
COLUMBUS AIR FORCE BASE, MISSISSIPPI
7 NOVEMBER 2022

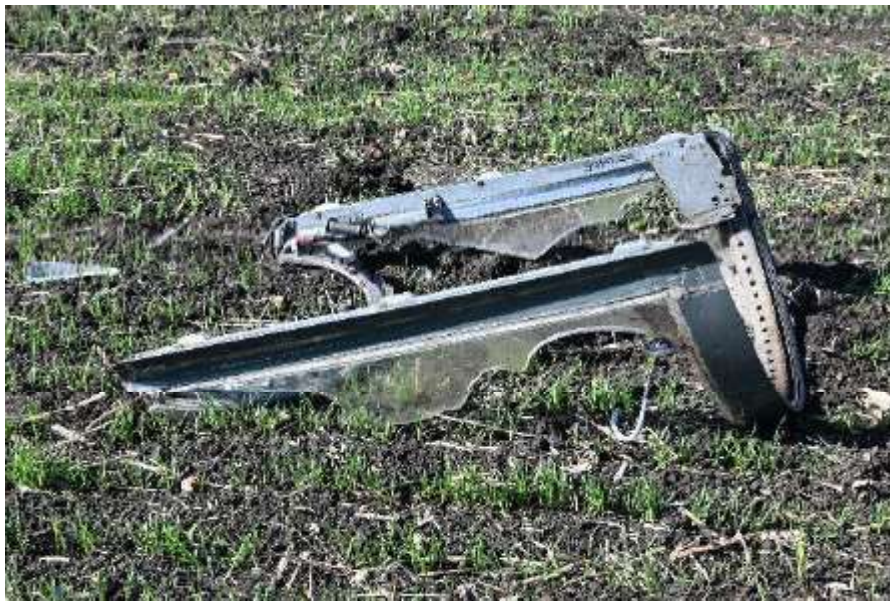
Figure 1
Front cockpit canopy (Tab S-6)

The front windshield was received in one piece, but it had marks "from impacts with hard objects ... along with scratches, scuff marks and cracks." (Tab J-97). The front cockpit canopy, the middle section of the canopy, was recovered with significant damage:

Virtually all the acrylic of the front cockpit canopy was missing and bird remains were found on the metal frame (Tab J-97). The rear canopy was found in multiple pieces and the acrylic had broken into several large pieces (Tab J-98). "Impact marks on the acrylic indicate hard object collision. The aft bow of the rear canopy had a small amount of bird remains present." (Tab J-98).

The MFL observed significant damage to the MA's cockpit canopy immediately after the bird strike and stated "the front canopy was basically open. To me it looked like it was just, most of it was gone." (Tab V-2.8). The MP stated that the front cockpit canopy was shattered by the bird strike (Tab V-1.6 to V-1.7).

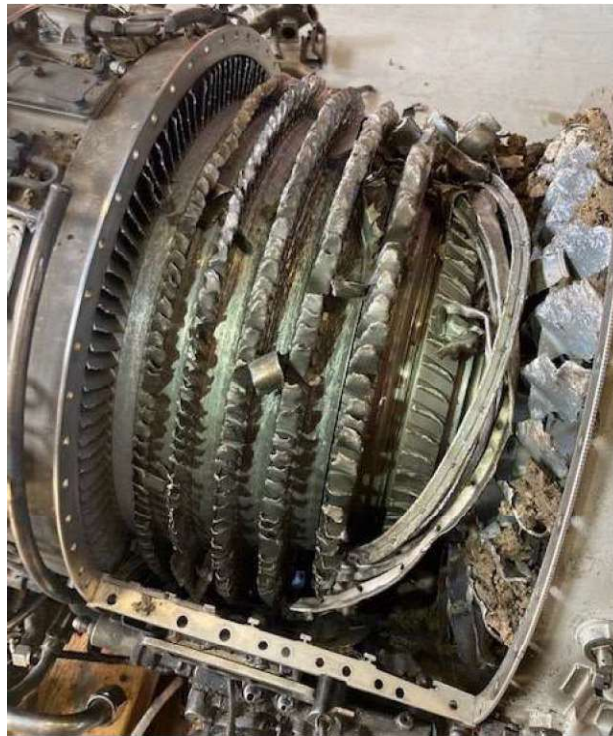
Figure 3
Left engine compressor (Tab J-13)

The left engine had damage consistent with a tumbling crash (Tab J-7). The upper half of the engine was removed in order to evaluate the internal state of the engine (Tab J-12). This revealed damage to the inlet guide vanes, multiple stage 2 compressor blades, small pieces of the stage 2 shroud ring, and multiple stator vanes from various stages to include stages 2 through 7 (Tab J-13).

Once the compressor rotor was exposed, the damage found was consistent with rigid FO ingested during flight at a high RPM (Tab J-13). This level of damage is indicative of either a large piece of rigid FO or multiple pieces of medium sized rigid FO (Tab J-13). The stage 1 blades were found intact, but all of the stage 2 blades were sheared at the root and found lodged further in the engine (Tab J-13). It was determined this is consistent with rigid FO that is small enough to pass into the engine and miss the stage 1 blades, but cause massive and thorough damage to the stage 2 blades which are further inside the engine than the stage 1 blades (Tab J-13).

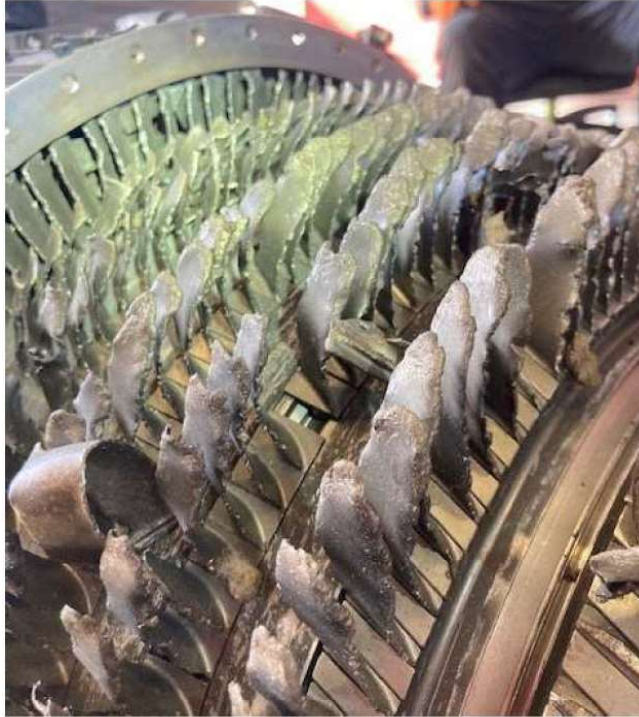
Figure 4
Left engine compressor section (Tab J-15)

The engine blades found further inside the engine, at stages 3 to 8, were bent over in the opposite direction of engine rotation (Tab J-15). Most of these engine blades were intact (Tab J-15). This damage is consistent with FO ingestion (Tab J-15).

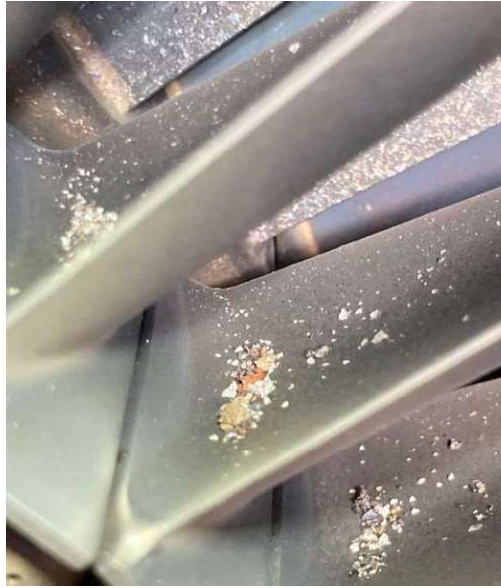
Figure 6

Samples taken from the left engine's turbine stages were a white and granular material (Tab J-20). Analyses did not find pieces of bird or other elements consistent with a bird being ingested into

the left engine (Tab J-27). Analyses of the white material is consistent with the acrylic of the canopy (Tab J-31). There was a significant amount of the white and granular material within the stage 1 turbine cooling holes sections of the engine, consistent with pieces of canopy being ingested by the engine (Tab J-20). The damage to the engine, specifically the scoring on the shaft circumference is consistent with the engine not rotating at the time of impact (Tab J-22).

Left engine turbine section with white granular material (Tab J-19)

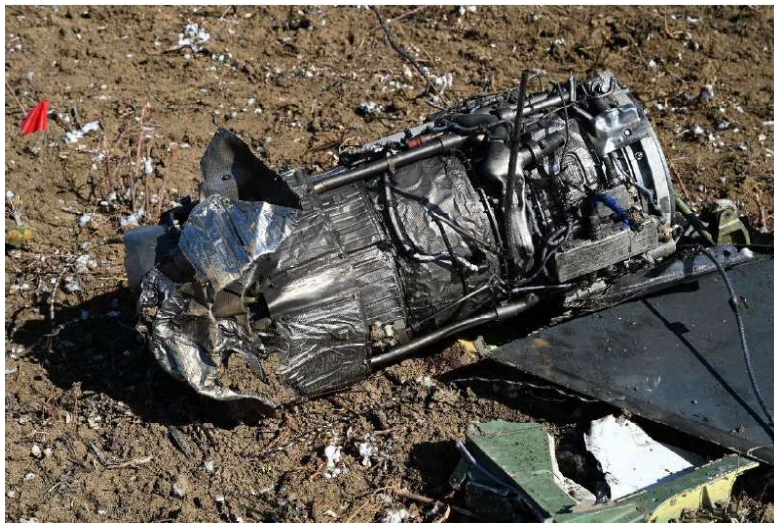
Figure 7

The right engine was found separated from the aircraft.

Right engine at crash site (Tab S-10)

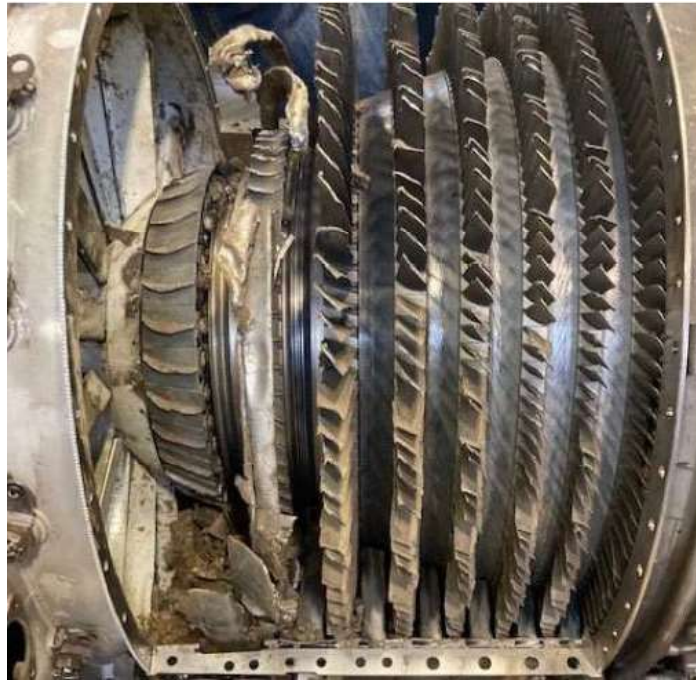
Figure 8
Right engine compressor section (Tab J-25)

Prior to tear down of the right engine, it was evident that there was significant damage to the forward portion of the compressor (Tab J-24).

The upper half of the engine was removed in order to evaluate the internal state of the engine (Tab J-24 to J-25). This revealed damage to the stage 1 and stage 2 compressor blades; all the blades from stage 1 and stage 2 were sheared from the compressor rotor and accumulated between the compressor rotor and the compressor case (Tab J-24). Since the damage was not observed further in the engine, it was concluded that the engine was still rotating at the time of impact (Tab J-26).

Compared to the left engine, there was no canopy FO material found within the right engine. However, the compressor blades had leading and trailing edge damage which suggested that FO was processed through all 8 stages of the compressor (Tab J-26). There was no evidence of canopy like FO in the engine, likely due to a small fragment(s) of canopy that would have been processed completely through as the engine continued to rotate all the way until ground impact. (Tab J-28). It is suspected, by engineering, that there was a minor FO ingestion of aircraft canopy immediately following the initial bird strike to the aircraft that led to a compressor stall. This would have resulted in a degraded engine that would be operating at a diminished capacity insufficient to sustain operable flight to make a controlled landing (Tab J-28).
