**UNITED STATES AIR FORCE**  
**AIRCRAFT ACCIDENT INVESTIGATION**  
**BOARD REPORT**

**F-15D, T/N 84-0046**

**114TH FIGHTER SQUADRON  
173D FIGHTER WING  
OREGON AIR NATIONAL GUARD**

**DATE OF ACCIDENT: 15 MAY 2023**

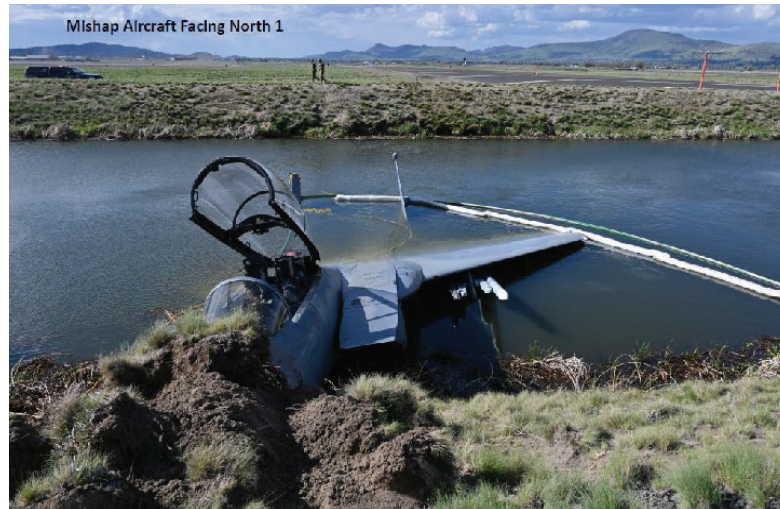
The MA impacted the irrigation canal approximately 0.2 NM south of the departure end centerline of RWY 14 at 15:00:02L (Tabs S-2 and Z-4). The impact parameters prevented major aircraft breakup but destroyed the nose section and forward fuselage of the MA (Tab S-2 to S-7). The MA came to rest partially submerged in the canal (Tab S-2 to S-6).

**Figure 1. Mishap Aircraft Wreckage in Canal (Tab S-2)**

Due to speed of the MA and the location of the canal, major aircraft breakup was prevented (Tab S-2 to S-4). The MA sustained significant damage to the radome and forward fuselage structure (Tab S-7). The nose landing gear and the right main landing gear separated from the MA during the mishap sequence, most likely during impact of the raised irrigation berm (Tab S-2 to S-4 and S-7). The wings, horizontal stabilators, and vertical tails remained intact with no major damage assessed to primary flight control surfaces (Tab S-2 to S-4 and S-7).

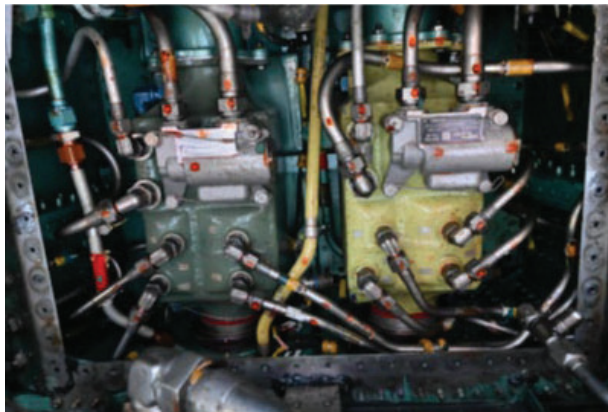
Post-mishap ground testing determined that the FOHE catastrophically failed due to a crack near a weld on the forward outboard housing, near the Utility outlet port (Tab X-3). Utility Hydraulic servicing and system pressurization confirmed the FOHE as the primary source of the MA hydraulic leak (Tab X-3). No additional leaks were found during system pressurization (Tab X-3). The FOHE was shipped to the F-15 Systems Engineer for analysis and returned to the supply system (CC-5). As a result, the FOHE was not available to the AIB for physical examination (Tab CC-5).

**Figure 2 Left and Right FOHE (Tab S-5)**

A thermal control valve routes hydraulic fluid to the FOHE through the Non-Reservoir Level Sensing (RLS) hydraulic circuit (Tab Y-17 to Y-20). A leak in the Non-RLS circuit cannot be isolated and will result in Total Utility Hydraulic System failure (Tab Y-17 to Y-20). The rate of hydraulic fluid loss will be significantly higher if the thermal control valve is open (Tab Y-17 to Y-20). When utility hydraulic fluid exceeds 225 degrees Fahrenheit, all fluid will be routed to the FOHE for maximum cooling (Tab Y-20). The structural crack in the FOHE led to a catastrophic leak from the Utility Non RLS System and a total utility system failure (Tabs Y-17 and X-3).
