UNITED STATES AIR FORCE
AIRCRAFT ACCIDENT INVESTIGATION
BOARD REPORT

F-15D, T/N 84-0046

**114TH FIGHTER SQUADRON
173D FIGHTER WING
OREGON AIR NATIONAL GUARD**

DATE OF ACCIDENT: 15 MAY 2023

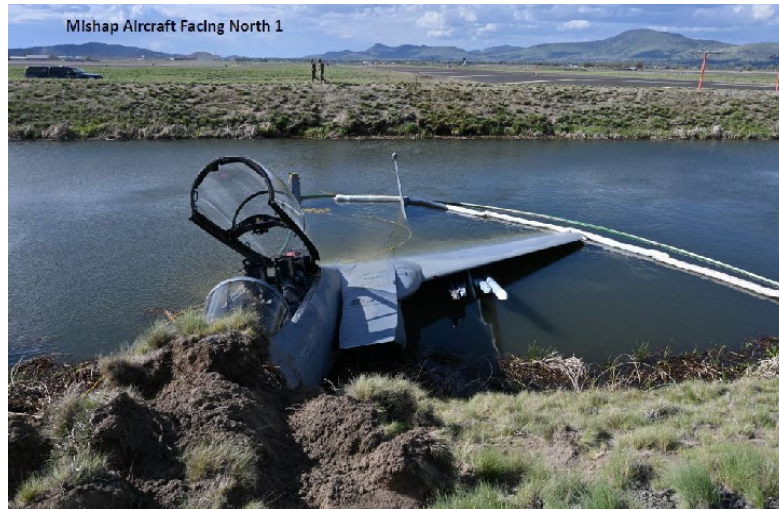
The MA impacted the irrigation canal approximately 0.2 NM south of the departure end centerline of RWY 14 at 15:00:02L (Tabs S-2 and Z-4). The impact parameters prevented major aircraft breakup but destroyed the nose section and forward fuselage of the MA (Tab S-2 to S-7). The MA came to rest partially submerged in the canal (Tab S-2 to S-6).

Figure 1. Mishap Aircraft Wreckage in Canal (Tab S-2)

Due to speed of the MA and the location of the canal, major aircraft breakup was prevented (Tab S-2 to S-4). The MA sustained significant damage to the radome and forward fuselage structure (Tab S-7). The nose landing gear and the right main landing gear separated from the MA during the mishap sequence, most likely during impact of the raised irrigation berm (Tab S-2 to S-4 and S-7). The wings, horizontal stabilators, and vertical tails remained intact with no major damage assessed to primary flight control surfaces (Tab S-2 to S-4 and S-7).

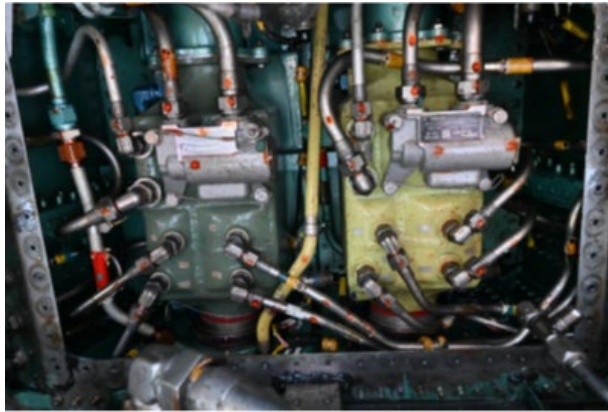
Post-mishap ground testing determined that the FOHE catastrophically failed due to a crack near a weld on the forward outboard housing, near the Utility outlet port (Tab X-3). Utility Hydraulic servicing and system pressurization confirmed the FOHE as the primary source of the MA hydraulic leak (Tab X-3). No additional leaks were found during system pressurization (Tab X-3). The FOHE was shipped to the F-15 Systems Engineer for analysis and returned to the supply system (CC-5). As a result, the FOHE was not available to the AIB for physical examination (Tab CC-5).

Figure 2 Left and Right FOHE (Tab S-5)

A thermal control valve routes hydraulic fluid to the FOHE through the Non-Reservoir Level Sensing (RLS) hydraulic circuit (Tab Y-17 to Y-20). A leak in the Non-RLS circuit cannot be isolated and will result in Total Utility Hydraulic System failure (Tab Y-17 to Y-20). The rate of hydraulic fluid loss will be significantly higher if the thermal control valve is open (Tab Y-17 to Y-20). When utility hydraulic fluid exceeds 225 degrees Fahrenheit, all fluid will be routed to the FOHE for maximum cooling (Tab Y-20). The structural crack in the FOHE led to a catastrophic leak from the Utility Non RLS System and a total utility system failure (Tabs Y-17 and X-3).
