**UNITED STATES AIR FORCE**  
**AIRCRAFT ACCIDENT**  
**INVESTIGATION BOARD REPORT**

**MQ-9A, T/N 11-4123**  
**432 WING**  
**CREECH AFB, NEVADA**

**DATE OF ACCIDENT: 18 JANUARY 2023**

**SUMMARY OF FACTS AND STATEMENT OF OPINION**  
**MQ-9A, T/N 11-4123**  
**SCLA, VICTORVILLE, CALIFORNIA**  
**18 JANUARY 2023**

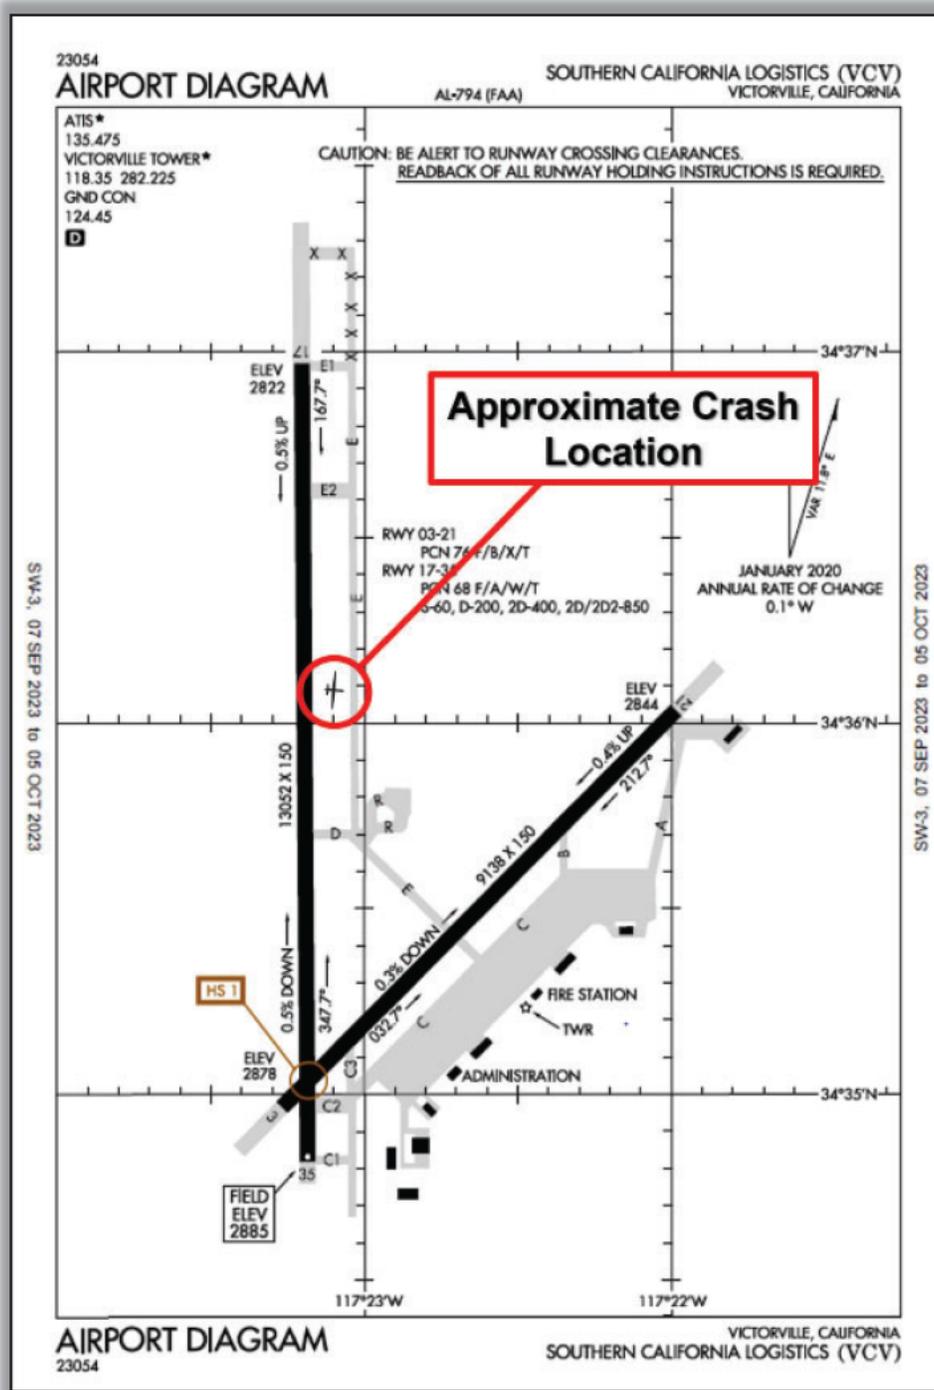
Figure 1. SCLA Diagram – Approximate Crash Location (Tab Z-1)

Technical Order 1Q-9(M)A-1 specifically states, "Transition to ABORT state is not allowed once the aircraft exceeds rotation speed or the commit point, whichever comes first" (Tab BB-5). A verbal "ROTATE" call made by MQ-9 sensor operators is standard operating procedure and is used as the "abort no later than air speed," as depicted in the i3 SkyRange KVCCV Standards dated 2 June 2022 (i3 SkyRange Standards) (Tabs BB-21, V-1.9, V-2.10, V-4.7). The MSO did not verbalize "ROTATE" at 78 KIAS, time 10:17:27 (Tabs N-4, V-4.7). Between 82-83 KIAS, at 10:17:28 PST, an "ABORT" call was made by the MSO (Tabs H-26, V-4.7). The MP acknowledged the "ABORT" call and executed takeoff abort procedures at 91 KIAS, time 10:17:32 when the MA was 1-foot above ground level (AGL) (Tabs H-26, Tab EE-4, V-2.10 to V-2.11). Both the MP and MSO recognized the MA went airborne at 92 KIAS (Tab N-5, EE-4). The MA climbed to an altitude of 18 feet AGL (Tab H-3). The MP subsequently directed the MSO to, "Kill the GDT (Ground Data Terminal)" (Tabs N-5, V-1.10). The MSO switched off the GDT power switch at 10:17:39 PST while the aircraft was stalled (67 KIAS, 2 feet AGL over the centerline of the runway) (Tabs N-5, V-2.11, Tab EE-4). The MA subsequently went lost link (losing all remote-control communication), impacted the runway, and veered off the paved runway surface into the dirt infield area (Figure 1) (Tabs N-5, Z-1, and FF-7).

Upon the MA departing the prepared runway surface the MA’s radome, sensor suite, landing gear, and engine were destroyed (Tabs H-5, H-26, and EE-4).

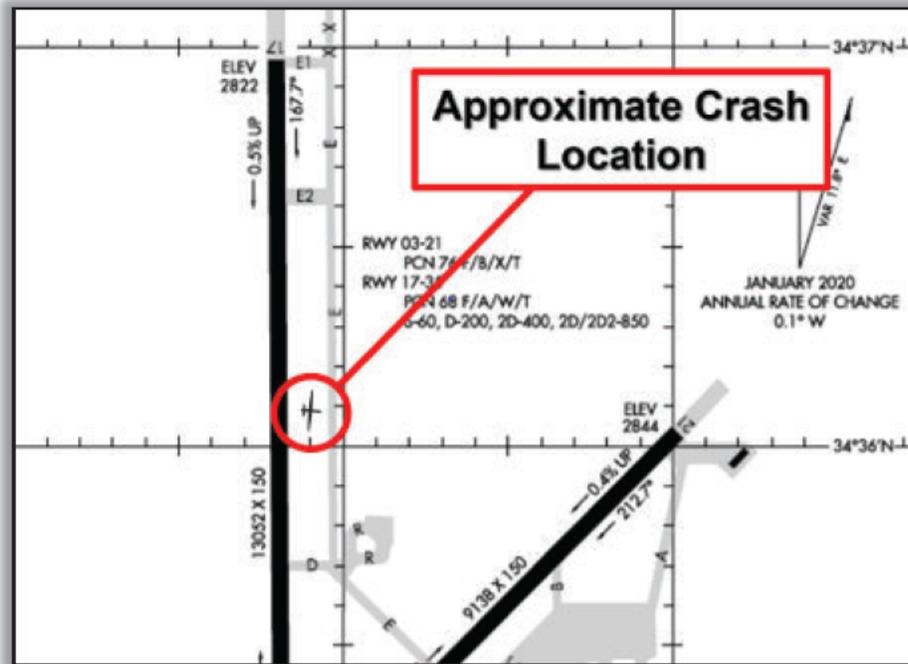
Southern California Logistics Airfield Diagram – Approximate Crash Location (Tab Z-1)

The MA impacted SCLA Runway 17, on the prepared runway surface, 4-5 feet left of centerline with the nose of the MA canted 1 degree to the right (Tabs EE-4, FF-6). All three of the landing gear impacted the runway nearly simultaneously (Tab EE-4). As the MA careened into the dirt surface surrounding the runway, all three landing gears collapsed causing catastrophic damage to the aircraft’s radome, lower data link antenna, MTS, and the engine (Tab EE-4). The MA came to a complete stop approximately 6000 feet down Runway 17, approximately 140 feet from the runway on the infield to the left, facing eastward (Tab Z-1).
