**UNITED STATES AIR FORCE**  
**AIRCRAFT ACCIDENT INVESTIGATION**  
**BOARD REPORT**

**T-38A, T/N 67-14831**

**LOCATION: HOLLOMAN AIR FORCE BASE, NEW MEXICO**

**DATE OF ACCIDENT: 27 FEBRUARY 2023**

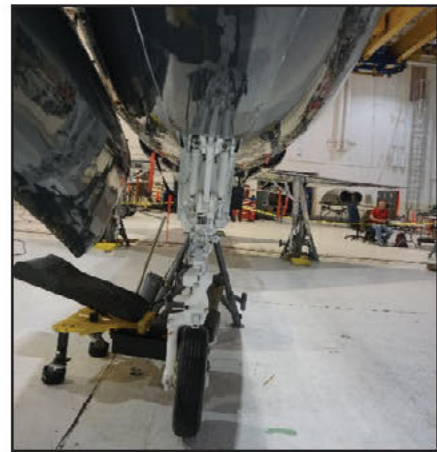
Figure 1, MA's NLG Day After Mishap (Tab Z-58)

When the MM performed the lube maintenance task on the NLG, the NLG retracted and caused the nose to collapse altogether (Tabs V-8.9 and V-9.16). The upper drag brace assembly, lower drag brace assembly, left side bungee spring, right side bungee spring, left retraction linkage, right retraction linkage, left shoulder bolt, right shoulder bolt, and NLG actuator were submitted to the Accelerated Material and Processing Solutions Branch at the Air Force Research Laboratory (AFRL) for analysis (Tabs I-3 to I-5 and I-7 to I-8).

The AFRL report states there were no fractured or significantly deformed components observed during testing (Tab D-35). Wear limitations were observed, but results were inconclusive as to the significance of these conditions as a contributing factor to the mishap itself (Tab D-35). Further, the AIB members did not observe any damage upon examination of the NLG safety pin. This suggests the NLG safety pin was not installed at the time of the incident.

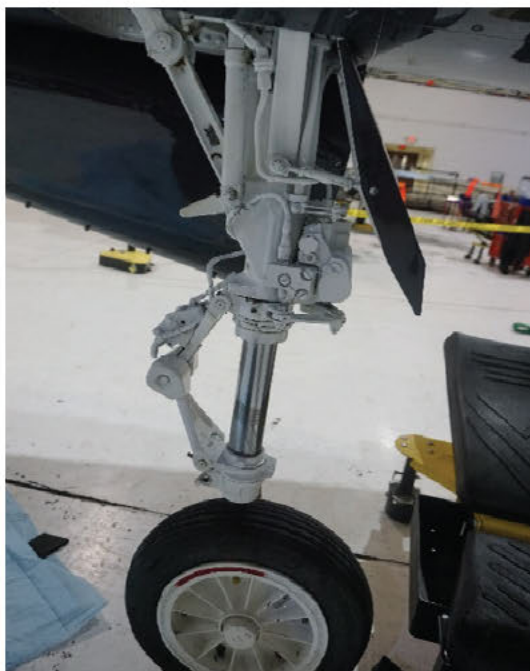
Figure 2. MA's NLG  
Day After Mishap (Tab Z-56)

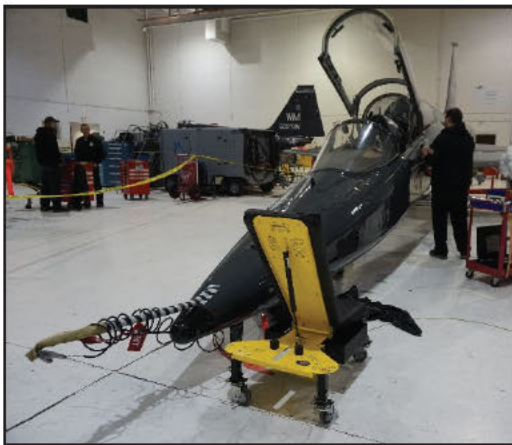
Figure 3, MA Day After Mishap (Tab Z-24)

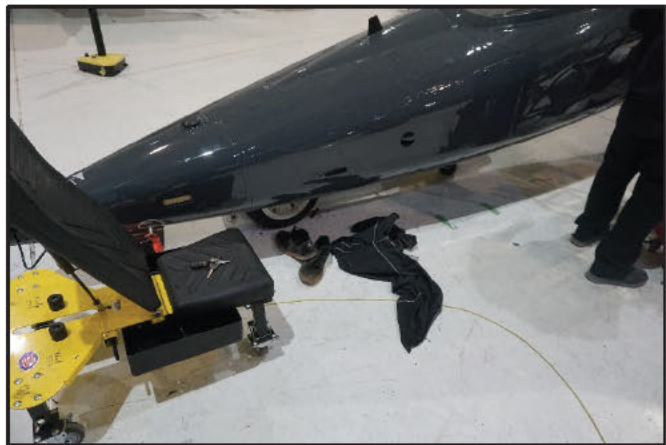
Figure 4, MA Day After Mishap (Tab Z-22)
