**EXECUTIVE SUMMARY
UNITED STATES AIR FORCE
AIRCRAFT ACCIDENT INVESTIGATION**

**MQ-9, T/N 13-4244
CANNON AFB, NM
5 SEPTEMBER 2023**

MQ-9, T/N 13-4244
CANNON AFB, NM
5 SEPTEMBER 2023

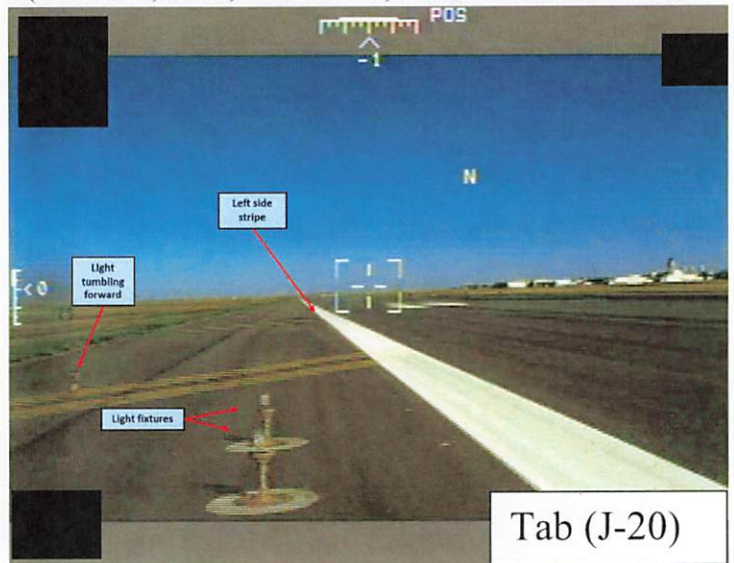
MP 1 and MP 2 completed a crew swap at 0901L (Tabs R-3, R-36, and V-2.17). MP 2 received clearance from the ATC for a touch-and-go landing with crosswinds at 16.45 knots (Tabs N-7 and V-2.18). MP 2 then initiated approach 7 (Tab V-2.18). Just prior to touchdown, MP 2 released crosswind controls (Tabs J-4, V-2.18, and AA-7). At 09:03:43L, the MA touched down and began drifting to the far-left side of the runway (Tabs J-5, R-56, R-69, V-1.18, V-1.19, V-2.18, V-3.7, V-4.20, and V-4.23). Once the MA crossed the left side runway edge stripe, the runway-shoulder illumination lights were visible from the MTS-TU camera feed as they are located on the asphalt shoulder of the runway (Tabs J-8 and V-2.24). While traveling along the shoulder, the MA struck three runway-shoulder illumination lights (Tabs J-5, V-11.1, and V-12.1). At 09:03:53L, the MA lifted off and returned to pattern altitude (Tabs V-2.18 and AA-4).

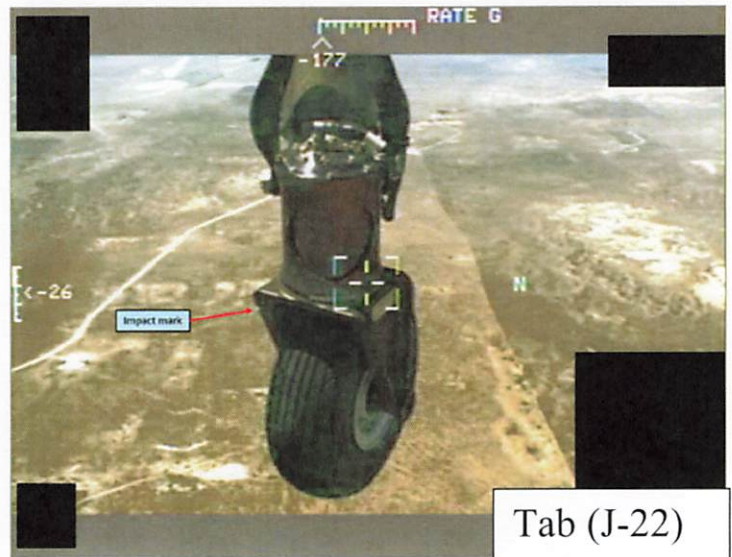
The MC departed the terminal airspace to troubleshoot before attempting a final landing (Tab V-2.26, V-5.12, V-5.14, and V-7.13). “Terminal airspace” or “the range” refers to a large area approximately ten minutes away from the airfield (V-2.27). MP 1 and the MSO had internal opinions about the cause of the nosewheel steering malfunction, but the MC did not discuss potential causes (Tab V-1.32, V-2.19, V-2.21, V-3.13 to V-3.14, V-3.16, V-3.18). An impact to runway edge lights was not part of the troubleshooting process until approximately 35 minutes prior to the mishap final landing when the MC identified the right main hydraulic brake line had been severed (Tabs R-37, V-3.16, V-4.21, V-4.25, V-4.30, V-5.7, V-5.13, V-8.18, V-8.20, V-12.1).

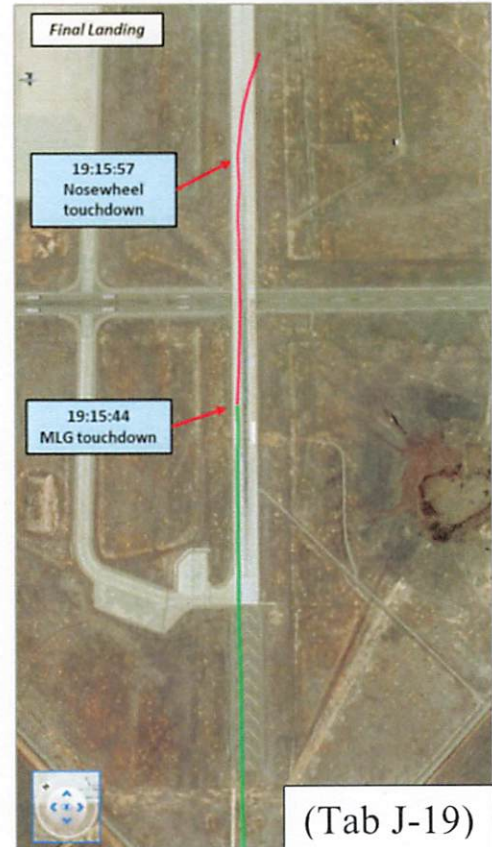
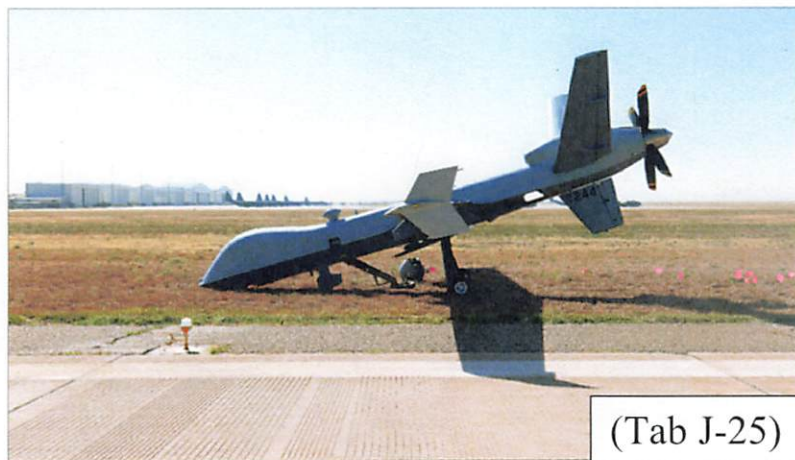
After approximately three hours of troubleshooting while orbiting at high altitude, the MC prepared to land the MA (Tabs R-37, V-1.27, V-2.22, and V-3.16). The MA elected to return to base (RTB) with 1000 pounds (lbs) of fuel rather than the minimum 400lbs (Tab V-1.28 and V-2.27). This may have reduced the landing distance by approximately 300 feet (ft) as the weight difference would have allowed the MA to stop sooner (Tab AA-2). The MA approached Runway 04, the runway with more favorable winds (Tab V-8.21, V-10.5, and V-11.1). The MC referenced the Nosewheel Steering Malfunction emergency procedure checklist and aligned toward the left edge the runway to account for the direction of the deviated NLG (Tabs R-37, R-57, V-1.27, V-2.22 and V-8.10). At 13:15:44L, the MLG touched down (Tab J-4). At 13:15:59, the NLG touched down and the MA began veering toward the right side of the runway (Tabs V-9.18, V-11.1, and Tab AA-5). At 13:16:07L, the MA departed the paved surface and entered terrain (Tabs V-1.28 and AA-5). Approximately 27ft from the runway, the NLG completely collapsed, causing the MA to come to a full stop (Tabs J-19, V-9.18, and AA-5). Without the NLG strut, the MA's nose was unsupported, tipped forward to hit ground (Tabs J-3, J-25, and V-9.18). Hitting the ground caused the MTS-TU to detach from the forward fuselage and land on the ground next to the MA (Tabs J-6 and V-9.19). The MC completed the air vehicle (AV) shutdown procedures and 27 SOW emergency responders were dispatched to the crash site (Tab V-1.28, V-2.22, and V-10.2).
